I/M/O the Board's Investigation Into Reliability Issues Related to New Jersey American Water's Swimming River Water Treatment Plant Pipe Bridge Collapse in Monmouth County

Prepared for
State of New Jersey Board of Public Utilities

February 15, 2013

CH2MHILL®

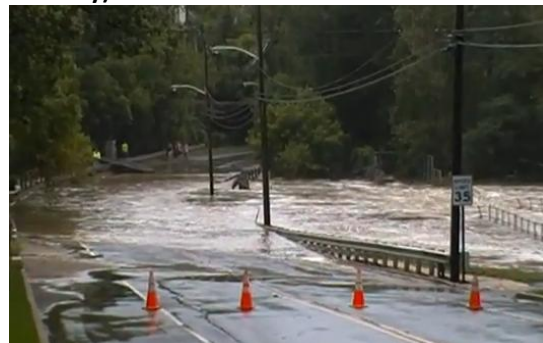
FIGURE 1
View of Inundated Pipe Bridge (to right of roadway)

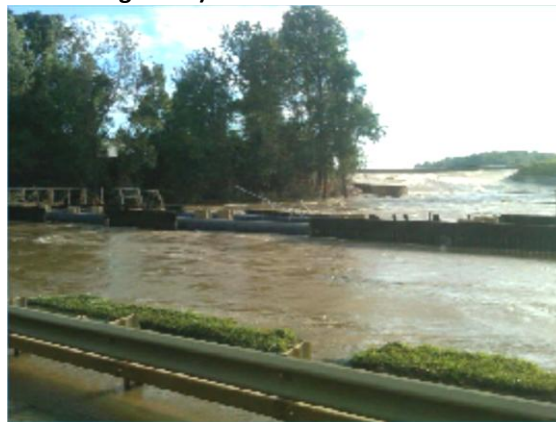
FIGURE 2
View of Inundated Pipe Bridge (beyond grassed area in the foreground)

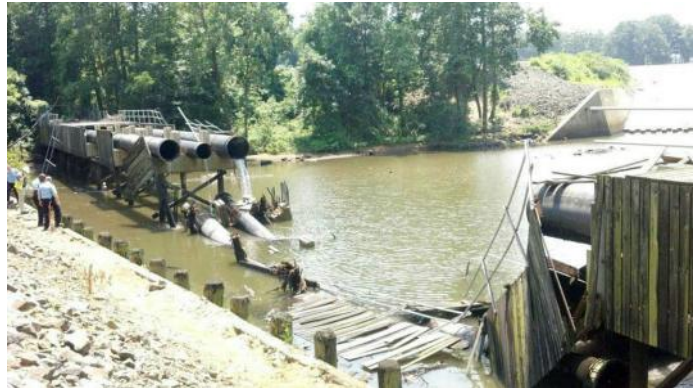
FIGURE 3

On June 29, 2012 at approximately 12:45pm, the SRWTP pipe bridge failed. The bridge failure was sudden and catastrophic, severing the three pipelines and disrupting water service. Figure 3 shows the failed pipe bridge and severed pipelines, a few days after the collapse.

Failed Pipe Bridge

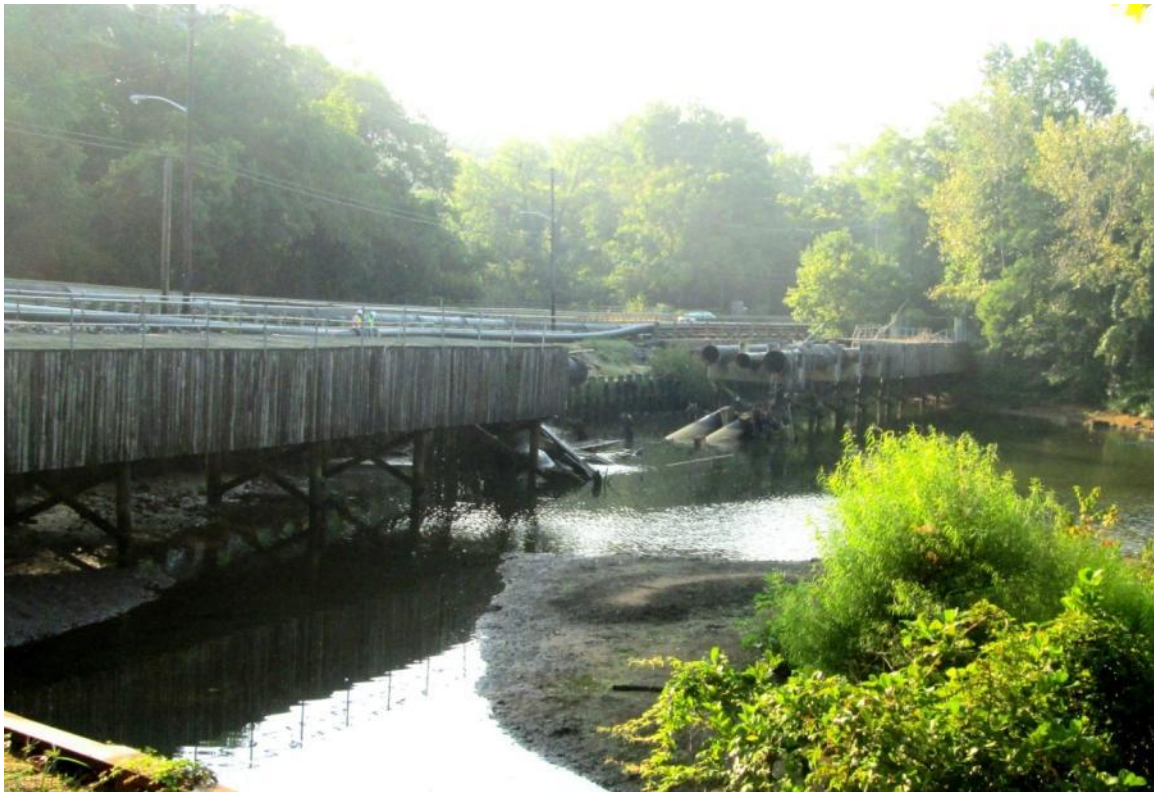
Swimming River Pipeline Bridge – August 2012. Note collapsed central portion

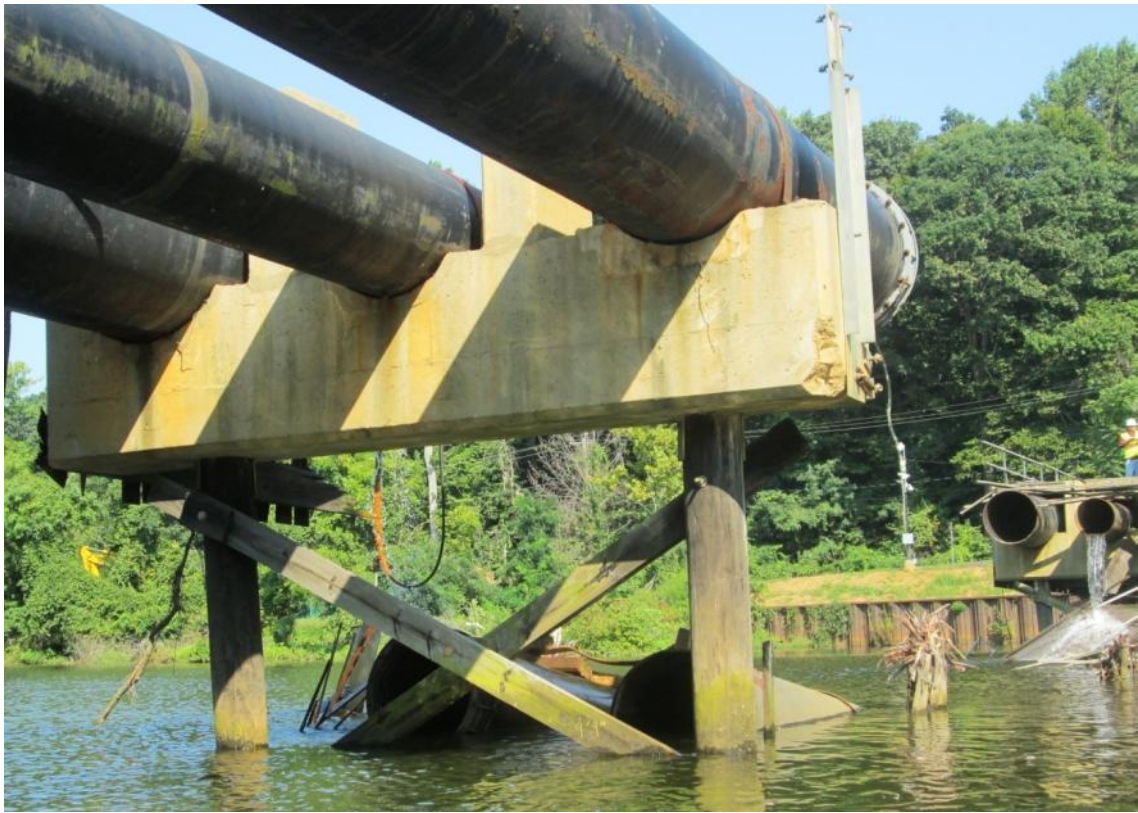
Pile Cap 6B - Typical pile bent with concrete pile cap. Note concrete cross bracing on timber piles and vertical steel channel on edge of pile cap

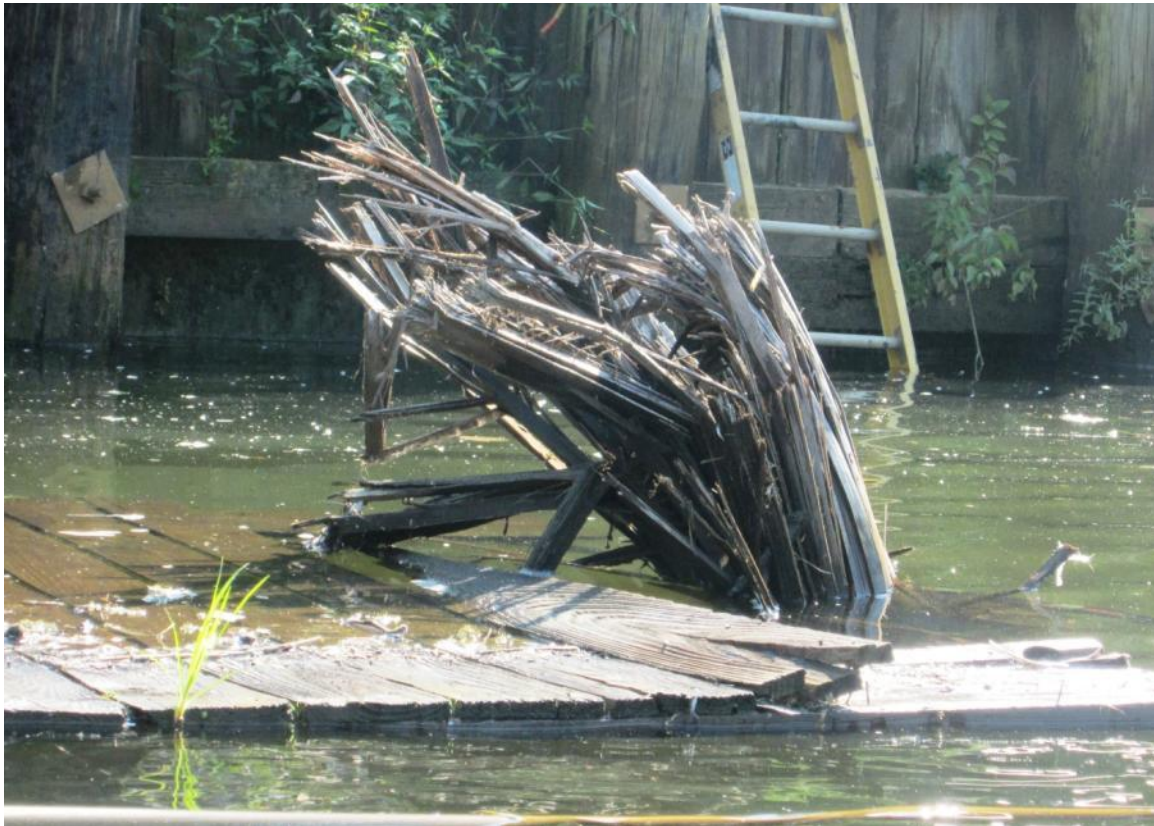
Timber Pile 5A East - Typical failed pile
