**Re: *Reconstruction of Bear Tavern Road
 Bridge Number 214.2 (1100-060)
 Bear Tavern Road Bridge (CR579) over Jacobs Creek
 Priority E Repair***

**JACOBS CREEK BRIDGE
PLAN AND ELEVATION
SKETCH**

COUNTY BRIDGE #1100-060
 COUNTY ROUTE 579 OVER JACOBS CREEK
 HOPEWELL TOWNSHIP, MERCER COUNTY

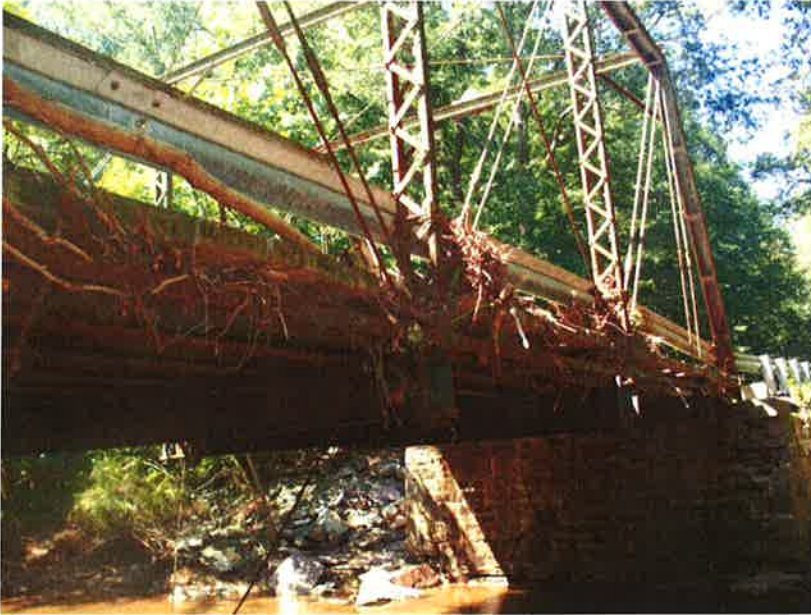
Floodwaters have caused numerous abutment stones to dislodge or loosen directly below all four truss bearing support points. In addition, it was evident that floodwaters overtopped both the bridge and approach roadway, as noted by the large amount of debris lodged in floor support members and on the top of the deck (See Photo 1), pavement failure and a large scour hole which has formed on the southwest quadrant of the bridge. The Bridge southwest wingwall fronting the scour hole has collapsed (See Photo 2).

Photo 1: General view showing large amount of flood debris lodged between the lower chord of the truss and the bridge mounted guide rail. Photo taken on the north side of the bridge looking south-west.

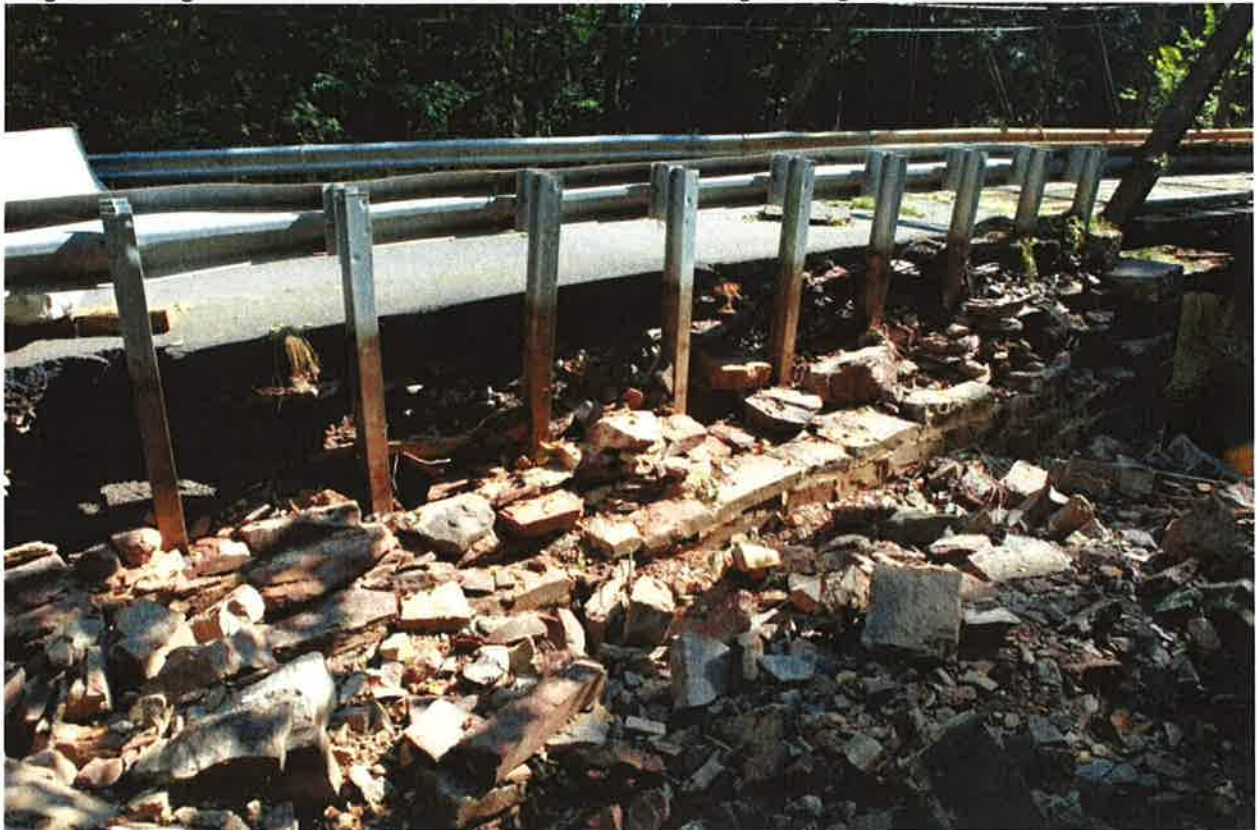
A significant portion of the existing southwest wingwall has collapsed and the existing roadbed has become undermined which likely occurred from the floodwater overtopping the roadway at this location (See Photos 2 and 7). Severe scouring has occurred at the Northeast, Southeast and Southwest embankments, as noted in the before and after photos in Photos 8 through 11.

Photo 2: Complete failure of the stone wing wall on the southwest quadrant of the bridge due to large scour hole in front of the wall. Looking Northeast

Dismantle Structure – This option proposes the dismantling of the existing historic truss and storing reusable historic elements for future rehabilitation and erection. This structure will need to be removed by a qualified contractor in a carefully planned manner with the greatest care practical as not to damage the existing truss components. Existing components will need to be braced as required during demolition to prevent buckling or damage during salvaging operations. The bracing will need to be designed by the Contractor as part of his/ her means and methods and reviewed by a Structural Engineer. Existing abutment & wingwall stones shall be removed and stockpiled for future use and the stream bed and banks stabilized.

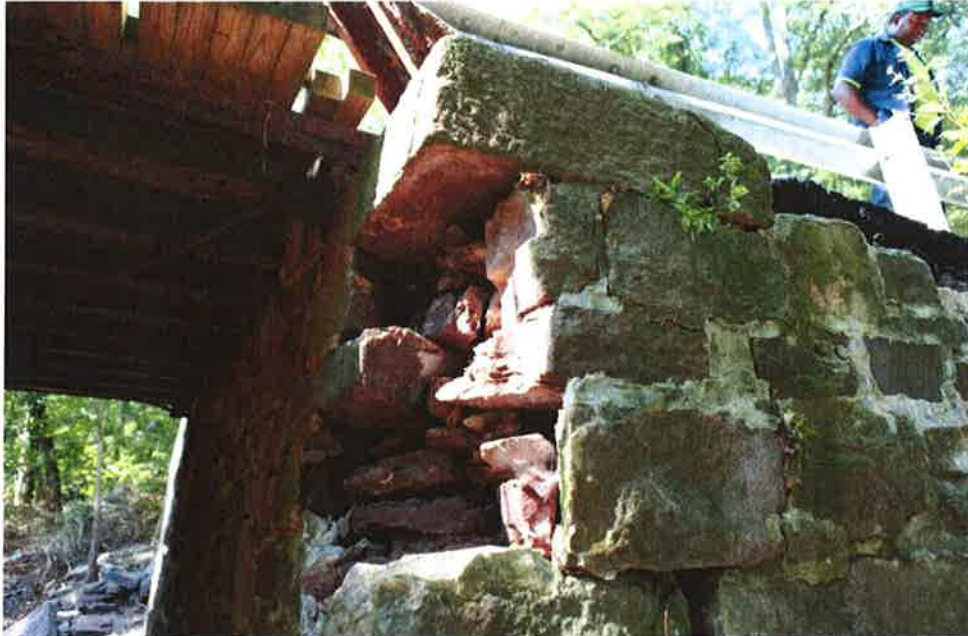
Most of the pointing between abutment stones is missing under the truss bearings (See Photos 3,4,5, 6, 11 and 12). Capstones and supporting foundations below each bearing point show signs of settlement (east side) with voids forming below each support (west side). Significant areas of concern were noted at the northwest corner and east abutment corners which compromise the bridge's structural stability. At the northwest corner, masonry abutment stones have completely dislodged (See Photo 3) creating large voids below the capstone undermining more than 50% of the support area. Only one remaining stone supports the bridge at this bearing point (See Photo 4). Failure of this stone will likely result in a partial or complete collapse of the bridge superstructure. At the eastern abutment, both bearings have settled downwards and rotated (See Photos 5, 6, and 12). At the southeast corner, the top of the stone abutment breastwall is bowed slightly outwards (towards the west). Continued or future settlement / bowing of this abutment will result in complete failure of the easterly abutment and subsequent collapse of the bridge.

Photo 3: Area of significant concern at the northwest corner of the structure. A large void has developed below the capstone undermining more than 50% of the support area.

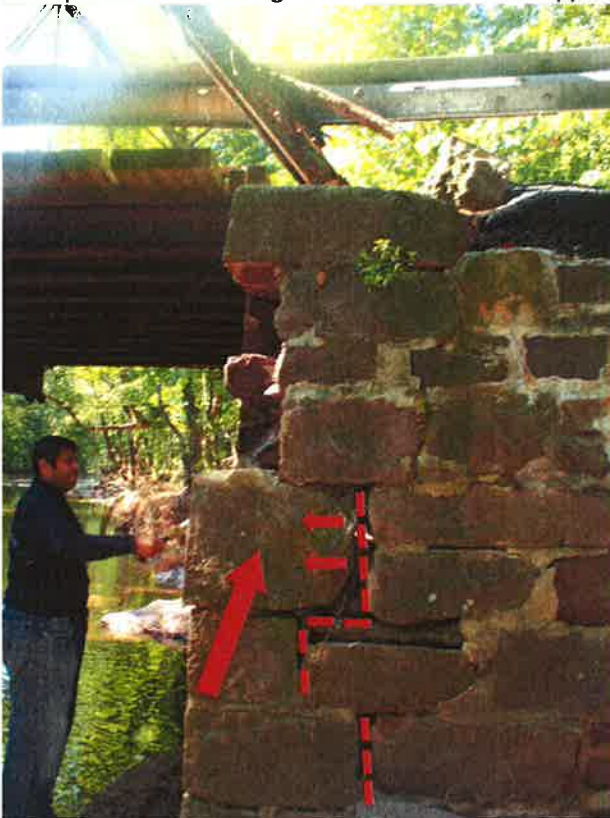
Photo 4: Note if one large stone becomes dislodged then a collapse or partial collapse of the superstructure is likely. Looking Southwest

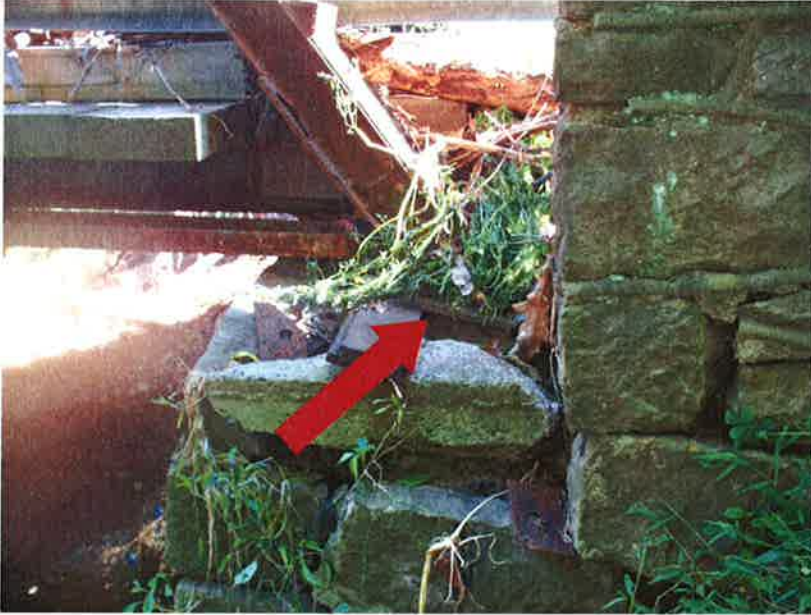
Photo 5: Southeast truss bearing exhibits settlement and rotation due to movements of the substructure. Note the loose supporting stone and lack of mortar between stones directly below the bearing. Looking north

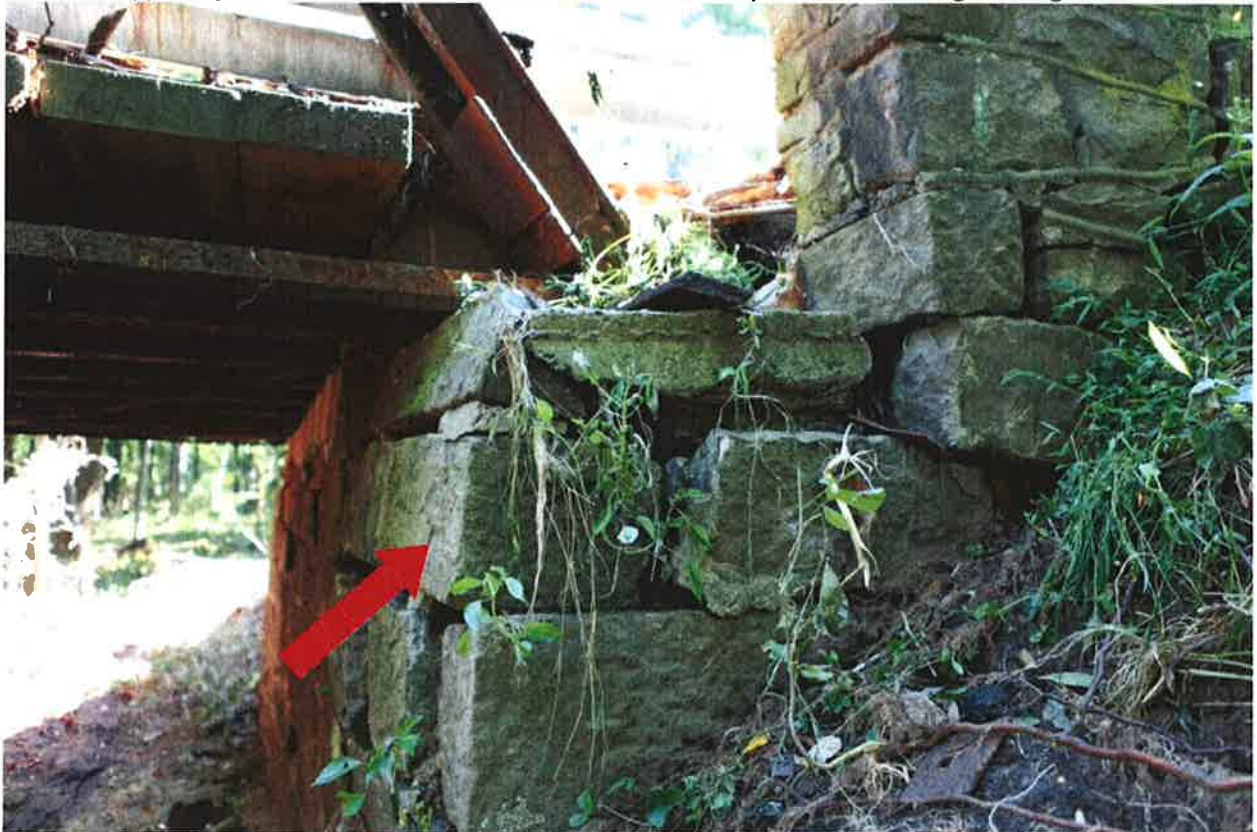
Photo 6: Loose bowed stone below the Southeast truss bearing. Looking south

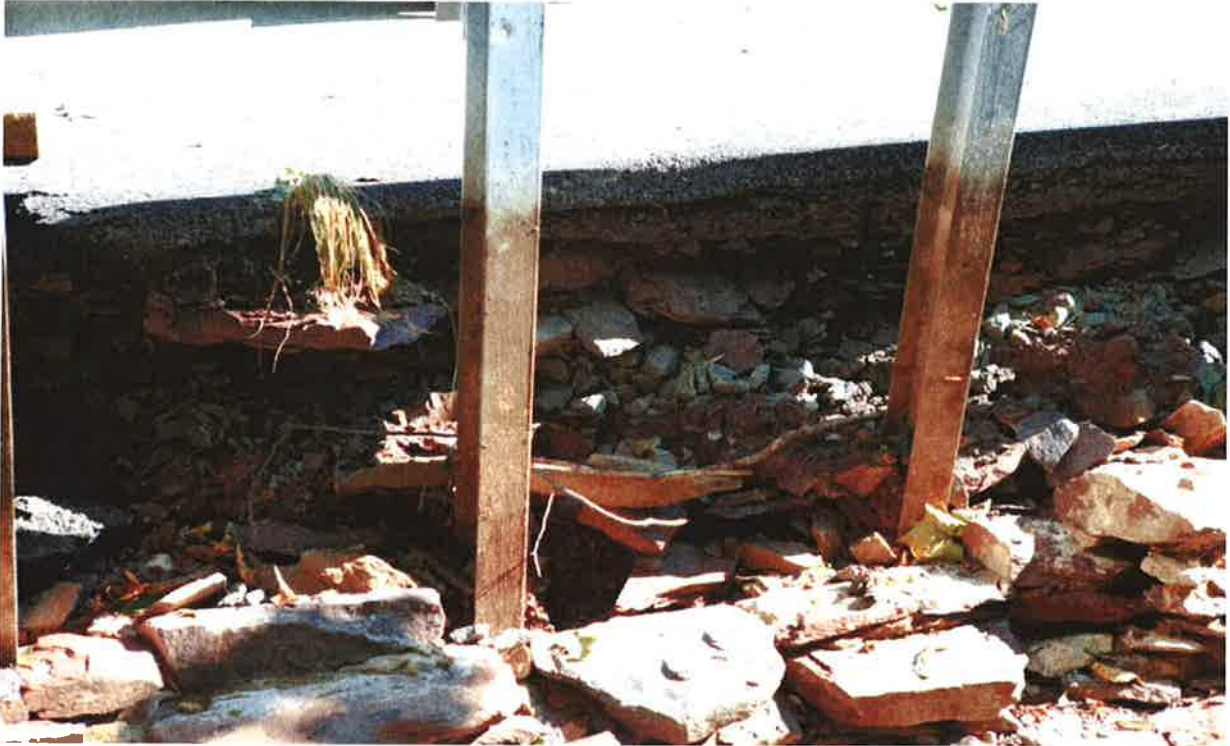
Photo 7: Undermining of the west approach roadway on the south side due to overtopping floodwaters. Looking North

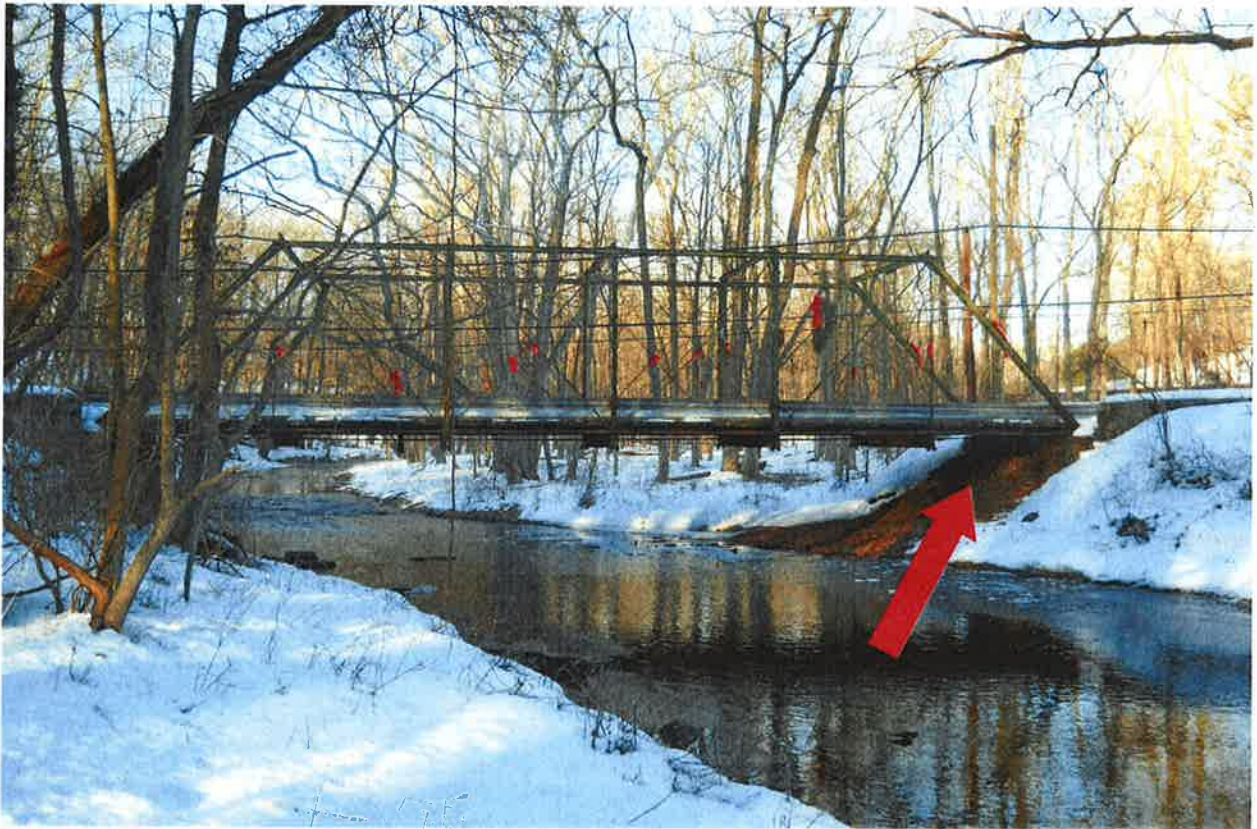
Photo 8: South Elevation of the bridge taken in February 2011. Note the location of the easterly riverbank. Looking North.

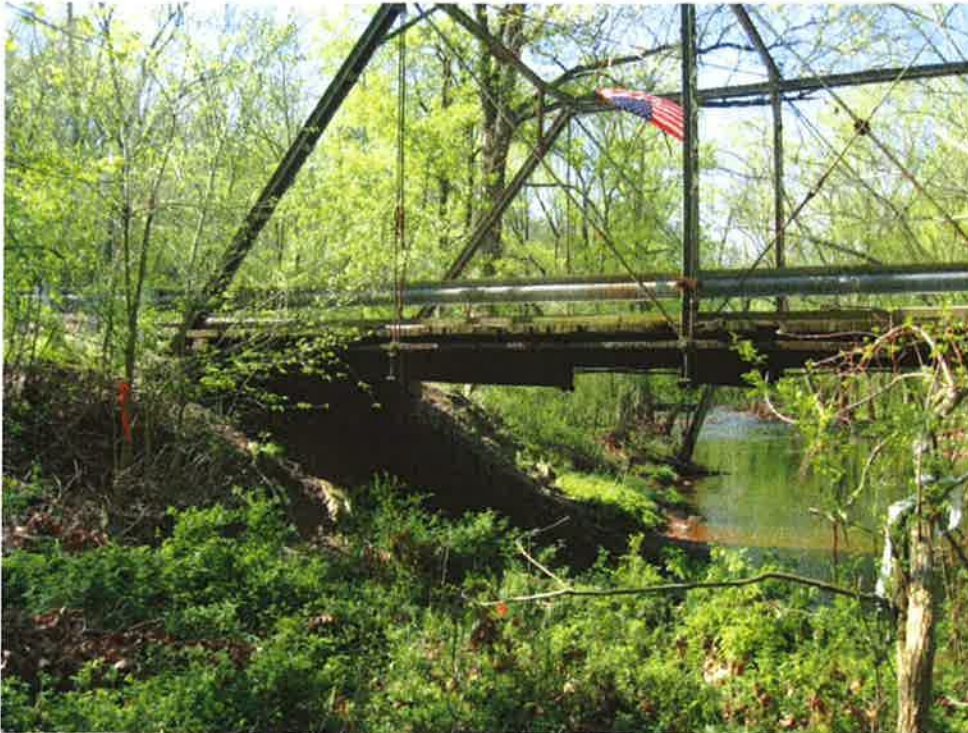
Photo 9: Location of embankment in front of the easterly abutment looking east. Photo taken on 4-27-11.

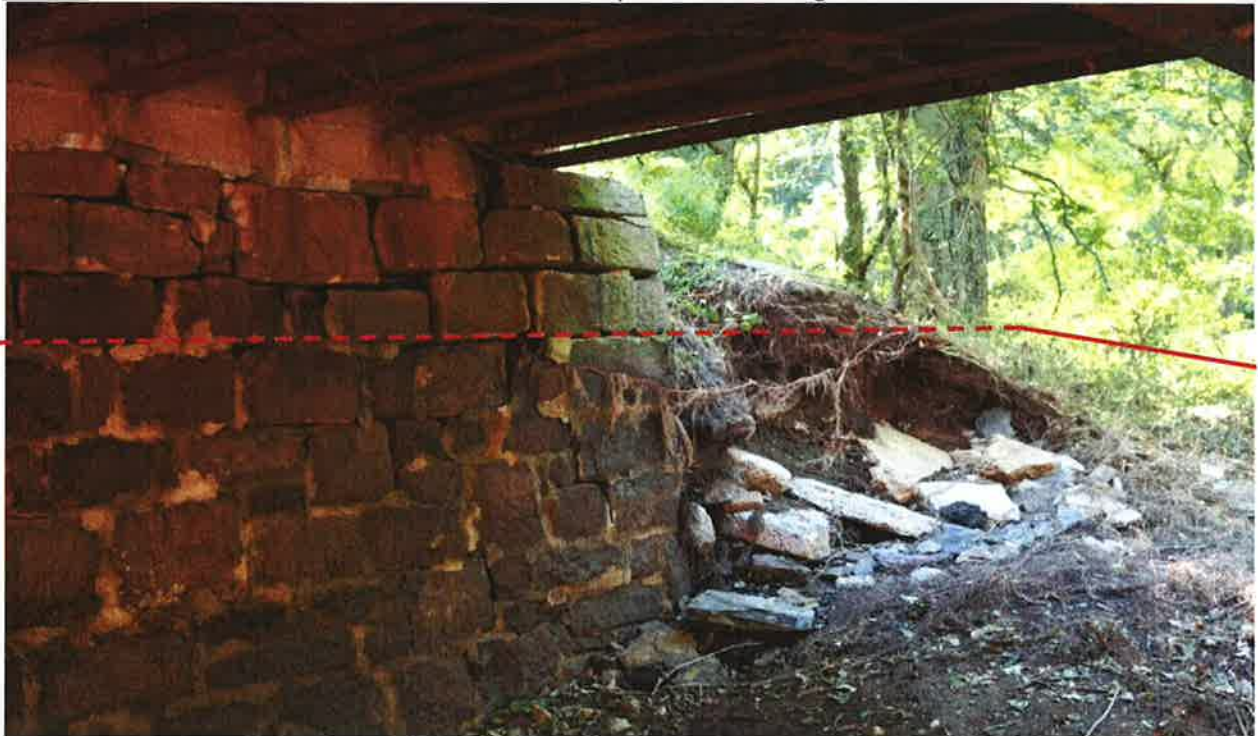
Photo 10: Location of embankment in front of the easterly abutment. Note the significant erosion in front of the stone abutment wall as compared with photo 9 and large scour hole on the southeast corner. Photo is looking southeast.

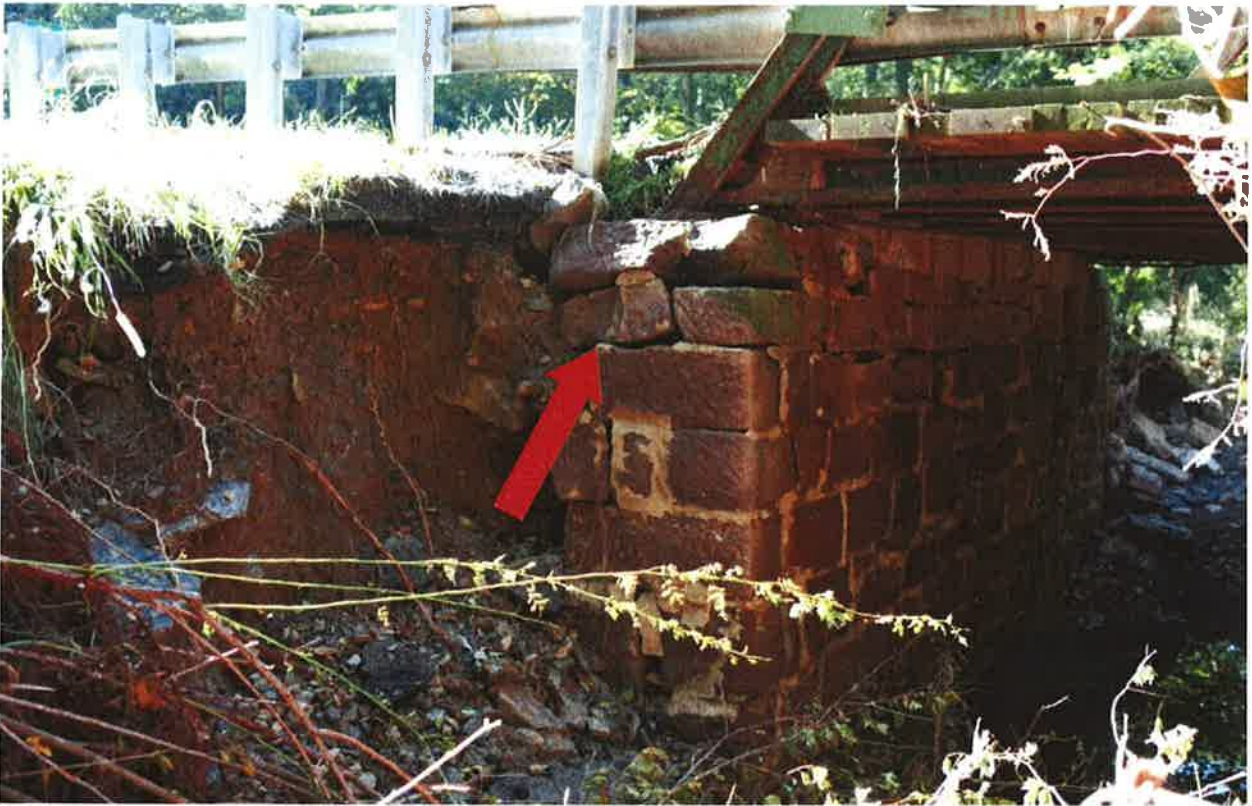
Photo 11: Large scour hole on the northeast corner of the bridge. Also note loose un-pointed stones below the truss bearing. Photo is looking southeast.

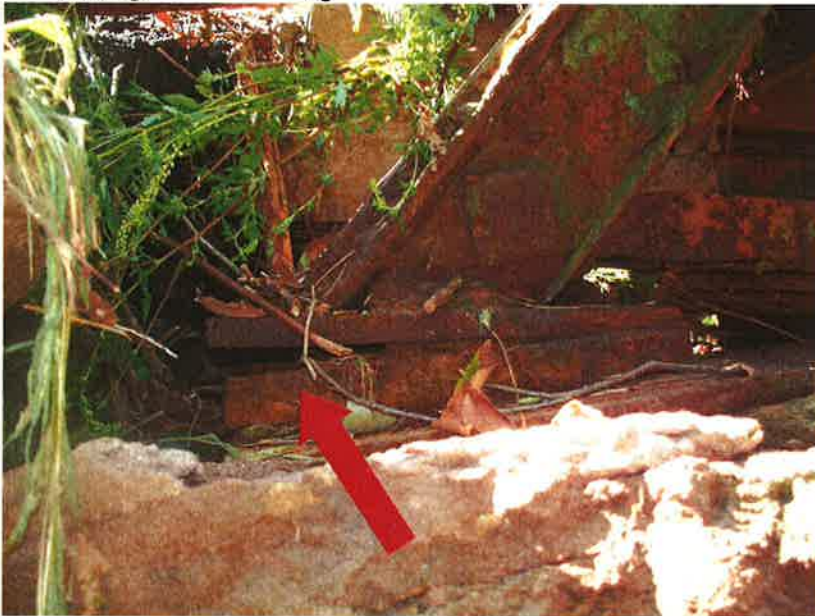
Photo 12: Rotated bearing and settled/bowed abutment.

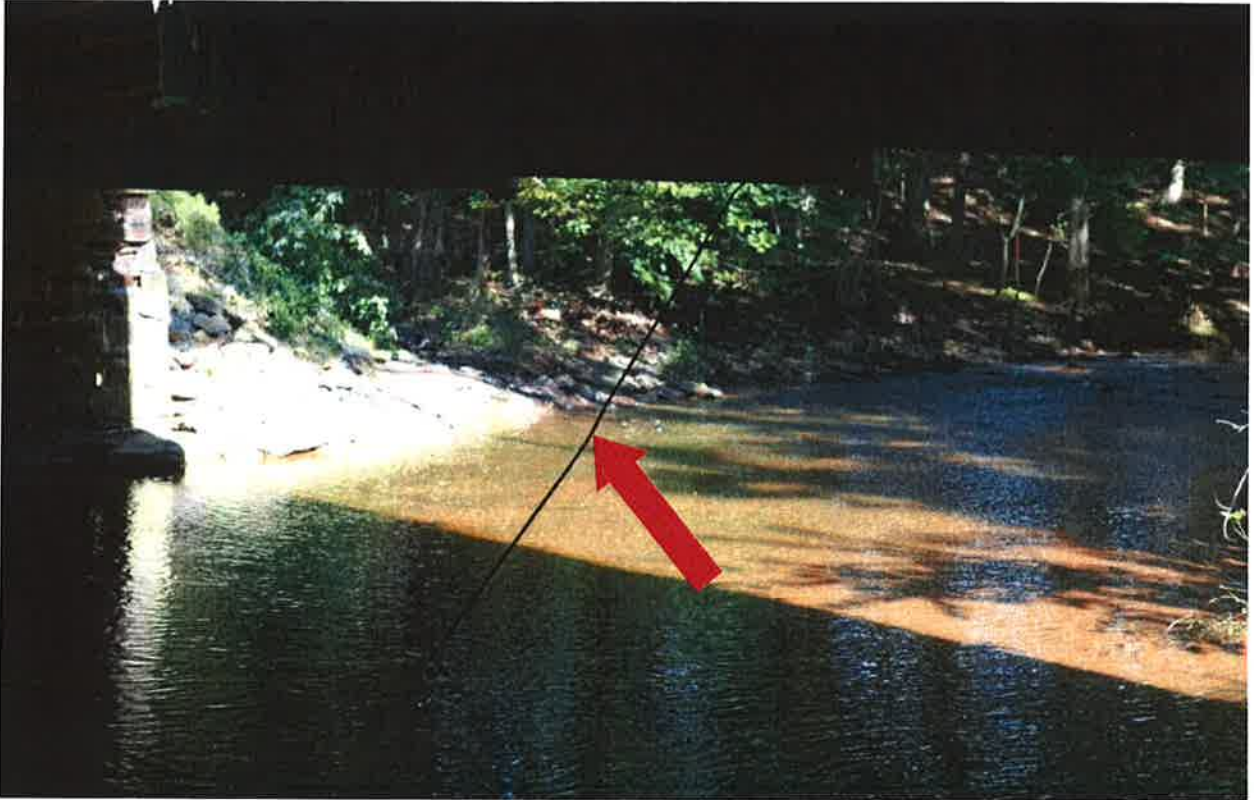
In addition, a few lateral bracing members have become severed below deck and are hanging downwards into the riverbed (See Photo 13) which will reduce the structural stability of the superstructure.

Photo 13: Loose underdeck lateral bracing members hanging down off the superstructure. Looking North
