NEW JERSEY DEPARTMENT OF COMMUNITY AFFAIRS
DIVISION OF FIRE SAFETY
OFFICE OF THE STATE FIRE MARSHAL

SAFETY ALERT 13-3

Honeywell Fire Systems BG-10 Series Pull Station Operation Issue Issued April, 2013

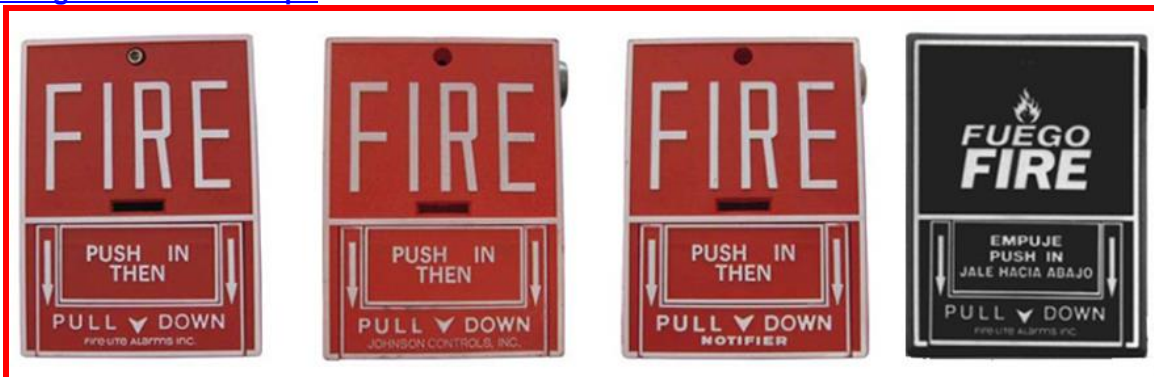
The issue is related to the seal installed around the alarm switch, which can deteriorate over time preventing the switch from signaling an alarm when the pull station is activated. Detailed information regarding this issue can be found at: <http://www.pullstationsafety.com>

Examples of manual pull stations that may be affected by this issue

Fire Officials and Inspectors should be aware of this issue when conducting inspections in buildings equipped with these pull stations. While it is possible that there may be no issues detected when tests of these pull stations are conducted by licensed fire alarm contractors, due to the age of the majority of these pull stations, Honeywell Fire Systems advises that replacement of BG-10 series pull stations is highly recommended.

If the BG-10 series pull stations are not replaced, Fire Officials and Inspectors must ensure that all installed BG-10 series pull stations are inspected and tested in accordance with NJ Uniform Fire Code requirements by a licensed contractor in accordance with N.J.A.C. 5:74-2.2 (a) 1. Additionally, if pull stations are not replaced, a new, free of charge, factory provided alarm switch seal should be installed once it has been documented by the Fire Official that the seal has not been replaced. In addition to replacing the seal, these pull stations should be inspected for cracking/fracturing of the plastic housing or bending of the pull station back plate. Any pull station showing signs of cracking of the housing or bending of the back plate should be replaced.
