ASBESTOS SURVEY REPORT

NEW JERSEY DEPARTMENT OF ENVIRONMENTAL PROTECTION ENVIRONMENTAL REVIEW CDBG-DR PROGRAM

Applicant ID NCR39505
LAKEVIEW FIELD
LITTLE FERRY, NJ 07643

Prepared by Inspector: MICHAEL COLLINS/LUIS MONROY 10/17/2014

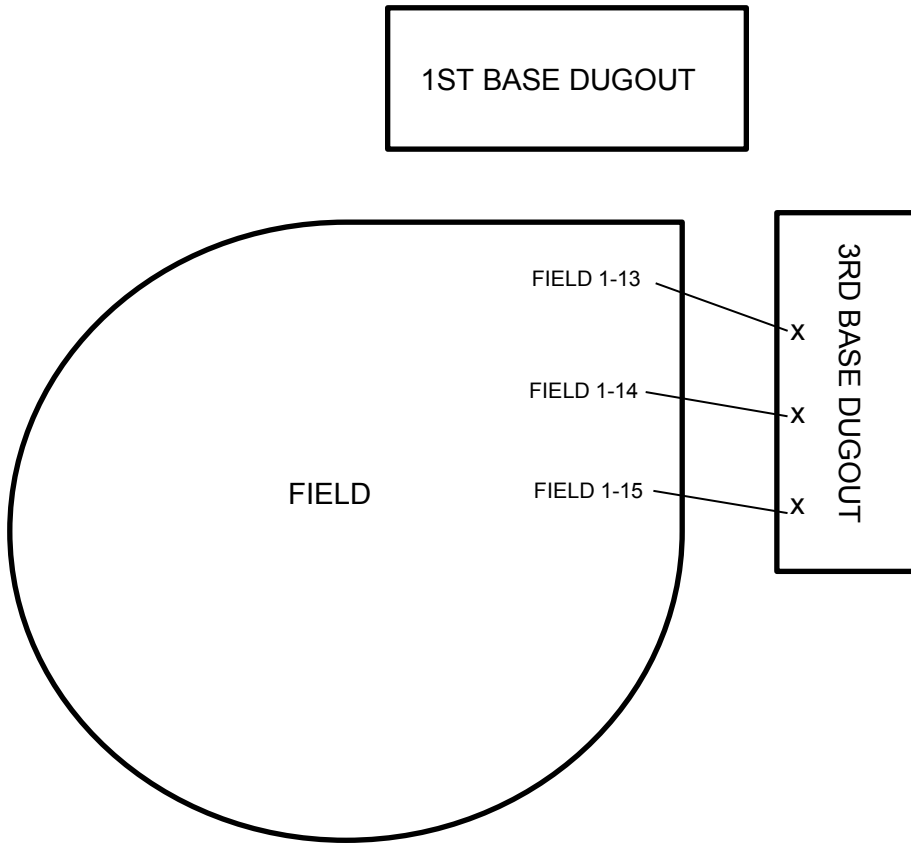
Unit Plan (field 1 dugout)

Three samples tested positive for asbestos. All were from a dugout in the North East (NE) corner of Field 1 (See Unit Plan for Field 1 Dugout). There are two dugouts in the NE corner of Field 1. Damage from the storm has left 20 percent of the roof intact on the first base dugout (20 sq feet), and 60 percent of the roof intact on the third base dugout (60 sq feet). Three samples of roofing tar taken from the third base dugout tested positive for ACM. Because the first and third base dugouts are of similar construction, both should be assumed to contain ACM in their roofing material.

Table 3 presents the inclusive list of PACM and ACBM detected at the Property. This list of materials will be managed during the reconstruction and/or renovation phase as an ACBM. These materials, if disturbed during the reconstruction and/or renovation phase will require special handling and waste disposal. The Contractor will engage the services of a New Jersey licensed firm that specializes in ACBM removal prior to the renovation occurring.
