Field Assessment Form

New Jersey Community Development-Disaster Recovery Block Grant (CDBG-DR)
Hurricane Sandy Disaster Recovery Program

Applicant ID: NCR39567	
PAMS Pin: Multiple	DCA Grant Number: B-13-DS-34-0001
Applicant Name: City of Perth Amboy	Inspection Date: 10/21/2014
Damage Address: Waterfront Park and Marina Area	Inspector: Malik Rasool
Program Type: NCR	Project Description: New Construction Outside Allowable Footprint
Location Verified By: Existing recreational features	Parcel Status: Recreational features largely exist

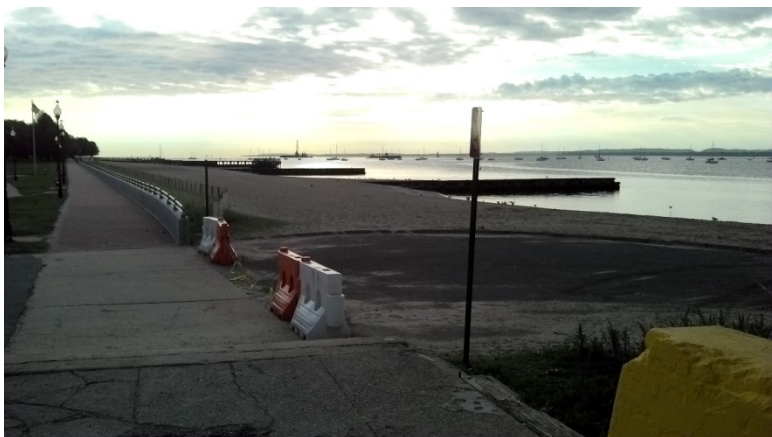
Description: New wall and sand dunes fence shown. This is in front of the City waste water pumping station.

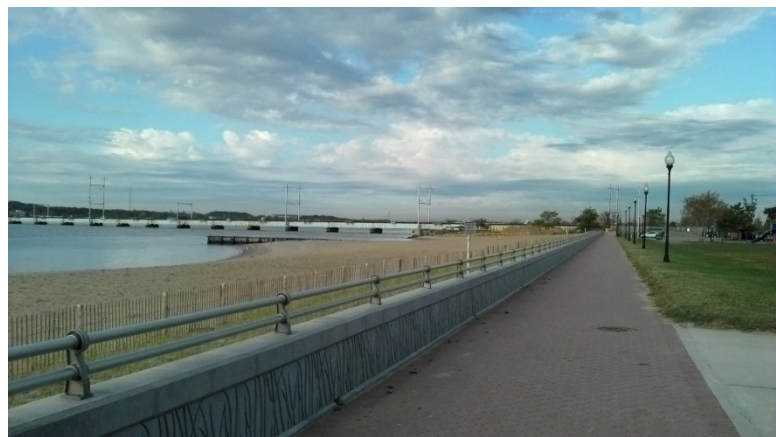
NCR39567Photo04

Description: New wall/railing, sidewalk and sand dunes fence can be seen in photo.

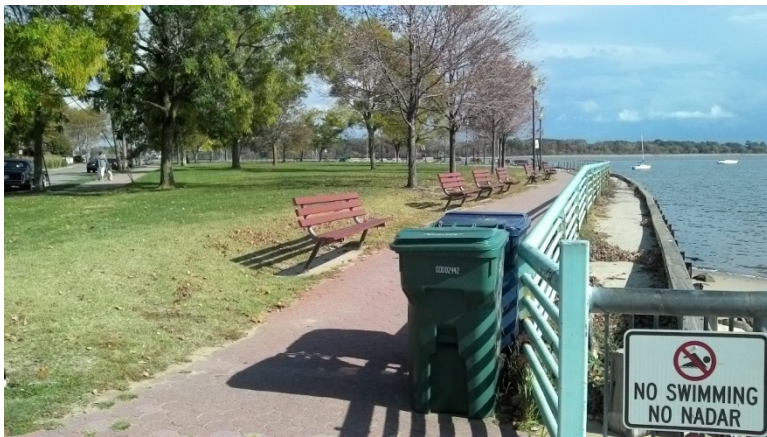
NCR39567Photo23

Description: Old railing can be seen in the photo

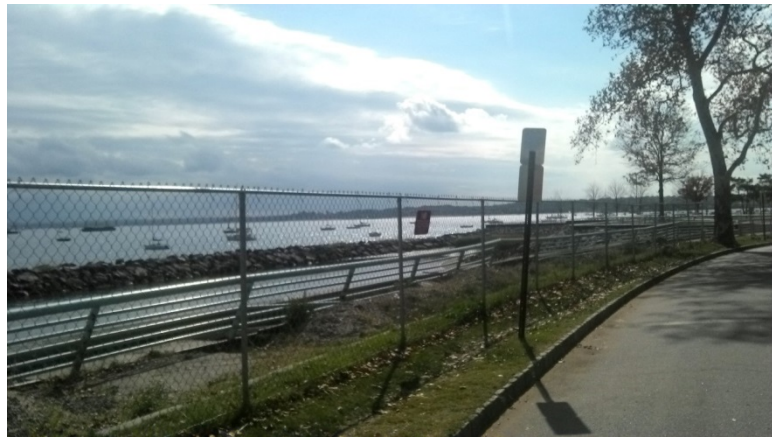
Description: Broken sidewalk

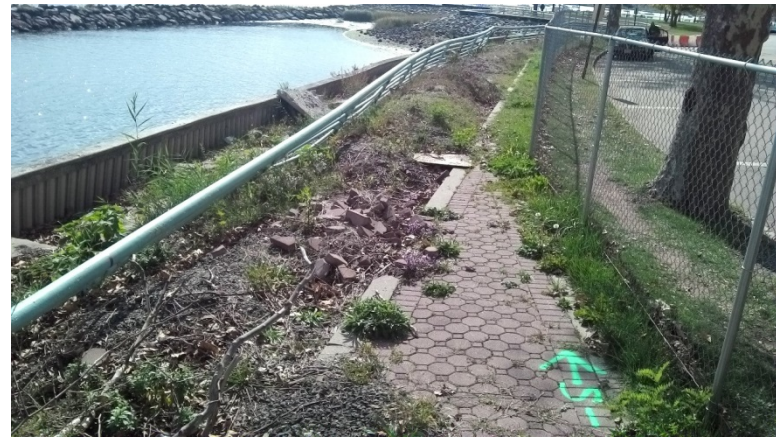
Description: Broken railing and collapsed sidewalk near Lewis Street

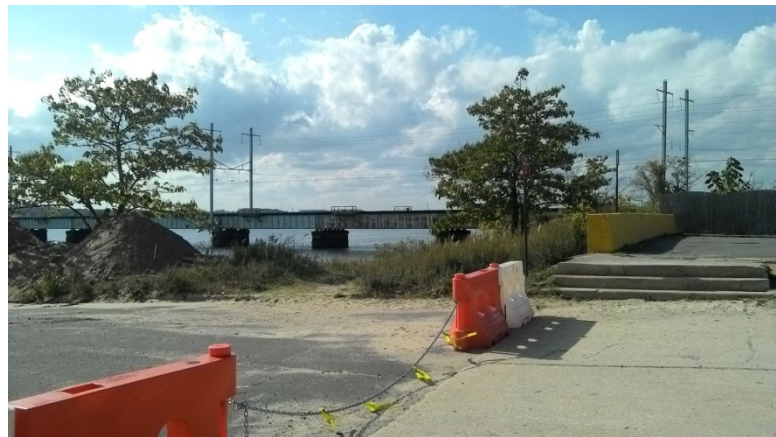
Description: Boundary of Area 1. Soil pile is outside project area.

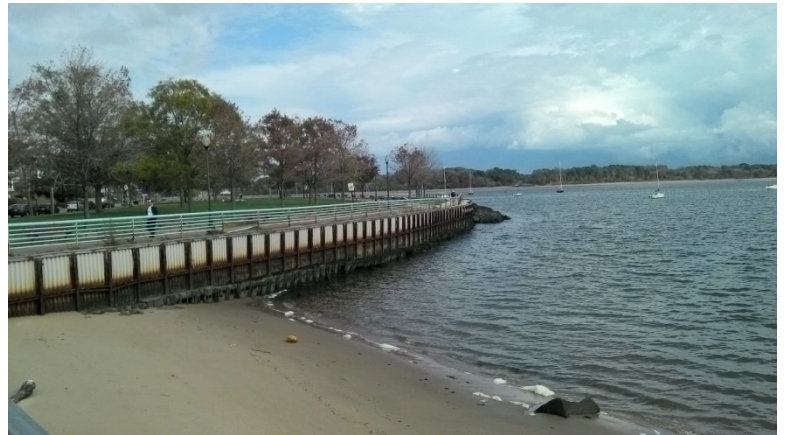
Description: Additional photo of old railing and walkway

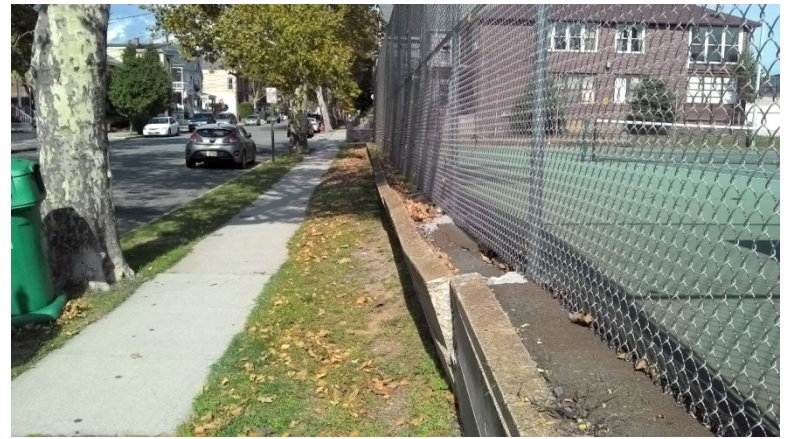
NCR39567Photo46

Description: Tennis courts with a collapsed side wall shown in photo
