Insured: William Ryan  
Property: 2 S Montgomery Avenue Apt 1  
Atlantic City, NJ 08401

**Claim Number:** RRE0006556

**Type of Loss:** Hurricane

Estimate: 06556\_RYAN\_ECR

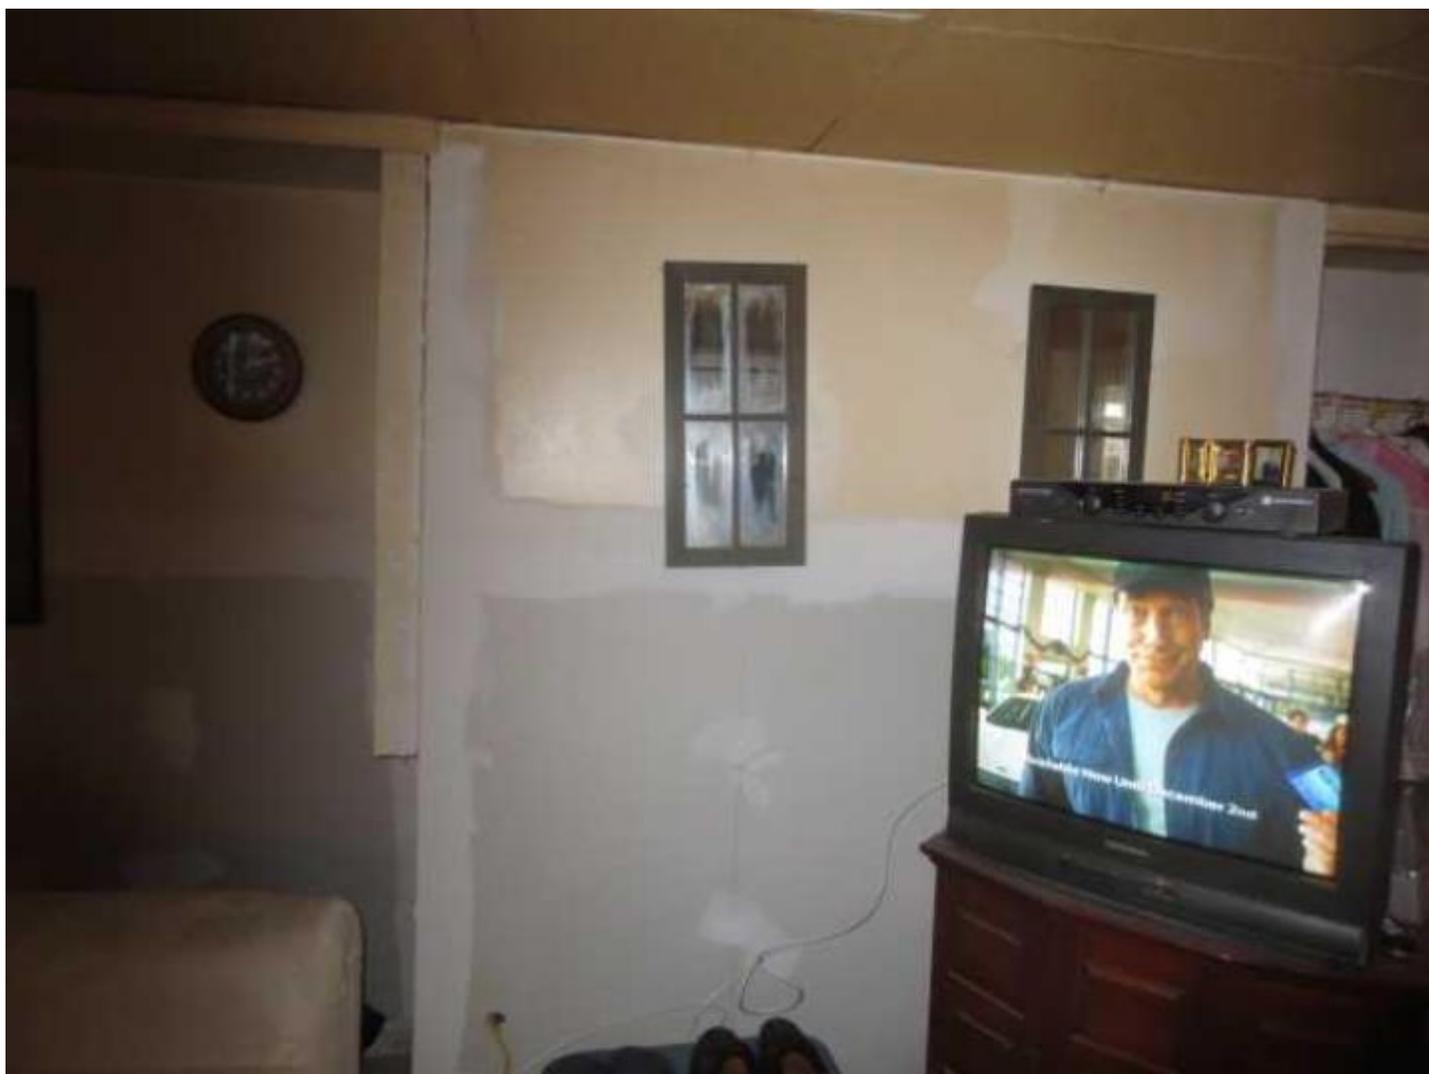
6 Living Room

<b>DESCRIPTION</b>	<b>QTY</b>	<b>UNIT PRICE</b>	<b>TOTAL</b>
12. 1/2" drywall - hung, taped, floated, ready for paint	88.33 SF @	2.10 =	185.49
<i>The above two line items are addressing drywall which has been hung only and needs to be finished.</i>

-----GENERAL ITEMS-----			
9. Content Manipulation charge - per hour	1.00 HR @	47.86 =	47.86
10. Final cleaning - construction - Residential	111.86 SF @	0.30 =	33.56
-----WALLS & CEILINGS-----			
11. 1/2" drywall - hung only (no tape or finish)	88.33 SF @	-1.30 =	-114.83

13. Seal/prime then paint the walls twice (3 coats)	176.67 SF @	1.04 =	183.74
14. Baseboard - 3 1/4"	22.08 LF @	3.32 =	73.31
15. Base shoe	22.08 LF @	1.53 =	33.78

16. Seal & paint baseboard w/cap &/or shoe - two coats	22.08 LF @	1.55 =	34.22
-----DOORS & WINDOWS-----			
17a. Remove Bifold door - Colonist - Single	2.00 EA @	14.76 =	29.52
17b. Bifold door - Colonist - Single	2.00 EA @	117.76 =	235.52

18. Paint bifold door - Single - slab only - 2 coats (per side)	4.00 EA @	26.40 =	105.60
19a. Remove Door opening (jamb & casing) - 32"to36"wide - paint grade	2.00 EA @	7.43 =	14.86
19b. Door opening (jamb & casing) - 32"to36"wide - paint grade	2.00 EA @	133.72 =	267.44

20. Paint door/window trim & jamb - 2 coats (per side)	4.00 EA @	26.56 =	106.24
-----FLOORING-----			
21. Floor preparation for resilient flooring	111.86 SF @	0.74 =	82.78

22. Vinyl floor covering (sheet goods)	128.64 SF @	4.71 =	605.89
<i>15% waste added for vinyl floor covering (sheet goods).</i>			
-----HVAC-----			
23. Baseboard electric heater - 6'	1.00 EA @	199.19 =	199.19
-----ELECTRICAL-----

24. Combination CO/Smoke detector	1.00 EA @	109.74 =	109.74
25a. Remove 110 volt copper wiring run, box and switch	2.00 EA @	6.33 =	12.66
25b. 110 volt copper wiring run, box and switch	2.00 EA @	74.93 =	149.86
26a. Remove 110 volt copper wiring run, box and outlet	4.00 EA @	6.33 =	25.32
26b. 110 volt copper wiring run, box and outlet	4.00 EA @	74.91 =	299.64

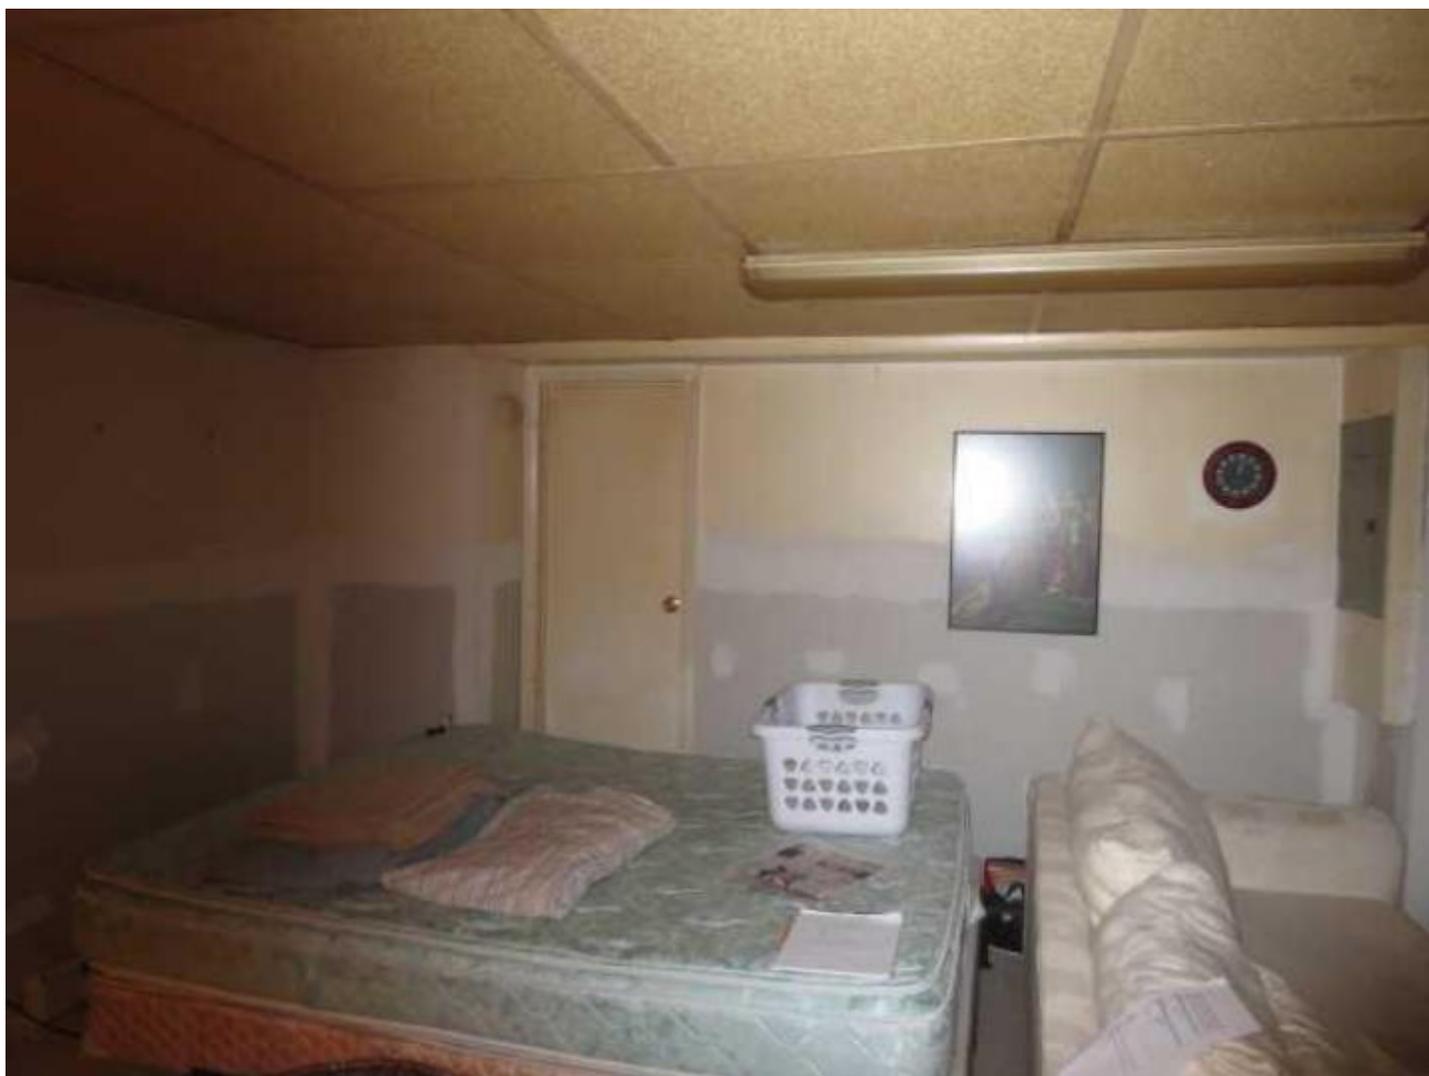
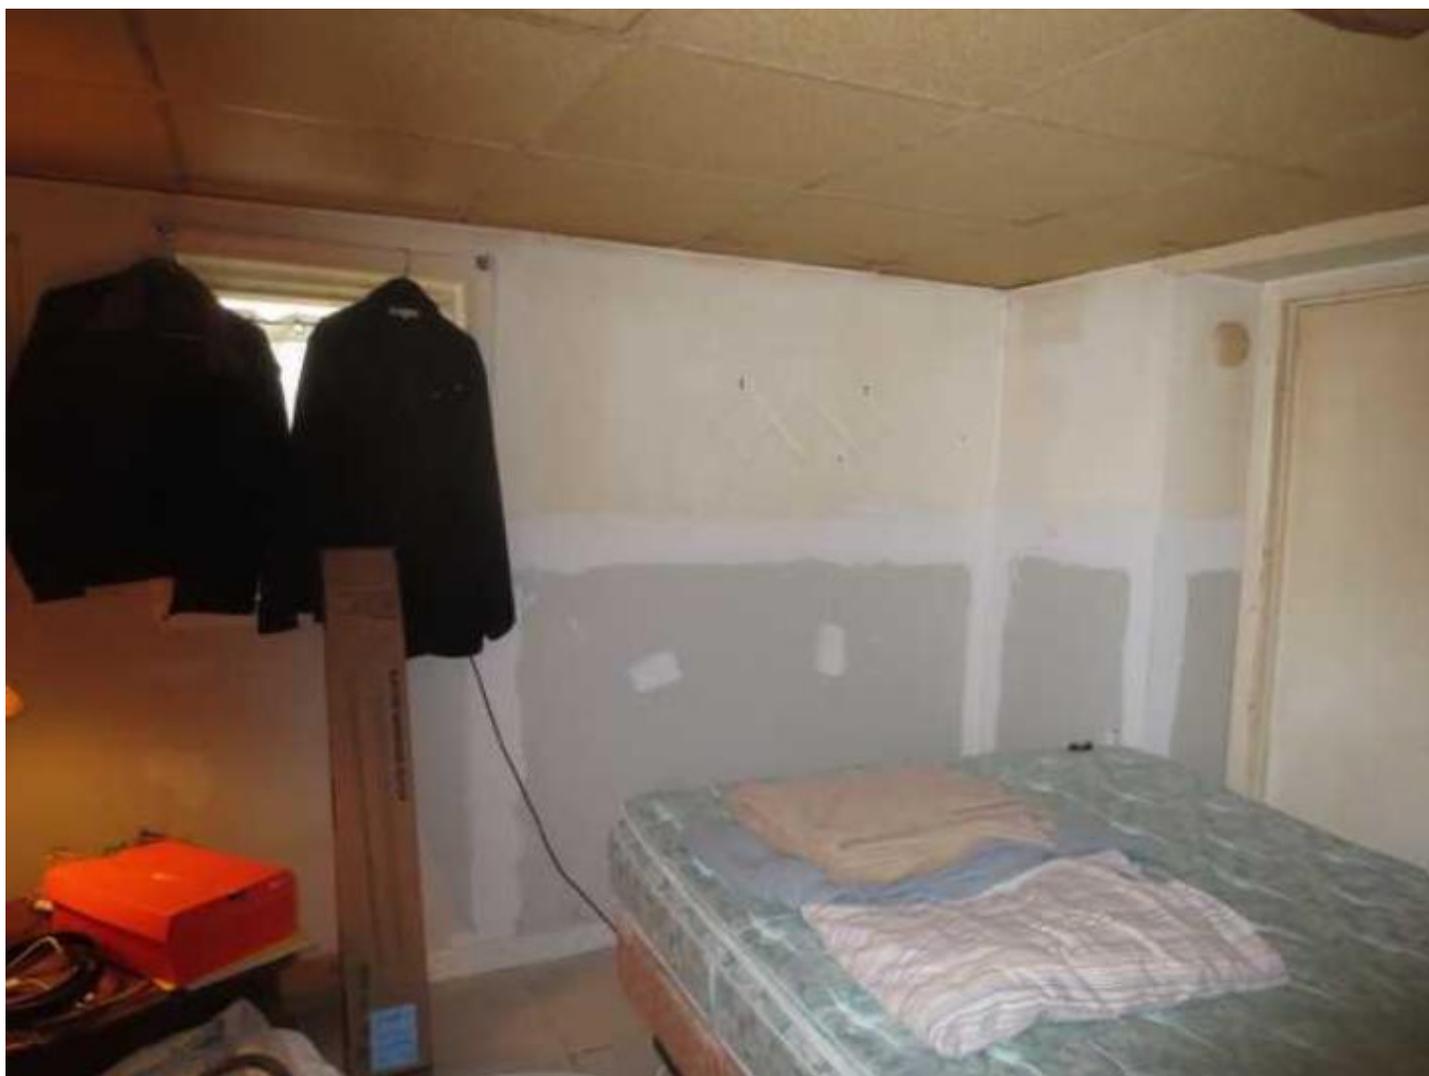
12 Bedroom

DESCRIPTION	QTY	UNIT PRICE	TOTAL
85. 1/2" drywall - hung, taped, floated, ready for paint	161.00 SF @	2.10 =	338.10
<i>The above two line items are addressing drywall which has been hung only and needs to be finished.</i>

DESCRIPTION	QTY	UNIT PRICE	TOTAL
-----GENERAL ITEMS-----			
82. Content Manipulation charge - per hour	1.00 HR @	47.86 =	47.86
83. Final cleaning - construction - Residential	165.13 SF @	0.30 =	49.54
-----WALLS & CEILINGS-----			
84. 1/2" drywall - hung only (no tape or finish)	161.00 SF @	-1.30 =	-209.30

86. Seal/prime then paint the walls twice (3 coats)	322.00 SF @	1.04 =	334.88
87. Baseboard - 3 1/4"	40.25 LF @	3.32 =	133.63
88. Base shoe	40.25 LF @	1.53 =	61.58

89. Seal & paint baseboard w/cap &/or shoe - two coats	40.25 LF @	1.55 =	62.39
-----DOORS & WINDOWS-----			
90a. Remove Exterior door - metal - insulated - flush or panel style	1.00 EA @	25.29 =	25.29
90b. Exterior door - metal - insulated - flush or panel style	1.00 EA @	324.06 =	324.06

91. Prime & paint door slab only - exterior (per side)	2.00 EA @	40.92 =	81.84
92. Paint door/window trim & jamb - 2 coats (per side)	2.00 EA @	26.56 =	53.12

93. Door lockset & deadbolt - exterior	1.00 EA @	114.09 =	114.09
94a. Remove Storm door assembly	1.00 EA @	20.83 =	20.83
94b. Storm door assembly	1.00 EA @	282.22 =	282.22
-----FLOORING-----

95. Floor preparation for resilient flooring	165.13 SF @	0.74 =	122.20
96. Vinyl floor covering (sheet goods)	189.90 SF @	4.71 =	894.43
<i>15% waste added for vinyl floor covering (sheet goods).</i>			
-----HVAC-----

97. Baseboard electric heater - 10'	1.00 EA @	271.73 =	271.73
-----ELECTRICAL-----			
98a. Remove 110 volt copper wiring run, box and switch	1.00 EA @	6.33 =	6.33
98b. 110 volt copper wiring run, box and switch	1.00 EA @	74.93 =	74.93
99a. Remove 110 volt copper wiring run, box and outlet	4.00 EA @	6.33 =	25.32
99b. 110 volt copper wiring run, box and outlet	4.00 EA @	74.91 =	299.64
