September 17, 2014

**Gilbane Building Company
New Jersey RREM Program**

RE: Asbestos Consulting Services
Limited Asbestos Inspection Report
Private Residence: 1201 Ocean Avenue, Apartment 86, Sea Bright, New Jersey 07760 - RRE0022516
CES Project # 13-07-339

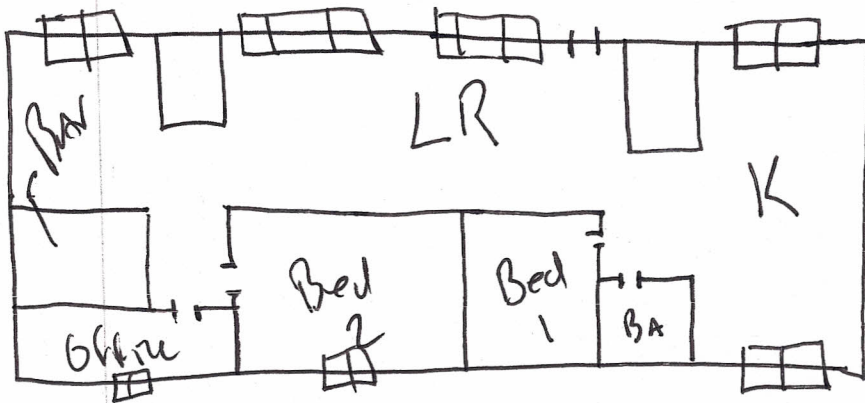
Sampling Locations:

this is a bottom floor
Condo
NO Access to roof
wood ~~siding~~ siding was plywood
with tyvek

Complete rebuild floor to
ceiling using all new building
materials
