ASBESTOS SURVEY REPORT

NEW JERSEY DEPARTMENT OF ENVIRONMENTAL PROTECTION ENVIRONMENTAL REVIEW CDBG-DR PROGRAM

Applicant ID SBL39430
70-86 HOBART AVE
BAYONNE, NJ 07002

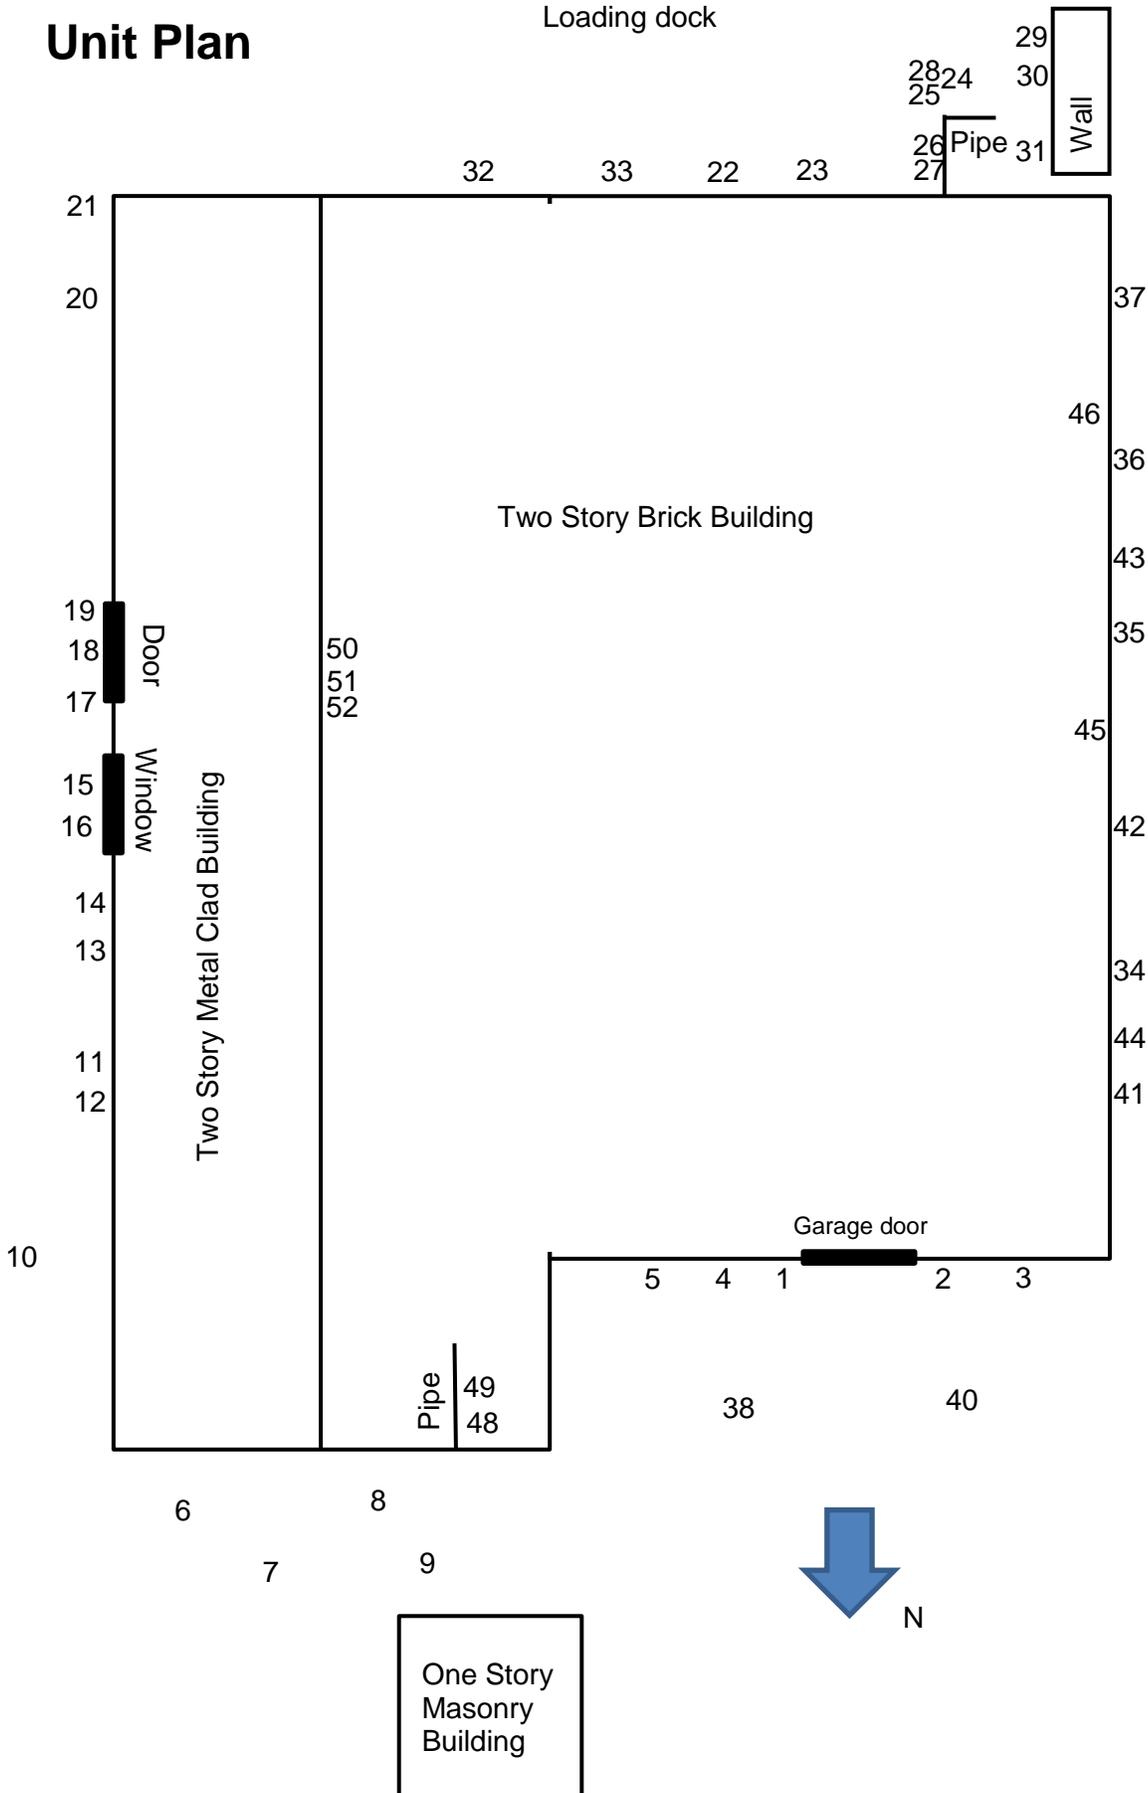
Unit Plan

Area	Notes
Facility	During post inspection review, It was discovered that the compass used in the field was inaccurate. In reference to the homogenous areas and sampling locations, the following should be noted in order to properly locate the ACM on the property: NE should be N SE should be E SW should be S NW should be W

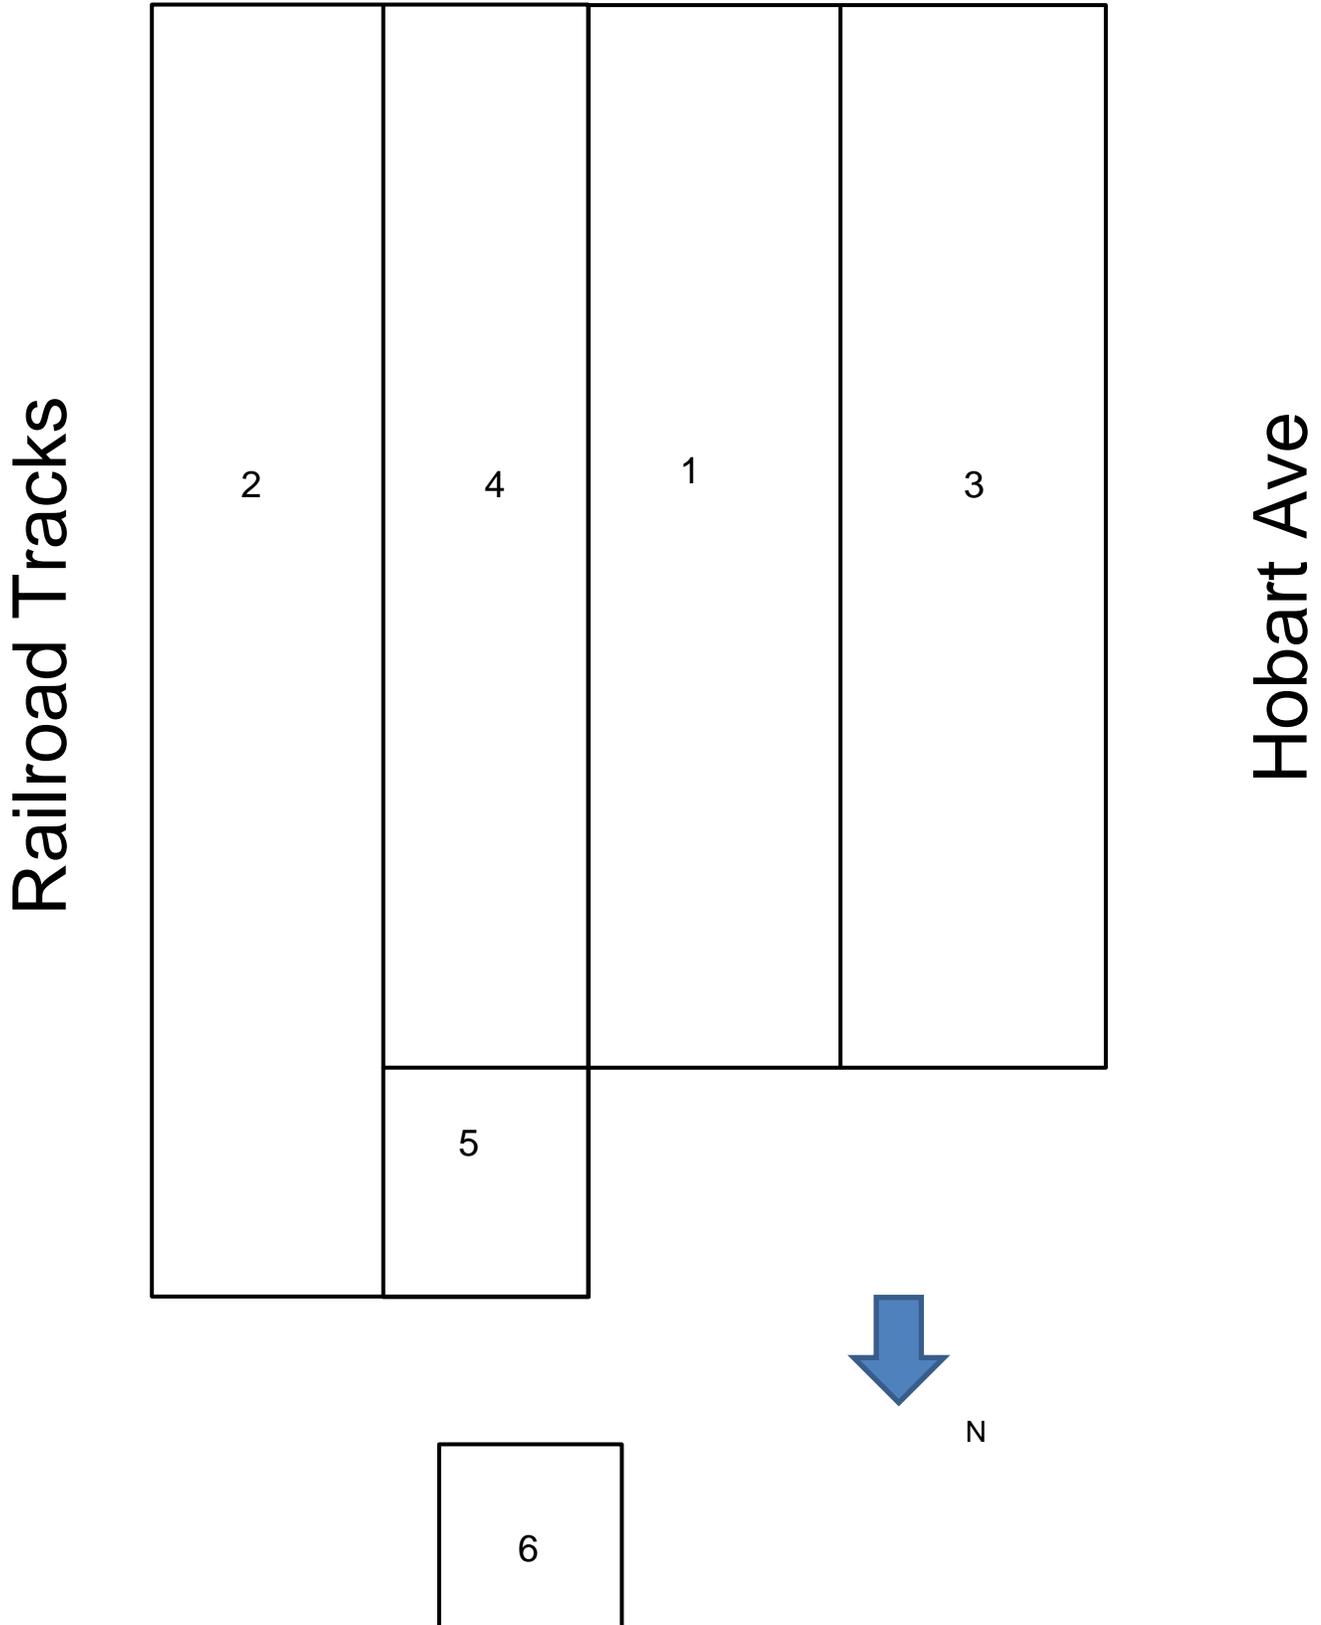
Roofing Plan

The roof was deemed unsafe to walk on and samples were therefore limited to roofing materials (such as vapor barriers and roofing guards) that were found in the immediate area surrounding the building. All roofing tile and other roofing material not sampled should be treated as PACM, and therefore the property owner will engage the services of a New Jersey licensed firm that specializes in ACBM removal prior to the renovation of any section of the roof.

The total area of the roofs is about 100,000 square feet. However, only 2,500 square feet of roof 5 and 3,640 square feet of roof 6 will need to be replaced, which is a total of 6140 square feet. The north side of the building and the side of the building along the railroad tracks have asbestos containing corrugated siding. The side on the railroad tracks contains approximately
