PRE-REHABILITATION: ASBESTOS SURVEY REPORT

**MALUSA & SONS, INC.
COMMERCIAL RESTAURANT
BLOCK 238, LOT 12
423 EAST MAGNOLIA AVNEUE
WILDWOOD, NEW JERSEY, 08260**

PARS PROJECT NO. 710-19

MAY 1, 2015

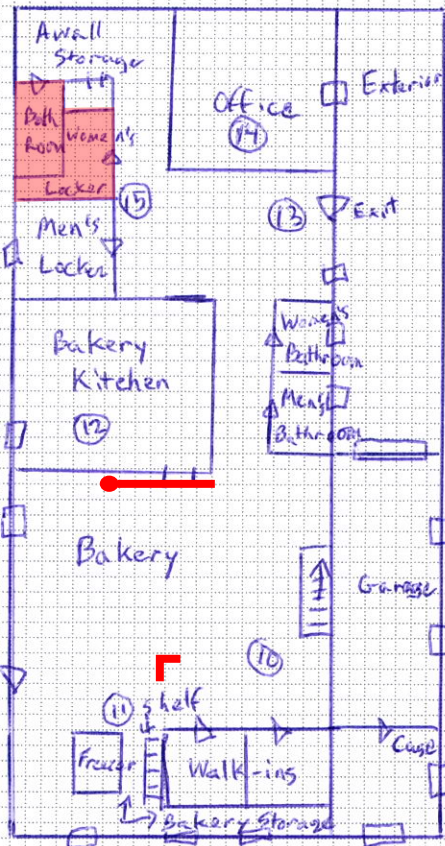
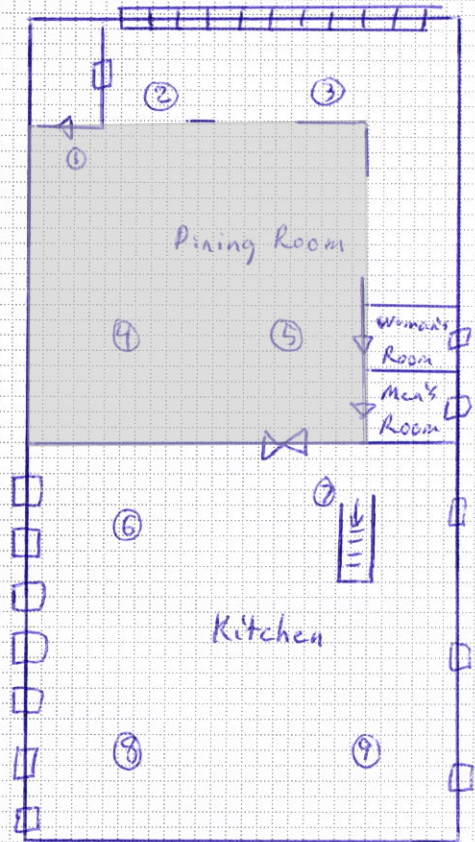
- = ACM 9"x9" Beige Floor Tiles & Black Tile Mastic
- = ACM Pipe Wrap Insulation
- = ACM 3" Aircell Insulation
- = PACM 1'x1' Old Ceiling Tile

All identified ACM/PACM that may be impacted by the planned re-habilitation should be removed and properly disposed of by a licensed asbestos abatement contractor utilizing industry standard procedures and in accordance with applicable federal, state, and local regulations prior to renovation or building demolition impacting these materials.
