**RE: ASBESTOS SURVEY REPORT  
840 MANTOLOKING ROAD, APT NO. 3  
BRICK, NEW JERSEY  
SRP0037020.05.03.D.003**

RE: Asbestos Consulting Services  
Limited Asbestos Inspection Report  
Private Residence: 840 Mantoloking Road, Unit #4, Brick, New Jersey 08723 – SRP0037020  
CES Project # 13-07.339

RE: Asbestos Consulting Services  
Limited Asbestos Inspection Report  
Private Residence: 840 Mantoloking Road, Unit #5, Brick, New Jersey 08723 – SRP0037020  
CES Project # 13-07.339

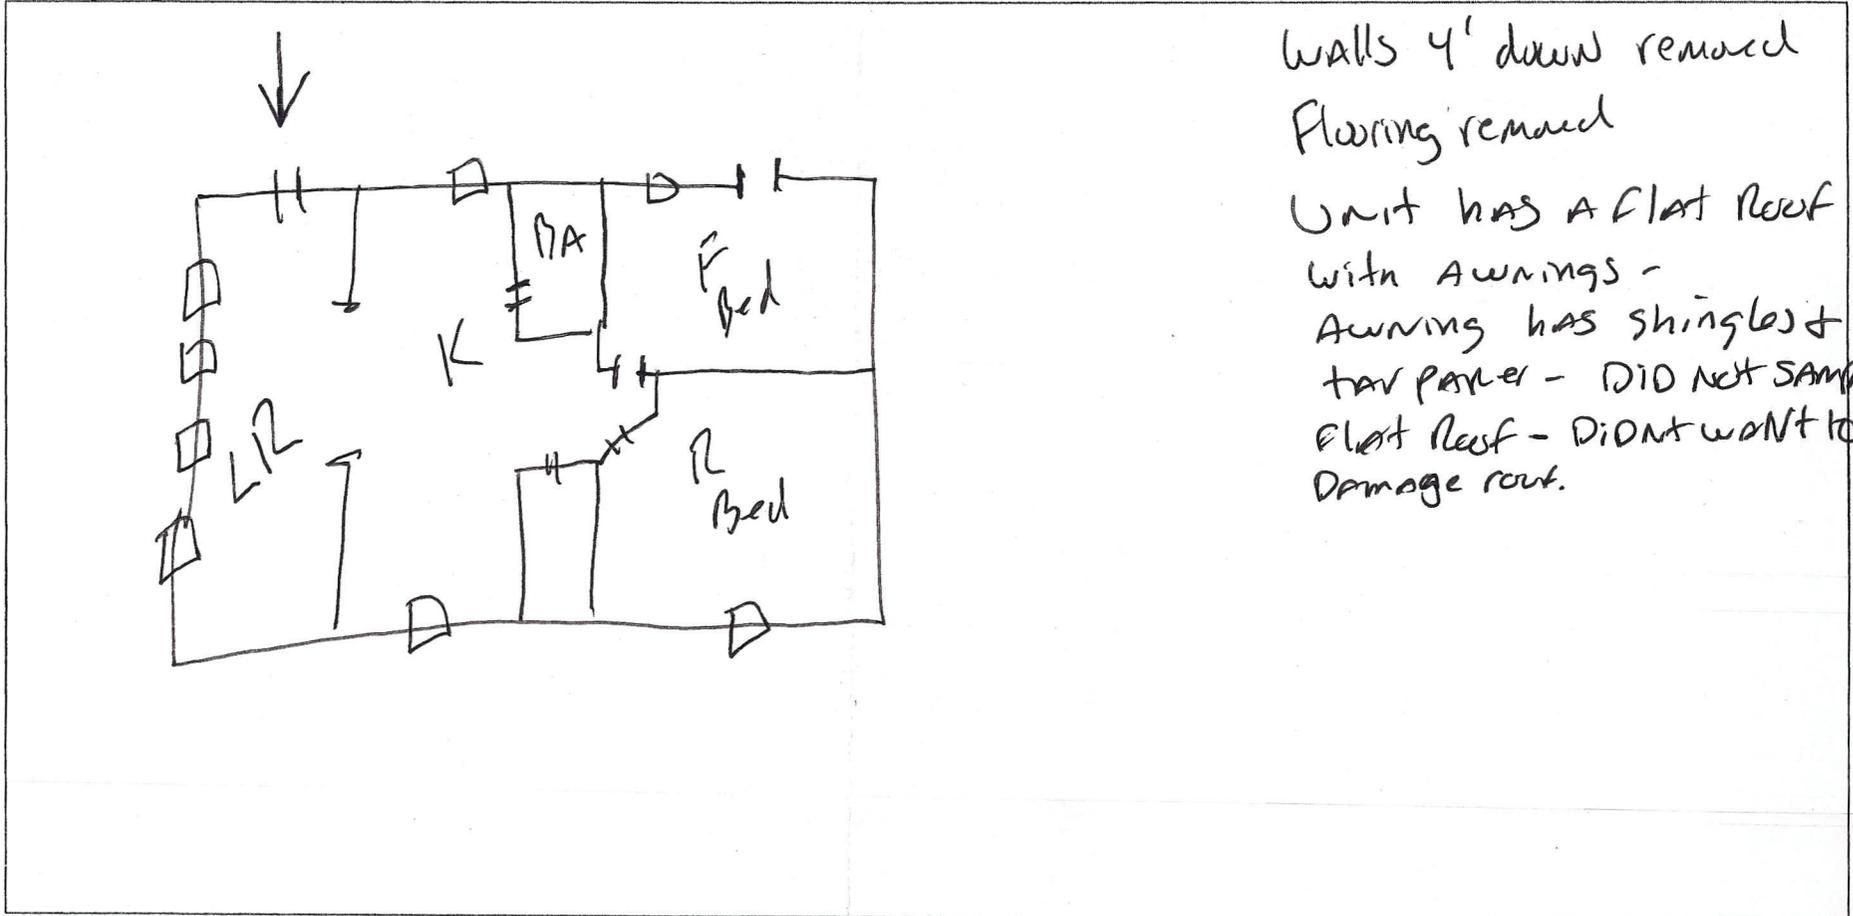
UNIT # 5

Walls 4' down removed  
 Flooring removed  
 Unit has a Flat Roof  
 with Awning -  
 Awning has shingles +  
 tar paper - DID NOT SAMPLE  
 Flat Roof - DIDNT WANT TO  
 Damage roof.
