LEAD HAZARD EVALUATION NOTICE

Address: 840 Mantoloking Road, Apt. No. 3, Brick, NJ

On March 8, 2014, PARS Environmental, Inc. (PARS) conducted a Lead-Based Paint Risk Assessment (hereinafter the "Assessment") of the residential property located at 840 Mantoloking Road, Apartment No. 3, Brick, New Jersey (hereinafter the "Property"). The Property had sustained damage during the October 2012 Hurricane Sandy and could be eligible for funding under the New Jersey Landlord Rental Repair (LRR) Program, which is being administered by the State of New Jersey Department of Community Affairs (NJDCA). NJDCA is providing funds made available by the US Department of Housing and Urban Development (HUD). PARS was authorized to perform this work by Gilbane Building Company (GBCO).

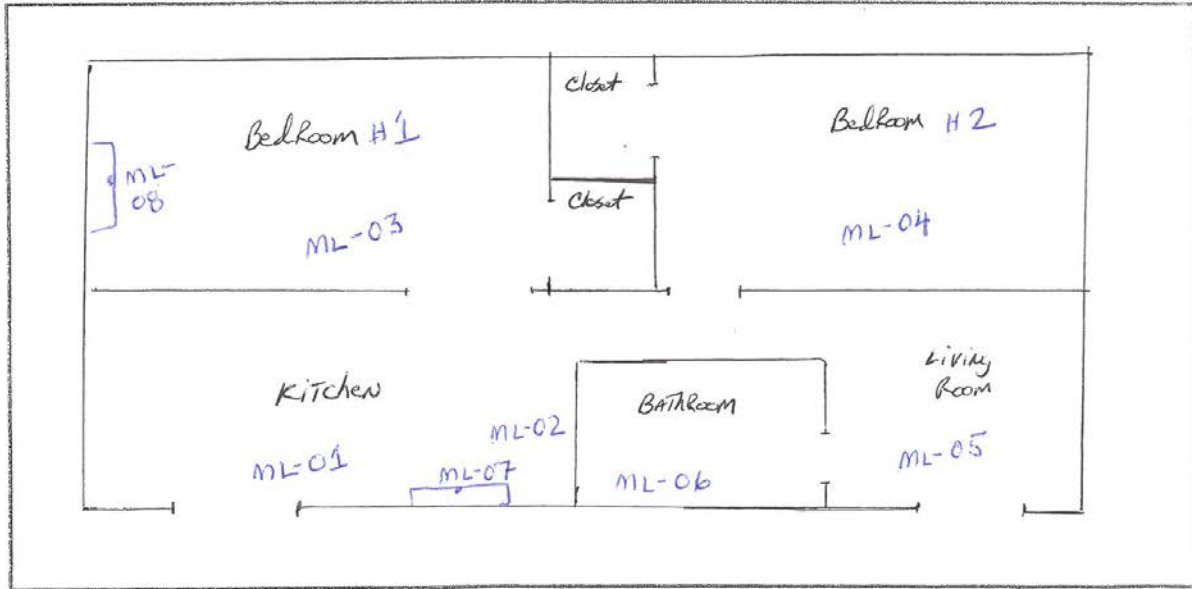
**Bare Soil / Deteriorated Paint / Lead Dust Wipe Sample
Location**

ML-01 = Wipe Sample Location
