Field Assessment Form

New Jersey Community Development-Disaster Recovery Block Grant (CDBG-DR) Hurricane Sandy Disaster Recovery Program

Applicant ID: SRP0043579	
PAMS Pin: 1350_74_4	DCA Grant Number: B-13-DS-34-0001
Applicant Name: KATHLEEN LESBIREL	Inspection Date: 2/28/2014
Damage Address: 1229 Florence Ave, Union Beach	Inspector: Steven Rozek
Program Type: LRRP	Project Description: Rehabilitation and Elevation Within Allowable Footprint
Location Verified By: Address on house	Parcel Status: Structure exists

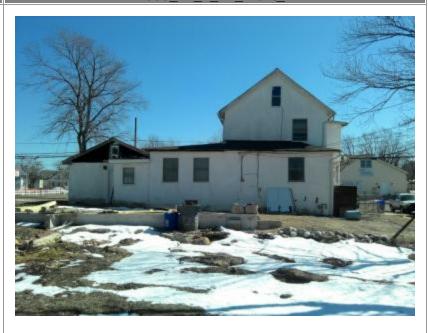
1350_74_4_EA_Rear_2

Are UST vents or caps present? If yes state specific location in relation to house or lot. Yes Comments: possible vent or fill cap located on rear of building by gas meter.
