## DEP TAKES ACTION TO REMOVE UNSAFE DAM

Brisbane Lake Dam is located in Wall Township, Monmouth County, New Jersey. The lake and dam are located within the Allaire State Park. Traversing the crest of the dam is County Route 524. The dam is an earthen embankment dam approximately 18 feet high and 200 feet long. The lake impounded by the dam is approximately 7 acres in size. The spillway is a concrete spillway approximately 14 feet high. The spillway is located on the downstream side of the County bridge structure. According to the plaque on the bridge, the structure was built in 1926. The dam is classified as a significant hazard dam due to the existence of the county roadway across its crest and the existence of the historic Allaire Village immediately downstream.

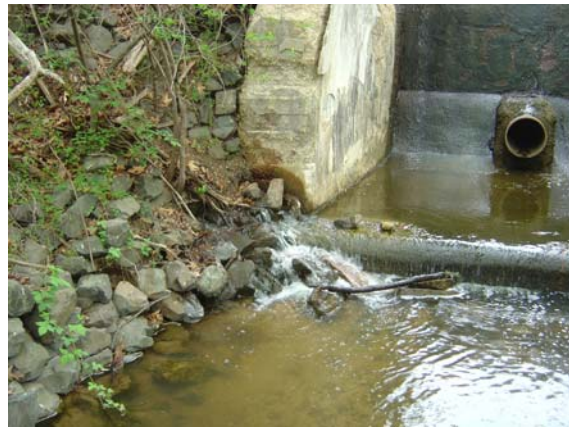
**Photo 1**

Previous inspections of the dam had identified a seepage condition behind the downstream wingwall (see Photo 1). Extensive investigations failed to identify the source of this seepage. No fines were noted in the flow and the flow was not impacting the ability of the dam to impound the lake. With a consulting engineer already on board for the design of a total rehabilitation of this dam, it was decided to closely monitor this condition until such time that the design could be finalized and the rehabilitation work completed.

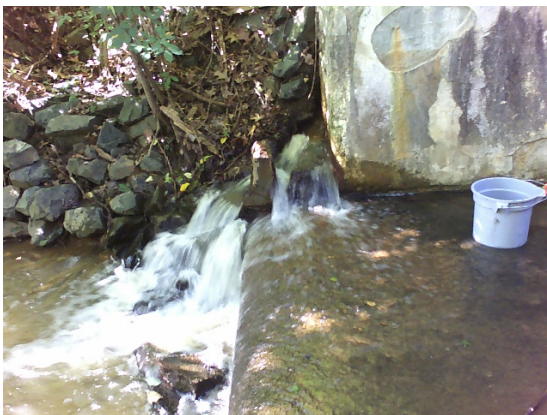
**Photo 2**

On September 12, 2007, it was reported to the Bureau of Dam Safety and Flood Control by Allaire State Park's Staff that the water level in Brisbane Lake had dropped and continued to recede. An immediate inspection by engineers from the Bureau identified that the seepage had increased significantly and that the seepage was carrying out fill materials from behind the wingwall (see Photo 2).

Given the rate of flow from behind the wingwall and the existence of suspended soil materials within the seepage, the Bureau and the Division of Parks and Forestry activated the Emergency Action Plan for this dam and declared a Dam Advisory Condition. To activate the EAP, the Department contacted State Police, Monmouth County and Wall Township Emergency Management Officials.

It could not be determined if the internal erosion of the embankment could potentially jeopardize the integrity of the dam and hence County Route 524. In consultation with Parks and Forestry, it was determined to take immediate action to remove this dam to relieve the head pressure on the piping condition. The dam was closely monitored while the Division of Parks and Forestry staff contracted with Caruso Excavating to undertake the emergency removal of the spillway. Due to quickly receding water levels, the Division of Fish and Wildlife was contacted and a fish salvage operation was carried out where numerous large mouth and calico bass were relocated to other impoundments.

The dam possesses a low level outlet, but the gate was not operable. Additionally, just opening the gate would not have provided additional spillway capacity, allowing the lake to refill during storm events, resulting in increased head pressure on the internal piping condition. It was decided to remove a 9 foot wide section of the concrete spillway. The spillway is an ogee shaped spillway approximately one foot thick at the crest and widening to approximately 5 feet thick at the base. The spillway is 13 feet wide between the concrete wingwalls.
