Cannonsville Dam Incident Response and Resolution

Thomas Murphy, P.E.
Chief, Reservoir Releases Policy Development
NYC DEP Bureau of Water Supply

December 3, 2015

Delaware River Basin Commission: Regulated Flow Advisory Committee

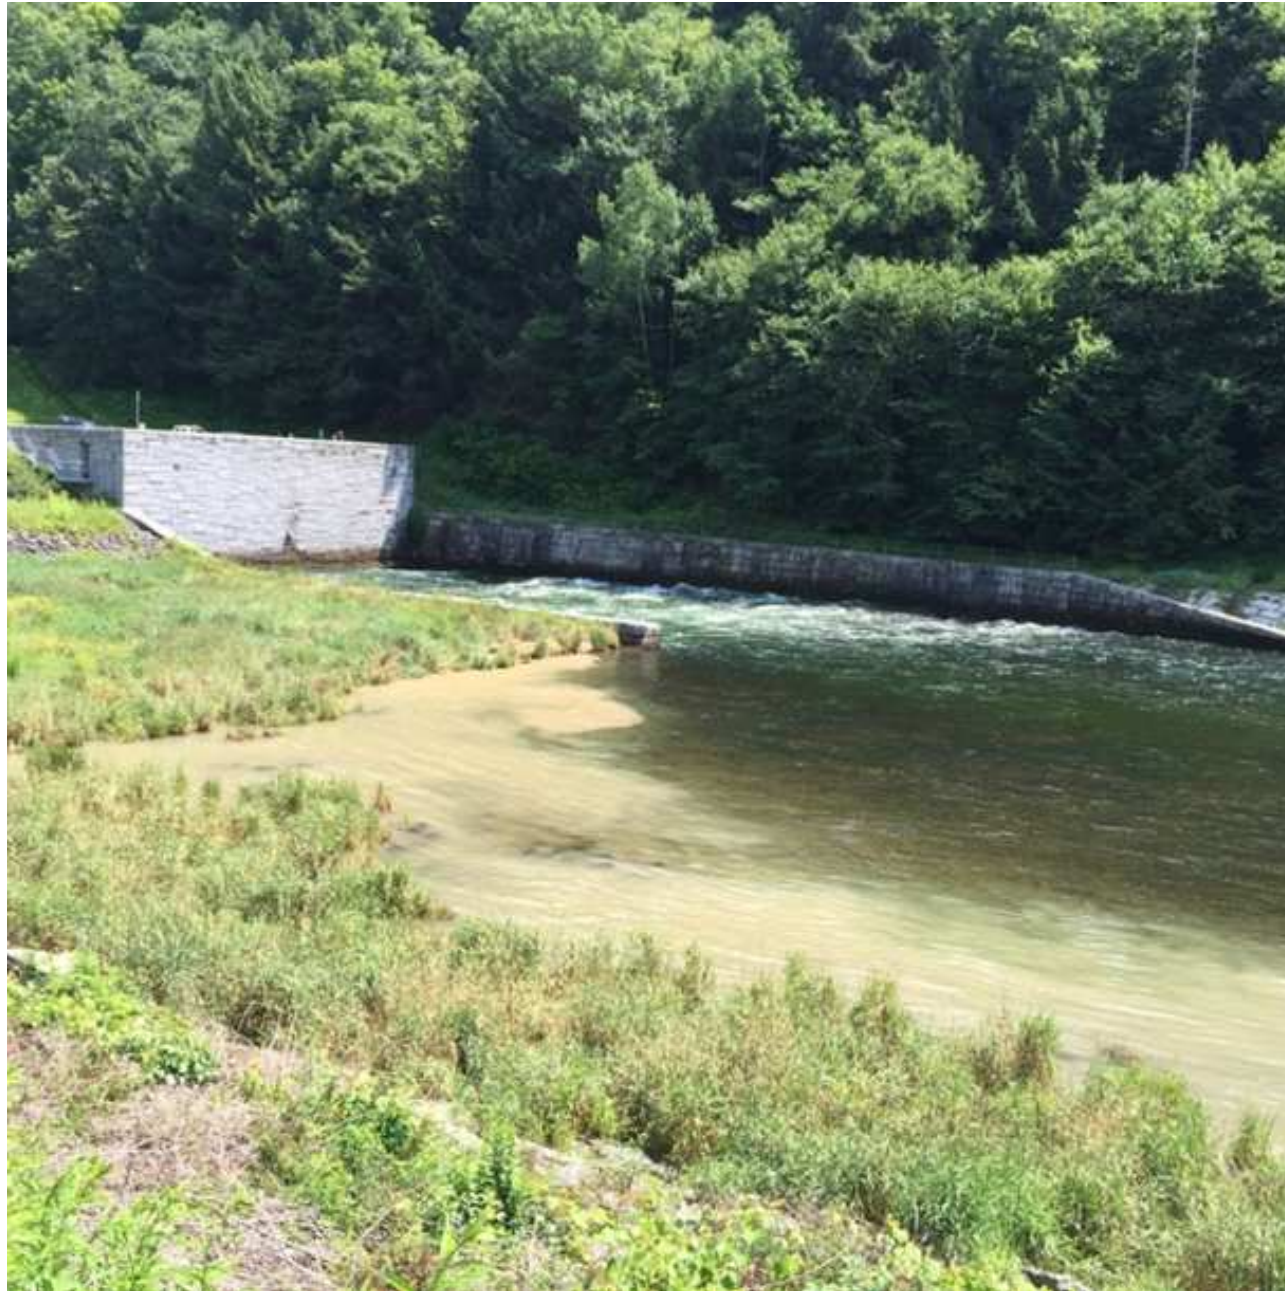
Turbid Discharge 7-13-15

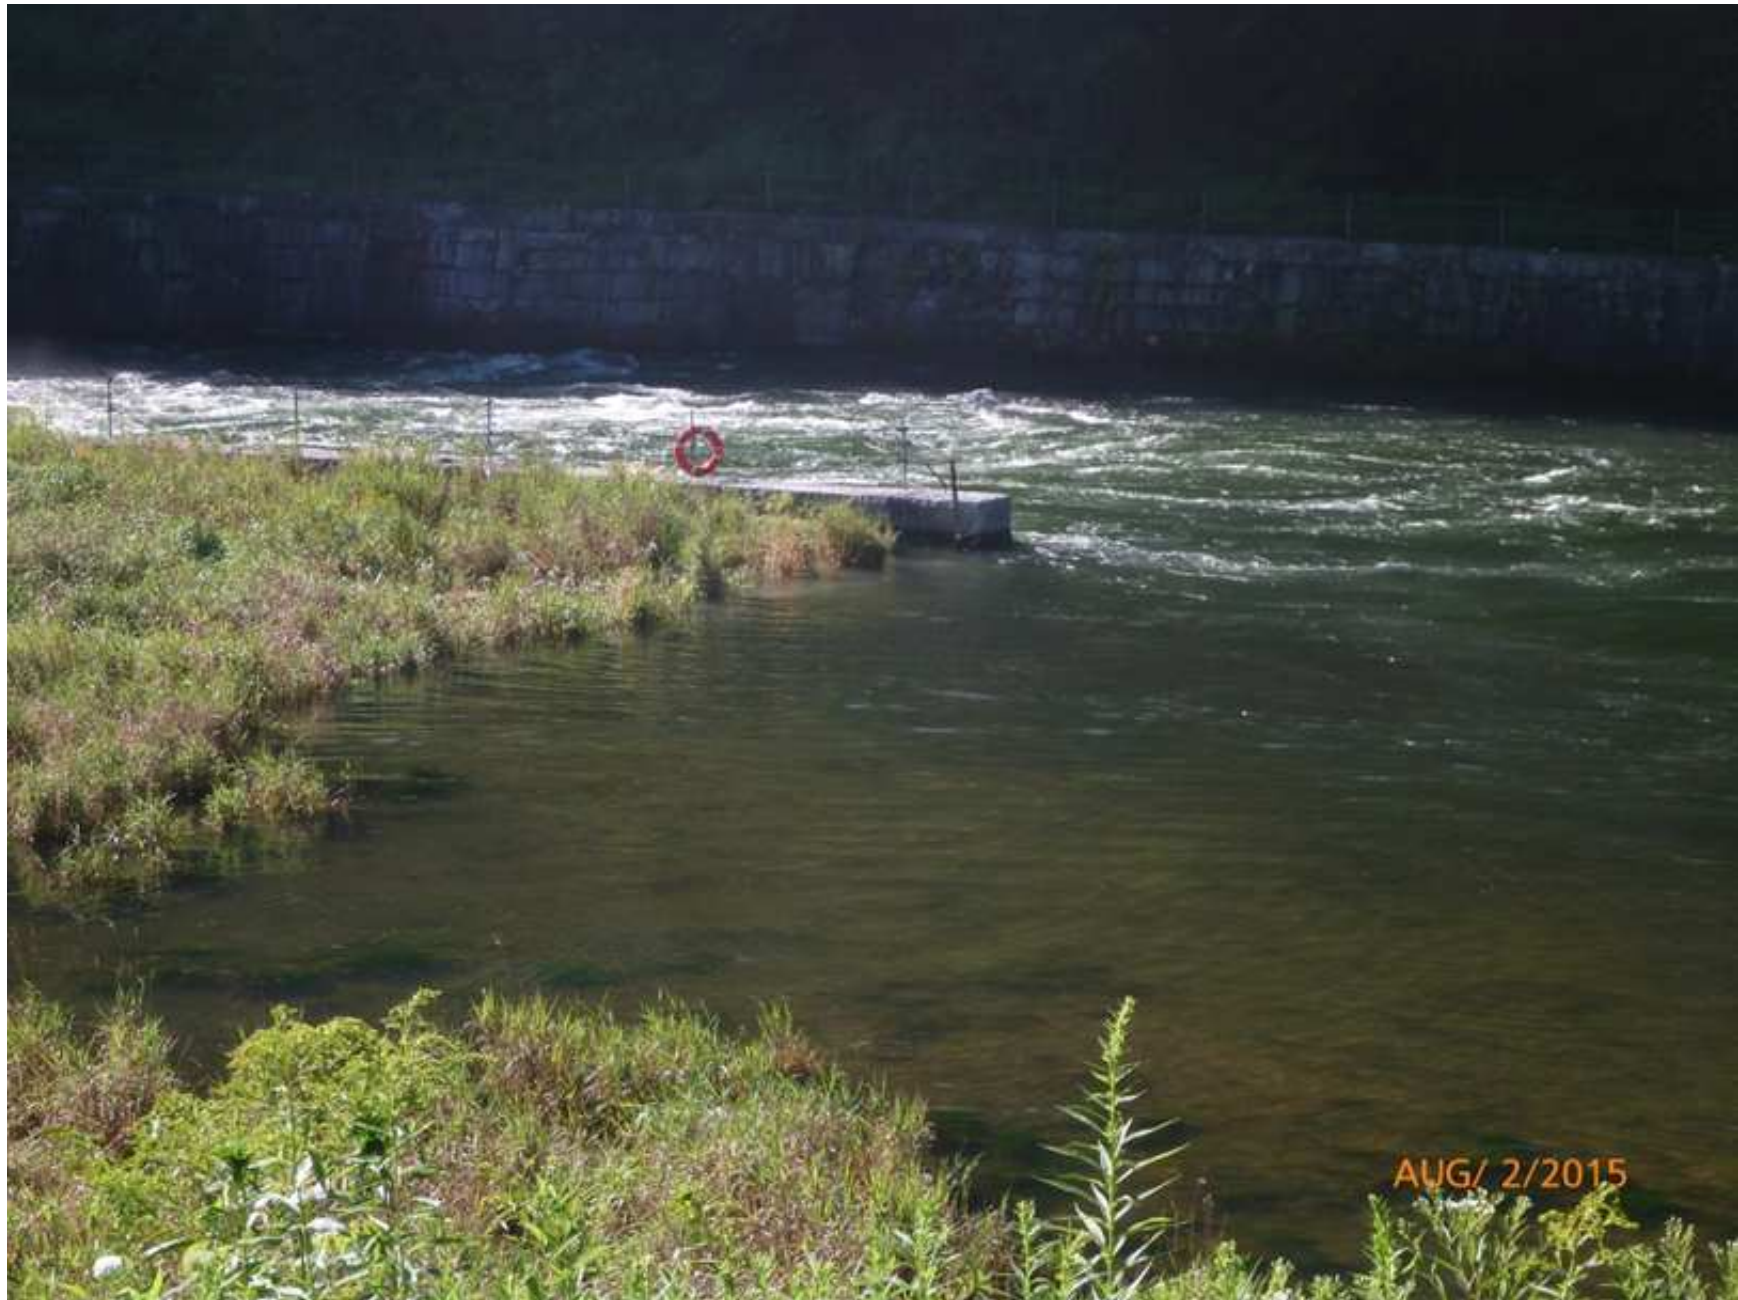
Turbid Discharge Ended 8-2-15
