Fatality Assessment & Control Evaluation Project

FACE 98-NJ-064-01

February 24, 1999

Building Maintenance Worker Dies After Falling Down a Material Lift Shaft

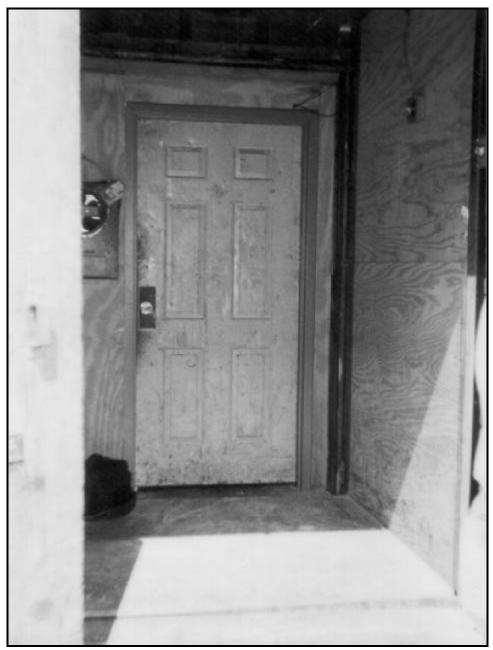
Discussion: This material lift was built to help the victim renovate the building and to move restaurant supplies into the basement. Although it appeared well constructed, the lift was not built to code and did not have the required interlocks to prevent the doors from being opened into an empty shaft.

Figure 2 Photo of material lift showing interior door

To prevent future injuries, FACE recommends that all lifting devices be constructed to comply

with building codes. All material lifts, elevators, and dumbwaiters must be constructed under a building permit issued by the municipality. Passenger and freight elevators must meet the American National Standards Institute (ANSI) construction and safety codes as per ANSI A17.1, *Safety Code for Elevators and Escalators*. These elevators must also be registered with the NJ Department of Community Affairs and are required to be inspected twice a year. Material lifts must comply with the ANSI standard B20.1, *Safety Standard for Conveyors and Related Equipment*. Material lifts are not subject to the NJ state registration and inspection requirements. However, a local construction official must determine if the device is considered a material lift or an elevator.
