Mullica River Watershed Stormwater Basin Assessment Project

September 2005

New Jersey Pinelands Commission
P.O. Box 7, New Lisbon, N.J. 08064

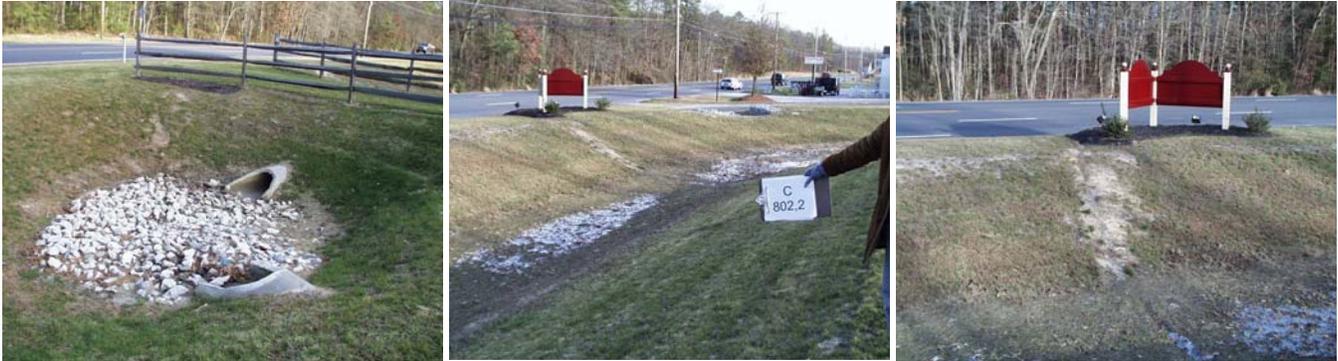
Basin ID#: C-1

Other observations: This basin is divided into one small basin (possibly designed as a forebay) with an inlet, connected by a pipe conduit to the larger basin. The conduit passes under a small footbridge. The basin is located parallel to the White Horse Pike and lies between the road and the senior home parking lot. A narrow strip of lawn/ turfgrass separates the basin from the pavement on all sides. Slight sedimentation is apparent on the basin floor.

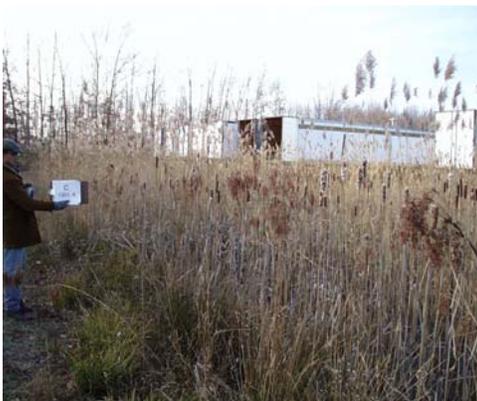
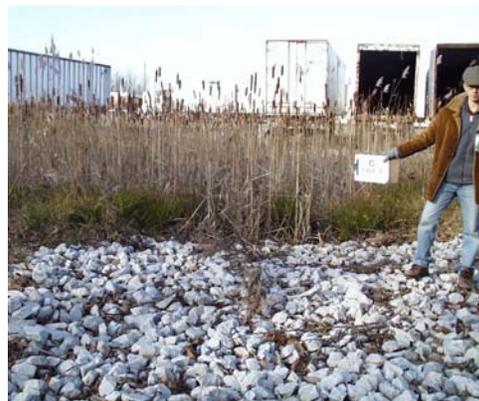
Basin ID#: C-2

Other observations: This basin is located directly adjacent to a parking lot on one side and a road on the other, with a wooded area adjacent to a third side. It appears relatively shallow and completely filled with water. A trench is visible which appears to conduct water from the road into one corner of the basin.

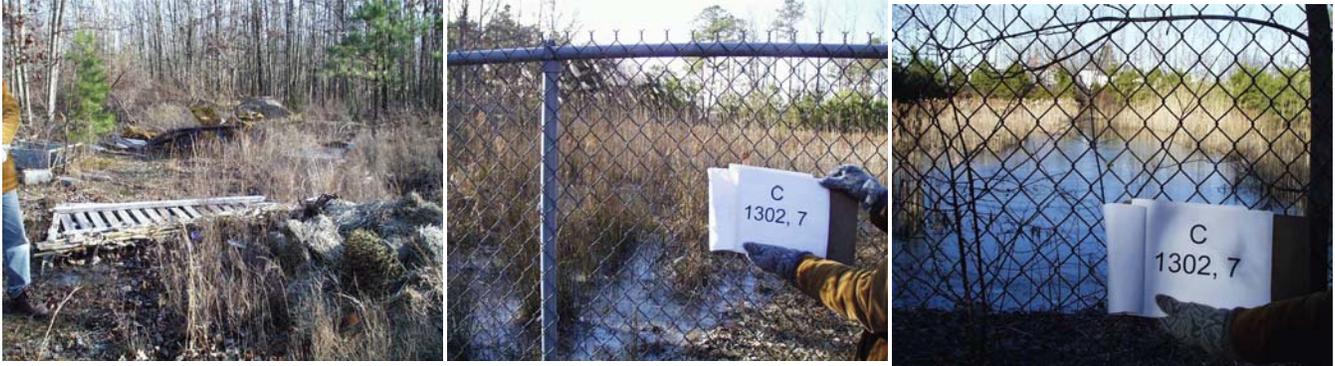
Basin ID#: C-5

Other observations: This basin contained shrubs, tall grasses and 15-20-foot trees. There was no evidence of recent maintenance/mowing. The basin had shallow, vegetated side slopes. Evidence of dumping was observed outside of basin.

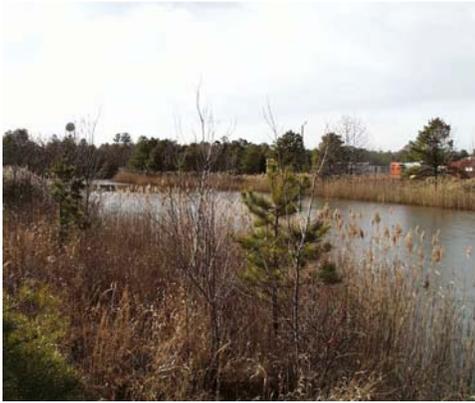
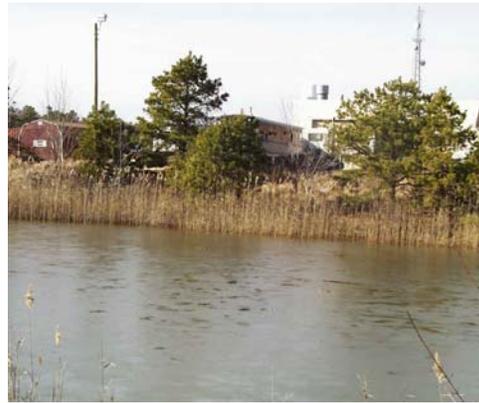
Basin ID#: H-1

Other observations: This basin is located off a relatively busy road, next to an industrial facility. Opposite the industrial site, a sand roads runs along the edge of the basin to a wooded area in back. This basin appears to be completely filled with relatively deep, open water. Mature wetland vegetation and 2-3-foot-high panic grass was observed around edges of basin.

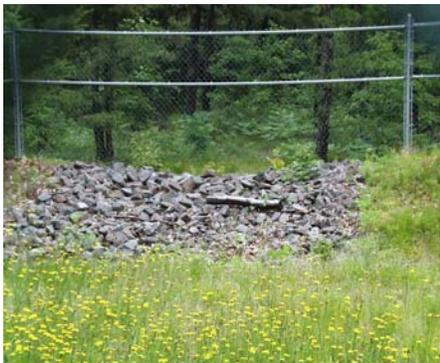
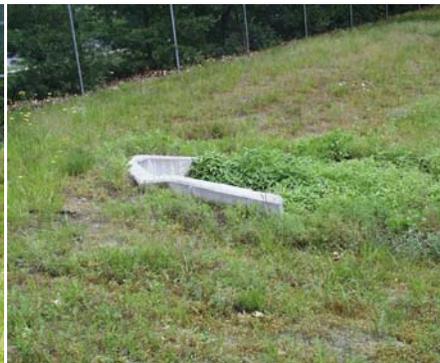
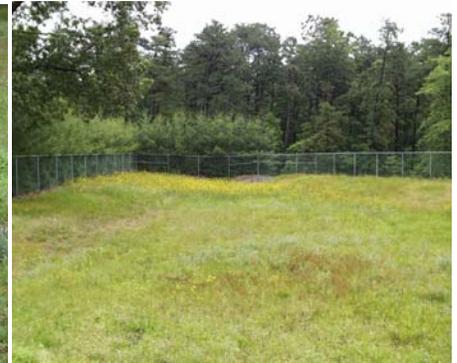
Basin ID#: H-2

Other observations: The basin floor and sides appear overgrown with weeds, especially at the single visible inlet.

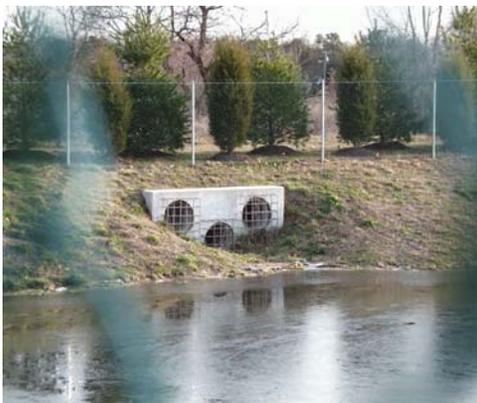
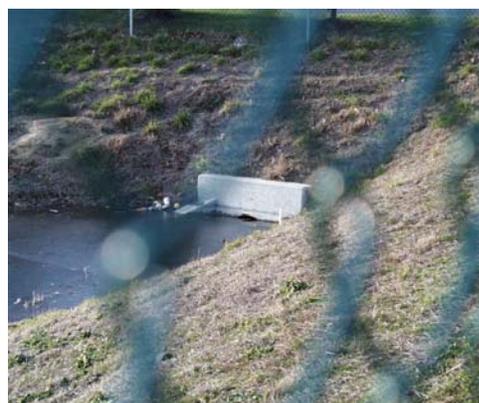
Basin ID#: H-7

Other observations: The floor of this basin appeared to be covered with water and not recently maintained (6-12 inch-high

weeds, dandelions observed).

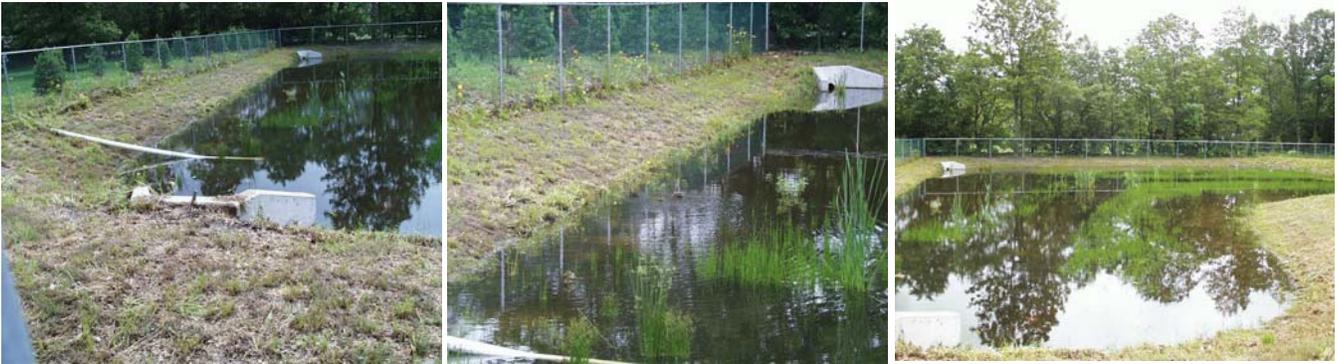
Basin ID#: H-23

Other observations: The floor of this basin appears to be completely covered by relatively deep, open water except for several clumps of emergent wetland vegetation. Two ducks were observed swimming in the basin.

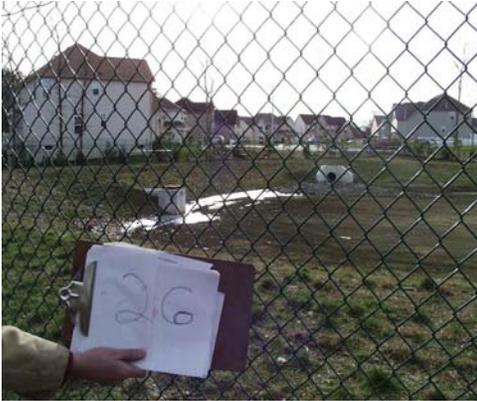
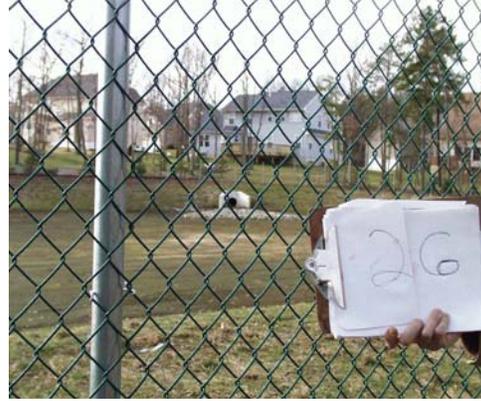
Basin ID#: H-26

Location: Grand St
Block, Lot: 3714, 12.01
Development type: Residential subdivision
Date assessed: 12/22/03
Previous 24-hour rainfall (in): 0.00
Previous 72-hour rainfall (in): 0.00
Basin size: 1.242 ac
Estimated portion of basin floor covered by water: <25%
Dominant soil hydrogroup: A
Dominant soil type: LasC
Emergent wetland vegetation observed: n/a
Basin sides appear recently mowed: Y
Debris in basin: few pieces street litter
Chain link fence: Y
Other observations: Localized ponding was observed in two areas of the basin.

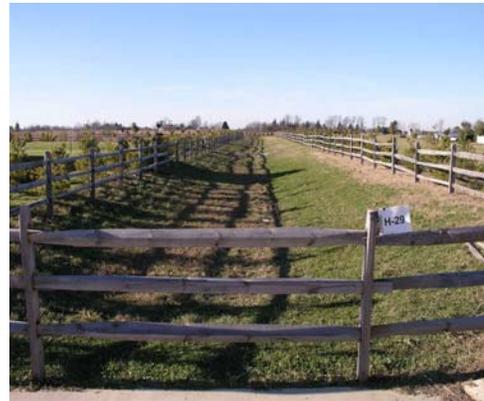
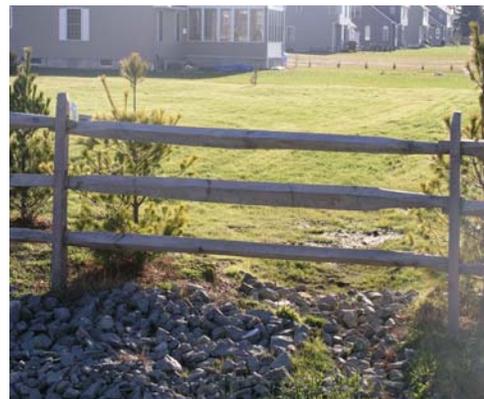
Basin ID#: H-29

Location: Basin Rd, off US30/White Horse Pike
Block, Lot: 4501, 33
Development type: Residential subdivision
Date assessed: 12/23/03
Previous 24-hour rainfall (in): 0.00
Previous 72-hour rainfall (in): 0.00
Basin size: 0.284 ac
Estimated portion of basin floor covered by water: 0 (dry)
Dominant soil hydrogroup: B/D
Dominant soil type: WoeA
Emergent wetland vegetation observed: n/a
Basin sides appear recently mowed: Y
Debris in basin: few pieces street litter
Chain link fence: N
Other observations: This is a shallow basin surrounded by a wooden split-rail fence, lawn/turfgrass and single-family houses on two sides. One cement overflow structure/access ramp was observed at one end of the basin.

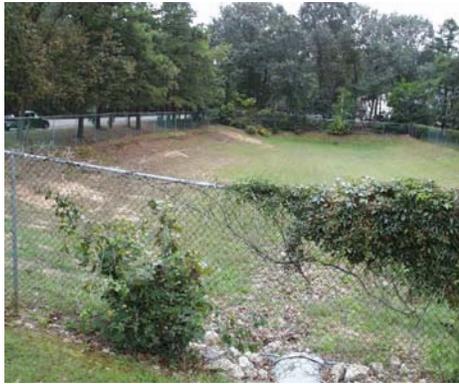
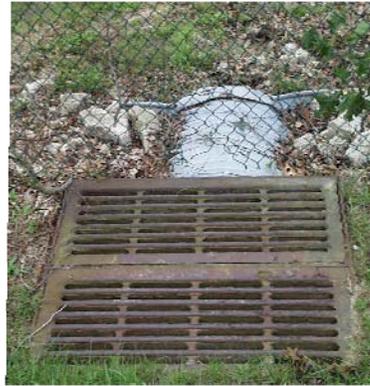
Basin ID#: W-17

Other observations: This basin appeared to have been recently mowed/maintained and appeared very clean. A few eroded patches on the side nearest the street were observed. One inlet (with grate) was visible.

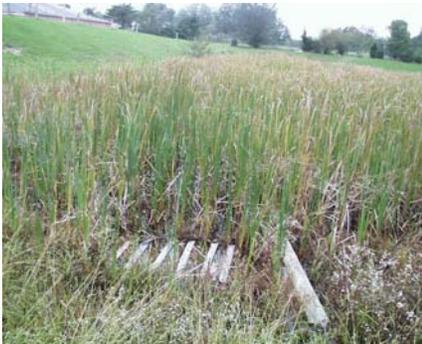
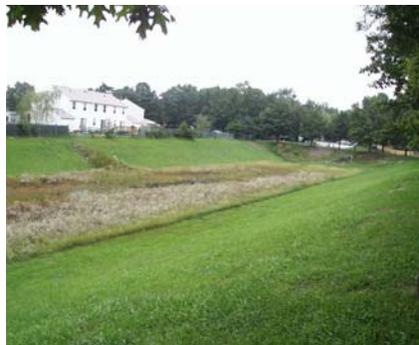
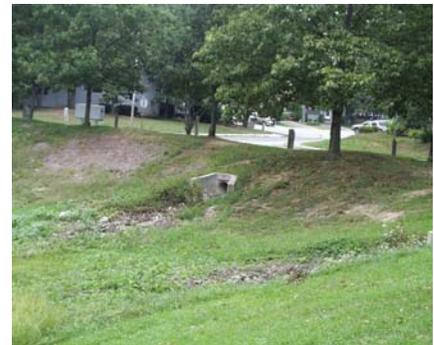
Basin ID#: W-22

Other observations: This a large, L-shaped basin located adjacent to a strip mall parking lot on one side, with residential streets on two other sides. The basin floor appeared to be largely covered with cattails and completely covered with water, with some areas of open water; frogs and ducks observed.

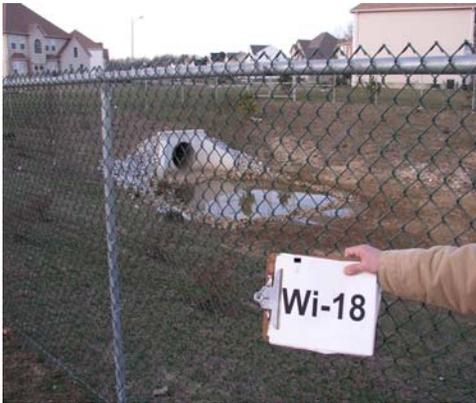
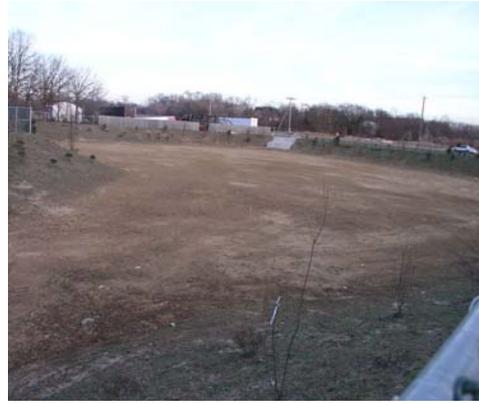
Basin ID#: Wi-18

Location: Near Old Egg Harbor Rd.
Block, Lot: 4504, 7.B
Development type: Residential subdivision
Date assessed: 12/23/03
Previous 24-hour rainfall (in): 0.00
Previous 72-hour rainfall (in): 0.00
Basin size: 2.627 ac
Estimated portion of basin floor covered by water: <25%
Dominant soil hydrogroup: B
Dominant soil type: Downer loamy sand, 0-5% slopes
Emergent wetland vegetation observed: n/a
Basin sides appear recently mowed: n/a (bare dirt)
Debris in basin: few pieces street litter
Chain link fence: Y
Other observations: Basin appears to have been constructed relatively recently as part of a new residential subdivision. Small landscape trees and turfgrass appear to have been recently planted on basin sides.

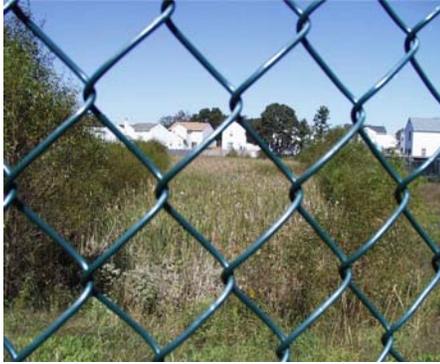
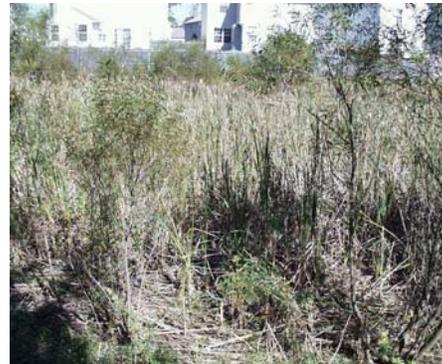
Basin ID#: Wi-19

Location: Off Waterford Rd.
Block, Lot: 2402.01, 1.06
Development type: Residential subdivision
Date assessed: 10/3/03
Previous 24-hour rainfall (in): 0.00
Previous 72-hour rainfall (in): 0.00
Basin size: 1.035 ac
Estimated portion of basin floor covered by water: 0 (dry)
Dominant soil hydrogroup: B
Dominant soil type: Downer loamy sand, 0-5% slopes
Emergent wetland vegetation observed: cattails, willows, rushes
Basin sides appear recently mowed: N
Debris in basin: few pieces street litter, large piece of corrugated plastic pipe (approximately 1 foot in diameter)
Chain link fence: Y
Other observations: Tall grass (1-4 feet) was observed within basin (no evidence of recent mowing). Some construction debris was visible on the sides of the basin.

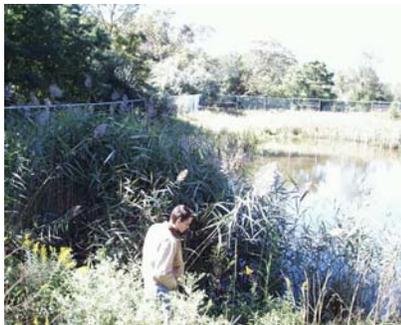
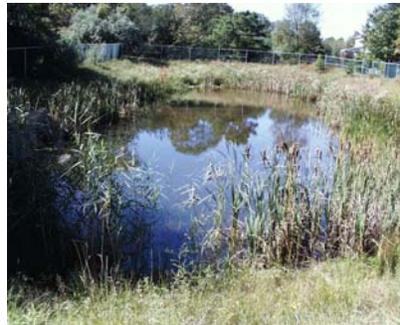
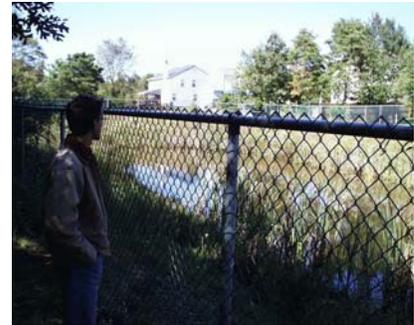
Basin ID#: Wi-20

Location: Oakton Dr., near corner of Hayes Mill Rd.
Block, Lot: 2402.01, 1.06
Development type: Residential subdivision
Date assessed: 10/3/03
Previous 24-hour rainfall (in): 0.00
Previous 72-hour rainfall (in): 0.00
Basin size: 0.280 ac
Estimated portion of basin floor covered by water: >75%
Dominant soil hydrogroup: B
Dominant soil type: Downer loamy sand, 0-5% slopes
Emergent wetland vegetation observed: cattails, rushes, phragmites
Basin sides appear recently mowed: N
Debris in basin: few pieces street litter
Chain link fence: Y
Other observations: The majority of the basin floor appeared to be covered by open water, with clumps of vegetation at the edges. The sides of this basin do not appear to have been recently mowed (2-4 foot tall grass). The gate was unlocked. Some muck/sediment was visible on basin floor. The inlet appeared to be obscured by a large stand of phragmites. One

eroded strip was visible on one side at the rear of the basin. Several frogs were observed within the basin.

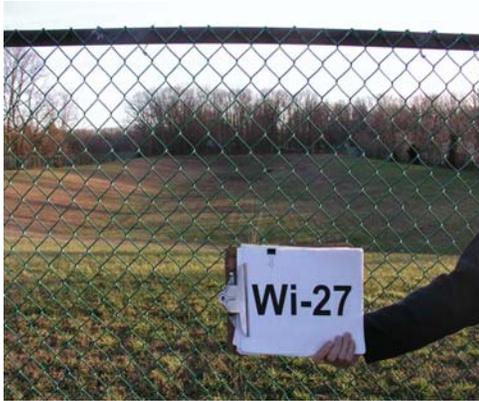
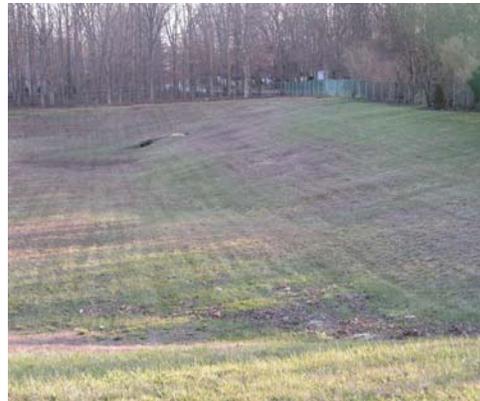
Basin ID#: Wi-27

Location: Sherry Lyn (front) (off Waterford Rd., near Whiting St.)
Block, Lot: 4909, 5
Development type: Residential subdivision
Date assessed: 12/23/03
Previous 24-hour rainfall (in): 0.00
Previous 72-hour rainfall (in): 0.00
Basin size: 0.508 ac
Estimated portion of basin floor covered by water: 0 (dry)
Dominant soil hydrogroup: B
Dominant soil type: Downer-Aura complex, 5-10% slopes
Emergent wetland vegetation observed: n/a
Basin sides appear recently mowed: Y
Debris in basin: few pieces street litter
Chain link fence: Y
Other observations: This basin appeared dry and recently mowed.
