RT. I-78 SHOULDER REHABILITATION EVALUATION

Final Report

JULY 1988

New Jersey Department of Transportation
Division of Research and Demonstration

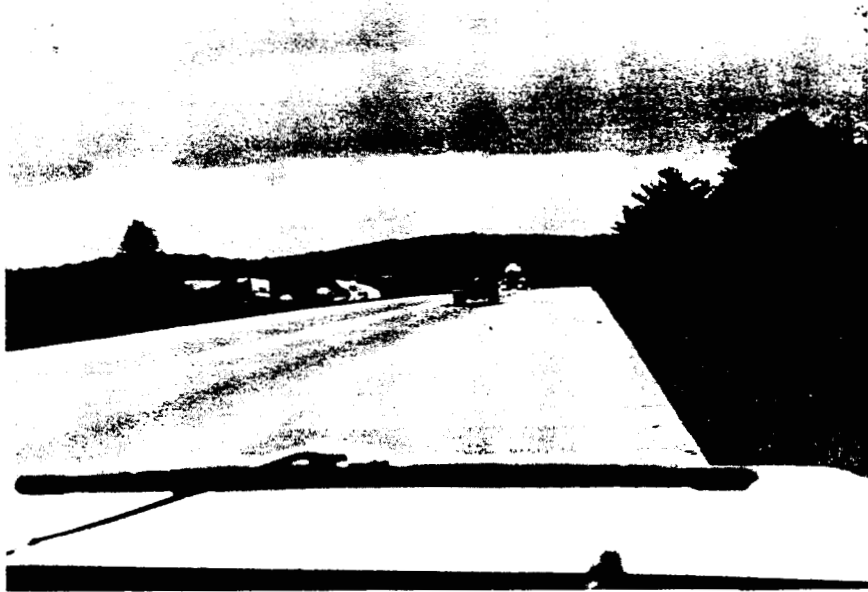
As might be expected, the 1.5 miles of shoulder which was replaced with 8" thick concrete, has remained in excellent condition. Only a few small hairline cracks were observed, with one large crack reflecting through from an inlet. Figure 4 shows the overall condition of the concrete shoulder, while Figure 5 depicts the hairline cracks. It should be noted that the addition of the concrete shoulder has eliminated pumping in the adjoining truck lane.

Figure 4. Overview of tied portland cement concrete shoulder section

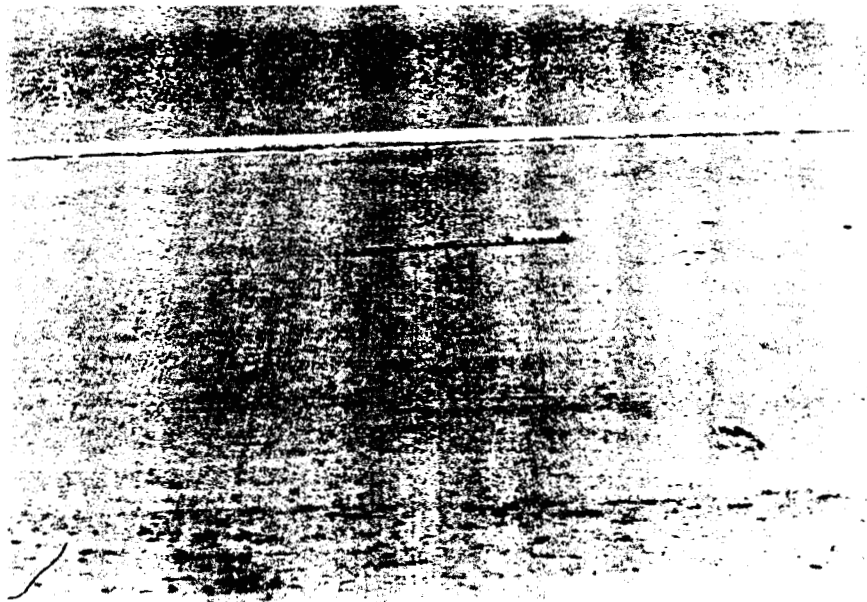
Figure 5. Random hairline cracks in portland cement concrete shoulder section

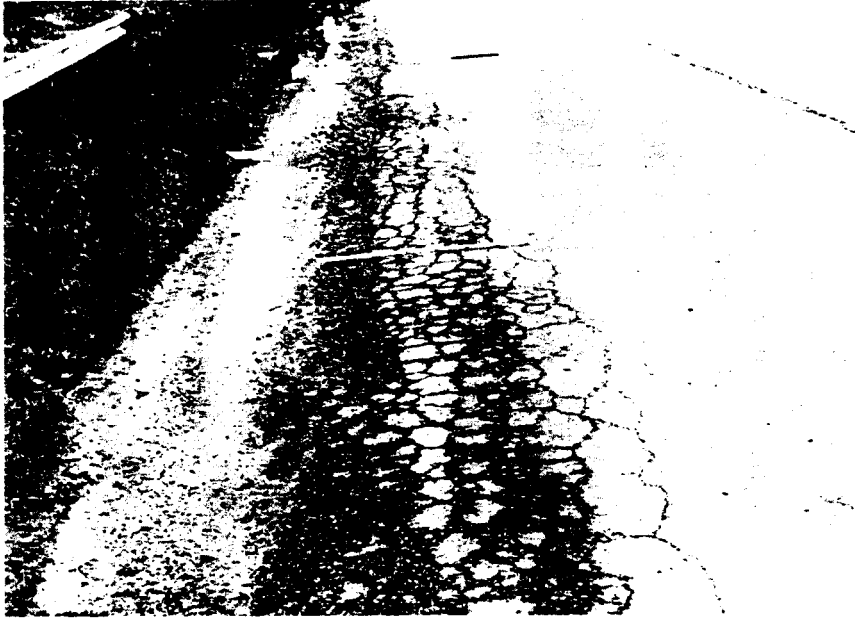
The 1.1 mile section of mixed-in-place soil cement has remained in relatively good condition as can be seen in Figure 8. There are a few isolated areas of alligator cracking on this shoulder, however, the pavement/shoulder joint has failed over approximately 8% of the length as noted in Figure 9. The area does not appear to be as poorly drained as the section where the LFA material was used. In addition, trucks are not using the area as a rest stop as much as was observed on the LFA section.

Figure 8. Alligator cracking on soil cement section
(Note excessive water in this area.)

6. Although the field mixed soil cement section performed relatively well, problems with the blowing of cement during construction suggests that if used in the future, cement stabilized base should be plant mixed.

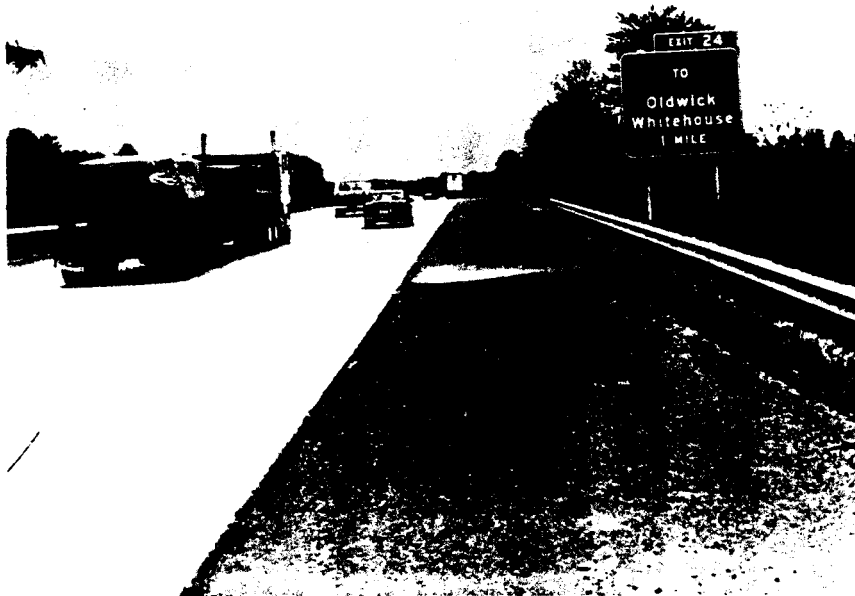
Figure 9. Mainline/shoulder joint failure at
soil cement section

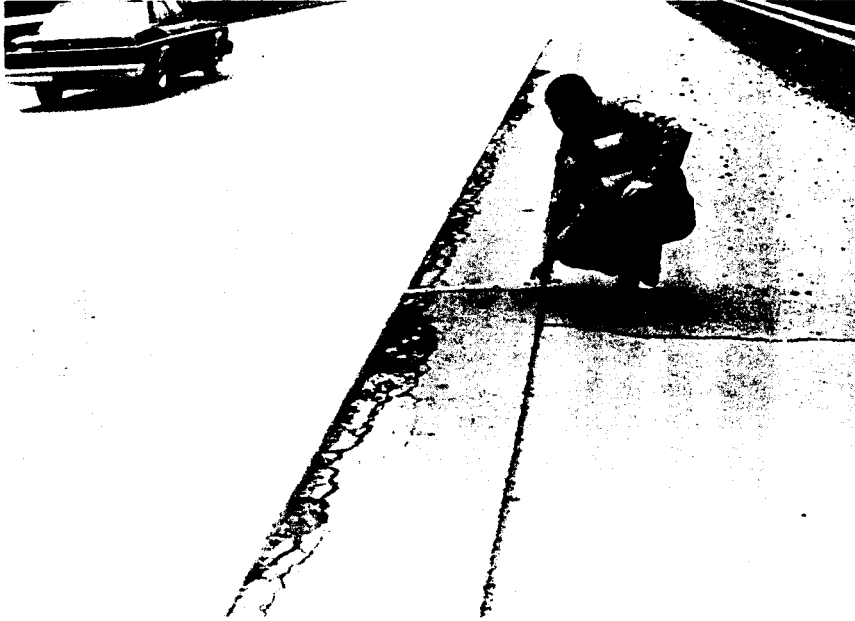
This 4 mile section employed a 25" wide inlay 7" deep of plant mixed LFA overlaid with 2" of the I-4 recycled bituminous concrete material. The entire shoulder was then slurry sealed. Approximately half of the total length of the outside edge of shoulder is alligator cracked. The mainline/shoulder joint has failed in approximately 5% of the section as illustrated in Figure 10. In addition, the inlay seam has opened up for approximately 66% of the length. There is an excessive amount of free water in the area, as evidenced by the extensive pumping shown in Figure 11.

Figure 10. Mainline/shoulder joint failure in LFA inlay section

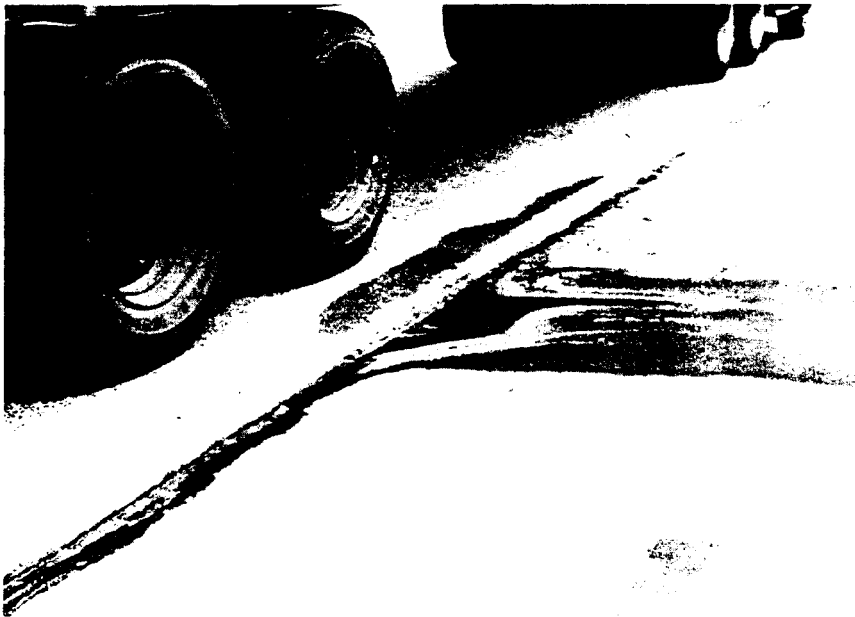
Figure 11. Pumping slabs in LFA inlay section

Most of the shoulder distress noted during this evaluation was directly or indirectly caused by excessive water in the pavement section. To maximize the life of any rehabilitation effort, the drainage problems -- both surface and subsurface water -- must be alleviated. Ditches must be maintained to prevent standing water near the roadway. Curbs, either portland cement or inexpensive bituminous curbing, can channel water and also provide lateral support to the pavement edge. On this project very little alligator cracking was noted when the shoulders contained curbing. In addition, longitudinal underdrains should be included wherever possible to remove subsurface water and prevent pumping.

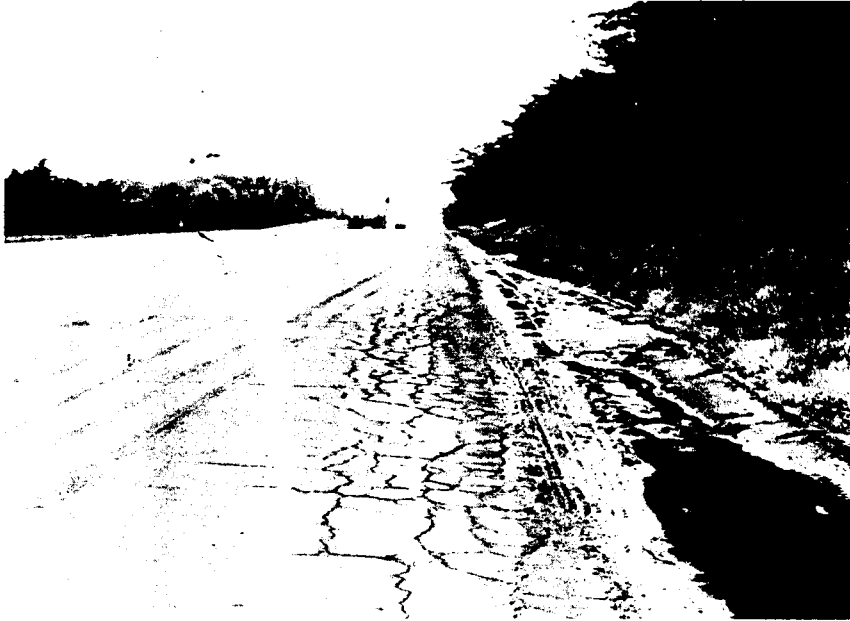
The final section on the project consisted of 3.5 miles of a 25" wide, 4" thick I-4 inlay along the pavement/shoulder edge. The entire shoulder was then slurry sealed. This section is exhibiting alligator cracking over about one-third of its length (Figure 14). Additionally, the inlay seam has opened up for approximately 43% of the length of the section. While the concrete pavement continues to pump in this area, the mainline/shoulder joint has remained in relatively good shape (Figure 15).

Figure 14. Alligator cracking in I-4 inlay section
(Note standing water in truck pull-off area at shoulder edge.)

2. Where the shoulder distress is limited to the mainline/shoulder joint, the 2-foot wide I-4 inlay with a slurry seal over the entire shoulder is an appropriate method. The removal of the 2 foot wide strip of bituminous shoulder material adjacent to the mainline will also allow the addition of longitudinal edge drains, which are highly recommended in any rehabilitation effort.

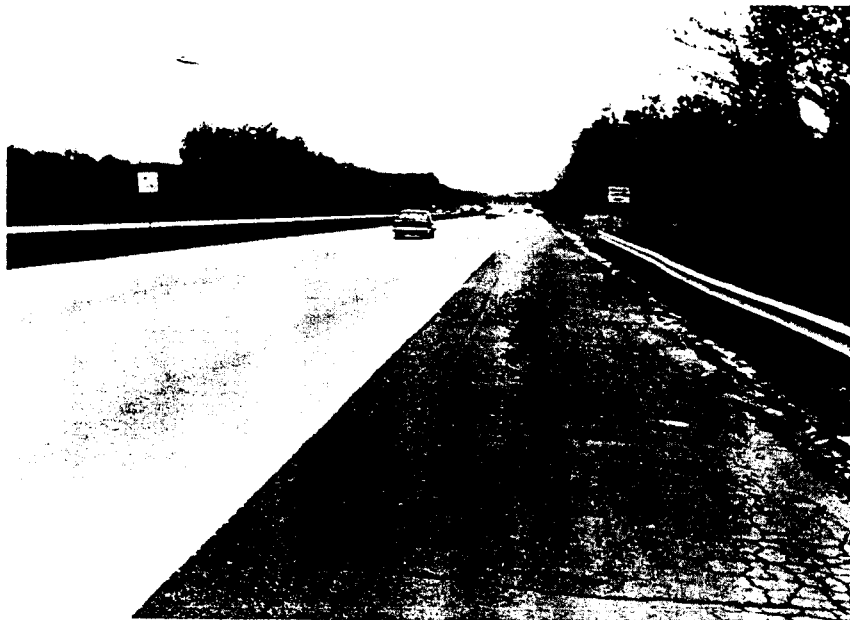
Figure 15. Mainline/shoulder joint is in good condition
on I-4 inlay section
