Report to the
State of New Jersey Board of Public Utilities
I/M/O the Board's Investigation
Into Reliability Issues related to
Jersey Central Power & Light Company's
Morristown Underground System

BPU Docket No. EO11090526

February 3, 2012

Prepared by PJ Downes Associates, LLC

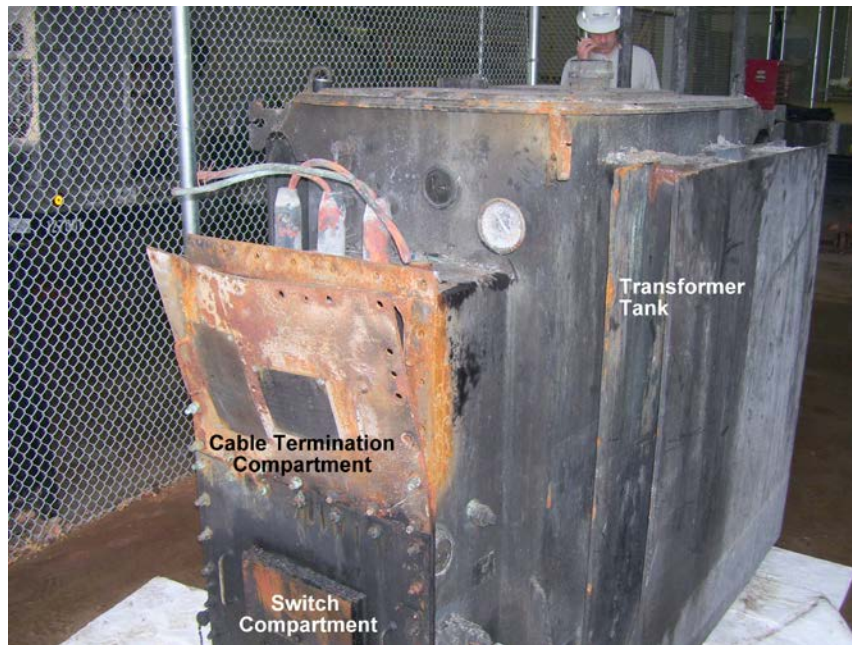
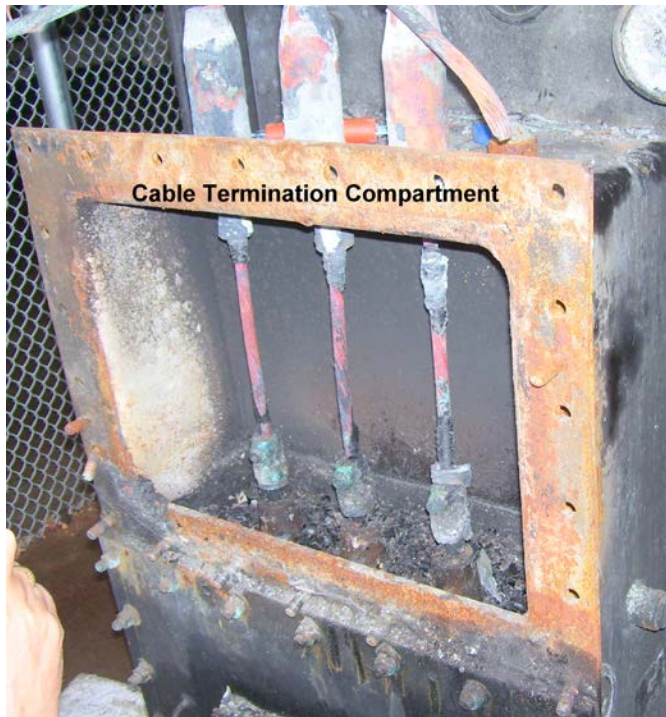
On June 9, 2011, a Westinghouse 500 KVA transformer failed in Vault # 849. The resulting fire caused extensive damage to the transformer and the other circuits that were in the vault. An investigation by Company personnel and representatives of the Power Cable Consultants determined the primary cable failed in the cable termination compartment. Since this compartment is sealed after the cable has been connected, air tested for leaks and filled with oil, the Company, as many other utilities, conducted visual inspections as preventive maintenance.

Photographs # 5 and # 6 that were taken by a member of the BPU staff show the failed transformer. It is appropriate that additional preventive maintenance should be conducted on all transformers in the Morristown Network that use a cable termination compartment for connection to the primary circuit.

1. Sample the oil from the cable termination compartment and test. This will allow data collection regarding any deterioration of the oil up to this time.
2. Drain oil, remove terminal chamber cover, and inspect the compartment and cable terminations for signs of deterioration. If necessary make repairs. Reinstall terminal chamber cover and air test the compartment for leaks. If necessary make repairs.
3. Fill the compartment with Cooper Power System Envirotemp FR3 Fluid or an equivalent dielectric fluid. This is a non-petroleum product with a higher flash point than petroleum based products.

1. Initiate the program and complete refurbishing of transformers with cable termination compartments by June 1, 2012. The Company has agreed to this recommendation.

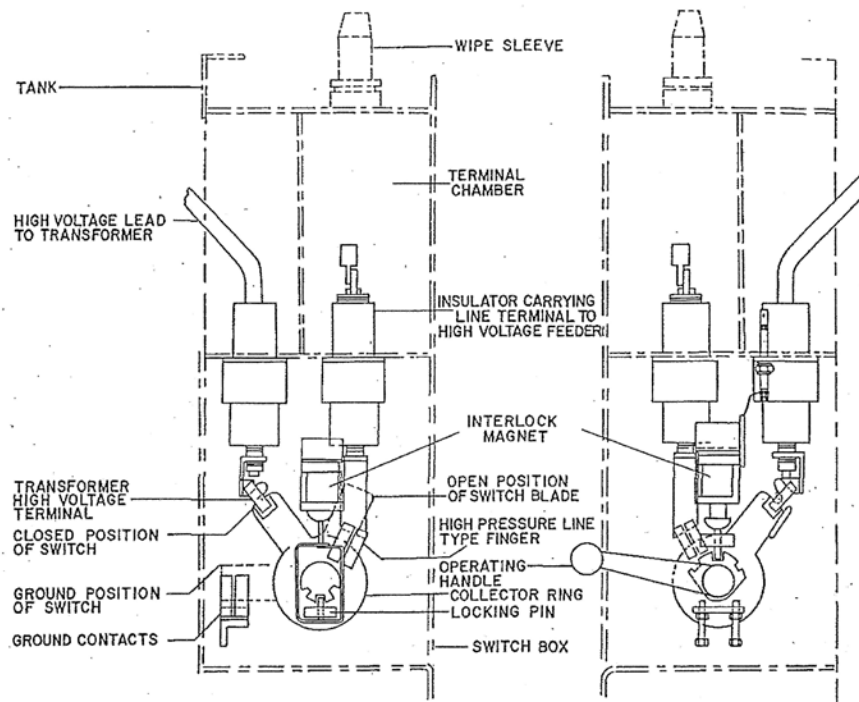
Figure 2

Figure #2 depicts a typical connection compartment and switch compartment on the transformer.
