IN THE MATTER OF THE BOARD'S INVESTIGATION)
INTO RELIABILITY ISSUES RELATED TO JERSEY)
CENTRAL POWER & LIGHT COMPANY'S)
MORRISTOWN UNDERGROUND DISTRIBUTION)
SYSTEM) DOCKET NO. EO11090526

IN THE MATTER OF THE BOARD'S INVESTIGATION INTO
RELIABILITY ISSUES RELATED TO JERSEY CENTRAL POWER & LIGHT COMPANY'S
MORRISTOWN UNDERGROUND SYSTEM - DOCKET NO EO11090526.

February 3, 2012

Prepared by PJ Downes Associates, LLC

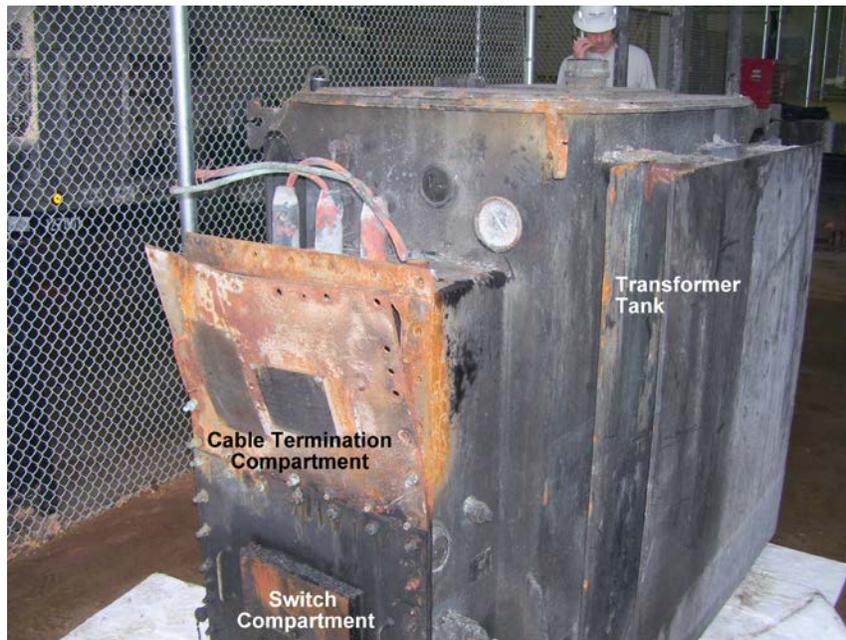
Photograph # 5

On June 9, 2011, a Westinghouse 500 KVA transformer failed in Vault # 849. The resulting fire caused extensive damage to the transformer and the other circuits that were in the vault. An investigation by Company personnel and representatives of the Power Cable Consultants determined the primary cable failed in the cable termination compartment. Since this compartment is sealed after the cable has been connected, air tested for leaks and filled with oil, the Company, as many other utilities, conducted visual inspections as preventive maintenance.

Photographs # 5 and # 6 that were taken by a member of the BPU staff show the failed transformer. It is appropriate that additional preventive maintenance should be conducted on all transformers in the Morristown Network that use a cable termination compartment for connection to the primary circuit.

Initially it will be necessary to identify the number and location of these transformers. The maintenance should include the following items:

1. Sample the oil from the cable termination compartment and test. This will allow data collection regarding any deterioration of the oil up to this time.
2. Drain oil, remove terminal chamber cover, and inspect the compartment and cable terminations for signs of deterioration. If necessary make repairs. Reinstall terminal chamber cover and air test the compartment for leaks. If necessary make repairs.
3. Fill the compartment with Cooper Power System Envirotemp FR3 Fluid or an equivalent dielectric fluid. This is a non-petroleum product with a higher flash point than petroleum based products.

1. Initiate the program and complete refurbishing of transformers with cable termination compartments by June 1, 2012. The Company has agreed to this recommendation.

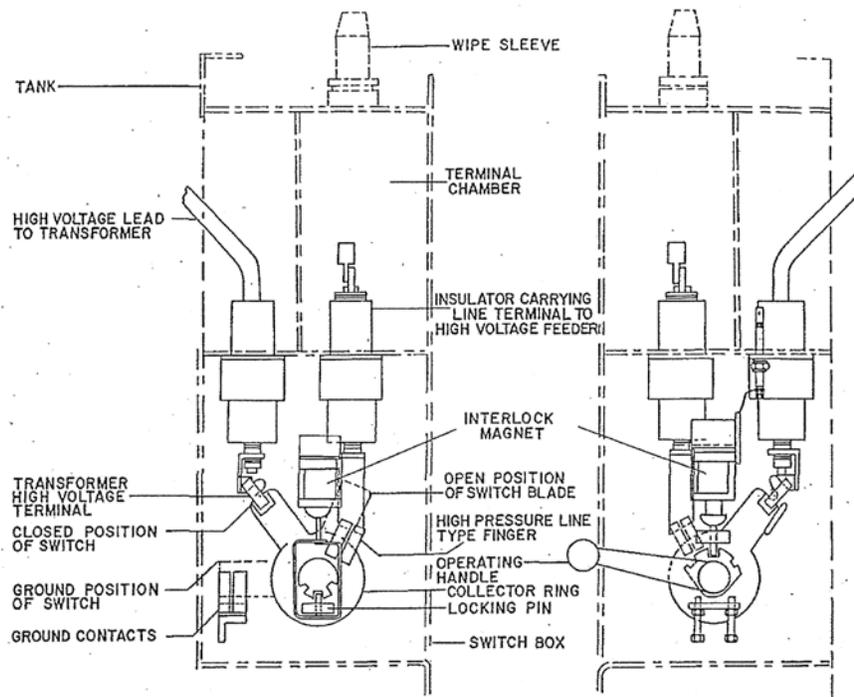
Figure 2

Figure #2 depicts a typical connection compartment and switch compartment on the transformer.
