**STATE OF NEW JERSEY**  
**Board of Public Utilities**  
44 South Clinton Avenue, 9<sup>th</sup> Floor  
Post Office Box 350  
Trenton, New Jersey 08625-0350  
[www.nj.gov/bpu/](http://www.nj.gov/bpu/)

| IN THE MATTER OF THE BOARD'S INVESTIGATION | ) | SPECIAL RELIABILITY |
| INTO RELIABILITY ISSUES RELATED TO JERSEY | ) | MASTER REPORT AND |
| CENTRAL POWER & LIGHT COMPANY'S | ) | ANALYSIS |

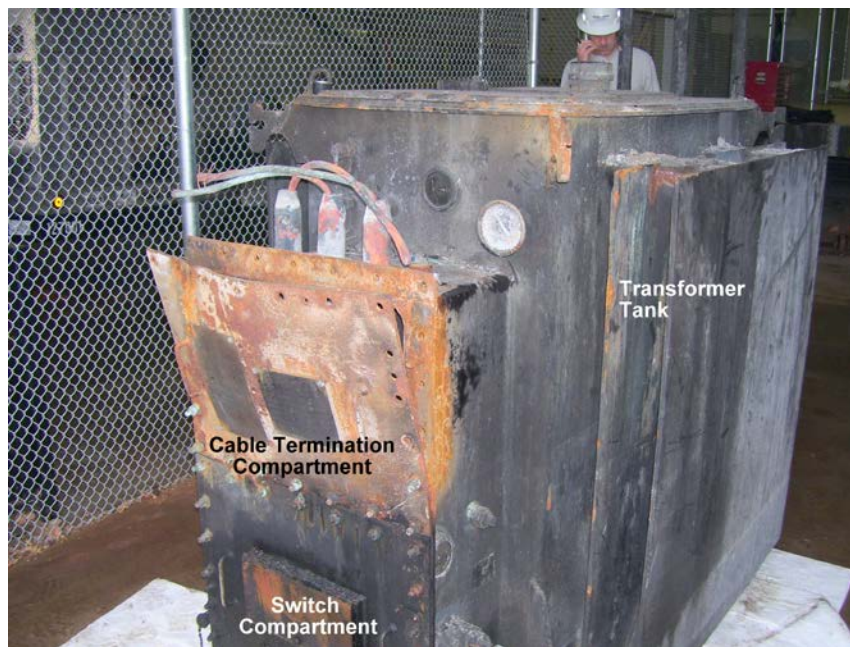
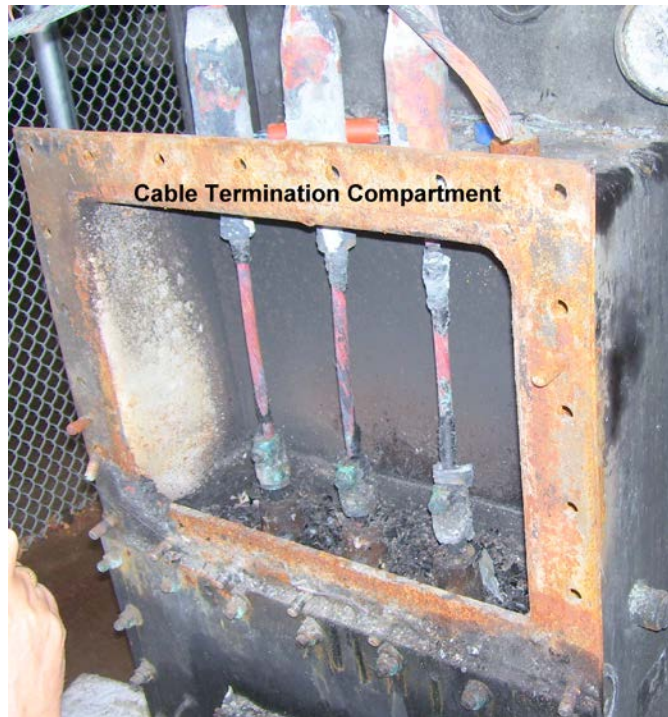
**Photograph # 5**

On June 9, 2011, a Westinghouse 500 KVA transformer failed in Vault # 849. The resulting fire caused extensive damage to the transformer and the other circuits that were in the vault. An investigation by Company personnel and representatives of the Power Cable Consultants determined the primary cable failed in the cable termination compartment. Since this compartment is sealed after the cable has been connected, air tested for leaks and filled with oil, the Company, as many other utilities, conducted visual inspections as preventive maintenance.

Photographs # 5 and # 6 that were taken by a member of the BPU staff show the failed transformer. It is appropriate that additional preventive maintenance should be conducted on all transformers in the Morristown Network that use a cable termination compartment for connection to the primary circuit.

1. Sample the oil from the cable termination compartment and test. This will allow data collection regarding any deterioration of the oil up to this time.
2. Drain oil, remove terminal chamber cover, and inspect the compartment and cable terminations for signs of deterioration. If necessary make repairs. Reinstall terminal chamber cover and air test the compartment for leaks. If necessary make repairs.
3. Fill the compartment with Cooper Power System Envirotemp FR3 Fluid or an equivalent dielectric fluid. This is a non-petroleum product with a higher flash point than petroleum based products.

1. Initiate the program and complete refurbishing of transformers with cable termination compartments by June 1, 2012. The Company has agreed to this recommendation.

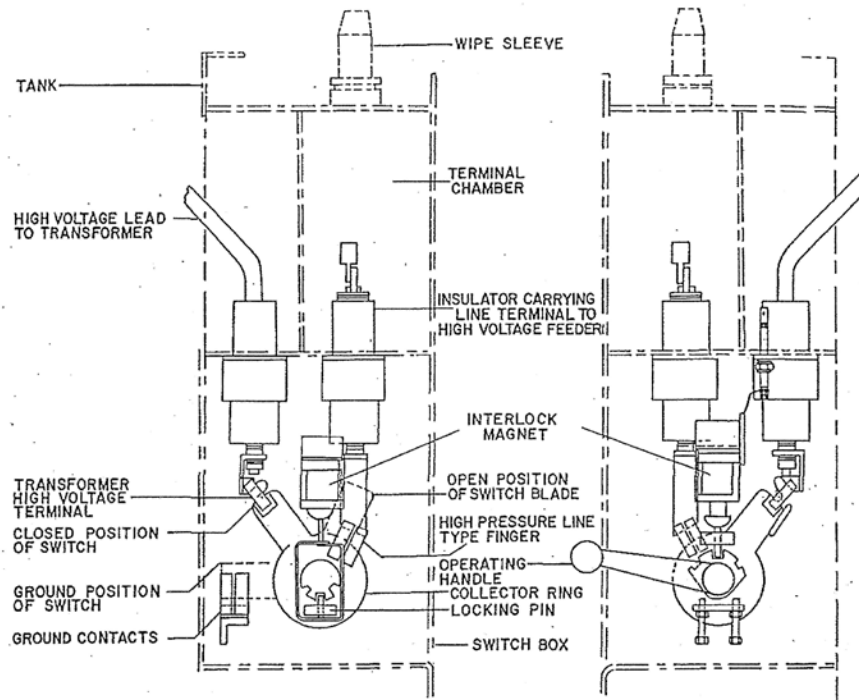
Figure 2

Figure #2 depicts a typical connection compartment and switch compartment on the transformer.
