NEW JERSEY DIVISION OF FIRE SAFETY

Firefighter Fatality and Serious Injury Report Series

Career Firefighter Killed Upon Being Run Over by Fire Apparatus

**Elizabeth, New Jersey
January 2, 2009**

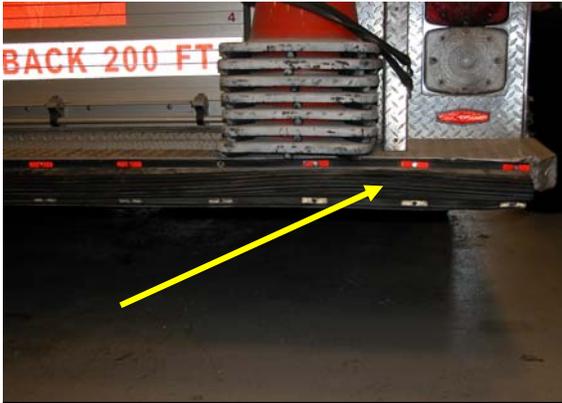
- 2. FACTOR:** The rear step bumper of E-2 had pre-existing and undocumented impact damage that may have prevented the supplemental backing safety system from properly operating upon Acting Captain (FF) Stephens being struck.

However, following the official commercial vehicle inspection, investigators attempted to activate this system by applying significant pressure to various areas of the device while the vehicle was backing. The system failed to activate the vehicle’s brakes as designed during each of multiple attempts. It was also observed that some components of this system appeared to be inoperable due to damage to the rear bumper near the right corner area. This damage could not be attributed to the incident that resulted in the death of Acting Captain (FF) Stephens, as it is believed to have occurred at some time after March 5, 2008, which was the last documented successful test of the BACKSTOP® system performed by the EFD maintenance shop. This bumper damage was undocumented by E-2 personnel and was therefore not repaired prior to this incident.

It should be noted that the testing performed during this investigation cannot confirm the outright failure of this system during this incident. However, if the rear step bumper area of E-2 had not been damaged, and the components of the BACKSTOP® system had been operable, the system could have locked the truck's brakes as designed.

PHOTO 1: Shows rubber bladder component of the "BACKSTOP" system, and pre-existing impact damage near right corner area of rear step bumper of E-2. This is also believed to be the area where FF Stephens was struck.

REMEDY: *Any vehicle damage should be reported and repaired in a timely manner regardless of the perceived insignificance, as said damage could negatively affect other vehicle systems.*

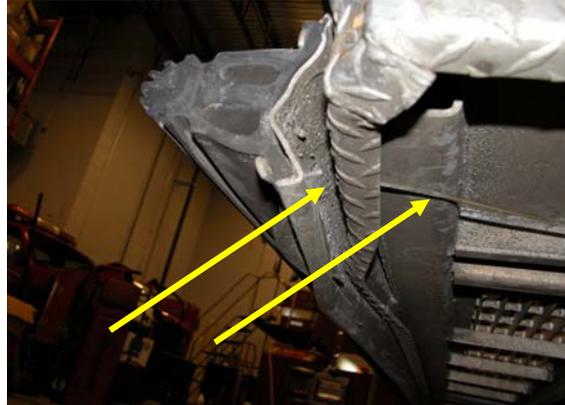
- 1. FACTOR:** E-2 was equipped with a supplemental backing safety system which failed to operate. If operational, this system could have activated the apparatus' brakes when Acting Captain (FF) Stephens made contact with the safety system. The investigation revealed that this system was not routinely checked or properly maintained in accordance with manufacturer's recommendations. Further investigation discovered operational deficiencies and/or failure of the backing system equipped on three other EFD apparatus.

PHOTO 2: Underside view of right rear corner area of step bumper and components of the "BACKSTOP" system. The separation between the truck's bumper, the rubber bladder, and the air pressure sensor hose prevented the system from operating as designed during our testing.

REMEDY: *Personnel should be instructed on how to inspect fire apparatus safety items, and these inspections should be performed and documented in accordance with manufacturer's recommendations on a regular basis. Personnel should also be informed when the system is not operational.*
