Bridge Site Visit Report

ARUP

Hackensack River, 4.17

Date	July 14, 2020
Surveyor	Heros Gnesotto

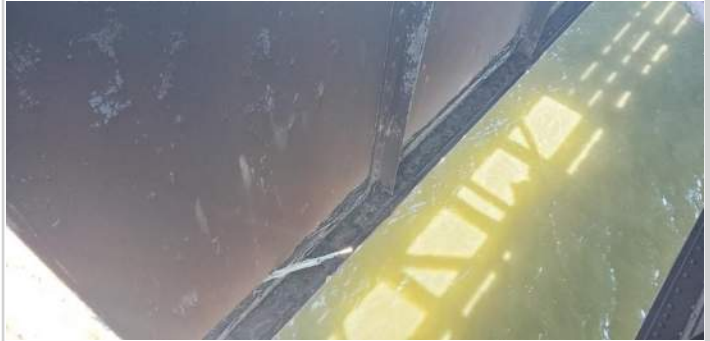
Deck Type	Wood
Deck Condition	Poor
Deck Remarks	
Primary Member Type	Steel
Primary Member Condition	Poor
Primary Member Remarks	Lowest 1' of the girders is severely corroded
Secondary Member Type	Steel
Secondary Member Condition	Poor
Secondary Member Remarks	Some of the lowest connections are entirely dissolved
Drainage System Remarks	None present

(2) Looking down through deck at corrosion at bottom of girders

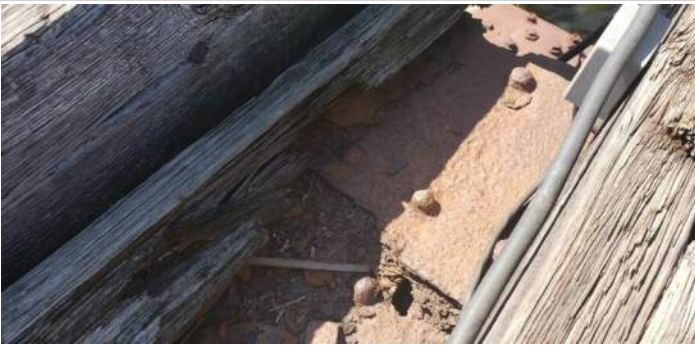
(3) Corrosion at top flange of approach girders between deck timbers

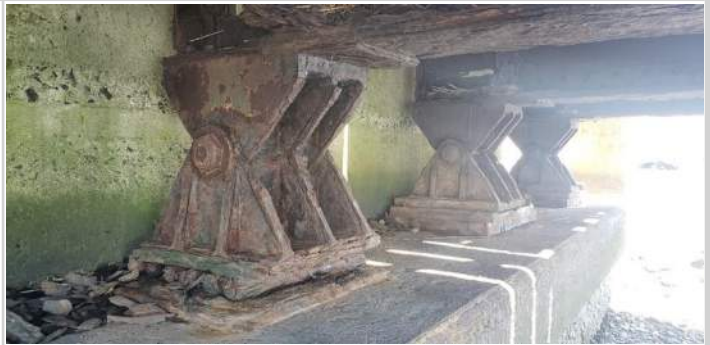
Bearings/Bearing Seat Condition	Severe
Bearings/Bearing Seat Remarks	Masonry plates in severe conditions. Bearings in places crumbling
Stem Wall/Wingwall Type	Concrete
Stem Wall/Wingwalls Condition	Good
Stem Wall/Wingwall Remarks	
Foundation Type	Unknown
Foundation Condition	Unknown
Foundation Remarks	Not visible
Scour/Erosion Remarks

(4) Deterioration at bearings at west abutment

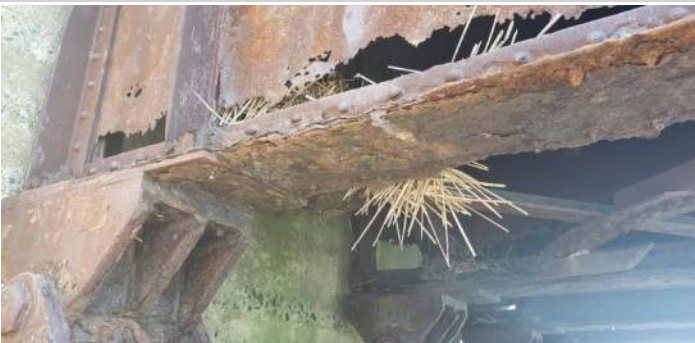
(5) 100% section loss in web and significant deterioration of bottom flange in approach girder at west abutment

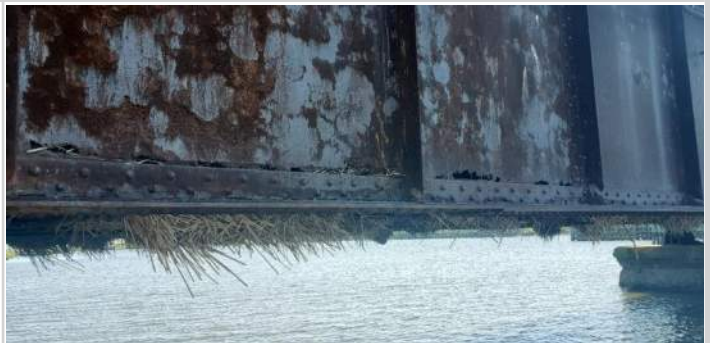
(6) Corrosion and section loss in bottom 1' of approach webs at southern girder west side

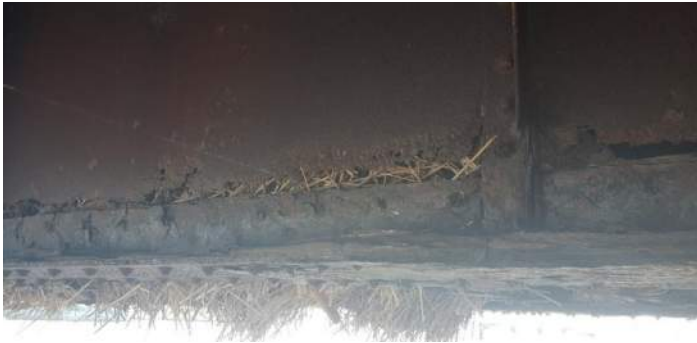
(7) Corrosion at section loss in bottom 1' of approach webs interior girder west side

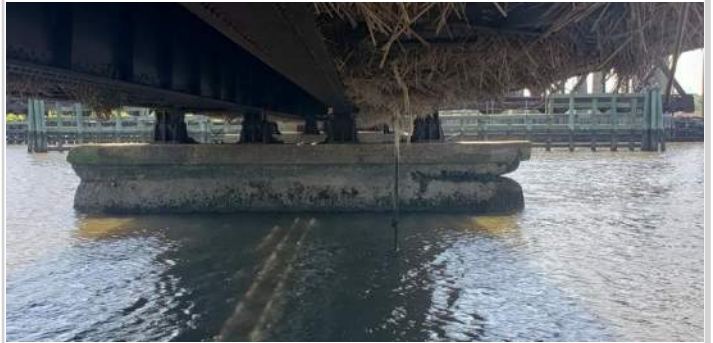
Bearings/Bearing Seat Condition	Poor
Bearings/Bearing Seat Remarks	No direct access possible but evident corrosion
Columns/Cap Type	Concrete
Columns/Cap Condition	Poor
Columns/Cap Remarks	Large spalls (over 1T) about to fall in water. In other places concrete corroded 6-8" at water level.
Foundation Type	Unknown
Foundation Condition	Unknown
Foundation Remarks	Not visible
Scour/Erosion Remarks	Not visible

(8) View of spalling and section loss in substructure at waterline in west approach. Note sea grass stuck in girders

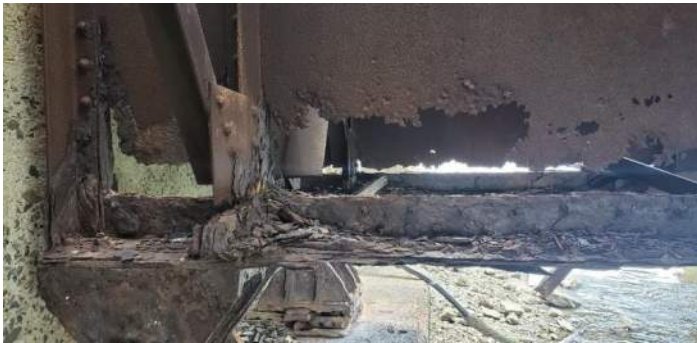
(9) Full section loss of web and severe deterioration of bottom flange in approach girders at east abutment

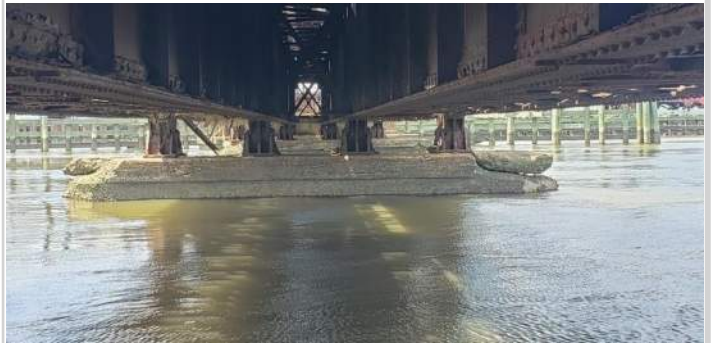
(10) Substructure in east approach with significant spalling at waterline

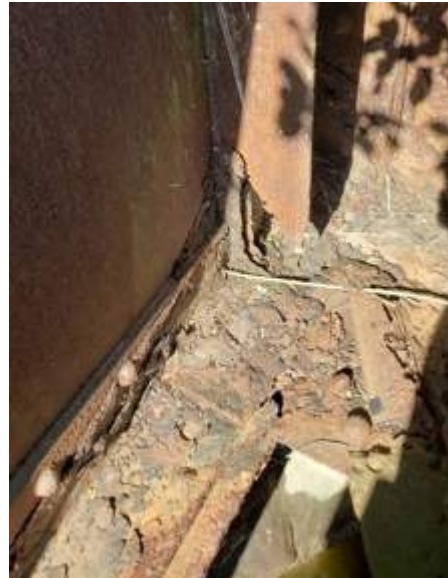
(6) Corrosion on the bottom flanges of the girders

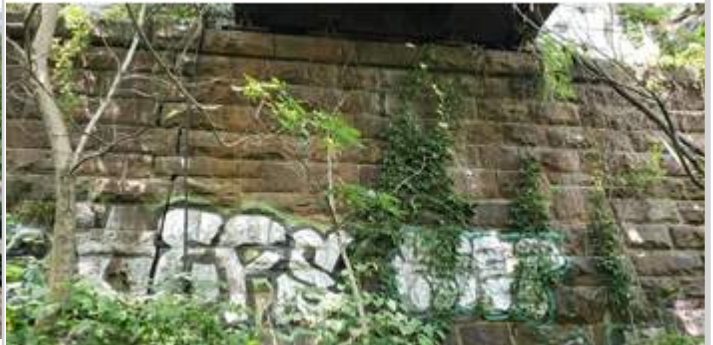
Stem Wall/Wingwall Remarks	East abutment concrete, minor cracks. West abutment stone, visible cracks
-----------------------------------	---

(2) West masonry abutment exhibiting some cracking

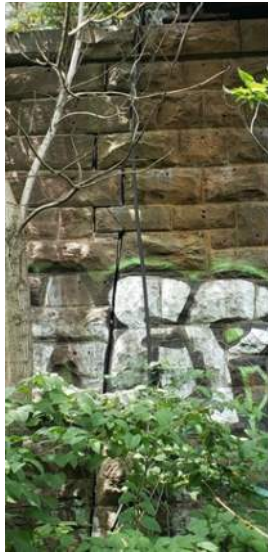
(3) West masonry abutment exhibiting some cracking

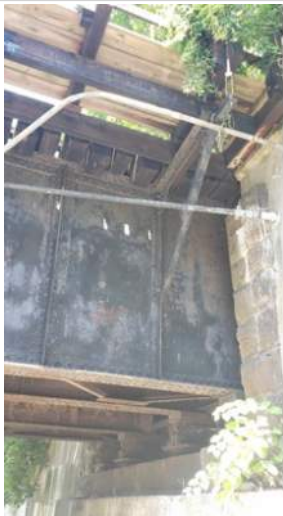
(5) Corrosion on the girders

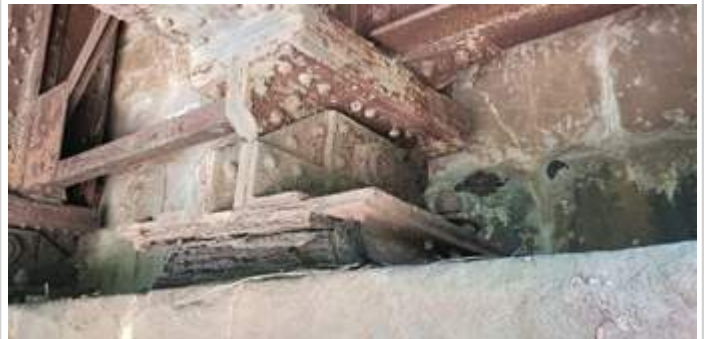
Bearings/Bearing Seat Remarks	Masonry plate corroded
--------------------------------------	------------------------

(6) Corrosion of bearings at the eastern side of the bridge

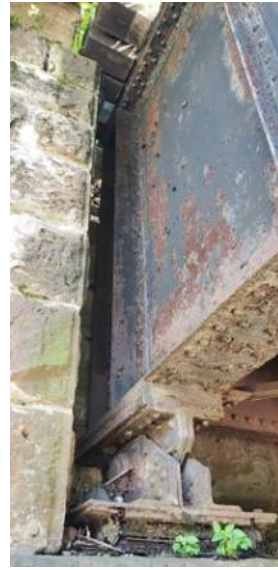
(8) Corrosion in girders and bearings

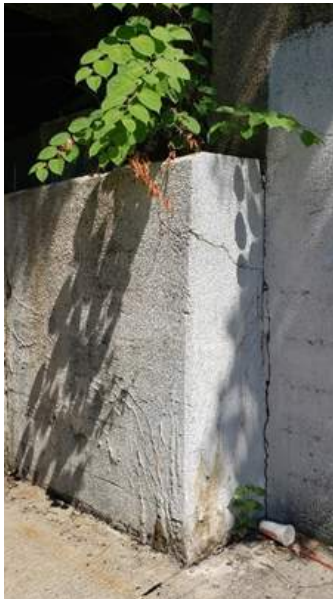
(9) East concrete abutment exhibiting some cracking

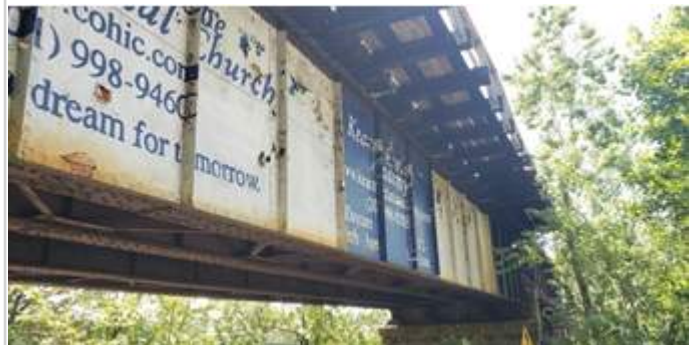
(10) Superstructure with some corrosion

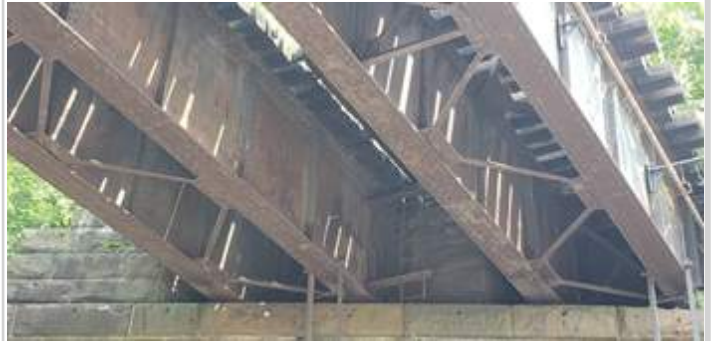
(6) Minor corrosion on the girders

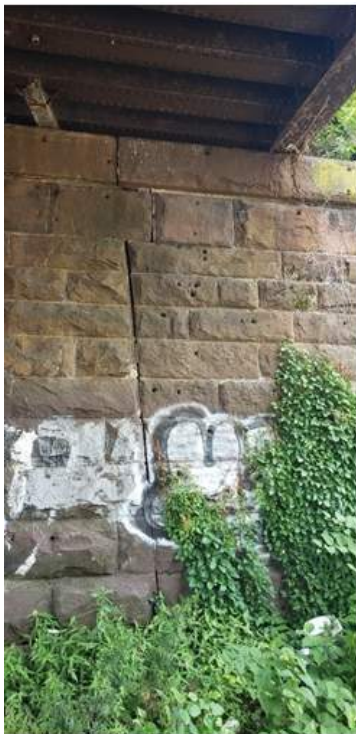
(5) Crack in western abutment

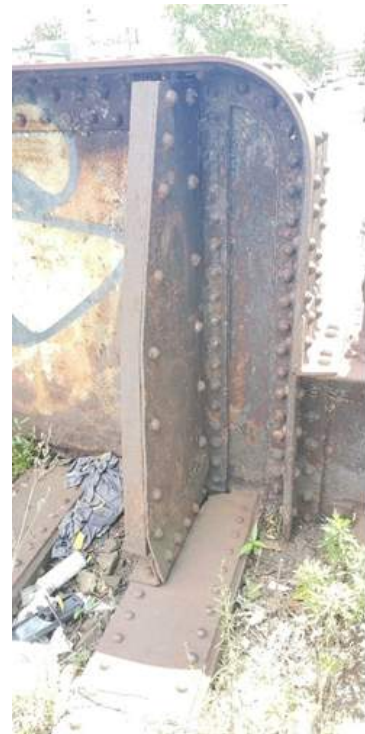
(6) Corrosion on one of the girders

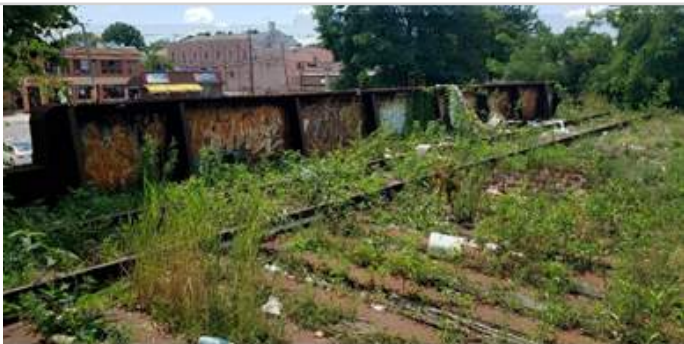
(7) View of overgrowth on top of metal deck

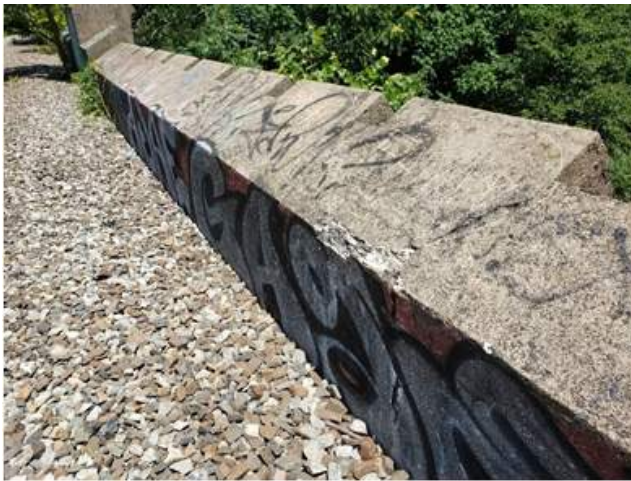
(3) Graffiti and some spalling on parapet

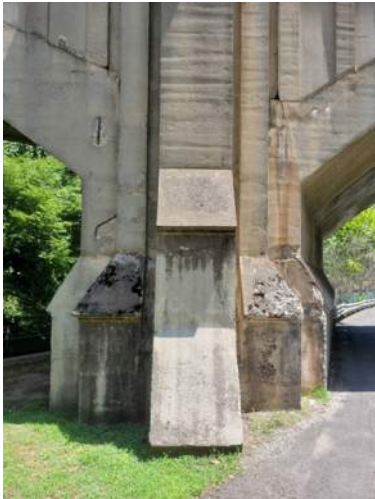
(7) Spalling at the base of one of the piers

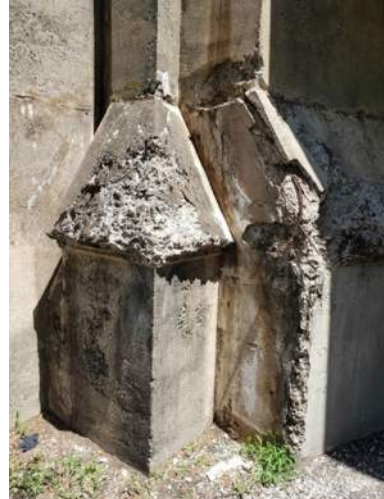
(8) Spalling at the base of one of the piers

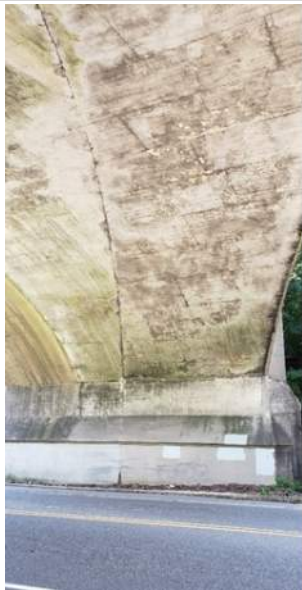
(9) Spalling at construction joint

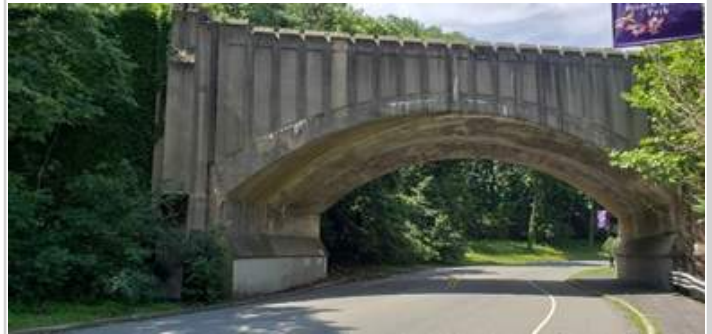
(10) Spalling and discoloration looking west

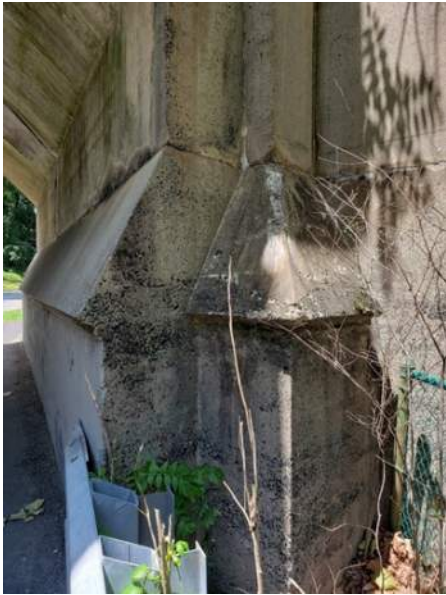
(11) Spalling at the base of one of the piers

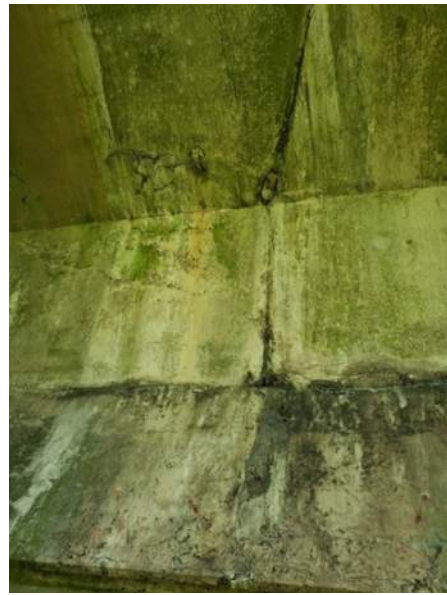
(12) Spalling and discoloration on the side of one of the piers

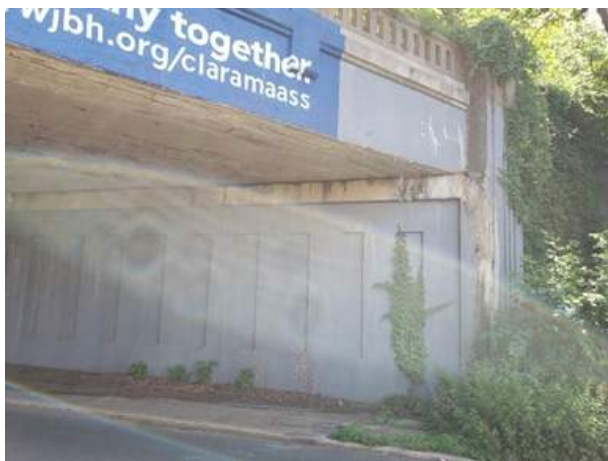
(5) Spalling at the southern abutment and cracking in the superstructure

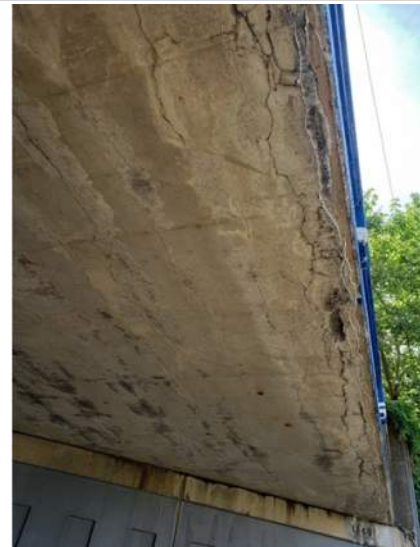
(6) Longitudinal cracking and spalling on underside of superstructure

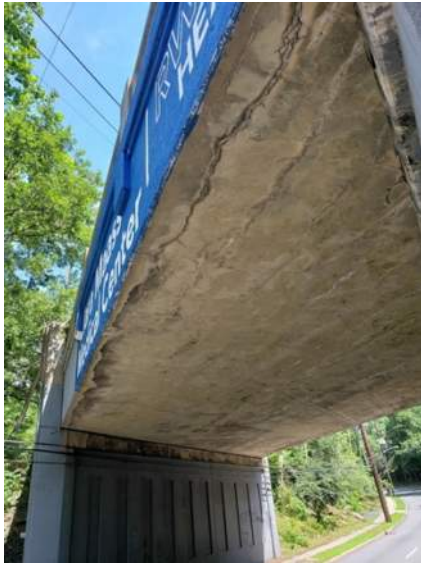
(7) Longitudinal cracking and spalling on underside of superstructure

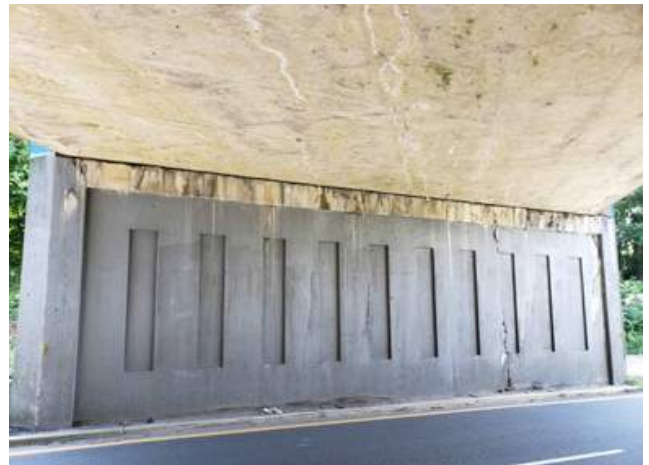
(8) Cracking on underside of deck and discoloration at the top of the pier

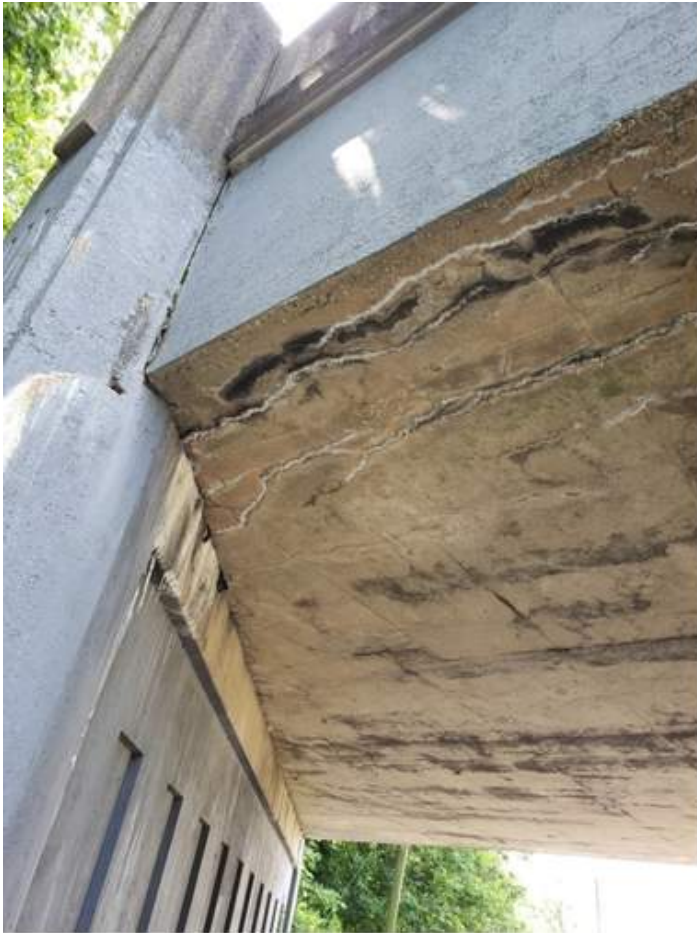
(11) Longitudinal cracking on underside of deck

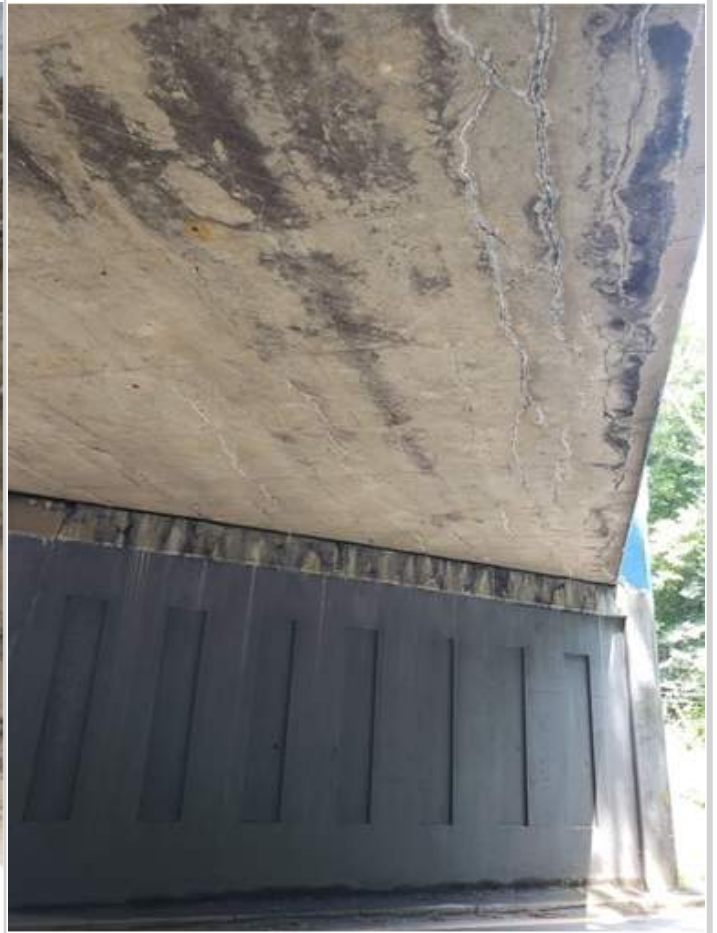
(12) Longitudinal cracking on underside of deck

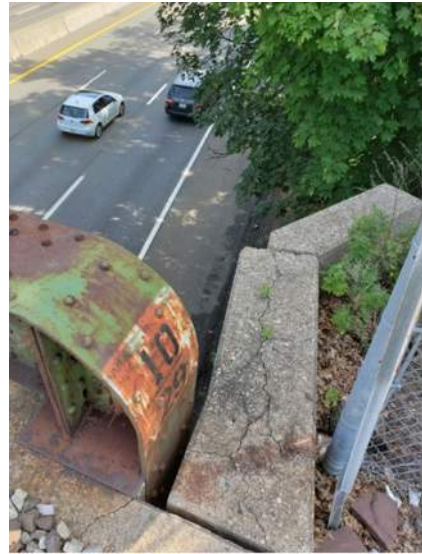
(2) Cracking in the concrete above the wingwall

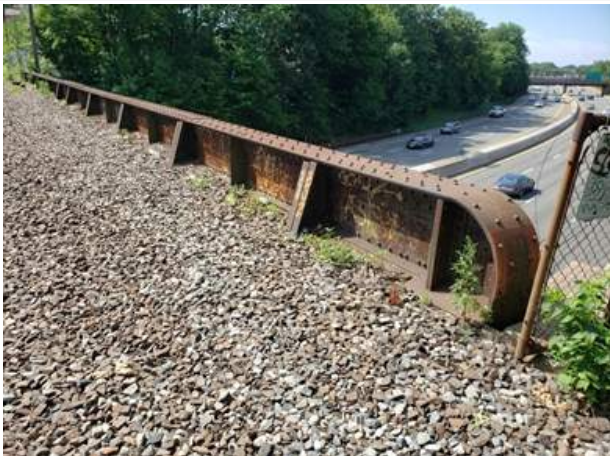
(3) Corrosion on the girder

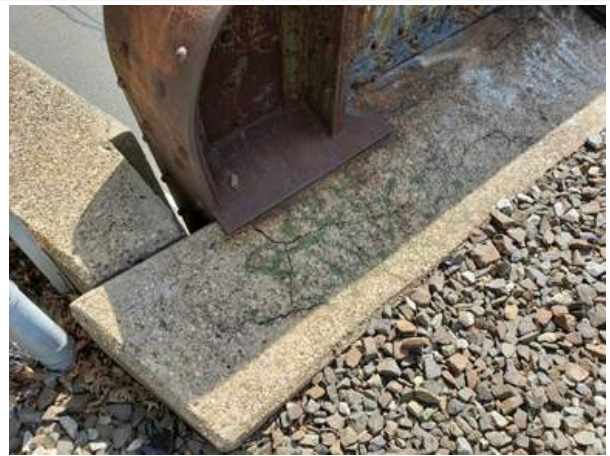
(4) Cracking in the concrete above the abutment

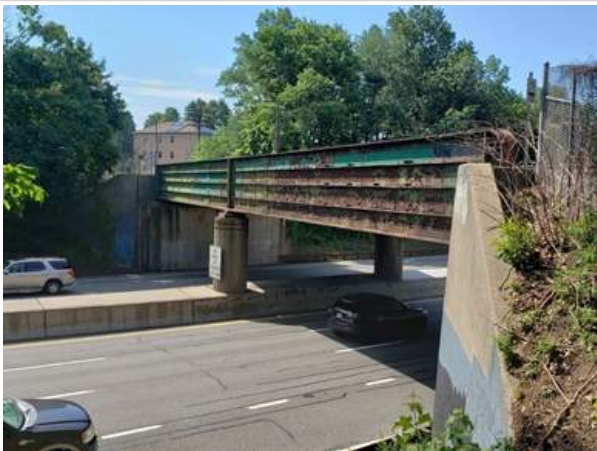
(5) Corrosion on the girders

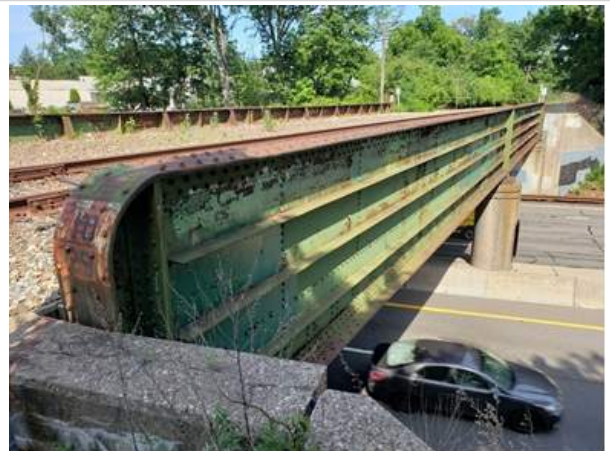
(6) Corrosion on the girders

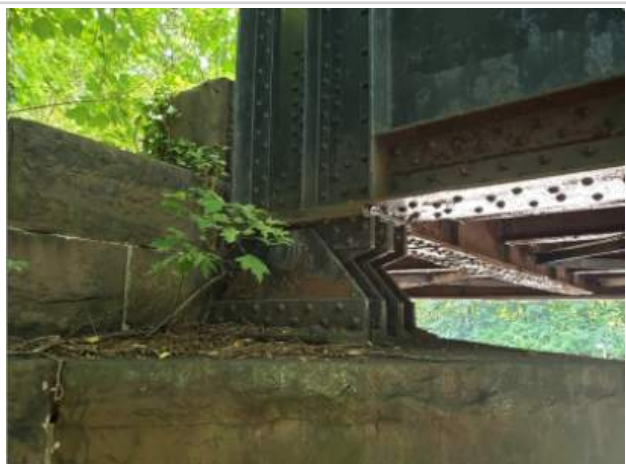
(4) Crack running horizontally in masonry under bearing

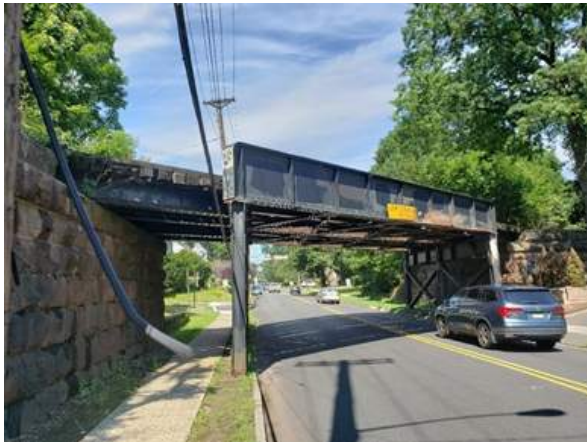
(1) Damage to the fascia girder due to vehicular impact

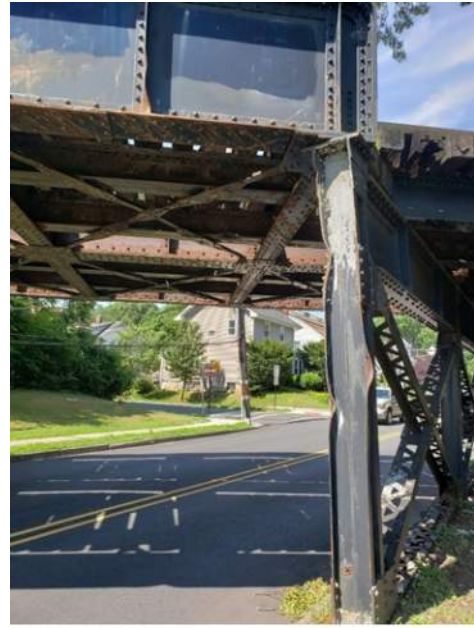
(4) Damage to the pier column due to vehicular impact

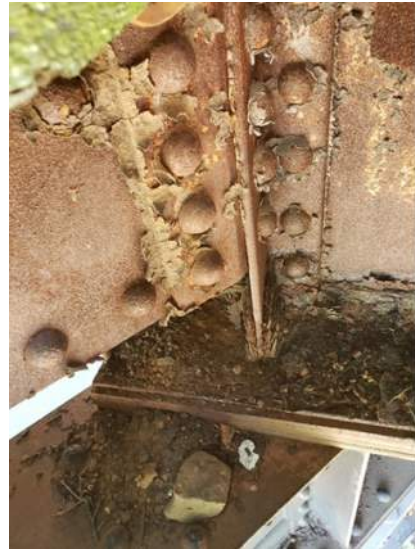
(6) Corrosion at a connection on the superstructure

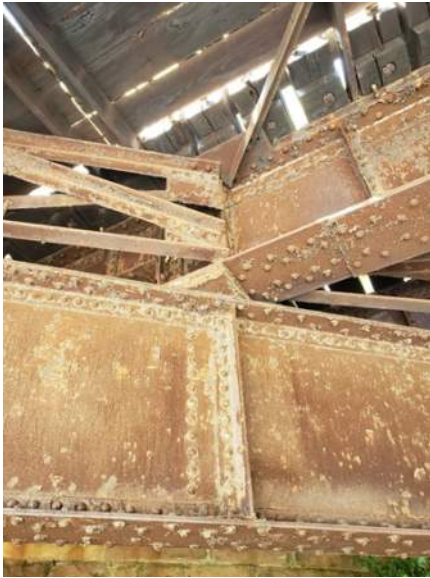
(3) Corrosion on superstructure
