# NJ FACE INVESTIGATION REPORT

FACE 00-NJ-073-01

July 19, 2001

## **Electrician Killed When Scissor Lift Tips Over**

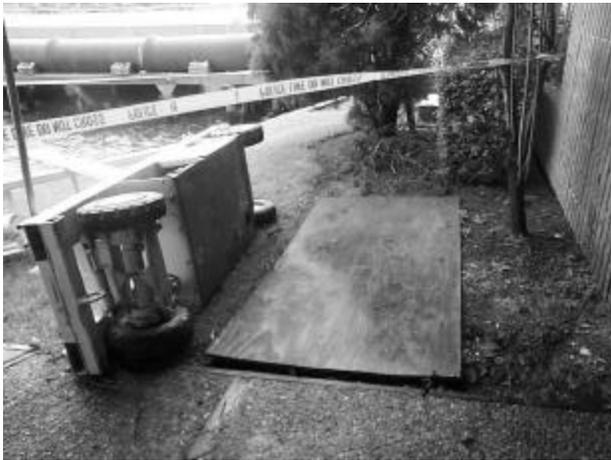
Shortly after lunch, the foreman drove the lift around the building and set it up near the corner of the building beside the patio. Since the awning prevented the lift from being set up on the cement patio deck, the crew decided to use a sheet of plywood on the ground as a base for the lift. After leveling the dirt and mulch with their feet, they put down a single four by eight-foot sheet of 3/4-inch plywood and positioned the lift on it. The foreman then raised the lift to test it. Seeing it was ok, the foreman rode up on the lift with the victim and noticed some branches from a tree were getting in the way, which they removed. The foreman then went to work on the other side of the building, leaving the victim and helper to their jobs.

**Photo 1**  
Plywood base on mulch

**Discussion:** The lift used in the incident was primarily designed for indoor use on hard, level surfaces. The victim was also sitting on the rails. FACE recommends that industrial lifts should be used as per the manufacturer's design and directions. If there is a question about proper use, the manufacturer or sales representative should be consulted. In this case, an all-terrain personnel lift would have been appropriate.

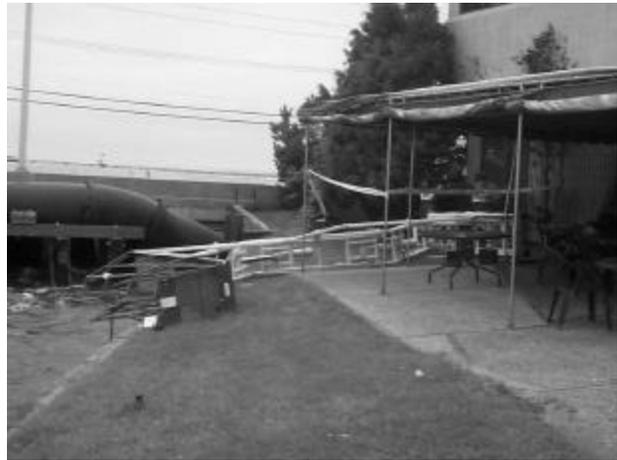
helper also saw that he was wearing personal stereo headphones as he worked. A few minutes later, while the helper was sawing a board near the bottom of the lift, he heard the victim cry out. The helper looked up and saw the lift tipping over. The lift platform landed just beyond the edge of the bulkhead, throwing the victim headfirst into the four to five foot deep tidal bay. The helper, who could not swim, jumped into the water but could not reach the victim. He climbed out of the water and went for the foreman as patrons from the cafeteria came to help. The foreman ran back to see the victim being pulled out of the water and a bus driver with EMT training start to work on him. The police and paramedics arrived and found that the victim had a pulse but was unresponsive. He was transported to the local hospital where he died of head and neck injuries at 6:46 p.m.

**Photo 2**  
Lift platform on bay bulkhead
