NJ FACE INVESTIGATION REPORT

FACE 01-NJ-098-01

Jackhammer Operator Run Over by a Truck in a Highway Work Zone

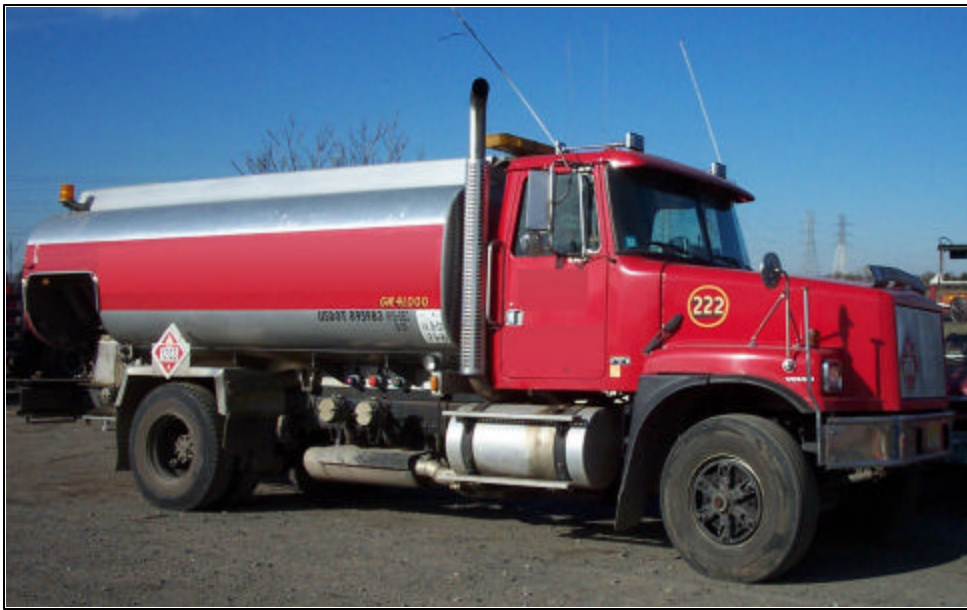
Photo 1
Fuel truck

No one directly witnessed the incident. Apparently, the victim was standing near the front of the truck when the driver moved away. The driver stated that he did not see or hear anything and that his line of sight was clear. It was noted during the investigations that the height of the front of the truck was over five feet high and could block the driver's view of anyone standing directly in front of it (see photo). The State Police report also noted some items hanging from the rearview mirror and a translucent "bug shield" mounted on the front of the truck that could block the driver's view.

Recommendation #2: Truck owners should examine their vehicles for blind spots and install mirrors to increase visibility.

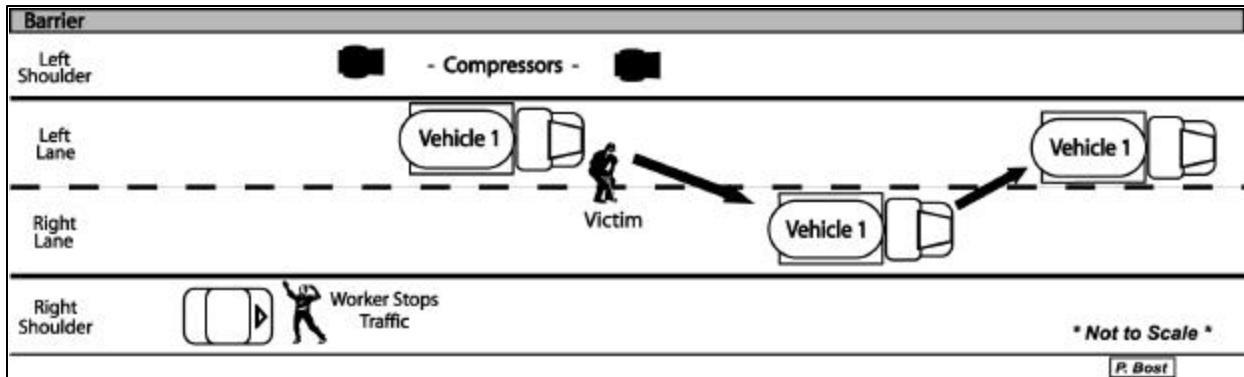
The weather on the morning of the incident, a Saturday, was clear and dry. The victim arrived and donned an orange safety vest for working at the site. At the time of the incident, the worksite consisted of 39 workers spread among three different work zone within the construction site. Both highway lanes were closed, and traffic was being diverted to a single-lane shoulder adjoining the right hand (slow) traffic lane. Traffic cones were used to mark off most of the area, with some sections of concrete “jersey” traffic barriers set up where needed. The victim was working at the largest work zone. Here, the roadway was an elevated highway spanning the local secondary roads. This area was slightly inclined but straight with good line of sight. All the asphalt from the right lane had been removed and the concrete surface had numerous holes jackhammered into it, exposing the rebar. The victim was working in the right lane on the edge of a large hole that measured approximately 11 feet long by 2 feet wide. Shortly after 10:00 a.m., a fuel truck owned by the joint venture arrived on site to refuel the air compressors that powered the jackhammers. The truck was a 1999 tanker truck with a gross vehicle weight of 41,000 pounds. With a capacity of 800 gallons of diesel and 800 gallons of gasoline, the truck was nearly full when it arrived. A laborer saw the truck arrive and moved a cone to allow it to move from the highway shoulder into the work zone, where the driver positioned it between the two compressors that needed refueling. At that time, all work in that part of the work zone ceased. The driver had 10 years of experience and quickly filled the compressors with diesel fuel, filling the compressor behind his truck first. After filling the second compressor, he moved towards the rear of the truck to reel in the fuel hose. He then climbed into the cab of his truck and waited a few moments for a laborer behind him to stop traffic and wave him on to leave. The driver moved his truck forward at a 45-degree angle towards the victim at a speed of less than five miles per hour. As he did this, two

Diagram 1
Overview of Incident Site

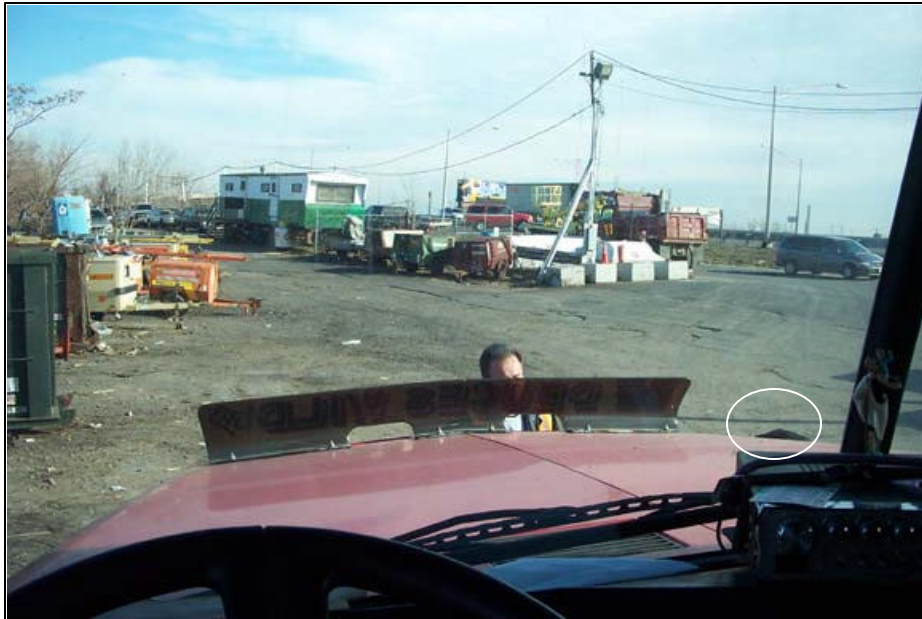
Photo 2

**Driver's field of view inside of tanker truck
Note pedestrians in front of and directly to the right of bug shield**

Discussion: The tanker truck driver stated that he did not see the victim as he started to drive out of the work zone. After the incident, the OSHA compliance officer and FACE investigator noted the driver's visibility from the truck's cab. Two people of varying height were photographed from the drivers seat of the truck. Only the very top of one pedestrian's head was visible over the right front corner of the truck's hood, while the second pedestrian was partly obscured by the bug shield (see Photo 2). To prevent this, NJ FACE recommends that all truck owners should examine their trucks for blind spots and install mirrors to cover the blind spots. It was noted that the construction company immediately examined their truck and installed convex mirrors to cover the blind spots.

Discussion: Employers should be aware that devices are available which can detect the presence of persons in the blind spots of vehicles and provide a warning to the driver. Devices using electromagnetic sensors are available which can detect persons in the front blind spot of vehicles. One device is intended to be mounted on the front of school buses to warn drivers when children cross into the bus's front blind spot. Similar devices designed for the rear of vehicles may also be applicable to the front. Employers and truck owners may wish to explore these options.
