# NJ FACE INVESTIGATION REPORT

FACE 07-NJ-077

June 21, 2011

## Construction Laborer Dies After Falling Through Temporary Bridge “Catch” Platform, 75 Feet To Ground

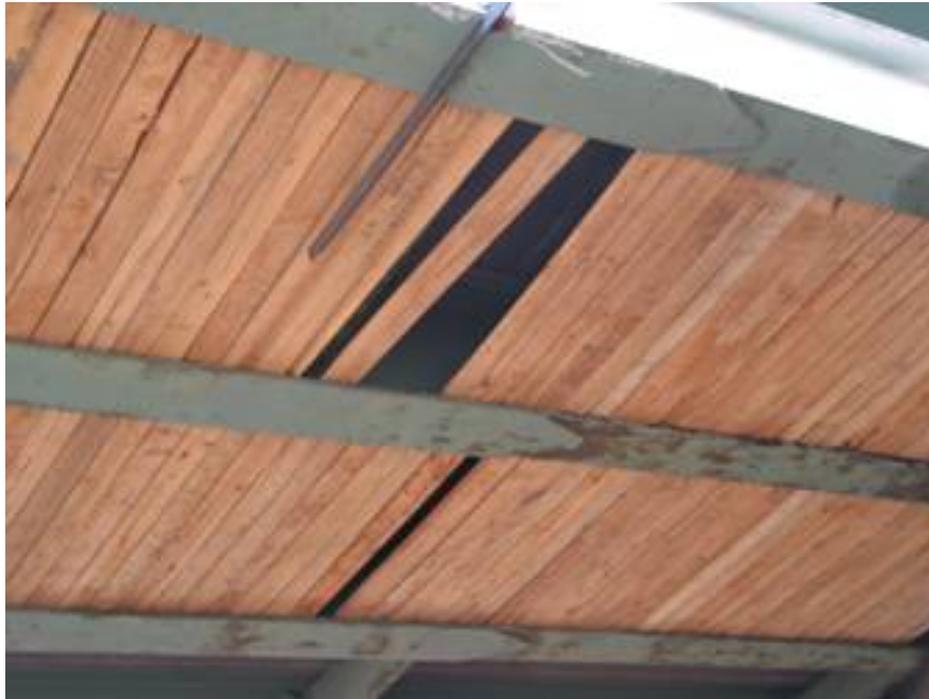
This fatal incident occurred at a large highway bridge construction project. The construction project was typical of other highway bridge projects that involved work on a bridge deck. A “catch” platform below the work area was designed to prevent any construction debris generated on site from falling to the ground below. Debris can be generated from a multitude of activities, including the breaking up of concrete or other surface material that is to be replaced or the installation of support structures and concrete for a new or expanded bridge. The “catch” platform is typically a set of wooden planks (e.g. 2’ X 10’) that are placed from the bottom of one I-beam to the bottom of another I-beam, with the end of the planks set to simply rest on the lip of the I-beam. The planks are typically not secured to the I-beam and it is common to observe gaps and shifting of the planks in a “catch” platform (See Figure 1).

**Figure 1. Example of shifting bridge deck “catch” platform wooden planks (view from ground).**

**Discussion:** Devices and/or designs for catch platforms to hold individual planks together to prevent shifting of the planks should be used. In this incident, although the plank that failed was only 9-<sup>3</sup>/<sub>4</sub>" wide several planks shifted allowing the victim to fall through the bridge "catch" platform. If the planks were affixed together, this may have prevented the victim from falling through the bridge "catch" platform. This can be accomplished through several means, including nailing the edges of the wooden planks together. However, it is important to note that OSHA 29 CFR 1926.451(b)(9) prohibits the use of any material that will obscure a visual inspection of the top or bottom surface of the wood planks. Some contractors have suggested covering the entire "catch" platform with plywood, however this would eliminate the ability to visually detect and replace defective or damage wood planks. This could be a particularly problematic if the plywood alone can not support four times the weight potentially placed upon it.

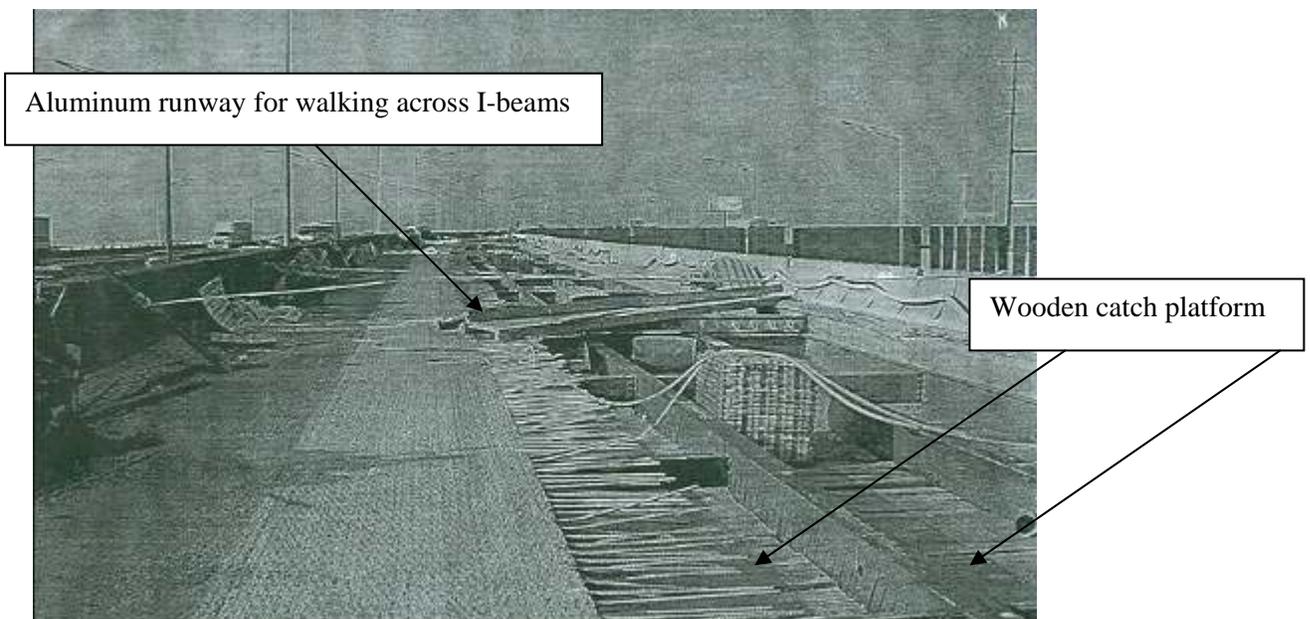
**Figure 2. Bridge deck where incident occurred**

The fatal incident occurred on a typical work day in 2007 shortly after the morning shift began. An OSHA Compliance Safety and Health Officer (COSHO) who had visited the work site several times since the fatal accident reported that it was not uncommon for employees to walk and work on the platform. The victim was not using any fall protection devices at the time of the incident. According to the COSHO, the victim stepped down from the I-beam onto the wooden catch platform to move a “pic” board, a metal runway used to transport concrete between work areas on the bridge. The distance from the top flange of the I-beam to the bridge “catch” surface was 16 inches. Immediately after the victim stepped down, one plank broke across its width, resulting in the employee falling partially through the platform. As the employee fell, other wooden planks making up the platform shifted because the planks were not affixed to one another, and the victim fell completely through the platform (see Figure 2, incident site).

The wooden plank that failed was a nominal 2' X 10' piece of economy-grade, white pine that was 67<sup>1</sup>/<sub>2</sub> inches long. The height and width of the failed plank was 1<sup>7</sup>/<sub>8</sub> by 9<sup>3</sup>/<sub>4</sub> inches, respectively. The plank broke with a curved split at approximately 29 to 29<sup>1</sup>/<sub>2</sub> inches from its end, near the location where the victim stepped onto it. This curved split caused the board to break into two large sections and one smaller triangular section. A failure analysis of the broken plank by OSHA revealed that the major strength reducing feature of the plank was the Slope-of-Grain (SOG), which was 1:2 (i.e., the grain along the length of the board deviated from the long axis of the plank by a distance of 1 inch for every 2 inches in length). Acceptable SOG for scaffold-grade lumber is a minimum of 1:12. The OSHA failure analysis demonstrated that the wood used in this platform was inadequate as a walking/working surface. In addition, the COSHO observed planks being reused on the bridge “catch” that had been previously removed from service due to structural concerns, and noted visibly damaged wooden planks as well as planks that had shifted, leaving open spaces in the platform.
