NJ FACE INVESTIGATION REPORT

FACE 98-NJ-094-01

Equipment Operator Killed After Backing a Forklift Into an Excavation

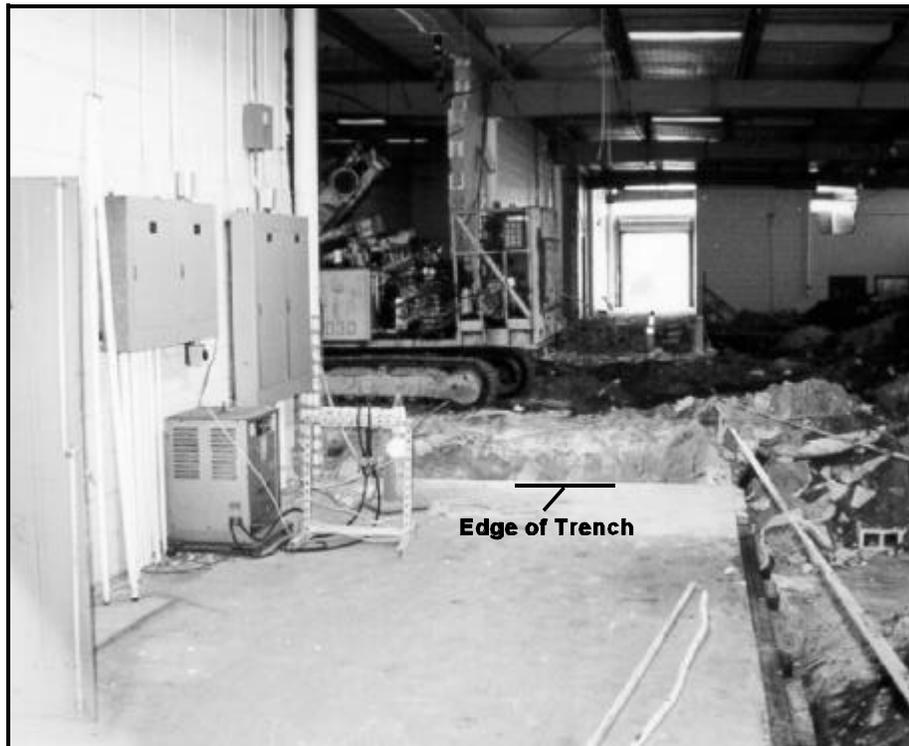
After talking with the construction coordinator, she apparently entered the building through a north side entrance and walked through the office areas to the loading dock. At this point she crossed over a yellow warning tape and spoke briefly with a subcontractor's employee. The forklift was connected to a charger about eight feet from the trench. This section of the trench had been dug earlier that morning and measured about five feet wide by four feet deep and extended across the entire width of the dock. It had been covered by three 4 x 8 foot sheets of 5/8 inch plywood that hid the edges of the trench. The victim disconnected the charger, started the forklift, and backed directly over the plywood. A worker for the contractor (who stated that he had covered the trench under direction from their safety person) saw the victim and tried to warn her, but the forklift broke through the plywood and fell backwards into the trench. The forklift's rear cage support hit the edge of the trench, crushing the victim when the impact bent the cage into the steering wheel. The witness and several other workers called for help and tried to free the victim. Police, fire, and EMS personnel arrived but were unable to raise the forklift out of the trench. She was pronounced dead at the scene at 1:51 p.m.

Discussion: The contractor recognized the hazard of the construction area and tried to correct it by putting warning tape around the area and covering the open trench with plywood. Unfortunately, the plywood covered and hid the trench. To prevent injuries, NJ FACE recommends placing warning tape or protective barriers near the edges of all unattended trenches and excavations. It should be noted that the federal OSHA standard 29 CFR 1926.501 requires guarding excavations that are more than six feet deep and not easily seen.

Photo of incident site, taken one month after incident

Recommendation #2: Construction contractors should ensure that excavations are clearly marked and/or properly guarded.
