NJ FACE INVESTIGATION REPORT

FACE 99-NJ-024-01

Recycling Plant Laborer Engulfed by a Load of Plastics on a Conveyor

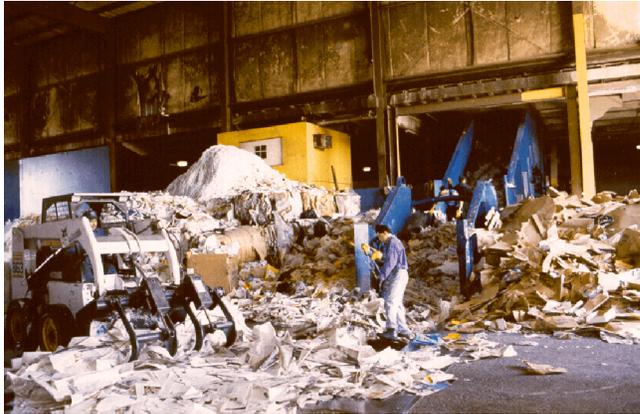
Loading Area of Conveyor

The hinged steel belt conveyor belt that fed the baler was 70 inches wide, 63 feet long, and surrounded by a smooth, stainless steel perimeter with a 3° grade at the beginning of the conveyor. Its speed was measured at approximately 2 feet 3 inches per 5 seconds (27 feet per minute). The flat section of the conveyor was 15 feet long. At 15 feet, the conveyor made its first angle upward and was protected by a steel skirt on each side.

Here an 18 inch circumference cross piece was welded across the skirt. A second cross piece was welded in place about 10 feet from the first. The first had been added to the conveyor system by the company to prevent materials from falling back as the conveyor

inclined. The second cross piece was installed for workers to hold on to as they worked on the slowly moving conveyor.

Discussion: The emergency shut off located on the side walls of the conveyor belt was not functioning. Workers had no way of stopping the movement of the belt when the emergency occurred. Only the baler operator, who could not see the workers on the belt, was able to shut down the operation.

The employer has repaired the shut off device. It is suggested that an emergency stop cord also be installed along the length of the top of the conveyor side frame. A worker on the moving conveyor would be able to pull the cord to stop the movement of the belt.
