BRIDGE RE-EVALUATION SURVEY REPORT

STRUCTURE NO. 2XXX-XXX
ROUTE US 22 OVER STONY BROOK
BOROUGH OF NORTH PLAINFIELD
SOMERSET COUNTY

SAMPLE REPORT
(FOR GUIDANCE ONLY)

14TH CYCLE
June 20, 2005

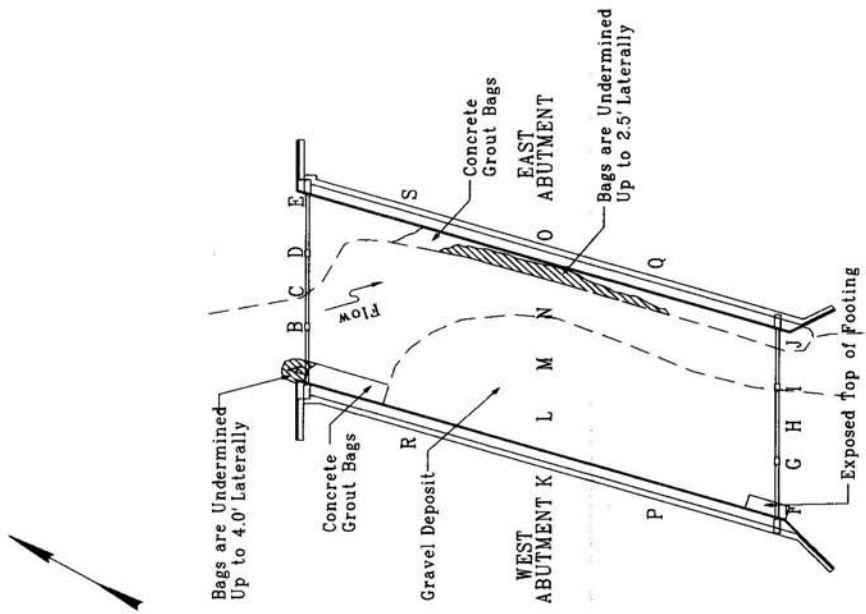
PLAN AND SOUNDING DATA

Based on the Bridge Scour Evaluation Program, Stage II results, the structure is determined to be scour critical (Item 113 = 3). This inspection revealed footing exposure at the south end of the west abutment for 6 feet. The footing was detected beneath soil along the southwest wingwall for 2 feet. The grout bags are exposed at the north end of the west abutment and are undermined up to 4' laterally. The grout bags are undermined up to 2.5' laterally near mid span of the east abutment. The streambed material consists of bedrock, boulders, cobbles, gravel, and some sand.

POINT	LOCATION	BASELINE		CYCLE 14	
		CYCLE 4		JUNE 2005	
		MAY 1985	WATER DEPTH	MAY 1985	WATER DEPTH
A	WEST ABUTMENT	4'-0"	-	5'-9"	-
B	1/4 POINT	-	-	6'-10"	0'-9"
C	MIDSPAN	7'-0"	0'-6"	5'-3"	-
D	1/4 POINT	-	-	4'-1"	-
E	EAST ABUTMENT	4'-0"	-	2'-4"	-
F	WEST ABUTMENT	5'-11"	-	6'-2"	-
G	1/4 POINT	-	-	5'-3"	-
H	MIDSPAN	8'-8"	-	5'-7"	-
I	1/4 POINT	-	-	8'-3"	1'-1"
J	EAST ABUTMENT	8'-4"	1'-3"	8'-4"	-
K	1/4 WEST ABUTMENT	-	-	5'-1"	-
L	1/4 POINT	-	-	4'-8"	-
M	1/4 MIDSPAN	-	-	5'-7"	-
N	1/4 POINT	-	-	7'-3"	0'-1"
O	1/4 EAST ABUTMENT	-	-	6'-0"	-
P	1/4 POINT W. ABUT.	-	-	5'-2"	-
Q	1/4 POINT E. ABUT.	-	-	6'-0"	-
R	1/4 POINT W. ABUT.	-	-	5'-7"	-
S	1/4 POINT E. ABUT.	-	-	5'-11"	-

We recommend installing scour countermeasures recommended in Stage II Scour Evaluation Report.

Install a flexible gabion mattress extending from the face of abutments across the entire bridge opening, placed level with the existing streambed to a depth of 1 foot.

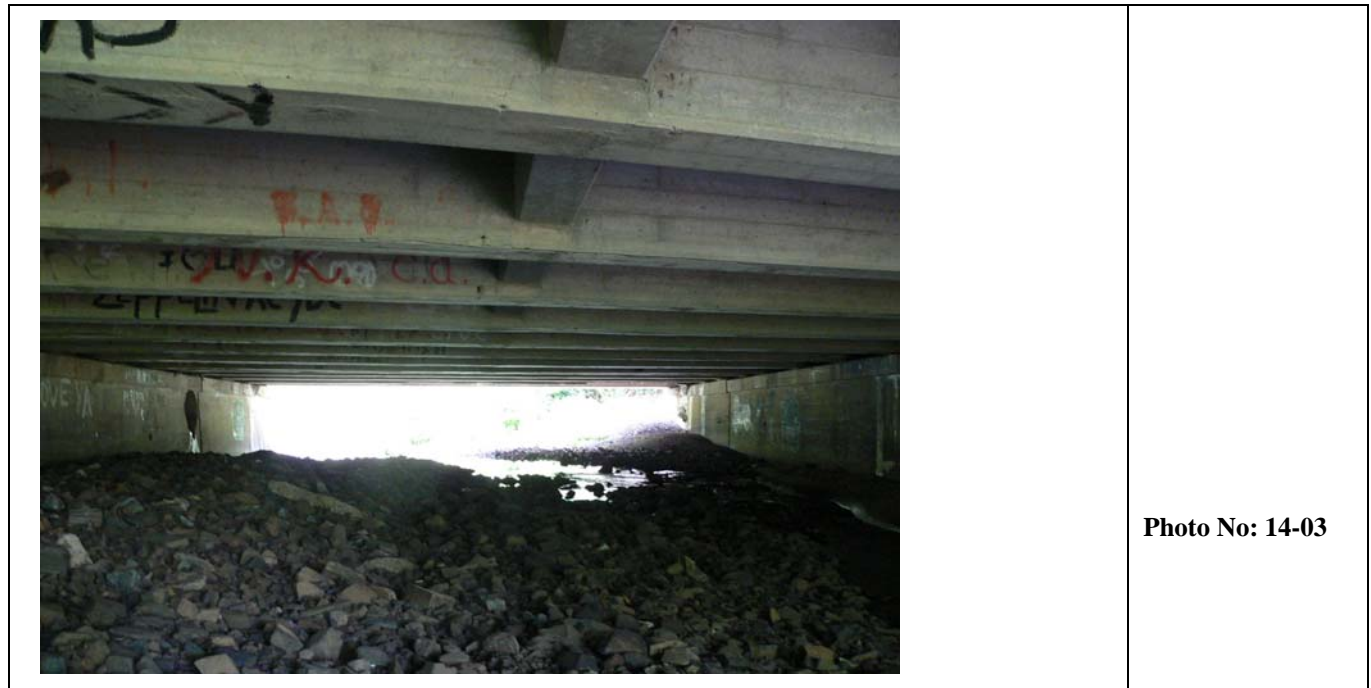
Photo No: 14-03

Location:	Superstructure, looking North.
Description:	General view of superstructure. Note: Debris in the channel.

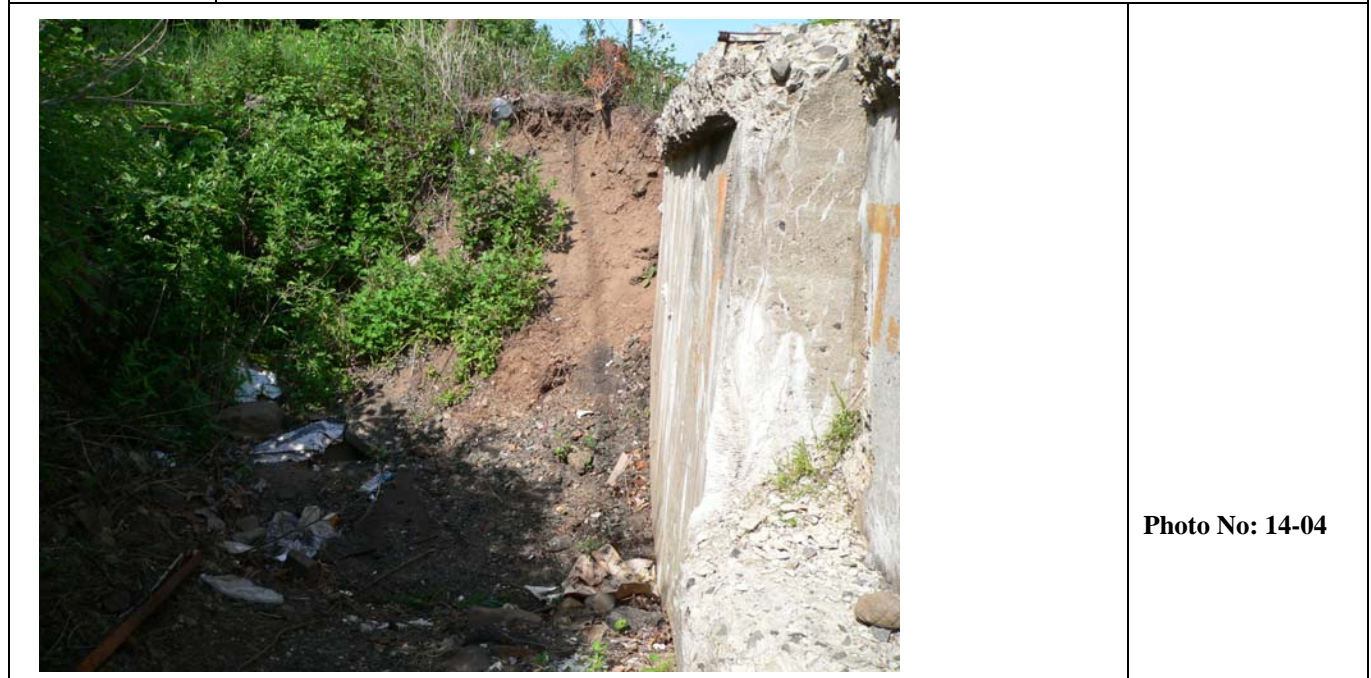
Photo No: 14-04

Location:	Northeast wingwall, looking East.
Description:	Severe erosion behind northeast wingwall (20 feet long x 10 feet wide x 2 feet deep).

Fill the severely eroded area at the north side of east approach embankment with suitable fill material, place rip rap and construct 30 feet long curb at the northeast approach to direct water runoff to a flatter slope on a Priority 2 repair basis (see [Photo Nos.14-04 to 14-06](#) and refer to [Priority Repair PR2_01 and NJDOT Memorandum dated 7/5/2005](#)).

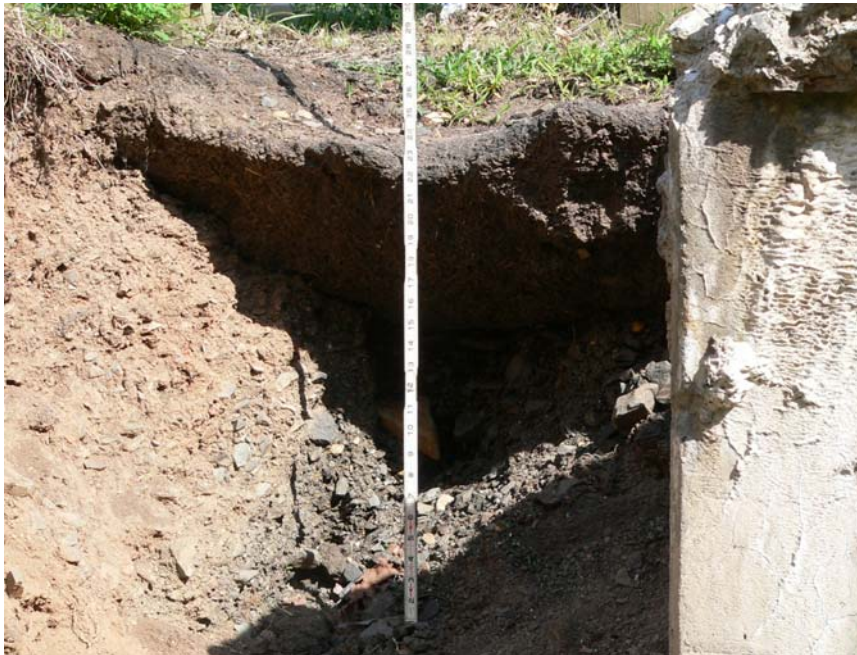
Photo No: 14-05

Location:	Northeast wingwall, looking South.
------------------	------------------------------------

Description:	Severe erosion at end of Northeast wingwall area of (3 feet x 3 feet) undermining bituminous concrete at East approach, North sidewalk up to (1 foot lateral x 2 feet wide x 1 foot 8 inches deep).
---------------------	---

RATING	COMPONENT	REMARKS
7	Approach Pavement (Bituminous Concrete)	
N	Approach Shoulder	None
	Approach Roadway Vertical and Horizontal Alignment	Vertical: Slight upgrade on to the bridge. Horizontal: Tangent.
4	Guide Rail Condition (W beam)	North: Damaged end terminal and several posts missing nuts on rear face (Photo Nos. 14-07 and 14-08).
5	Sidewalks	North: Bituminous Concrete with undermining at end of wingwall (1 foot lateral x 2 feet wide x 1 foot 8 inches deep) under asphalt sidewalk. South: Dirt & gravel.
5	Curbs	North: Lack of curb. South: Misalignment of 3" adjacent to the structure at the Southeast corner with minor scaling.
8	Utilities	Utility poles on each side and a fiber optic manhole on the North embankment.
4	Approach Roadway Embankment	North: Severe erosion (13 CY) beyond the wingwall (Photo No. 14-05).
8	Others Median (NJ Barrier)

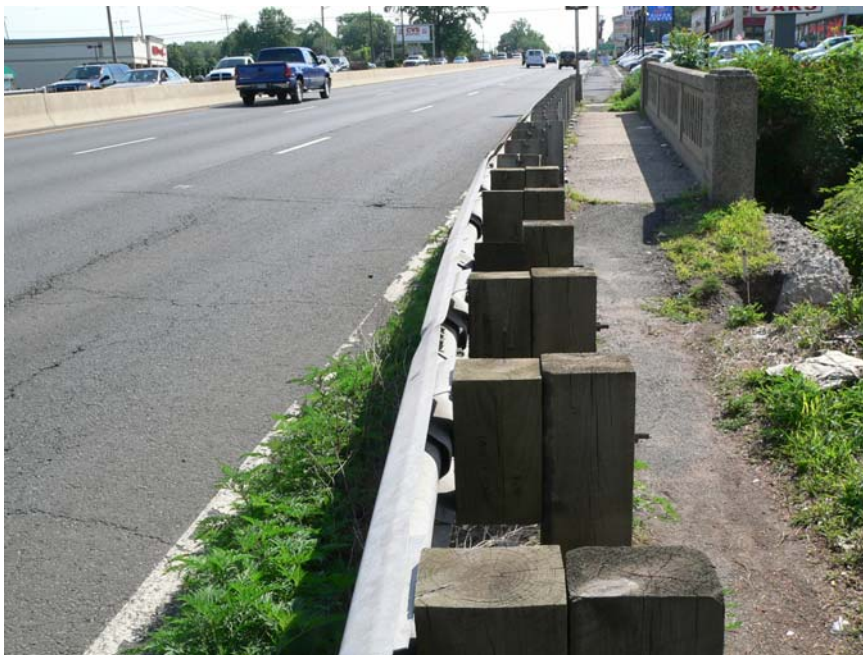
Photo No: 14-06

Location:	East approach north side, looking West.
------------------	---

Description:	Lack of curb at East approach on north side. Note: Area of erosion location at the Northeast wingwall.
---------------------	--

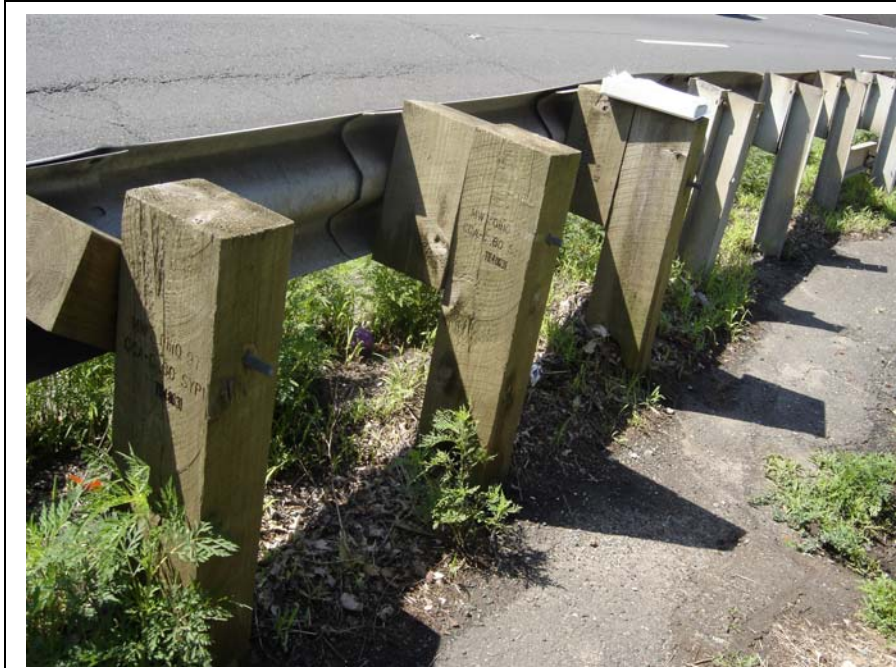
Photo No: 14-07

Location:	Northeast guide rail, looking Southwest.
Description:	Missing anchor bolt nuts at the rear face.

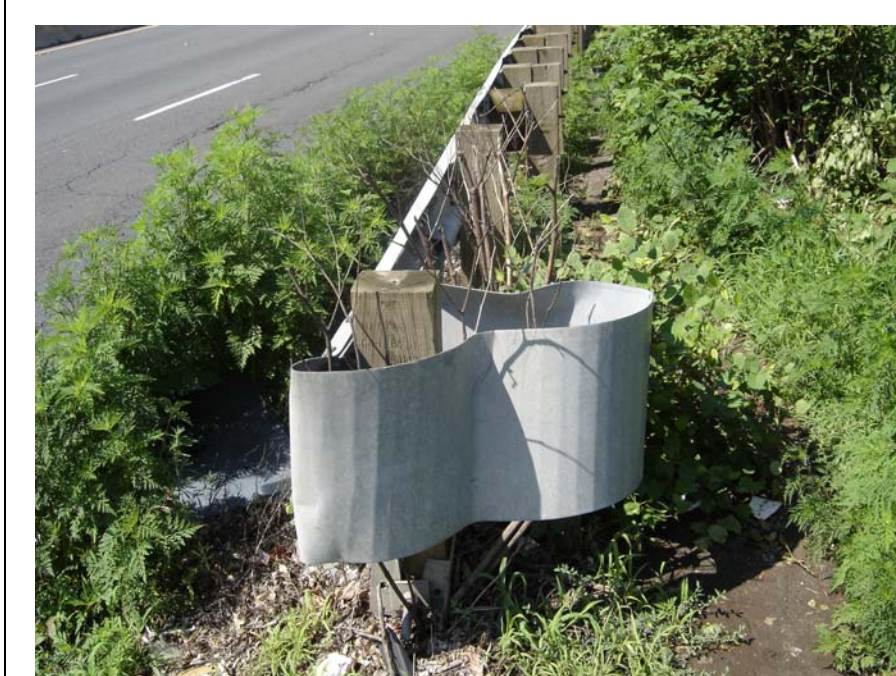
Photo No: 14-08

Location:	Northeast approach end terminal, looking West.
Description:	Collision damage to guide rail end terminal.
