# **SCOPE OF WORK**

## **Restoration of Windows and Doors**

Boxwood Hall Historic Site Elizabeth, Union County, NJ

# WINDOW CONDITIONS AND STRUCTURAL ASSESSMENT AT BOXWOOD HALL RESIDENCE STATE HISTORICAL SITE & MUSEUM 1073 E. JERSEY ST., ELIZABETH, NJ 07201

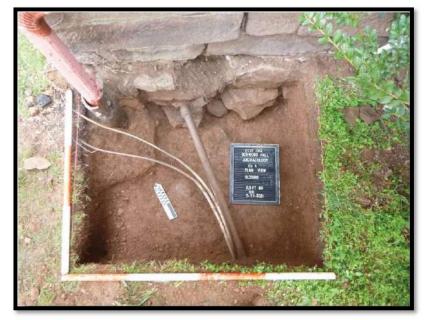
- 11. The Archaeoligical excavation allowed for a visual analaysis of the existing structure. The Structural Engineer determined that the existing feldstone foundation wall is not experiencing any movement and therefore is stable. The brownstone exterior foundation wall is what is noticeably displaced, most likely caused by water infilitration and mortar deterioration.

**Excavation Conducted by Archaeologists**

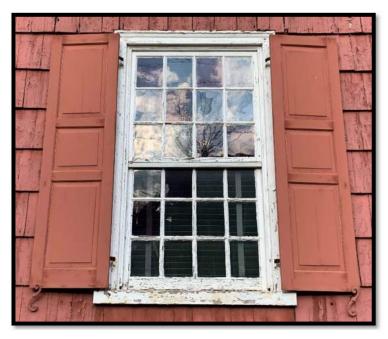
Currently, the windows have experienced a large amount of wear and tear as some components are missing from the system and others have core components, such as the meeting rail, that have began to deteriorate beyond salvagability. The cause of the deterioration appears to be stemming from two possible catalysts; One being the prolonged exposure to the elements such as moisture, high

Overall View of North Facade Window

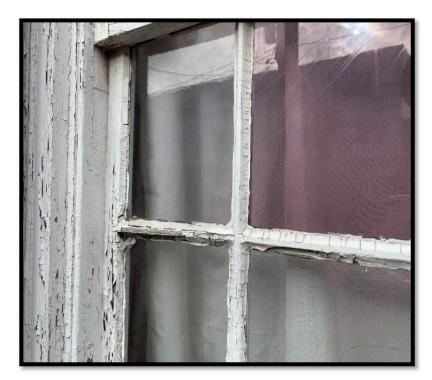
The major points of deterioration discovered consistently occurred along the bottom rail and sill on the exterior of the window and in many cases, the bottom wooden sill stop was missing entirely. The window sill construction was designed with a very light slope to ensure that water did not pool at the base of the window sill, although over time, as the wood began to deteriorate that slope became non-existent. This effectively allowed for moisture to gather and quickly effect the bases of the windows.

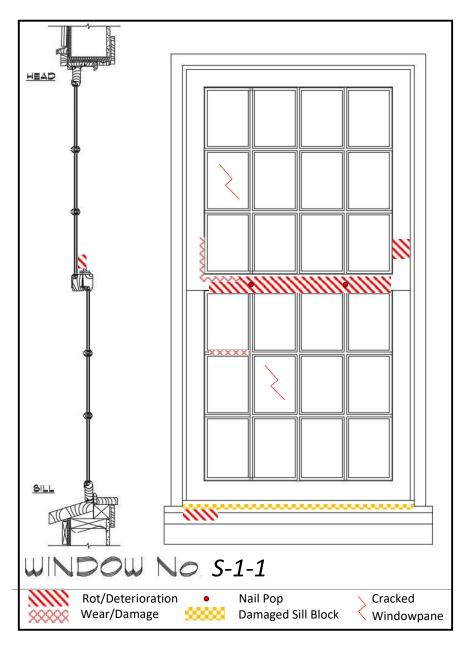
### **Photographs of Window S-1-1**

Overall, this window should be able to be repaired utilizing repair class 2 and 3 methods of repair. Other than replacing the bottom sill block and two glass windowpanes, the meeting rail deterioration is the main issue present at this window and although it is present at both the interior and exterior, if the proper technique is used, the window should be able to be restored to its working condition while all of its original pieces remain intact.

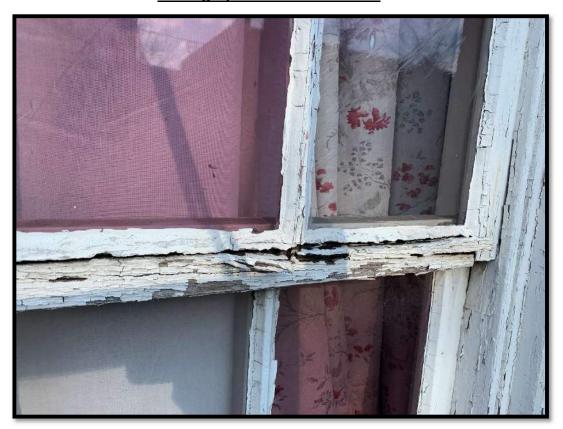
**Damaged/Deteriorated Exterior Meeting Rail**

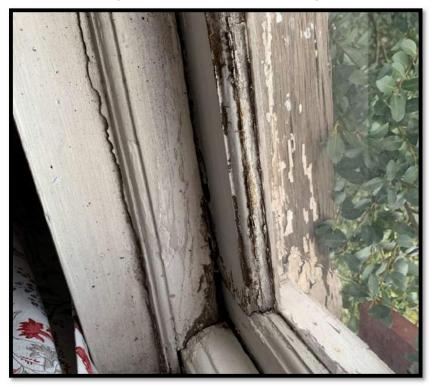
Damaged/Deteriorated Interior Meeting Rail

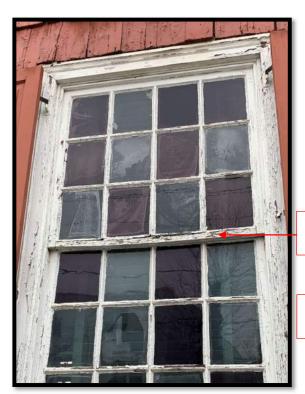
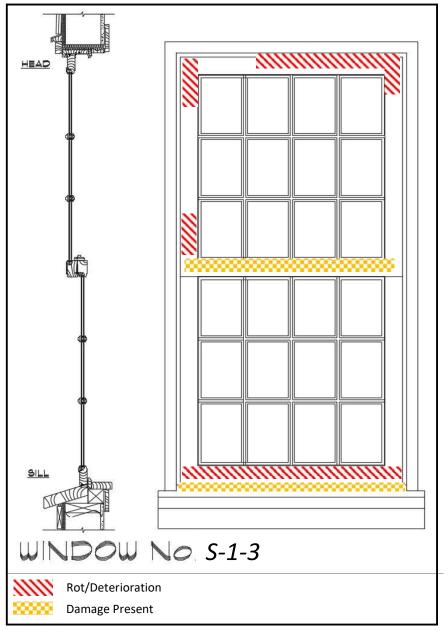
The issues present at window S-1-3 would fall under "Repair Class 2". The exterior face of this window will mainly require epoxy consolidation in areas in which deterioration/rot has begun to take place, replacement or reinforcing of the meeting rail, and replacing of the sill block at the base of the window. All general maintenance procedures should be conducted here as well, such as repainting the interior and exterior faces of the window.

Sagging Meeting Rail

Damaged Sill Block

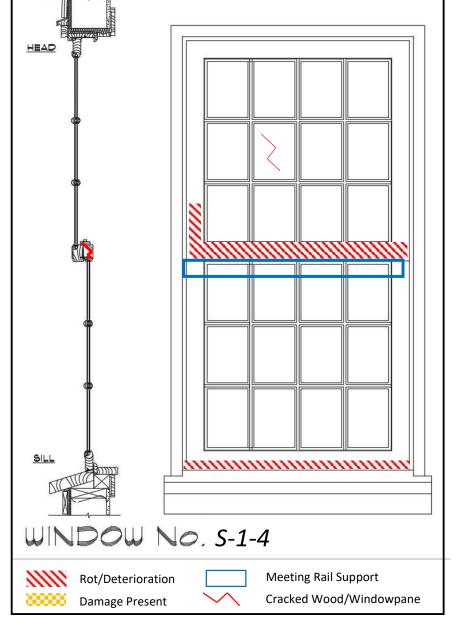
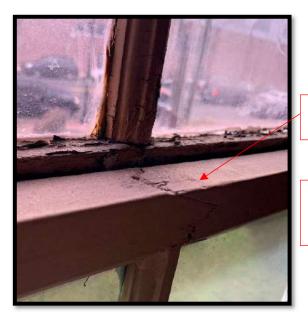
The window currently has a reinforcing block of wood that is supporting the meeting rail, as well as sealant placed, as it has already began to deteriorate. The meeting rail will need replacement under "Repair Class 3" and a new sill block will need to be provided. Other damage may be repaired through means detailed in "repair class 2". All general maintenance procedures should be conducted here as well, such as repainting the interior and exterior faces of the window.

Damaged Meeting Rail

Reinforcing Block at Meeting Rail

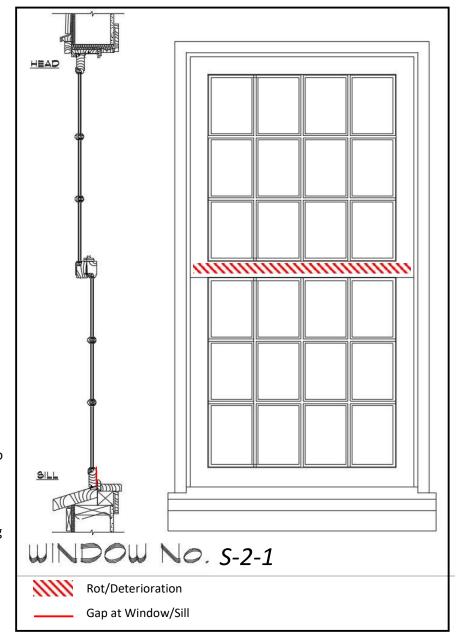
The issues present at window S-2-1 fall under "Repair Class 2". The exterior face of this window will mainly require epoxy consolidation in areas in which deterioration/rot has begun to take place. The cracked interior trim and gap between the base sill and window can be repaired utilizing standard repair and rehabilitation methods, including the repainting of the window.

Beginning of Deterioration

Gap at Window / Sill

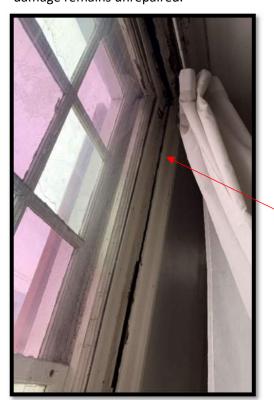
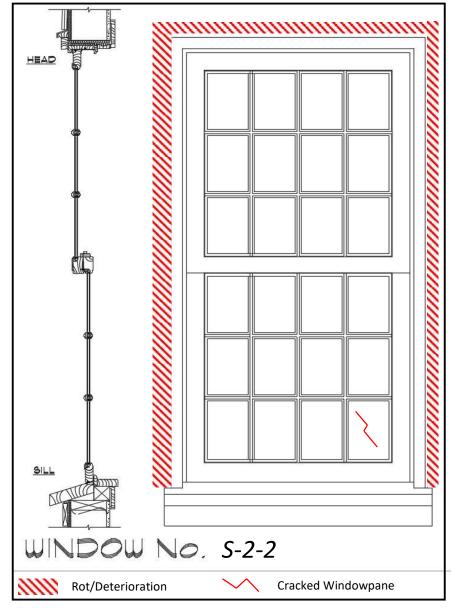
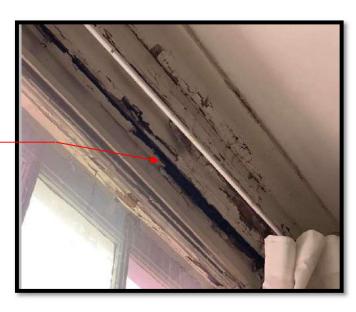
The issues present at window S-2-2 would fall under "Repair Class 3". As the repair needed to fix the entirety of the water damage present will require replacement of some elements. It was mentioned by the attending staff at Boxwood Hall that the window has received partial paint replacement and minor repairs following the water infiltration repairs. Although the large damage remains unrepaired.

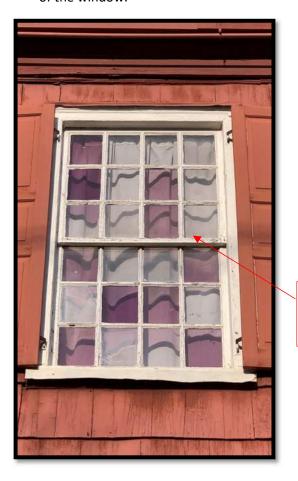
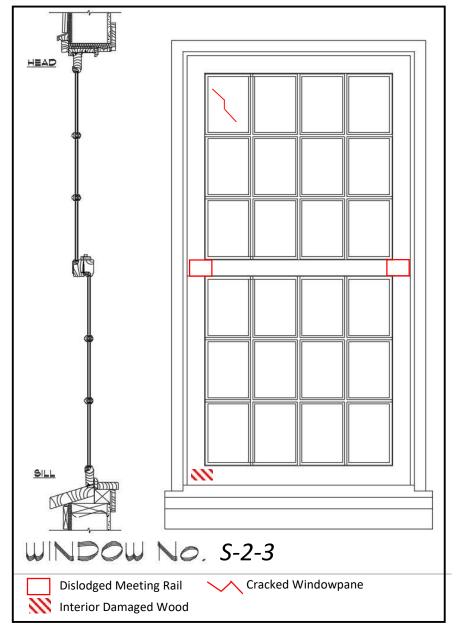
Window S-2-3 is in fairly good condition and would be classified under window repair class 1. The damaged windowpanes require replacement with float glass to match existing under "Repair Class 3". All general maintenance procedures should be conducted here as well, such as repainting the interior and exterior faces of the window.

Dislodged Meeting Rail

Damaged Interior Wood

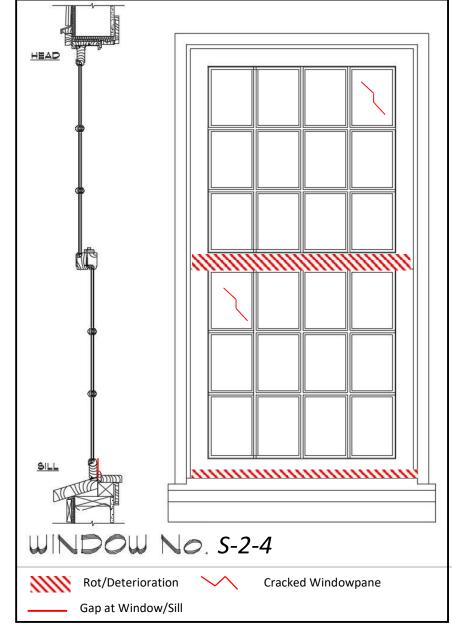
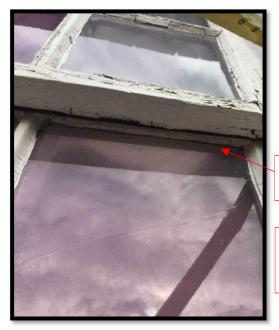
The exterior of the window is currently showing a large amount of deterioration and rot, although not to the point of being unsalvageable. The window is also showing a large seperation from the interior sill as well. With the proper rehabiliation work, these issues can be repaired utilizing "Repair Class 2". The cracked windowpanes will need to be replaced entirely utilizing methods detailed under "Repair Class 3".

Damaged Meeting Rail

Gap Forming at Interior Windowsill

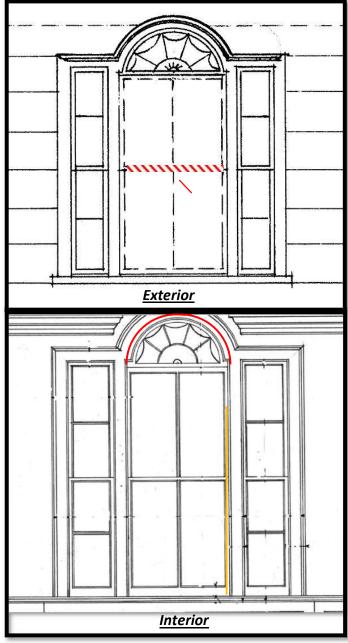
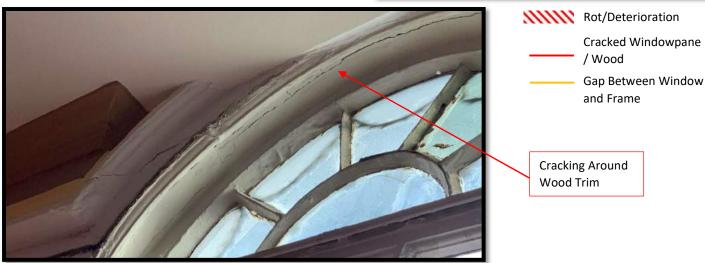
Overall, the Center Palladian Window is in a good structural state, although if left as is, the gaps will continue to expand and permanently damage the historical materials. The sun ornament atop the window and the damaged and missing garland will require historical restoration, and the damaged windowpanes will require replacement. This window would be covered under "Repair Class 2". The broken windowpane will need to be replaced under "Repair Class 3".

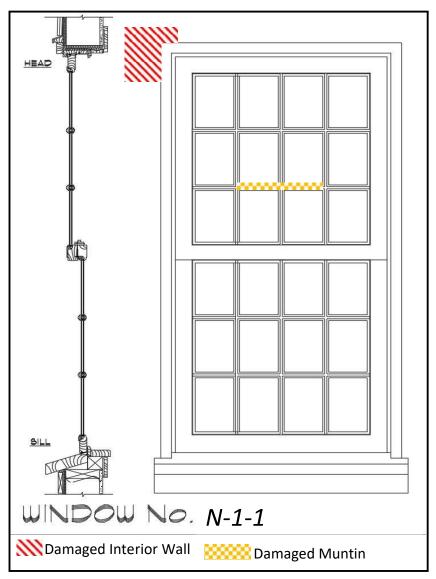
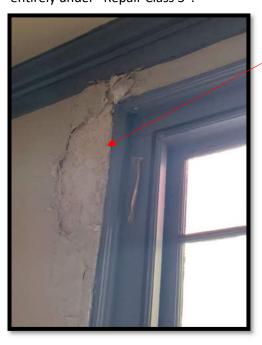
The exterior of the window is currently showing a large amount of peeling paint, although not to the point of being unsalvageable. There is currently an alarm installed at this window that is currently unoperational. The various repaintings of this window were not conducted properly as the paint has seized the operation of the weighted jamb system, leaving the entire window inoperable. The damage throughout the interior finish seems to be caused by excessive water infilitration at the corner of the window. With the proper rehabiliation work, these issues can be repaired utilizing "Repair Class 2". The cracked windowpanes will need to be replaced entirely under "Repair Class 3".

Damaged Interior Wall

Overpainted Weight Pockets

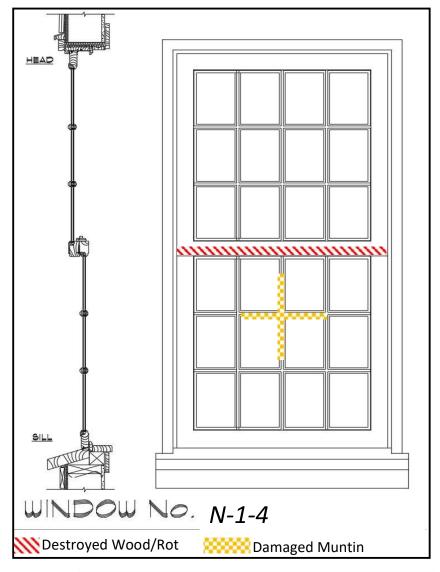
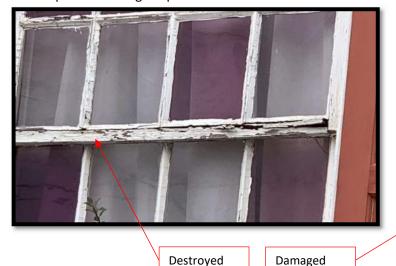
The various repaintings of this window was not conducted properly as the paint has seized the operation of the weighted jamb system, leaving the entire window inoperable. As elements of this window will need to be replaced in their entirety, the issues can be repaired utilizing "Repair Class 3".

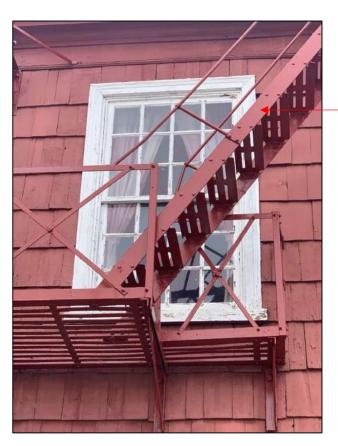
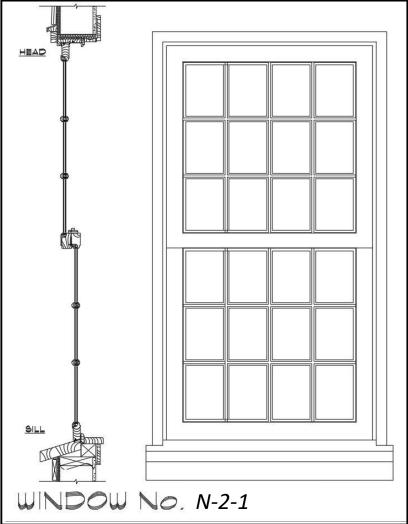
This window is also equipped with an alarm system similar to the first floor window N-1-1. The alarm system is currently not operational. The minor wear throughout this window can be repaired and classified under "Repair Class 1".

Overview of Escape Platform and Window

Overview of Minor Damage to Exterior Face

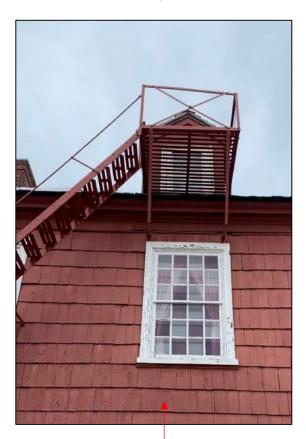
General maintenance and repainting classify this window under "Repair Class 1".

Overview of Emergency Egress Above Window

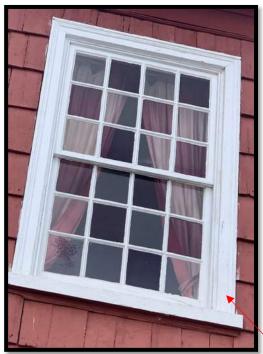
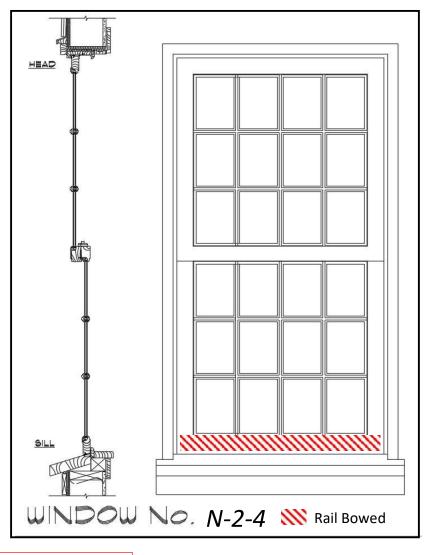
The replacement of the lower sash rail classifies this window under "Repair Class 3".

Exterior Face of Window

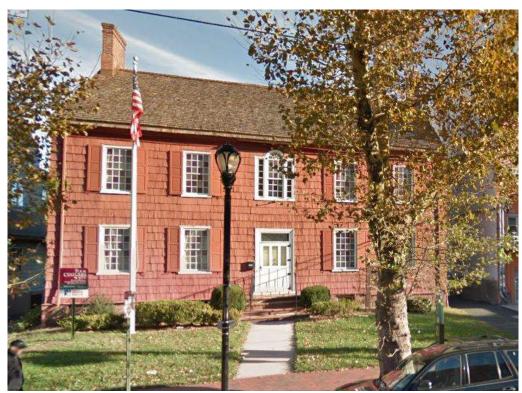
Photograph 1

As requested, the undersigned visited the referenced site to perform a walkabout structural condition assessment survey of the basement foundation walls at the building. The purpose of the condition assessment survey was to gather information to address concerns with the displacement of several stones of the basement foundation wall in the southwest building corner. If I may reiterate, the concerns involved cracking of the mortar joints between stones, two-directional displacement of stones, and the opening of the joint between the outer brownstone and the backup fieldstone.

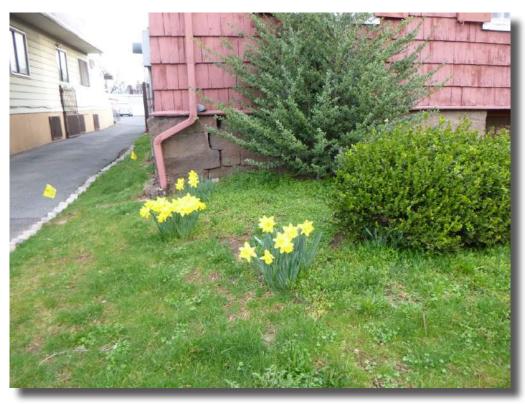
Plate 4.2: Close-up view of the project location showing the damaged foundation and the current location of the drainage gutter, markedout utility, and landscaping elements.

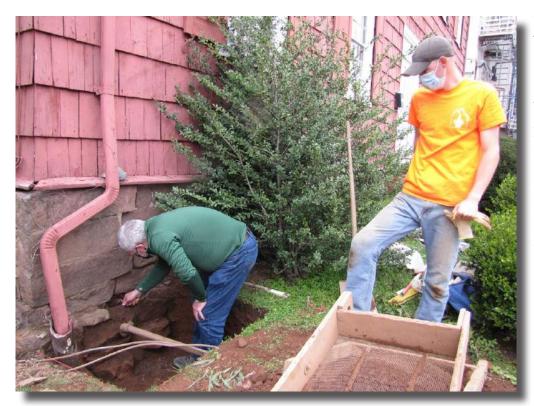
Plate 4.3: Structural engineer, Tom Langan, inspecting the extent of damage to the foundation with the drainage gutter, the oil tank pipe, and the copper piping visible to his left.
