# **SCOPE OF WORK**

## **Greenwood Lake Dam Repairs**

**Project No. P1389-00**

## 2025 REGULAR INSPECTION REPORT

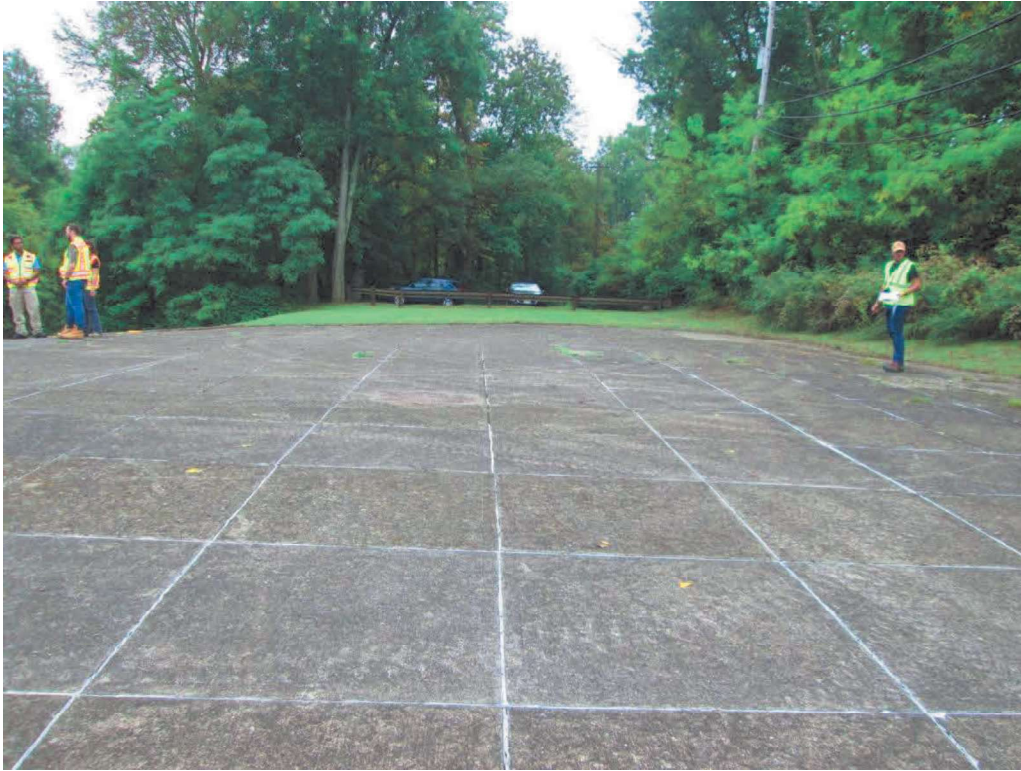
**Photo No. 1: Concrete paving sections of the dam crest looking downstream.**

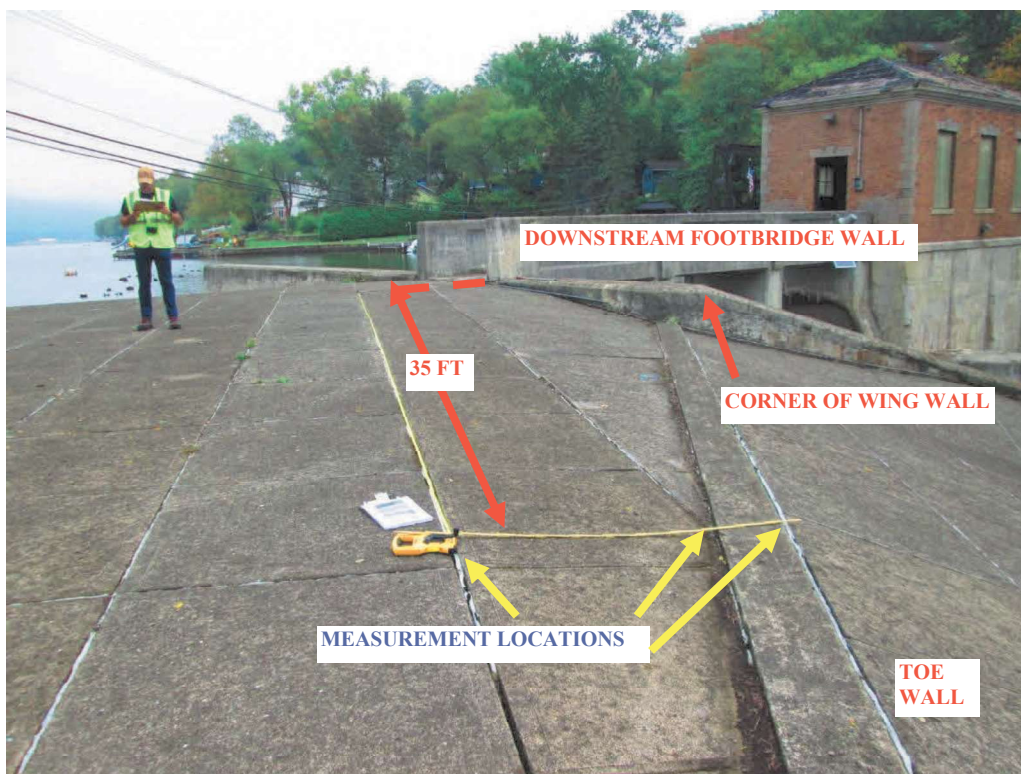
**Photo No. 2: Closeup of concrete paving sections of the dam crest at the contact with the downstream slope. Note the separation of the joints and the deteriorated joint sealant between paving sections.**

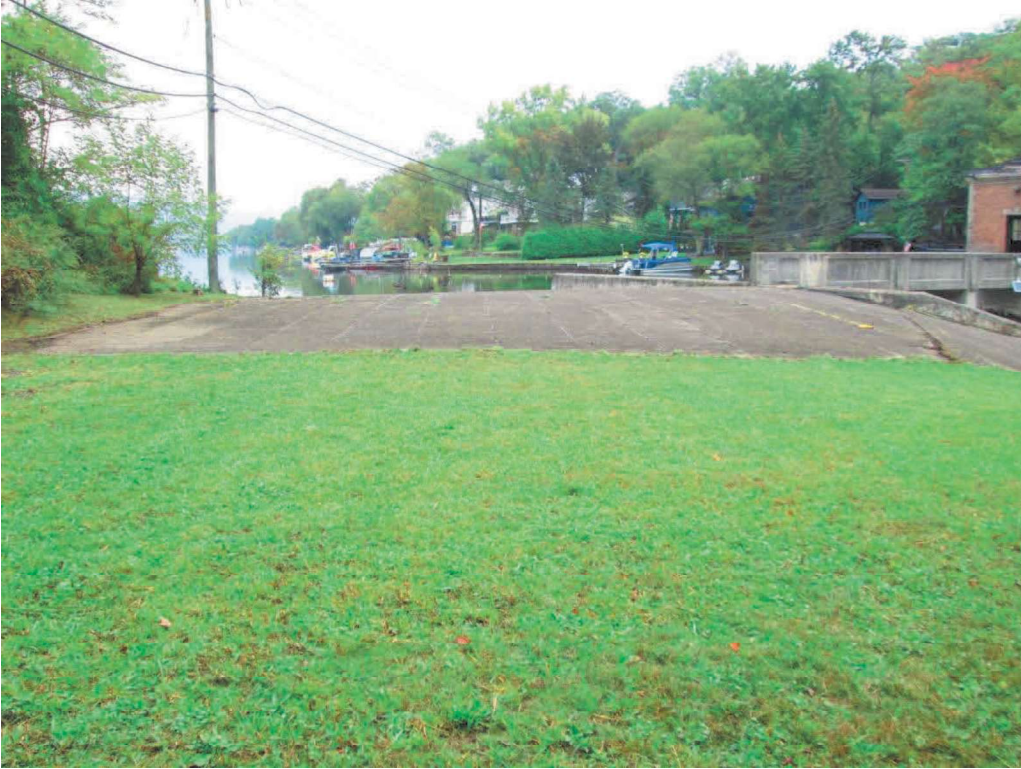
| <b>Unusual Conditions:</b> | According to the 2000 Record Drawings, the cellular concrete block mats are reportedly cable-tied. However, one of the cellular blocks was exposed during the 2023 inspection and no cable ties were observed.<br><br>Minor weedy vegetation was growing within the joints of the concrete paving. Grass growing on the cellular concrete block section of the crest appeared generally well maintained. |

**Photo No. 3: Cellular concrete block mats (covered by grass) and concrete paving sections of the dam crest looking upstream.**

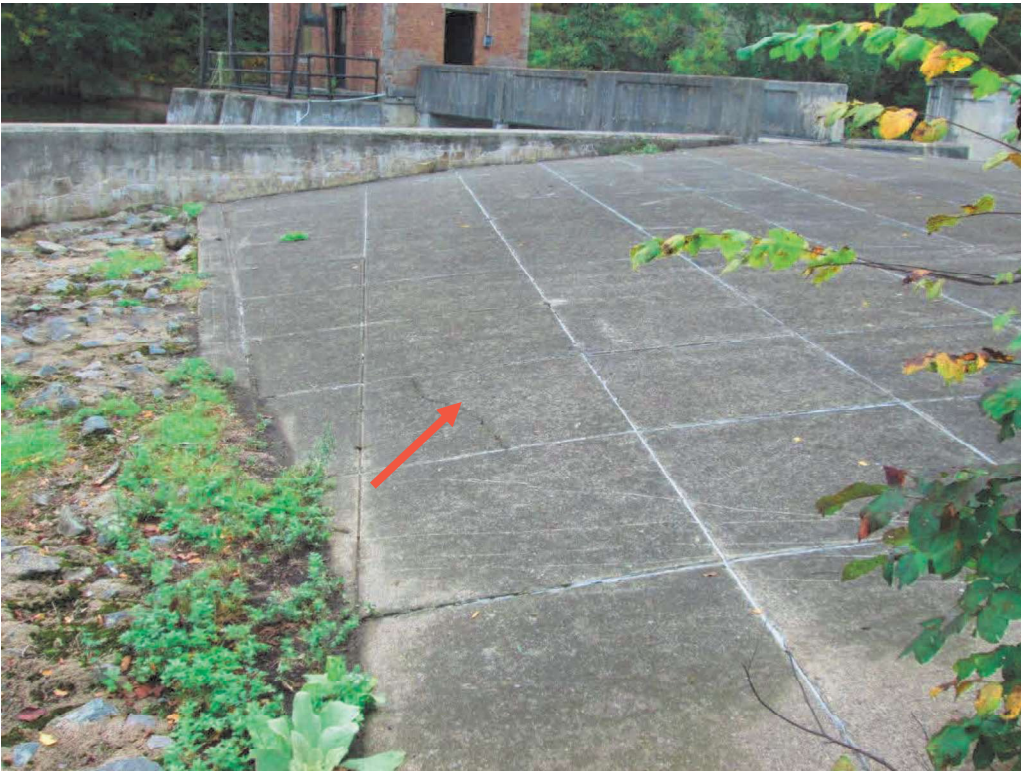
In general, concrete paving appeared intact and in good condition. A crack with minor spalling was observed in one concrete paving section near the right side at the contact with the grouted riprap. This crack was observed during previous inspections and no significant change was apparent since previous inspections. Construction joints in concrete paving sections were sealed with elastomeric sealant. Similar to previous inspections, the elastomeric sealant has continued to deteriorate. Minor settlement of the concrete paving was observed along the left side at the contact with the spillway training wall.

**Photo No. 4: Concrete paving sections on the upstream slope of dam looking left.  
Note the crack in one of the concrete sections.**

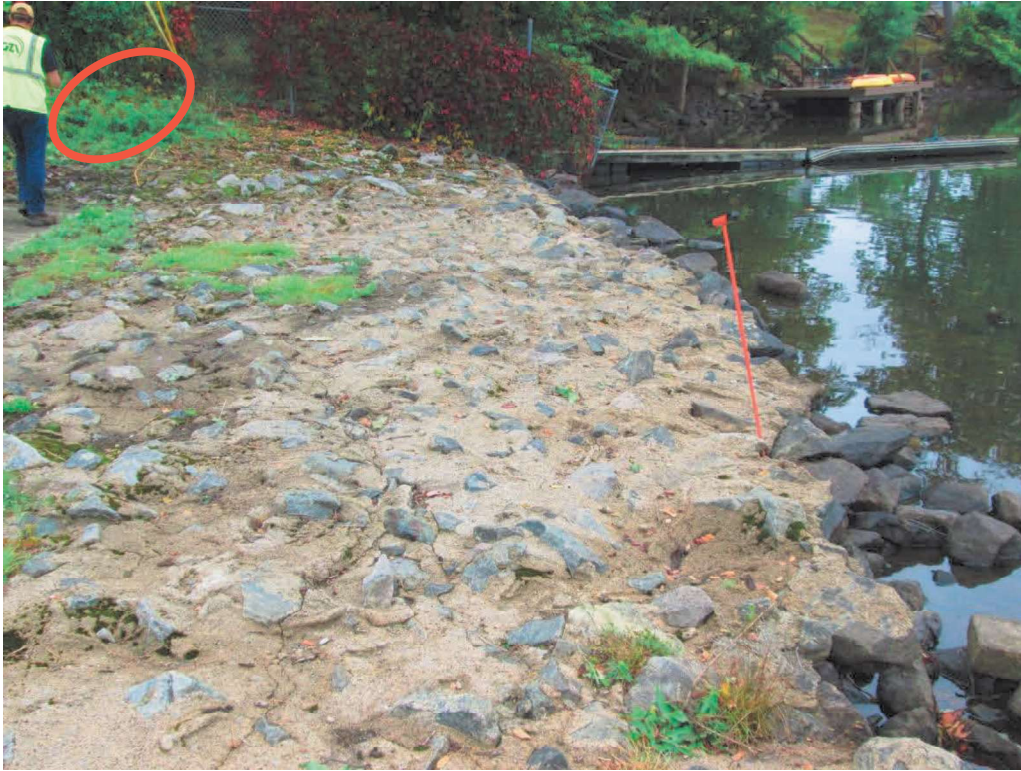
| <b>Sloughing, Subsidence or Depressions:</b> | During previous inspections, minor depressions were observed in the grass near the right abutment (near the electric pole) at the contact with the downstream edge of the grouted riprap. The grouted riprap was also previously observed to be locally undermined in the same location. The undermining was probed to a depth of about 1 foot during the 2020 inspection. The depressions and undermining were visually observed during the subsequent inspections but were difficult to measure due to overgrown conditions. During this inspection, the depression was measured to be approximately 0.7 feet deep. The area was overgrown, but no significant problems were apparent. |

**Photo No. 5: Grouted riprap on the upstream slope of dam looking right.  
Note the area of minor depressions and undermining of the grouted  
riprap at the contact with the grass near the right abutment.**

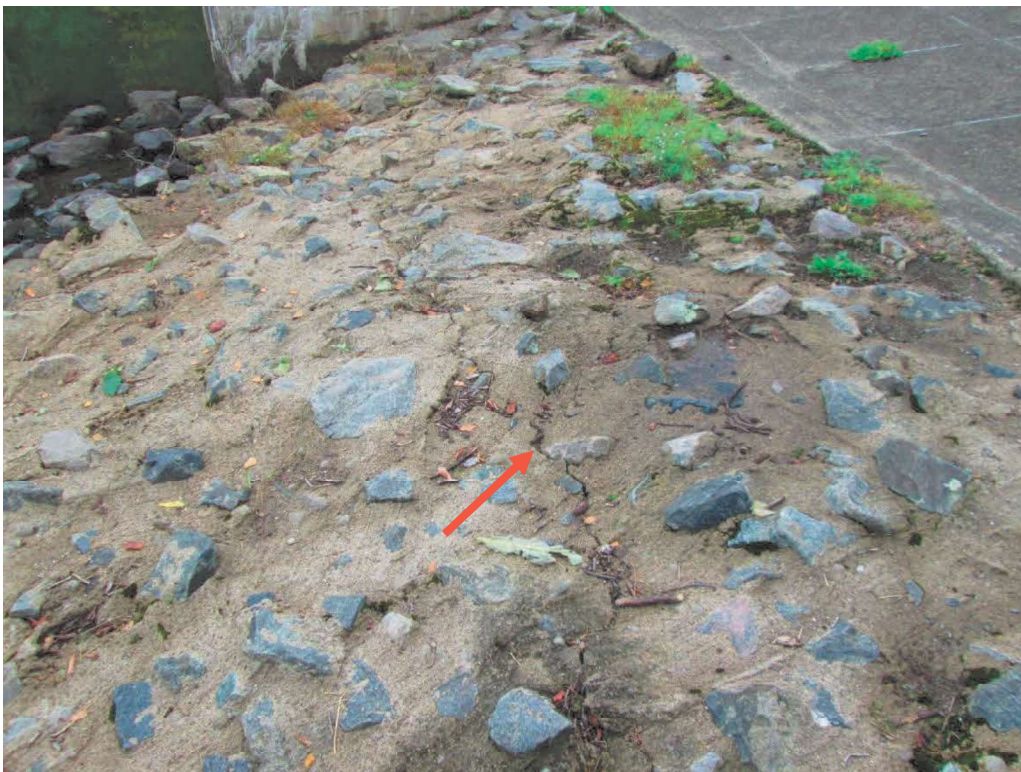
grout and the grout was broken up in a few areas along the top of slope. One larger longitudinal crack was also observed in the grout near the top of slope extending throughout the length of the slope. This crack was observed during previous inspections but was first measured during the 2021 inspection. Cracking of the grouted riprap appeared similar to the 2023 inspection when it was last measured.

**Photo No. 6: Closeup of grouted riprap upstream slope looking left.  
Note the various cracks throughout the grout.**

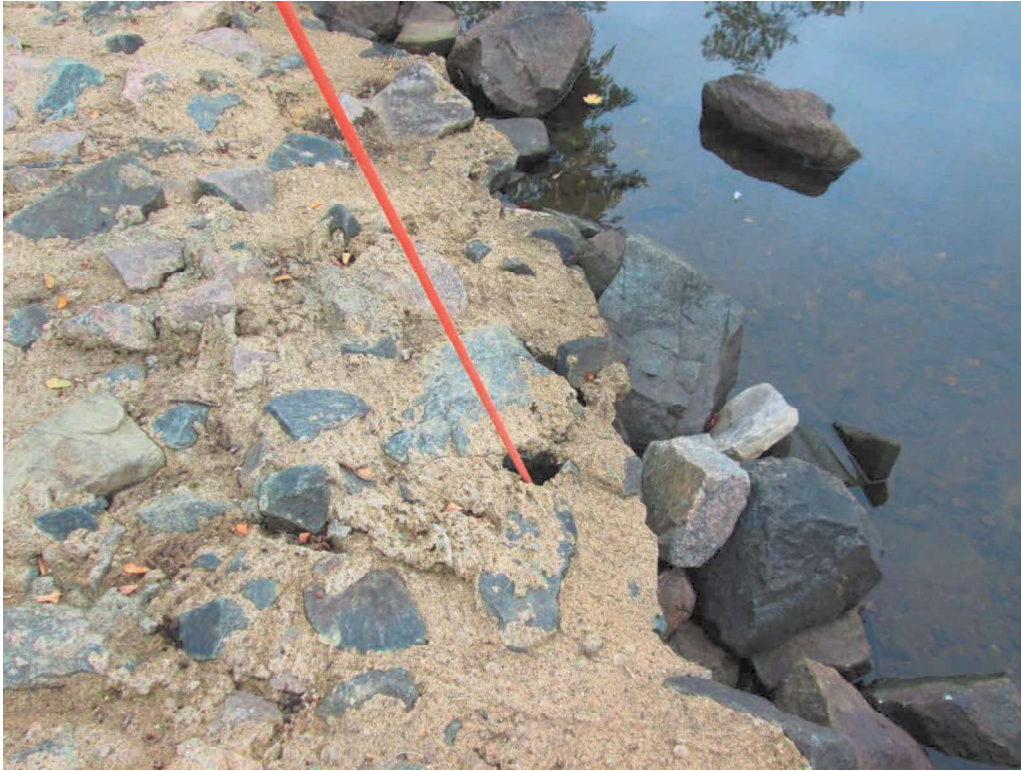
| <b>Condition of Materials:</b> | Similar to previous inspections, the grouted riprap was broken up at the lake edge and some movement of loose riprap down the slope was observed, but the condition had not resulted in erosion of the slope. The grout did not appear to penetrate the full depth of the riprap resulting in voids within the grouted riprap near the upstream edge. Some minor cracks were observed in the |

**Photo No. 7: Closeup of voids and loss of grout within grouted riprap on the upstream slope of dam along the lake edge.**

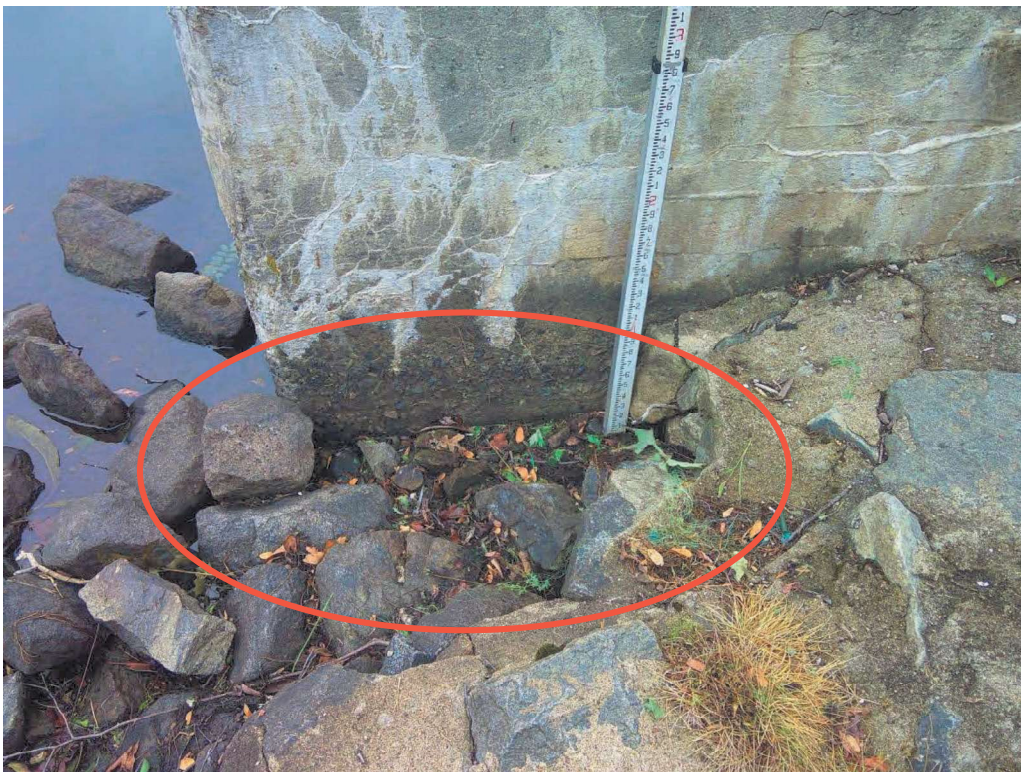
An area of displaced grouted riprap was observed along the upstream end of the right side training wall. The area was triangular and measured to be approximately 2.5 feet by 3 feet, with a maximum depth of about 1 foot.

**Photo No. 8: Area of displaced grouted riprap along the right side spillway training wall.**

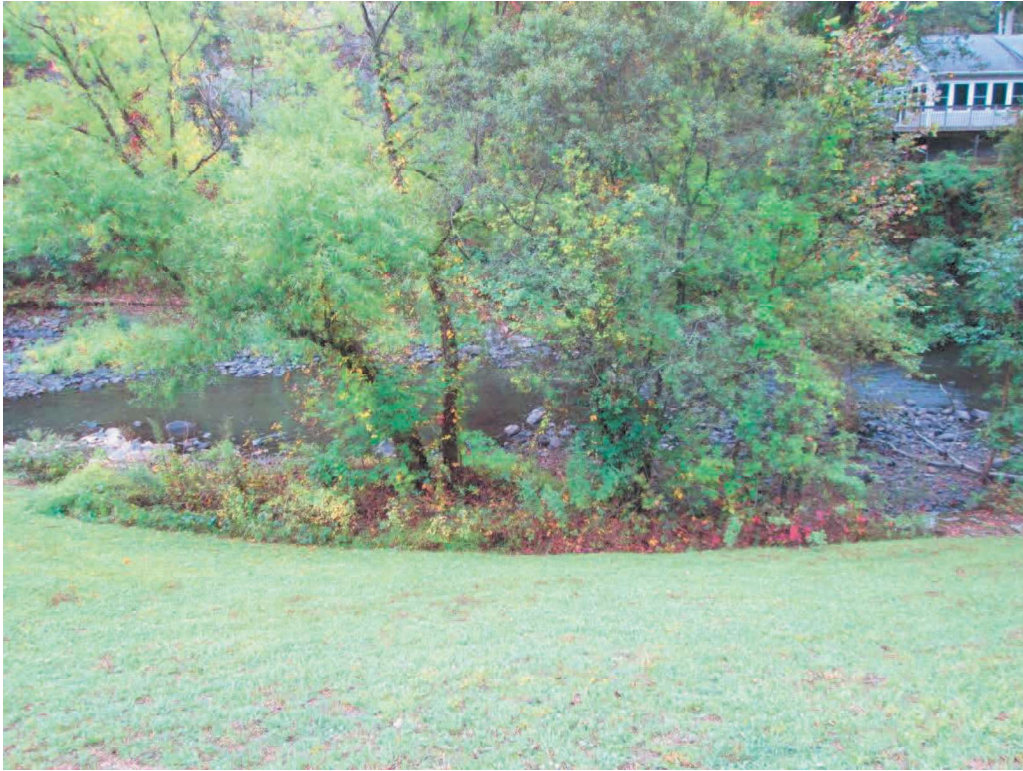
**Photo No. 9: Cellular concrete block mats (covered by grass)  
on the right side downstream slope of dam looking downstream.**

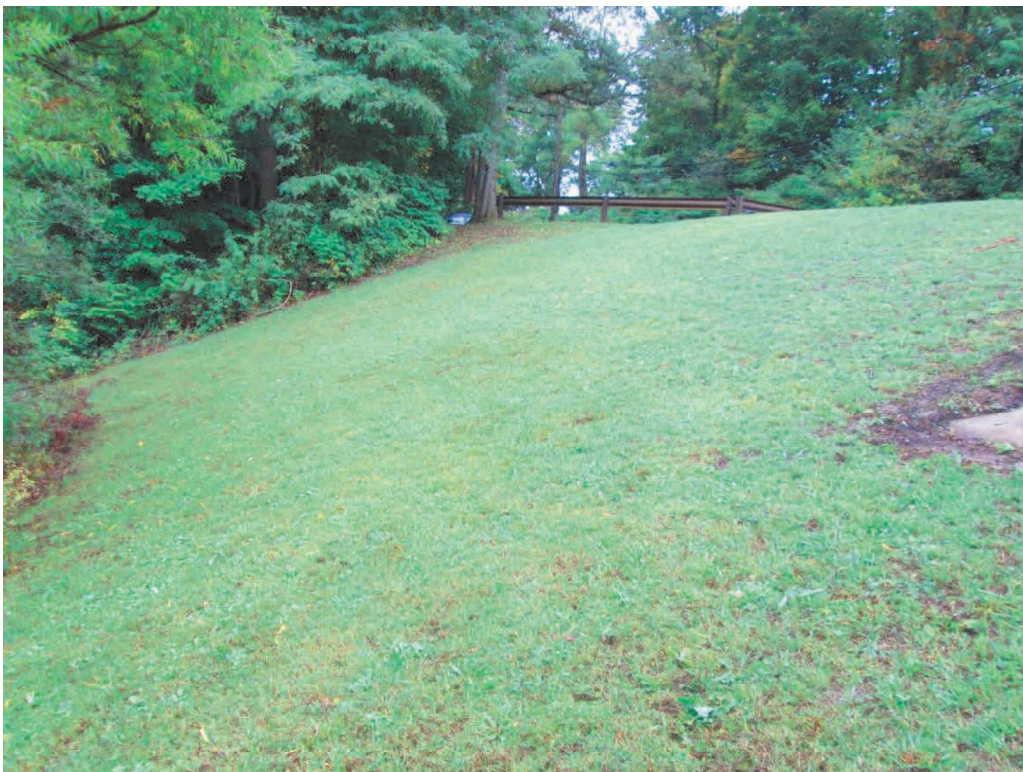
**Photo No. 10: Cellular concrete block mats (covered by grass)  
on the downstream slope of dam looking right.**

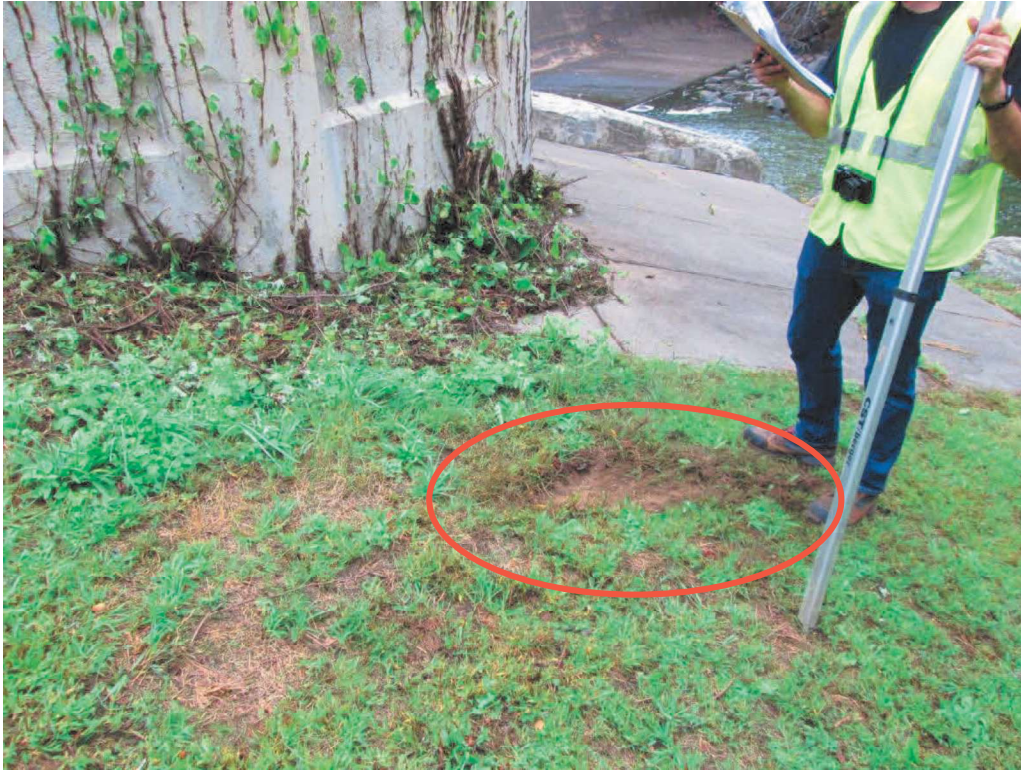
**Photo No. 11: Closeup of rutting within exposed cellular concrete blocks on downstream slope to the right of the surge tank.**

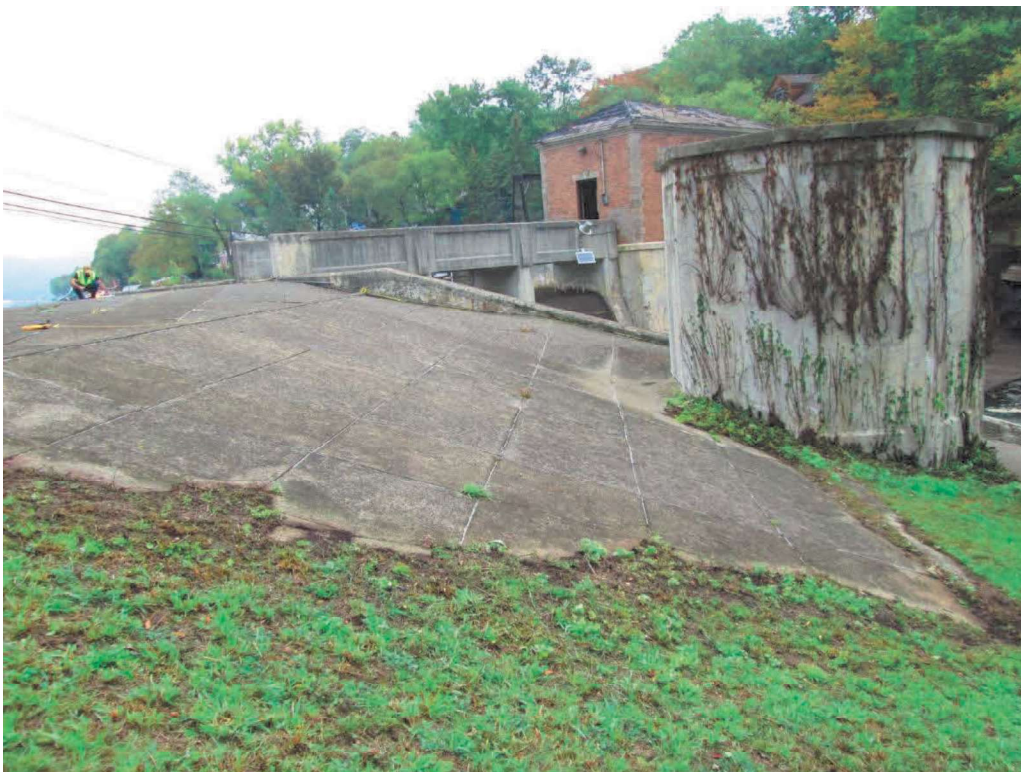
**Photo No. 12: Concrete paving along the upper downstream slope above the surge tank looking left.**

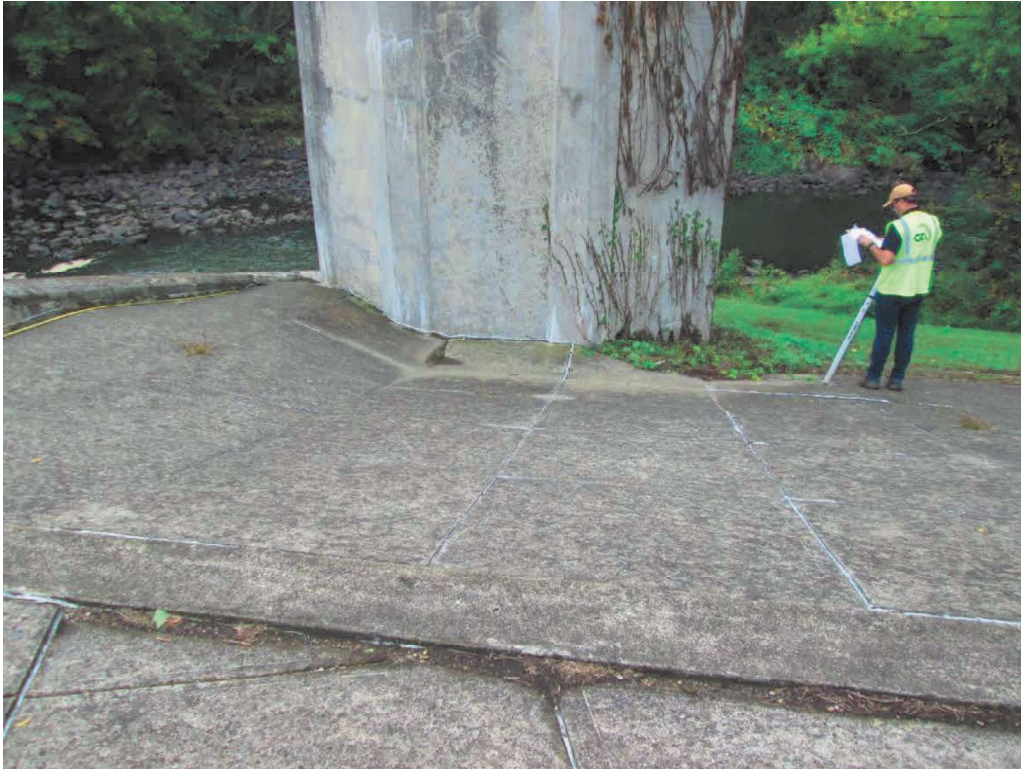
**Photo No. 13: Concrete paving on the downstream slope at the contact with the upstream face of the surge tank looking downstream.  
Note the vines growing on the surge tank.**

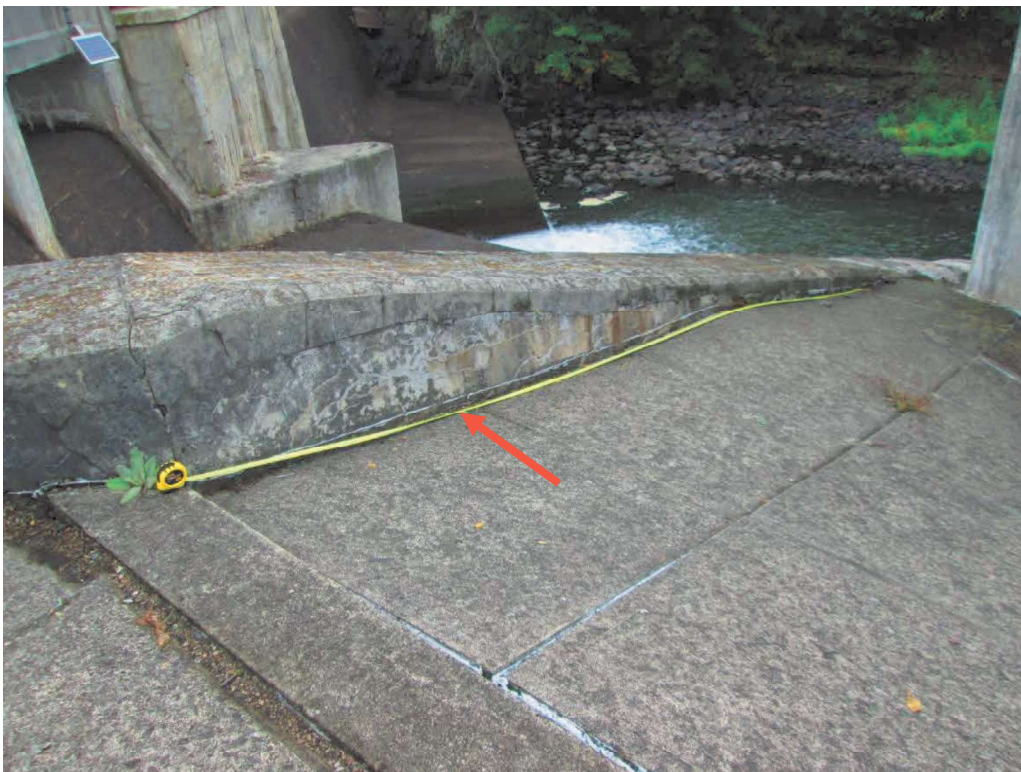
**Sloughing, Subsidence or Depressions:** Some settlement was observed between the concrete paving sections at the top left side of the slope adjacent to the concrete wing wall. This condition has been observed during previous inspections since 2008. There are 6 locations along the wall where measurements have been obtained since 2010 to monitor the settlement of the paving sections relative to the top of the wing wall (see attached table). The measurements collected during this inspection were compared to the 2024 measurements, which showed differences up to ¼ inch, which is not considered significant. The six locations should be permanently marked to allow accurate repetition of measurements.

**Photo No. 14: Concrete paving on the downstream slope at the contact with the downstream wing wall. Note the settlement of the paving sections along the wall.**

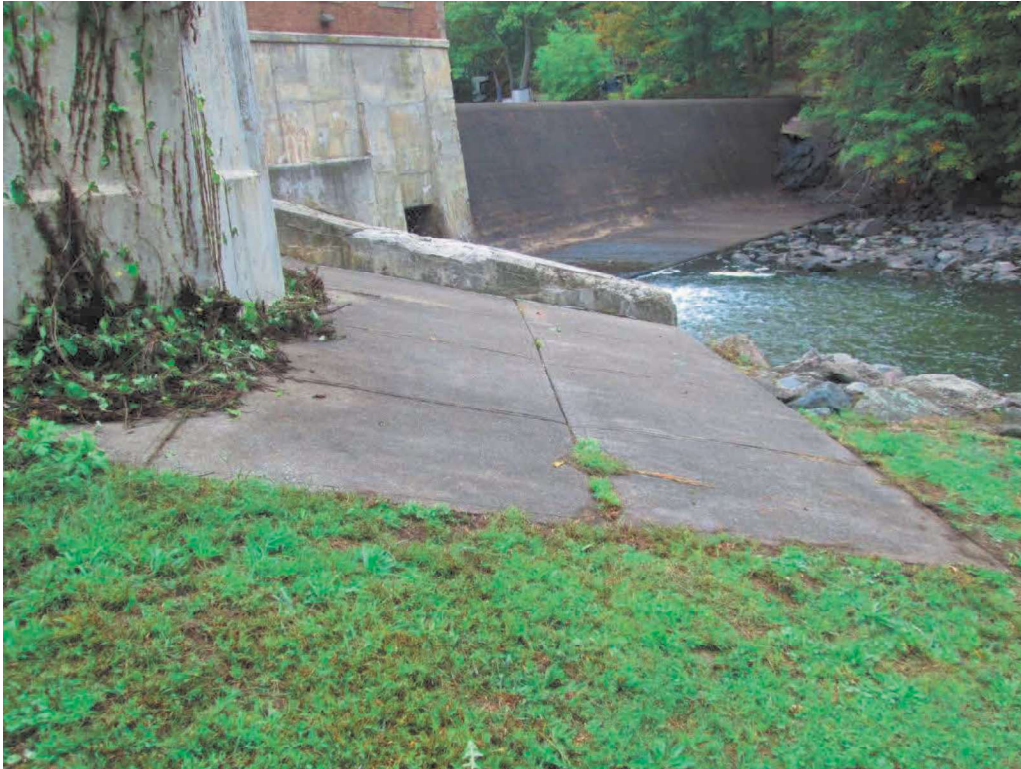
**Photo No. 15: Concrete paving along the lower downstream slope below the surge tank looking left.**

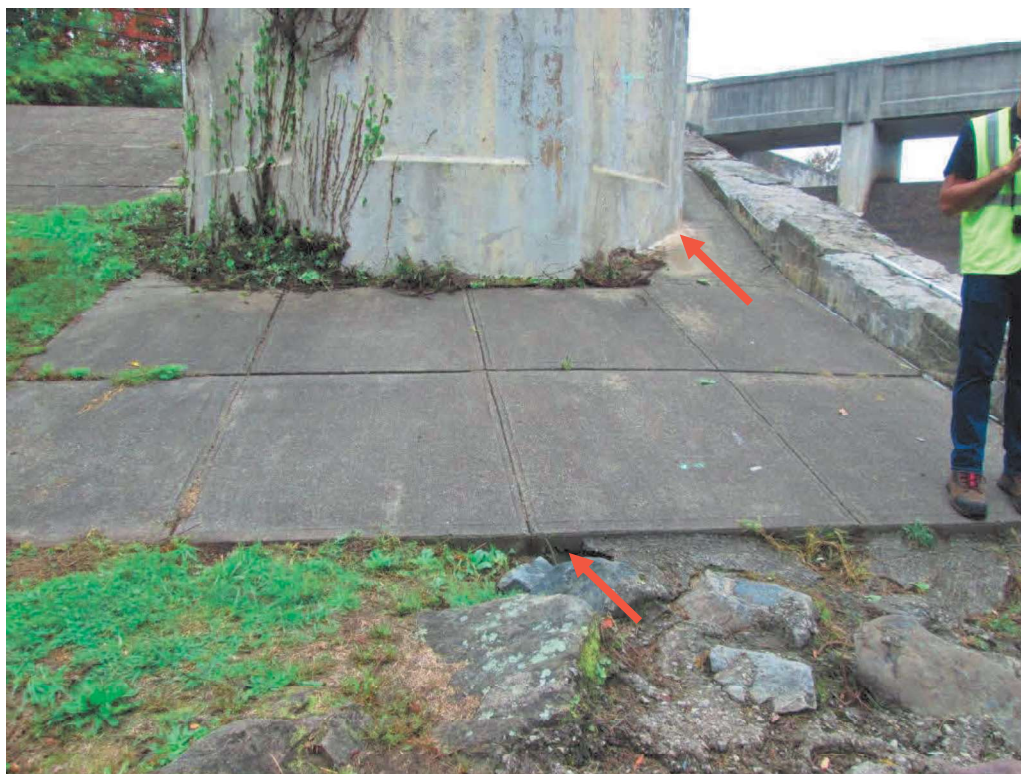
**Photo No. 16: Closeup of concrete paving at the contact with the downstream and left sides of the surge tank. Note the efflorescence on the surge tank wall where wetness has been observed in the past. Also note the void in the grouted riprap at the contact with the paving.**

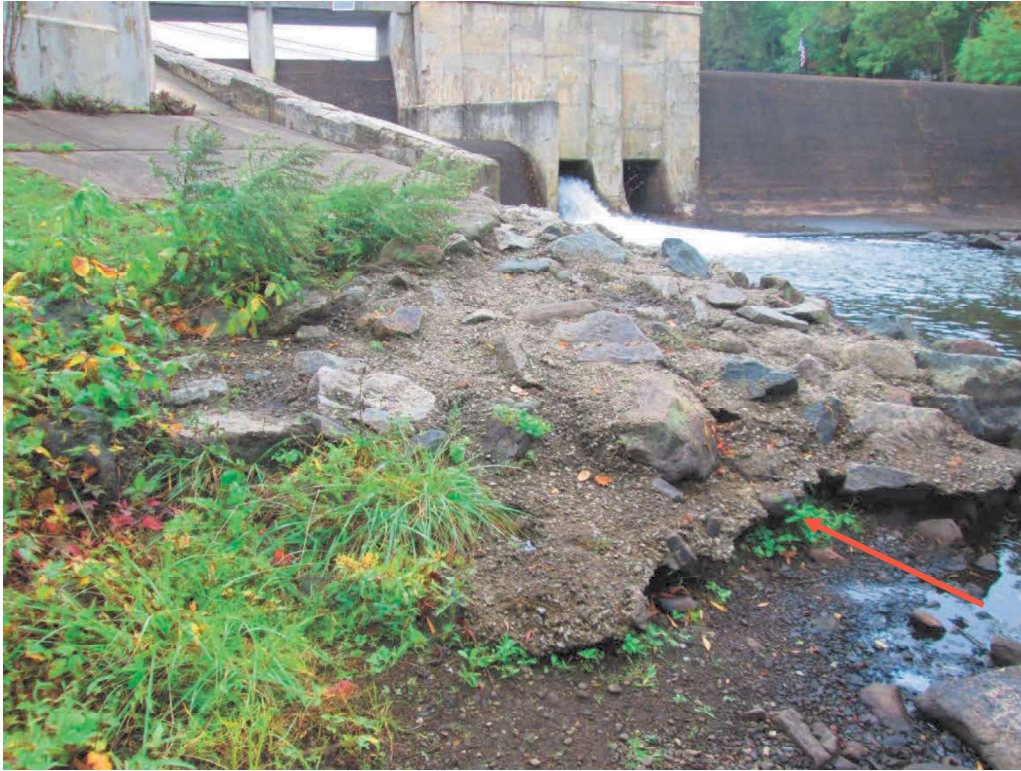
**Photo No. 17: Grouted riprap along the lower downstream slope and toe of dam immediately downstream of the concrete paving looking left and upstream.  
Note the undermining at the downstream end of the grouted riprap.**

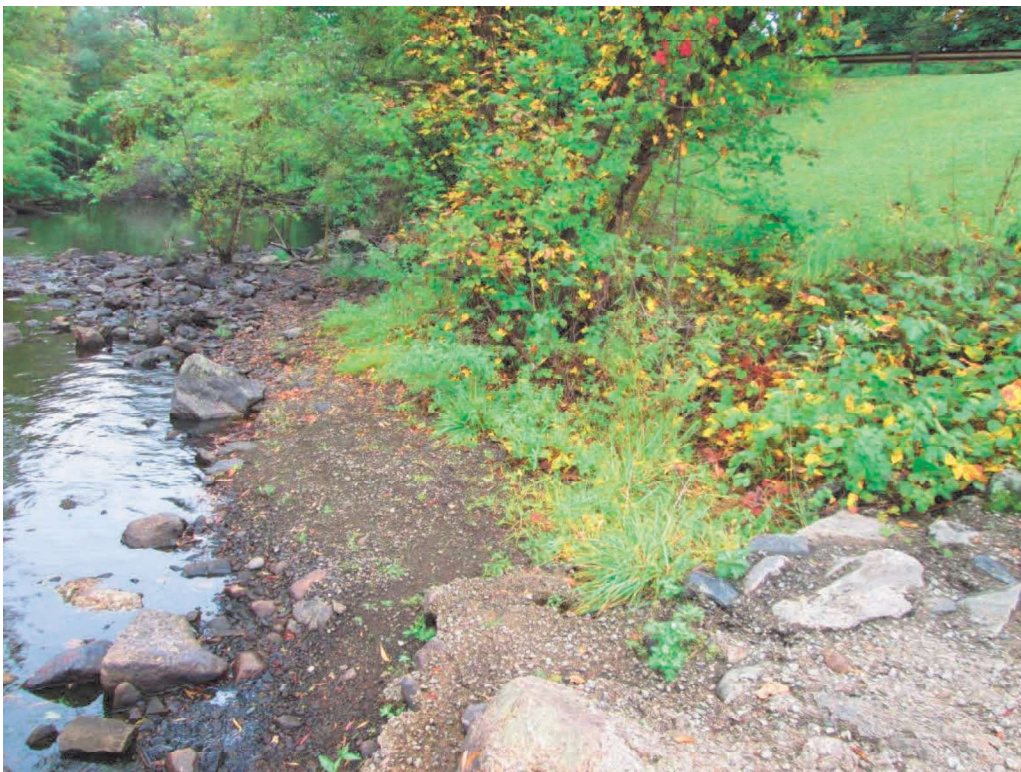
**Trees, Undesirable Growth or Debris, Animal Burrows:** Minor weedy and woody vegetation were growing in between the concrete paving sections. The grass growing on the cellular concrete block section of slope appeared generally well maintained. Minor woody vegetation was observed locally adjacent to the surge tank and the tank was covered in mature poison ivy vines. Several trees and weedy/woody vegetation were growing in the grouted riprap at the bottom of the slope along the downstream channel.

**Photo No. 18: Lower downstream slope and toe of dam looking right.  
Note the trees and vegetation growing in the grouted riprap along the toe.**

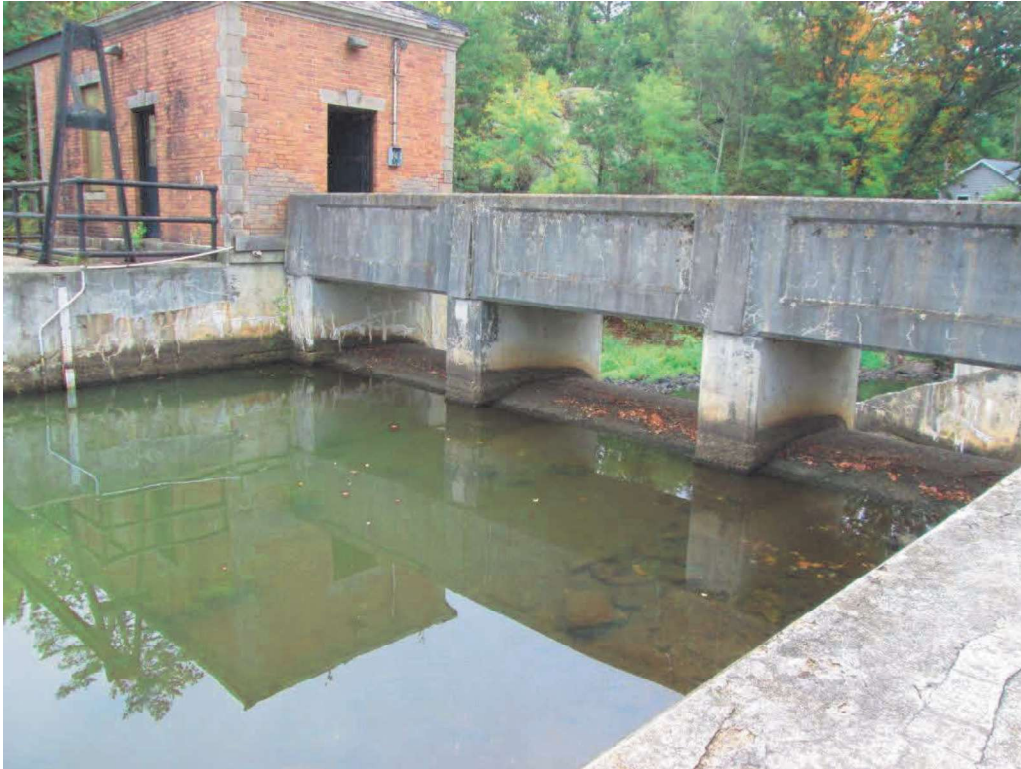
**Photo No. 19: Entrance channel to the 30-foot long spillway weir looking downstream.**

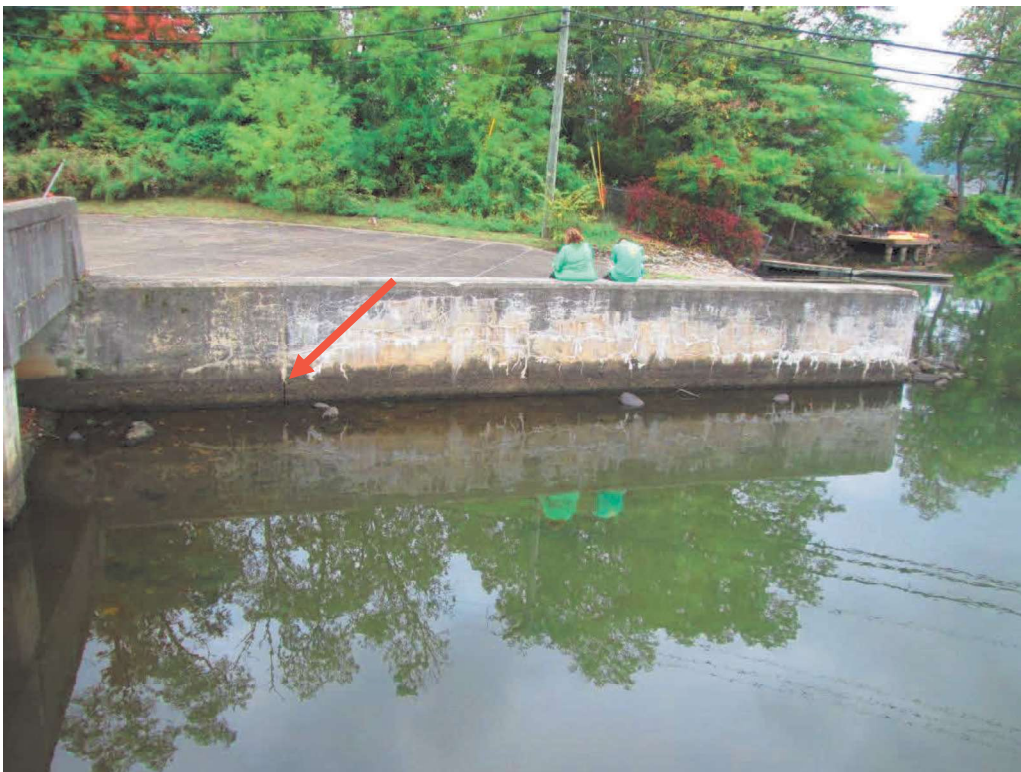
**Photo No. 20: Upstream right training wall along the entrance to the 30-foot long spillway weir. Note the location of the gap at a construction joint.**

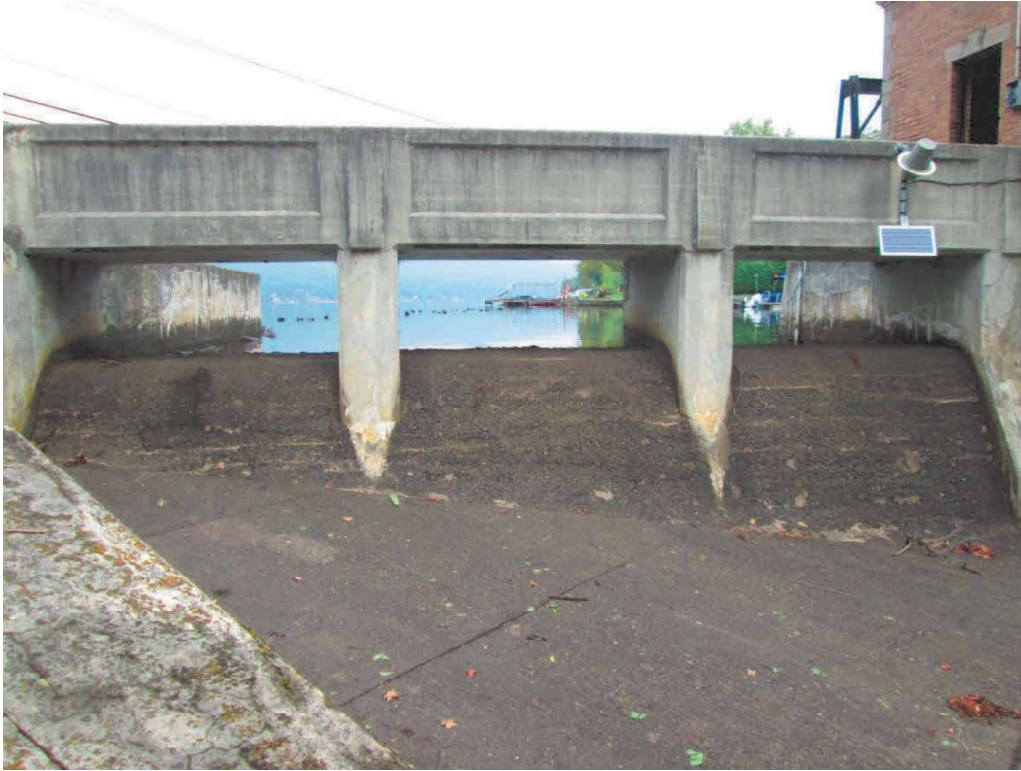
**Photo No. 21: Crest and downstream face of the 30-foot long spillway weir looking upstream.**

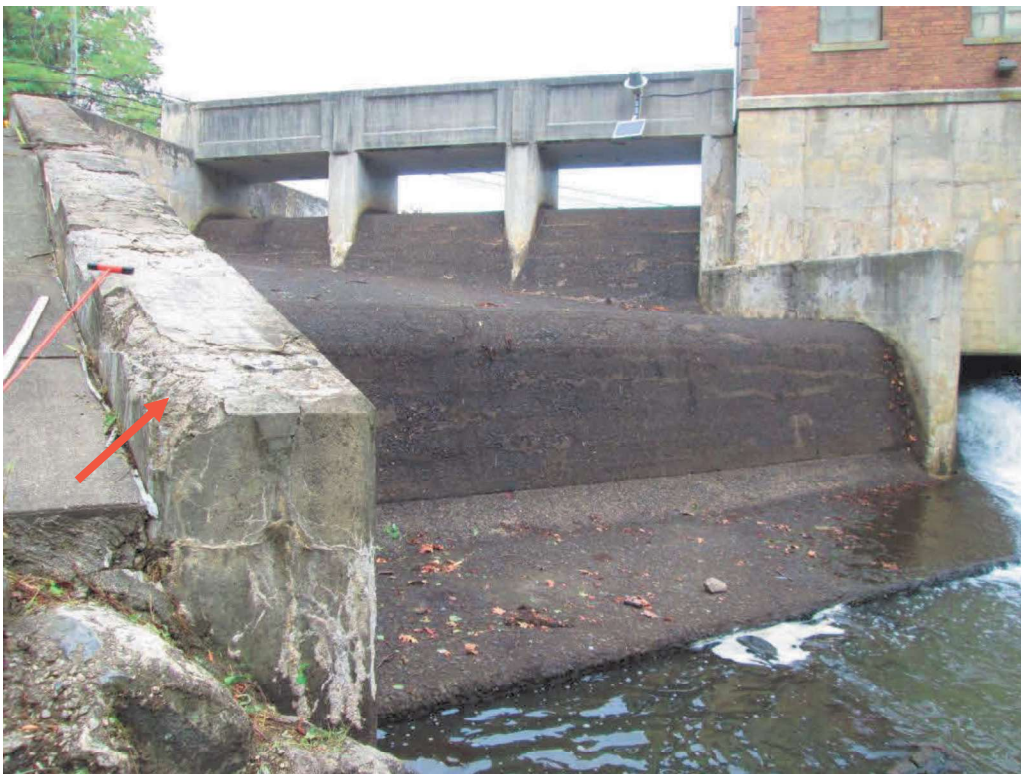
**Photo No. 22: Downstream face and apron of the 30-foot long spillway weir looking upstream. Note the cracks and spalls in the previous repair material in the downstream right wing wall.**

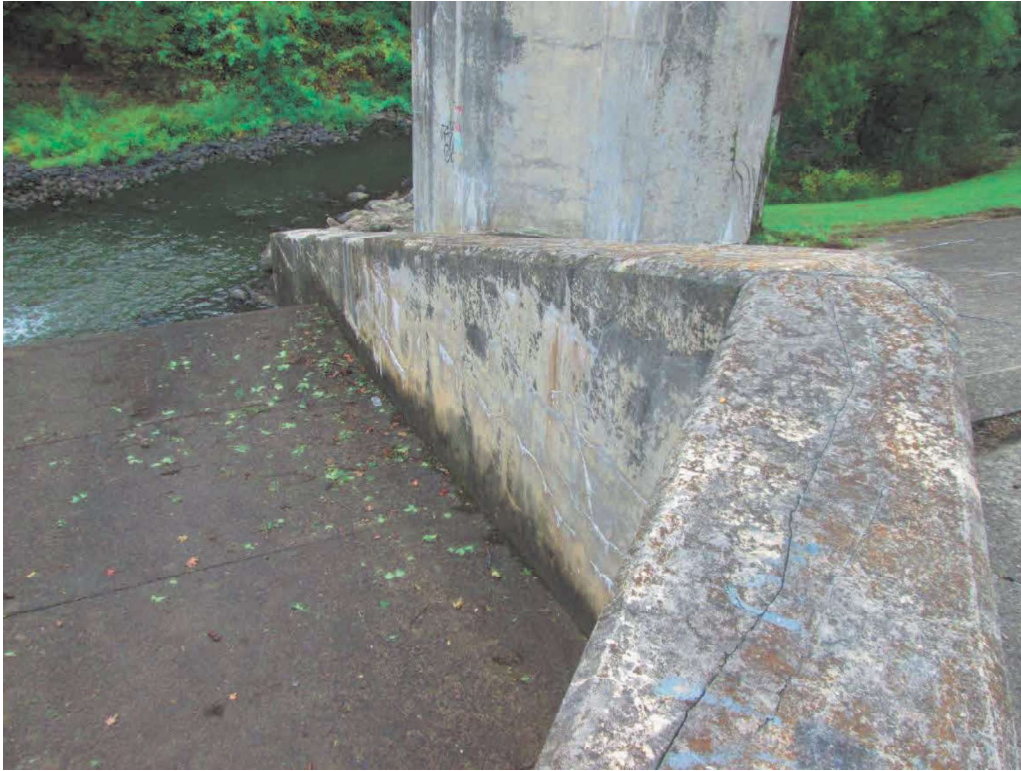
**Photo No. 23: Downstream right wing wall at the 30-foot long spillway weir looking downstream.**

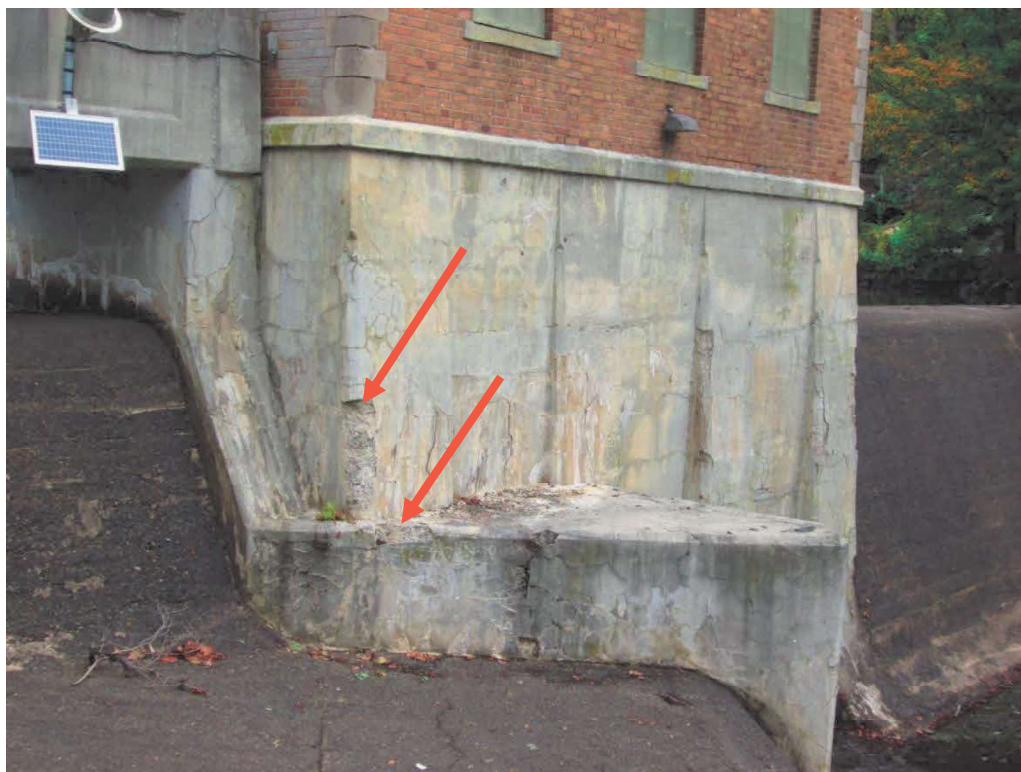
**Photo No. 24: Downstream left wing wall and right gatehouse sidewall at the 30-foot long spillway weir looking left. Note the cracks and spalls in the gatehouse walls.**

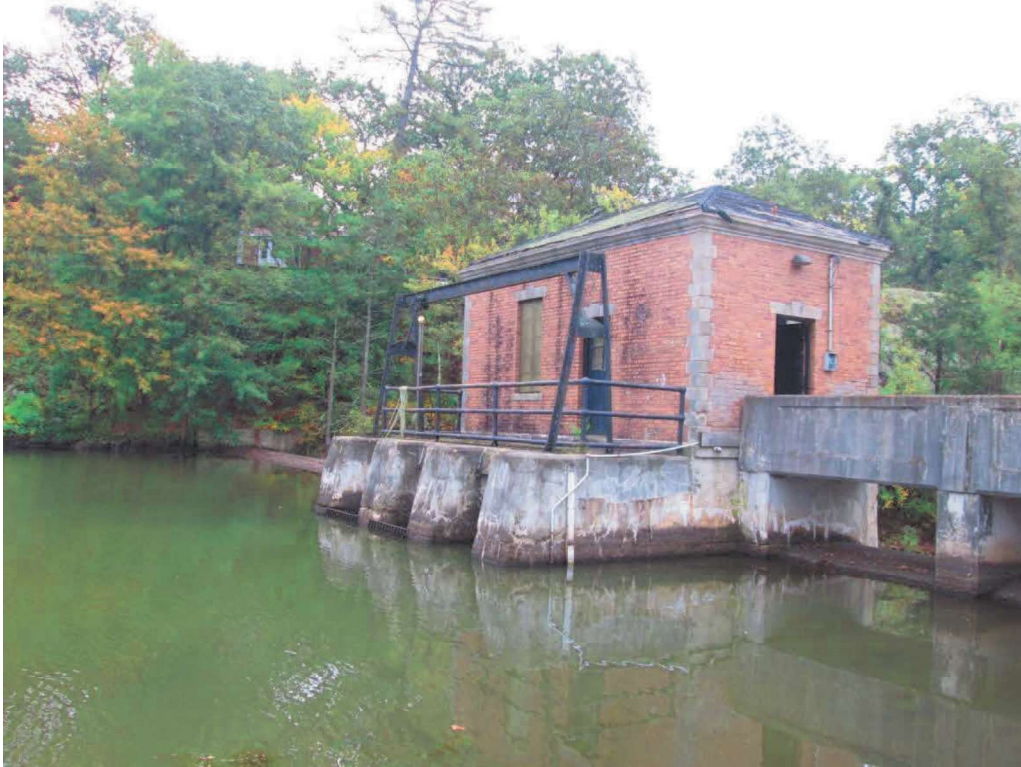
**Photo No. 25: Entrance channel of the 90-foot long spillway weir looking left.**

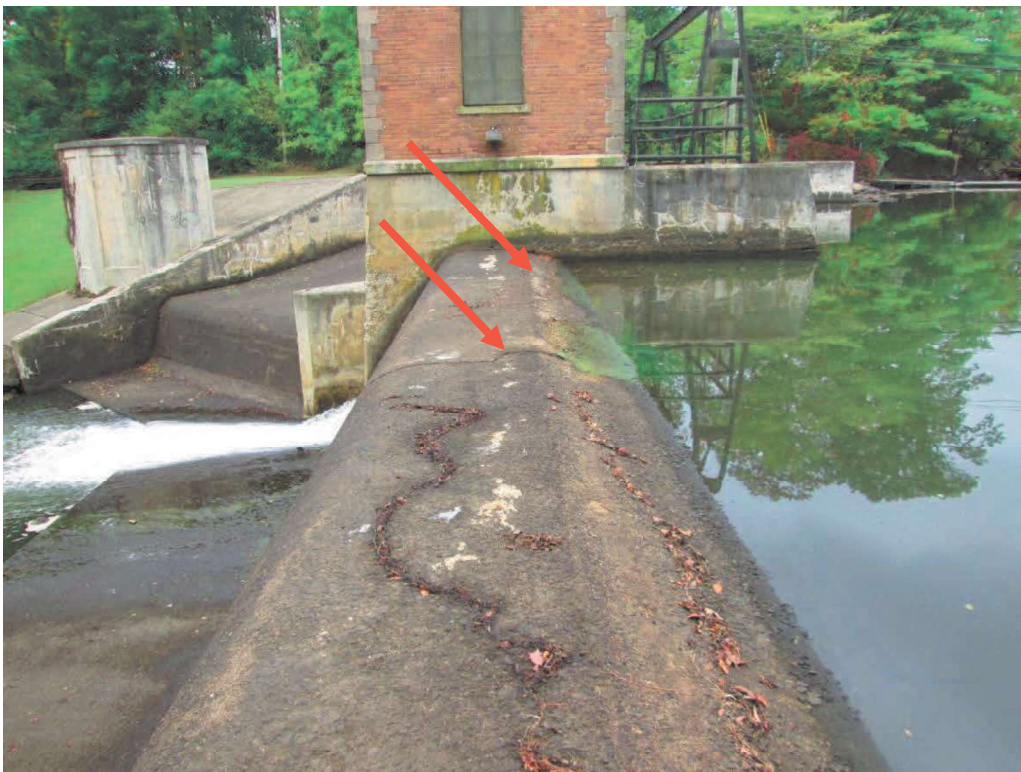
**Photo No. 26: Crest of the 90-foot long spillway weir looking right.  
Note the right keyway joint. Also note the longitudinal crack along the upstream  
edge of the crest.**
