# **SCOPE OF WORK**

## **Greenwood Lake Dam Repairs**

**Project No. P1389-00**

## 2025 REGULAR INSPECTION REPORT

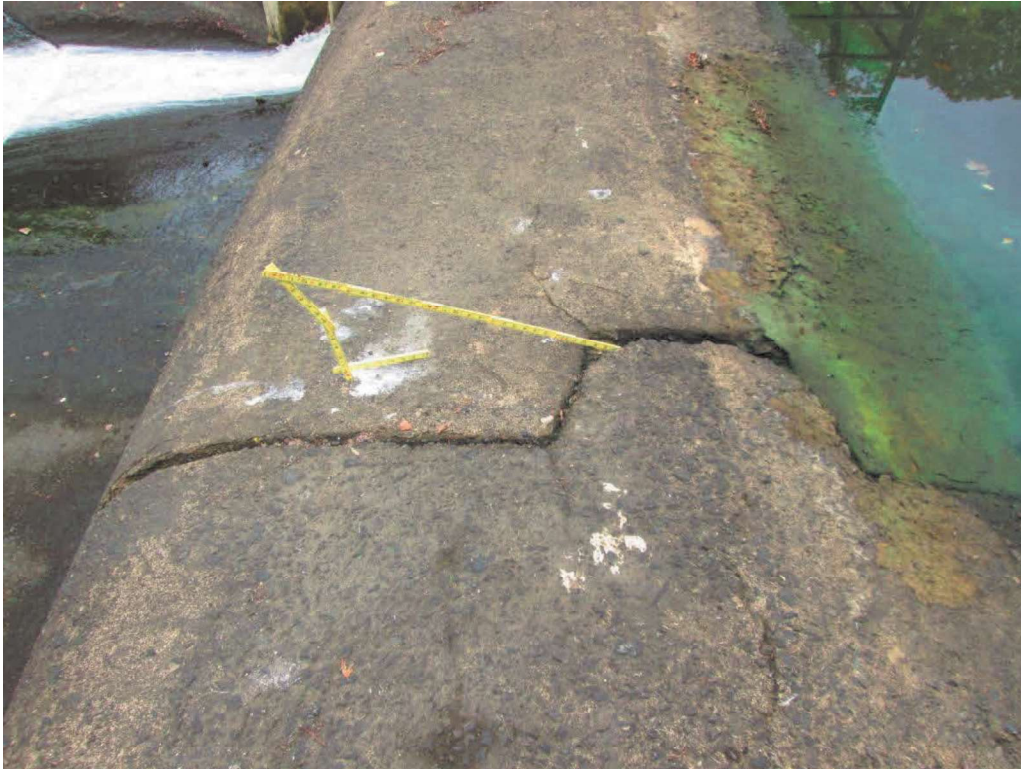
**Photo No. 27: Closeup of the eroded right keyway joint in the 90-foot long spillway weir.**

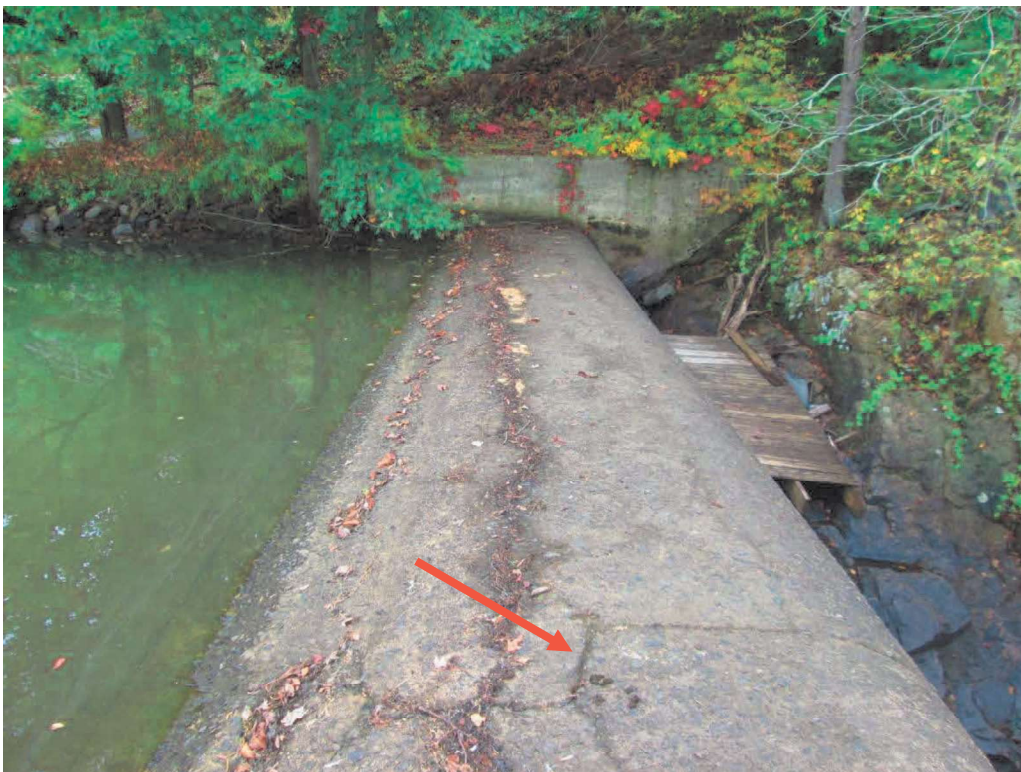
**Photo No. 28: Crest of the 90-foot long spillway weir looking left.  
Note the left keyway joint.**

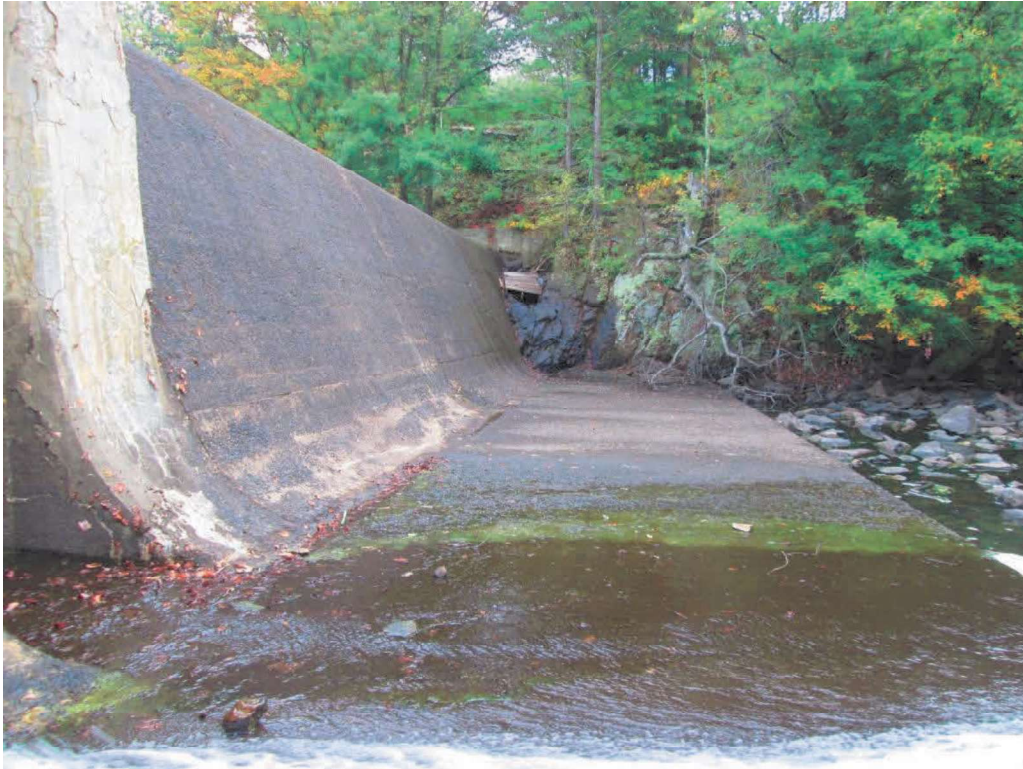
**Photo No. 29: Downstream face and apron of the 90-foot long spillway weir looking left.**

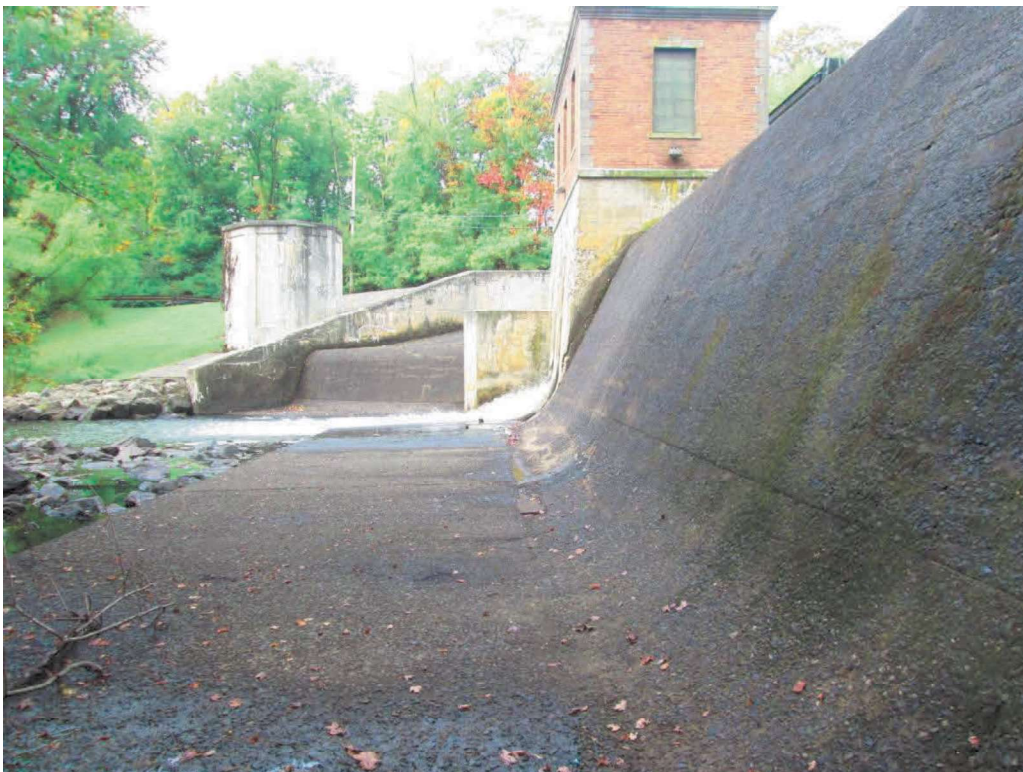
**Photo No. 30: Downstream face and apron of the 90-foot long spillway weir looking right.**

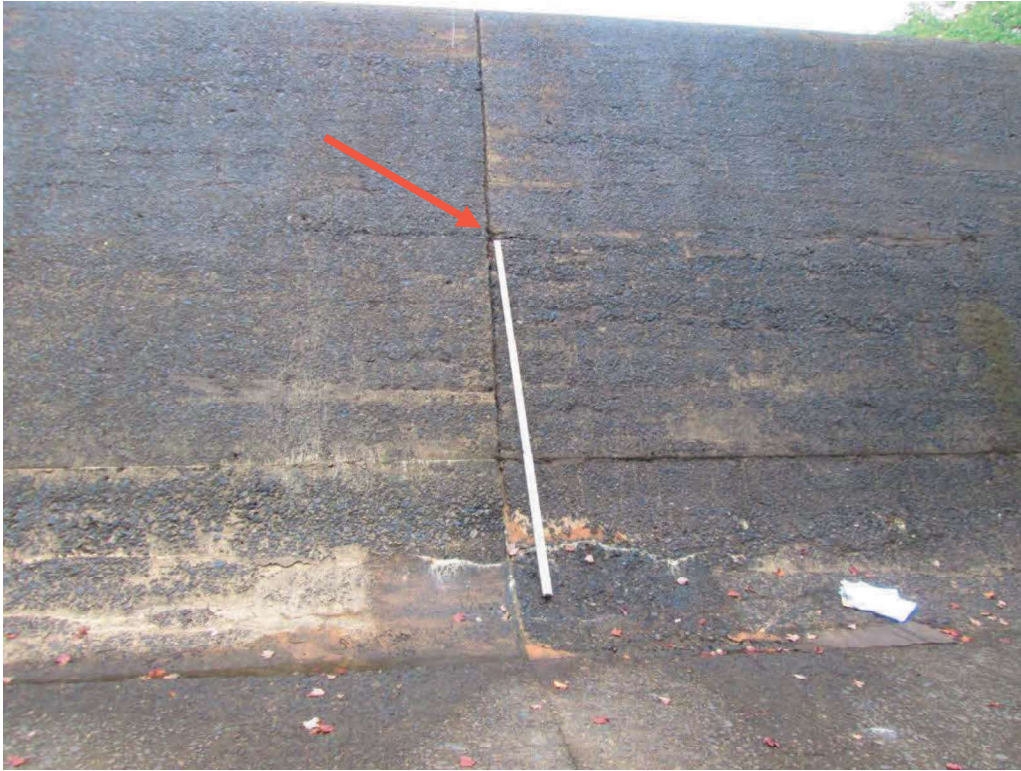
**Photo No. 31: Right construction joint in the 90-foot long spillway weir.  
Note the minor spall at the construction joint.**

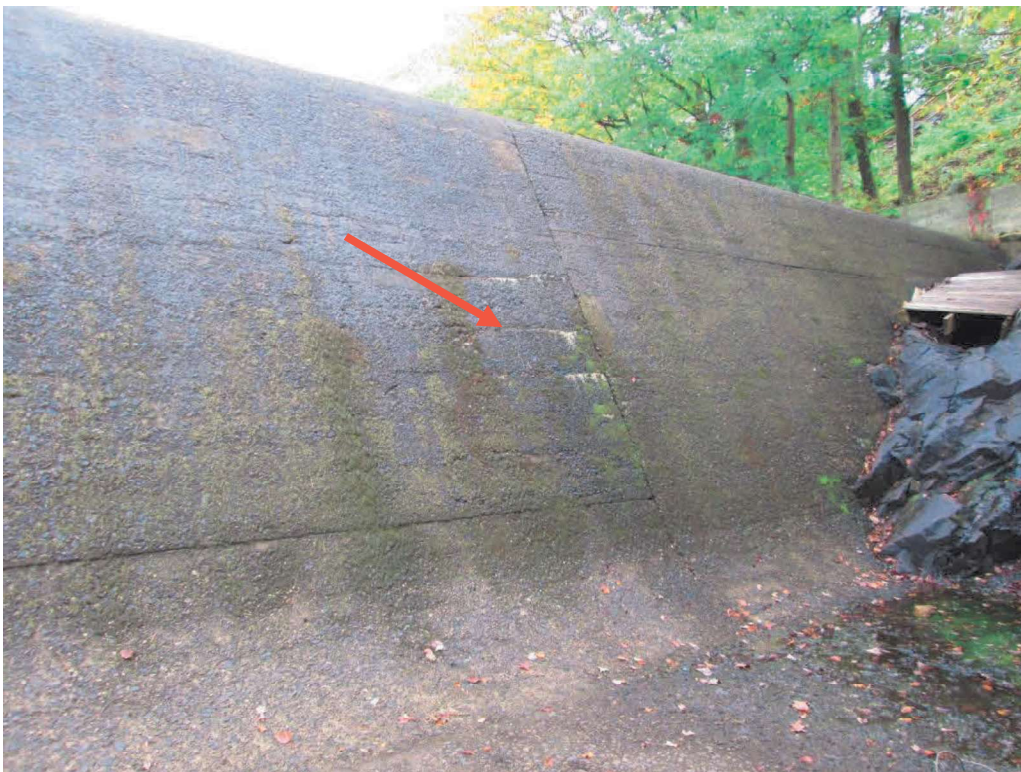
**Photo No. 32: Left construction joint in the 90-foot long spillway weir.  
Note the efflorescence at horizontal cracks which are likely concrete lift joints.**

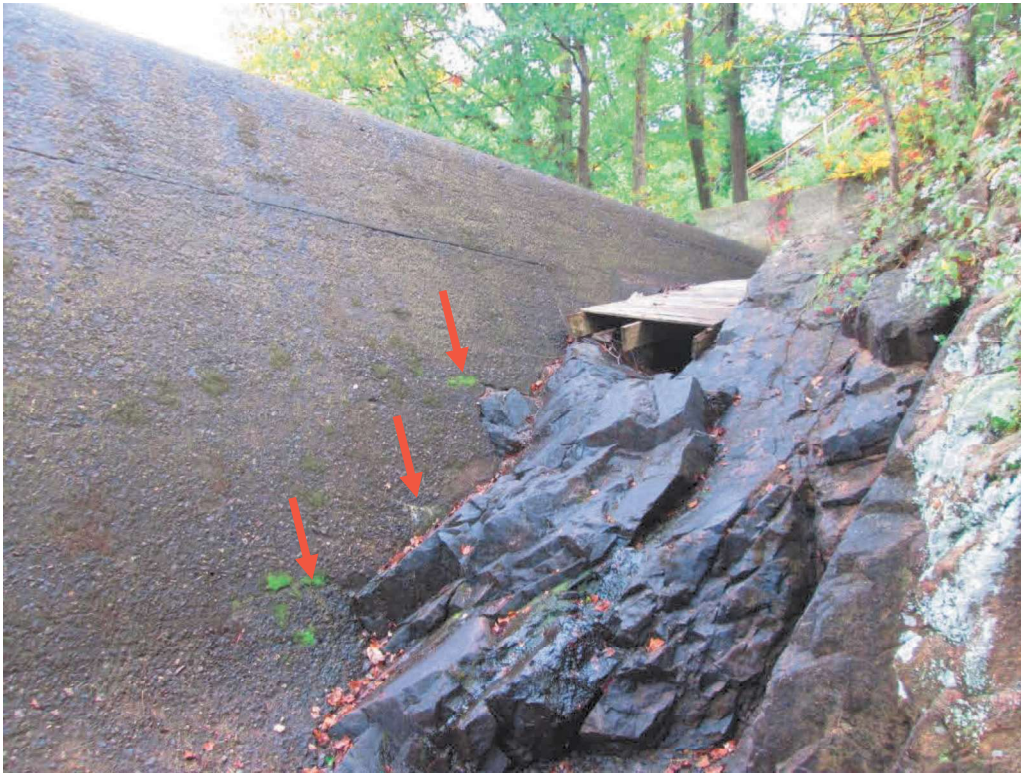
**Photo No. 33: Contact of the downstream face of the 90-foot long spillway weir with rock at the left abutment. Note the horizontal cracks/lift joints in the downstream face of the weir. Note the dock lodged on the rock abutment.**

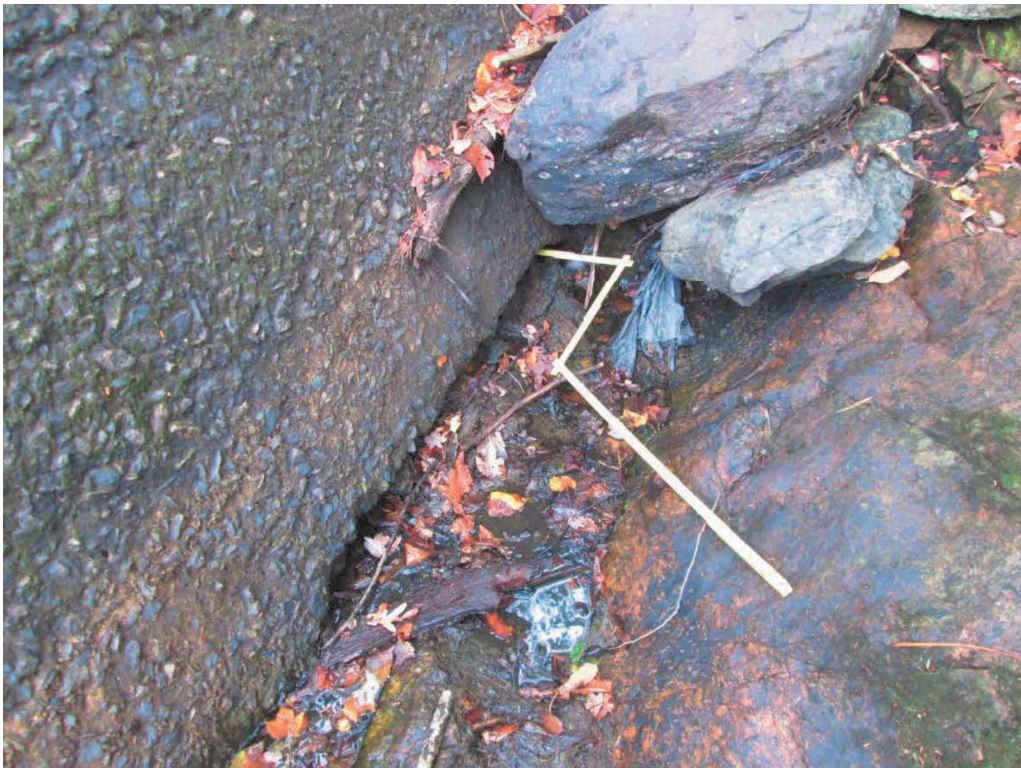
**Photo No. 34: Closeup of the gap at the contact of the downstream face of the 90-foot long spillway weir with rock at the left abutment.**

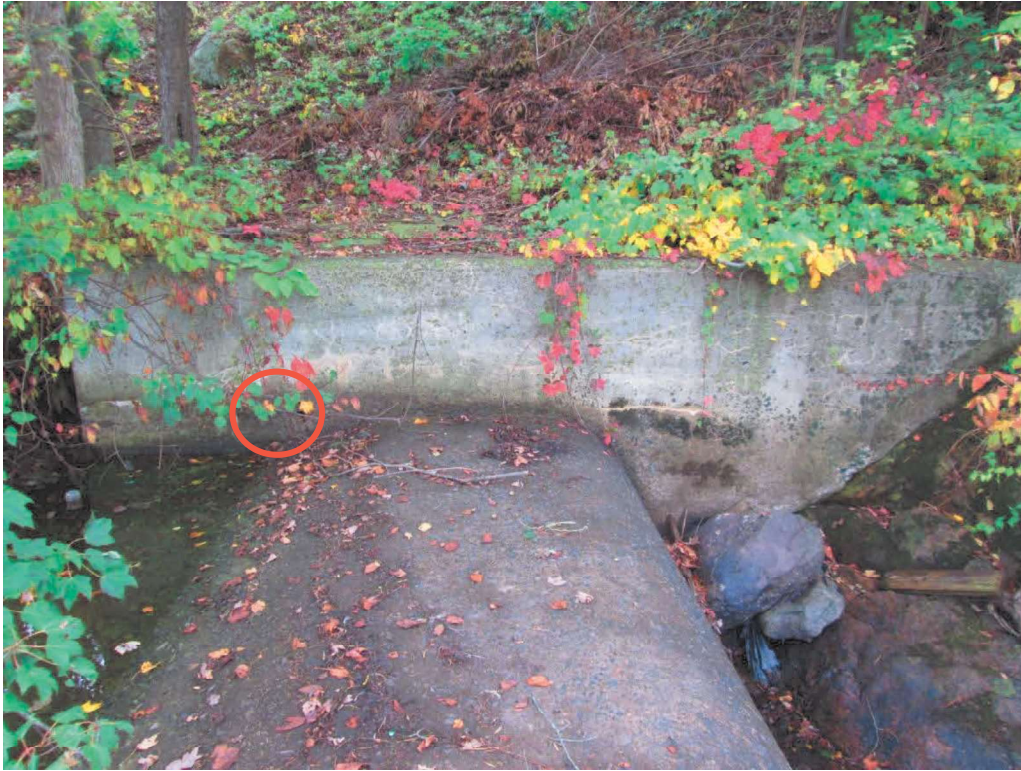
**Photo No. 35: Left training wall at the contact with the 90-foot long spillway crest and left abutment. Note the location of the small void in the training wall.**

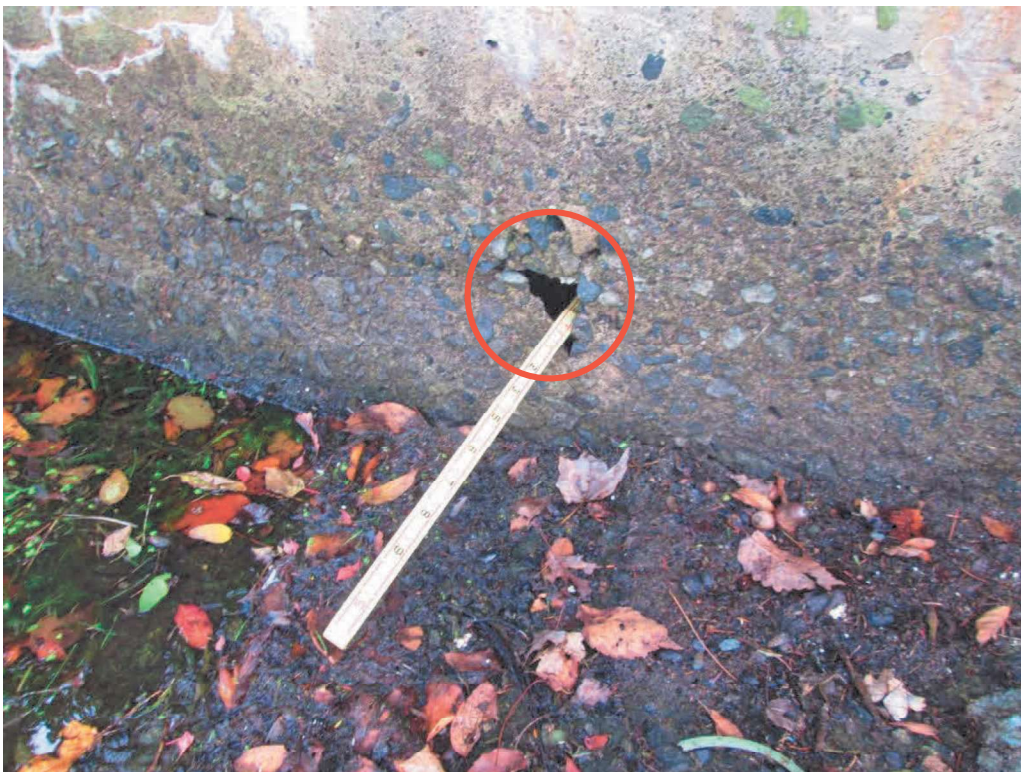
**Photo No. 36: Closeup of the small void (24 inches deep) in the left training wall of the 90-foot long spillway weir.**

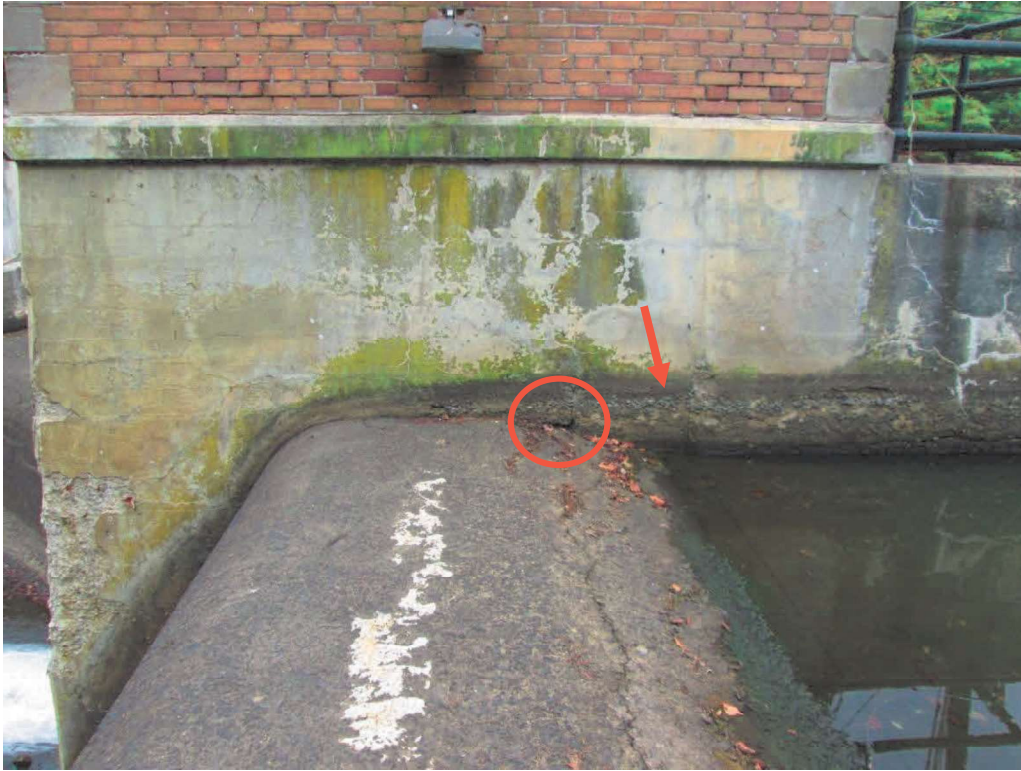
**Photo No. 37: Left sidewall of the gatehouse at the contact with 90-foot long spillway weir. Note the horizontal crack and void in the wall.**

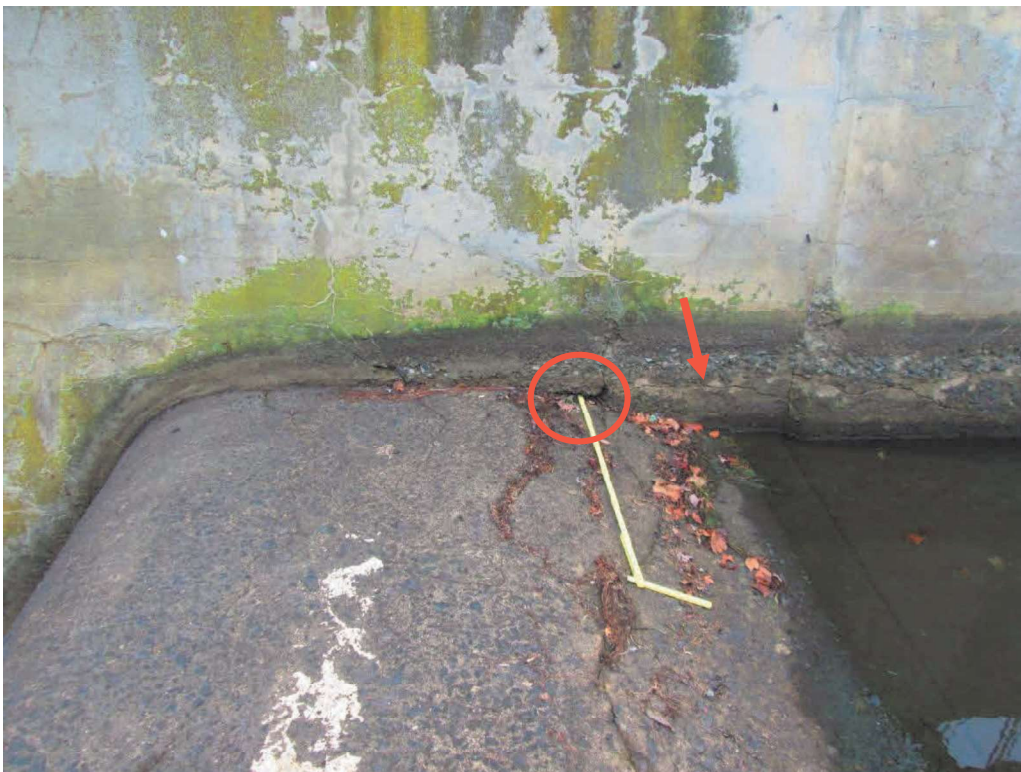
**Photo No. 38: Closeup of the horizontal crack and void in the left sidewall of the gatehouse at the 90-foot long spillway weir.**

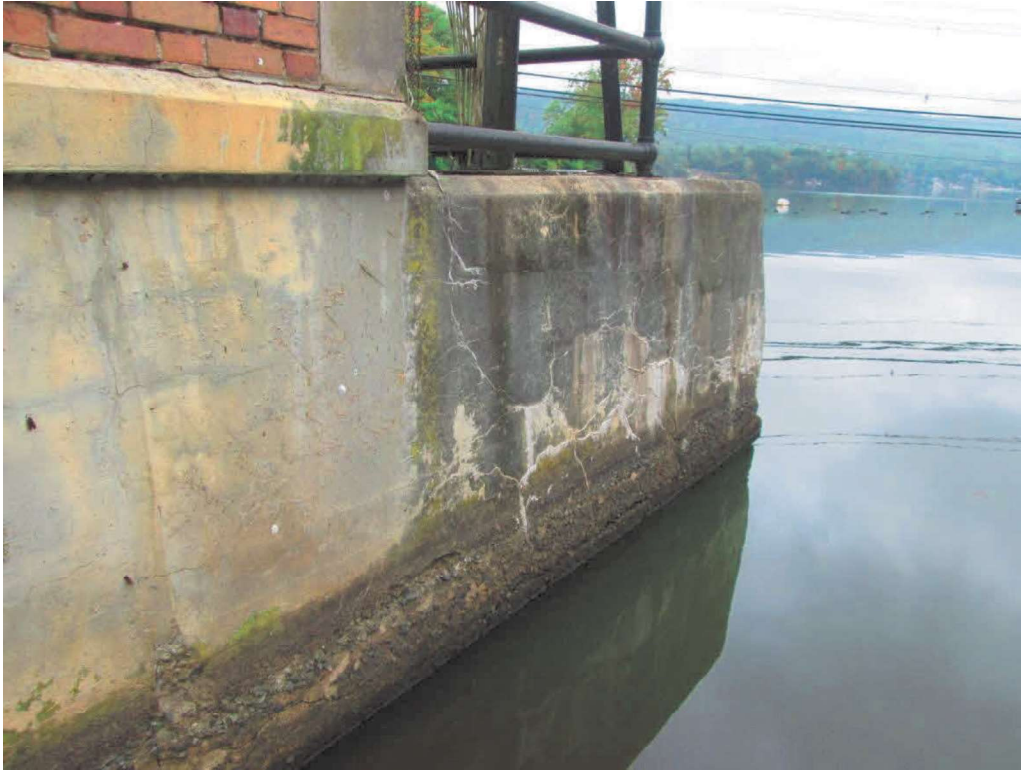
**Photo No. 39: Closeup of the upstream portion of the left sidewall of the gatehouse at the 90-foot long spillway weir. Note the various fine cracks in the wall.**

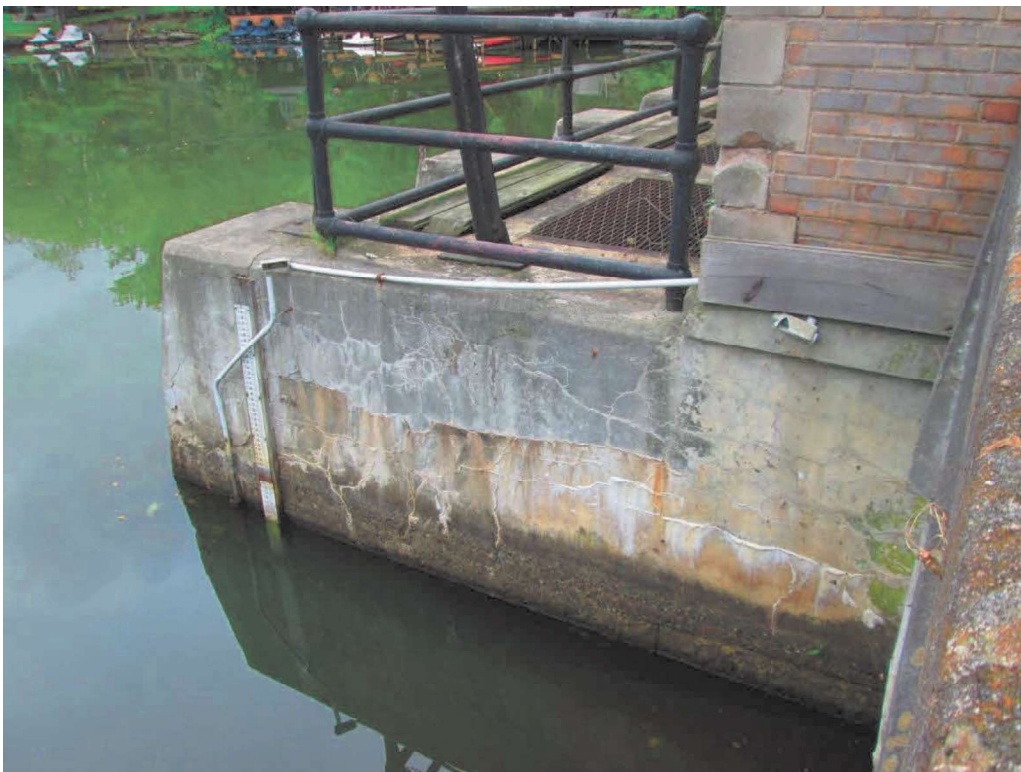
**Photo No. 40: Closeup of the upstream portion of the left sidewall of the gatehouse at the 30-foot long spillway weir. Note the various minor cracks in the wall.**

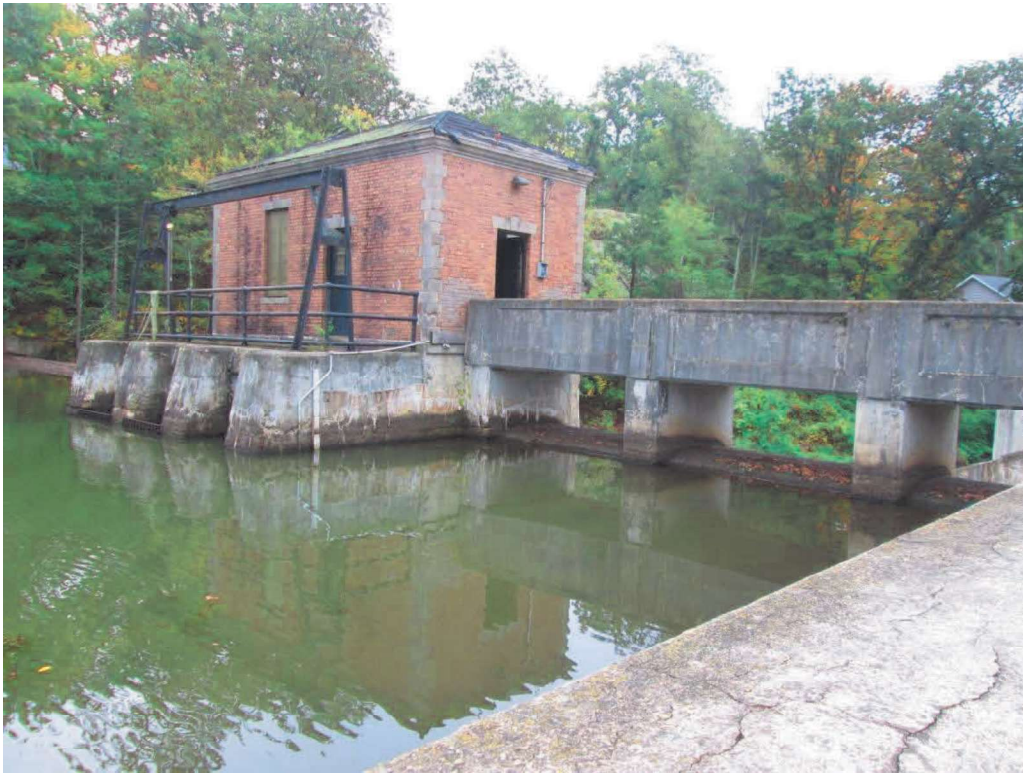
**Photo No. 41: Gatehouse and low level outlet entrance.**

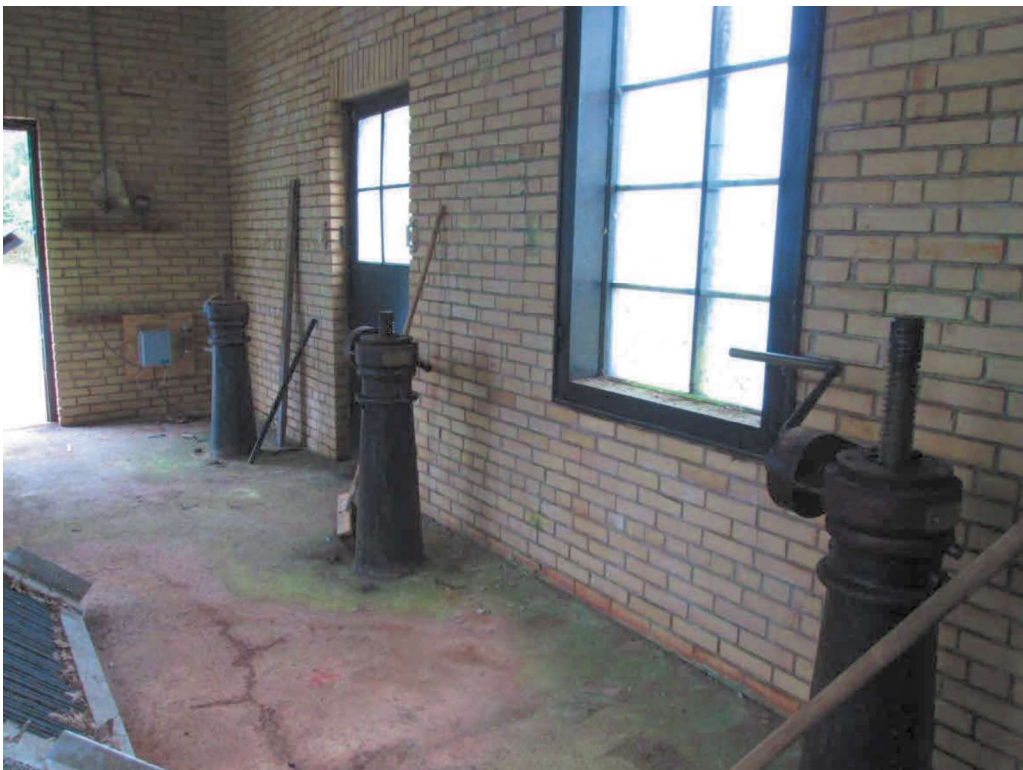
**Photo No. 42: Interior of gatehouse and the hand crank operators  
for the sluice gates.**

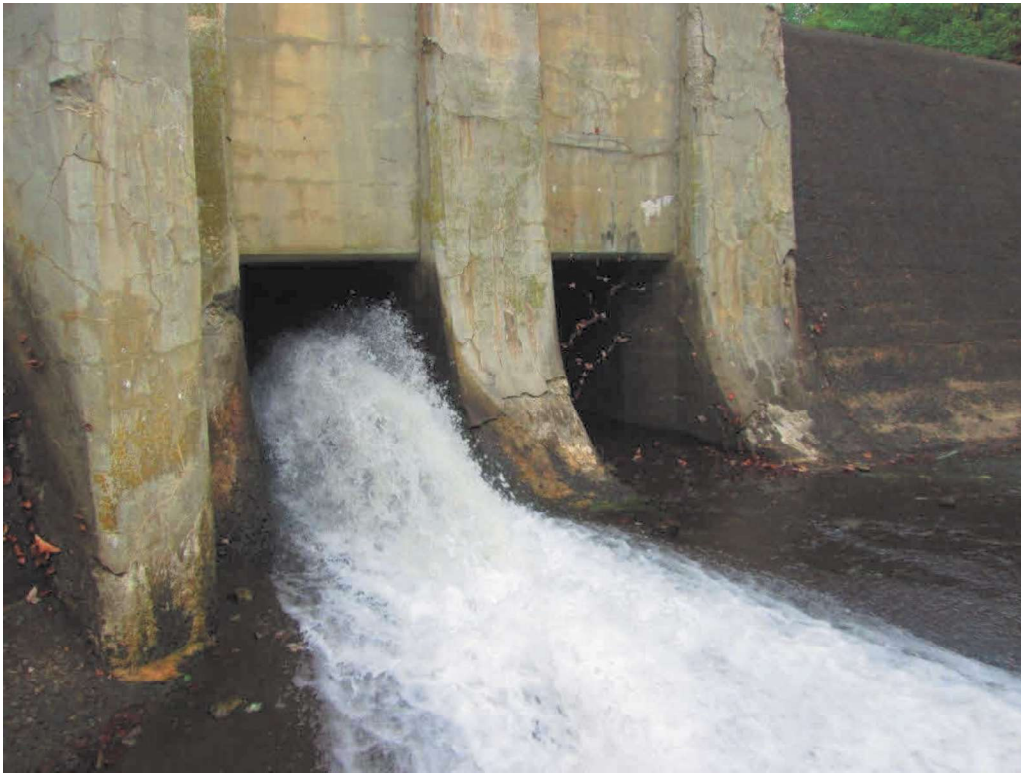
**Photo No. 43: Downstream side of the gatehouse and low level outlets.**

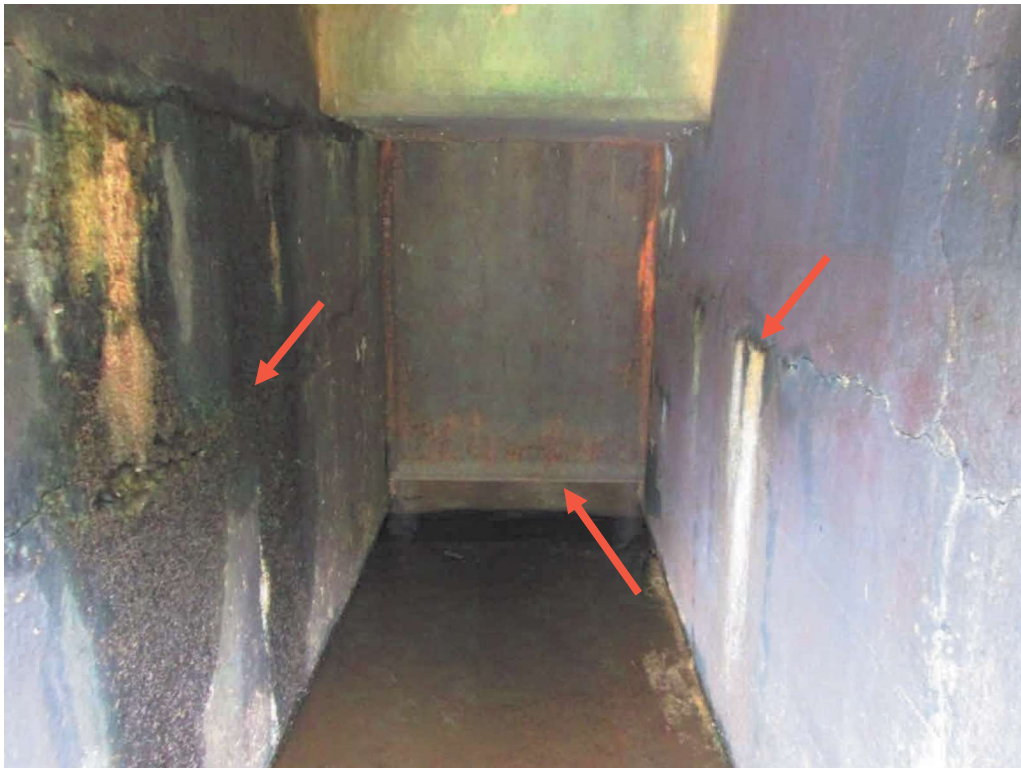
**Photo No. 44: Downstream side of left low level outlet sluice gate and discharge chute. Note that the gate was partially open. Note the cracks with minor weeping in the discharge chute.**

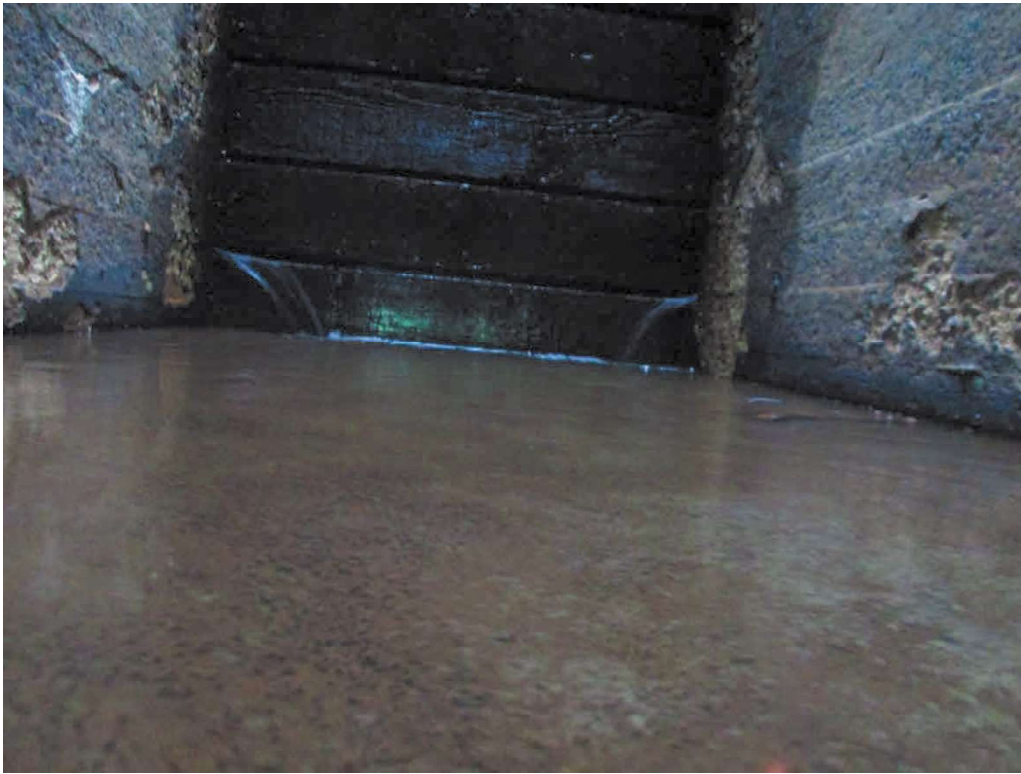
**Photo No. 45: Closeup of stop logs upstream of left low level outlet sluice gate.  
Note the minor leakage through the stop logs.**

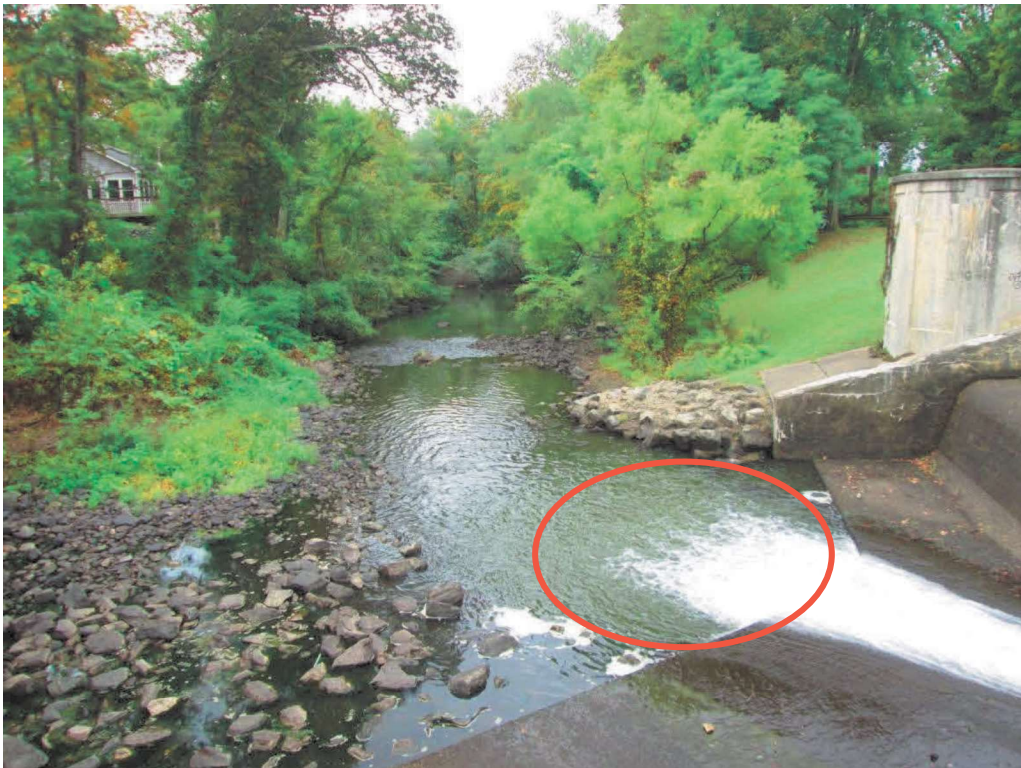
**Photo No. 46: Downstream channel from the 90-foot long spillway crest.  
Note the approximate location of the downstream scour hole.**
