SCOPE OF WORK

Colonnade Restoration

Princeton Battlefield State Park
Princeton, Mercer County, NJ

PRINCETON BATTLEFIELD COLONNADE CONDITIONS ASSESSMENT

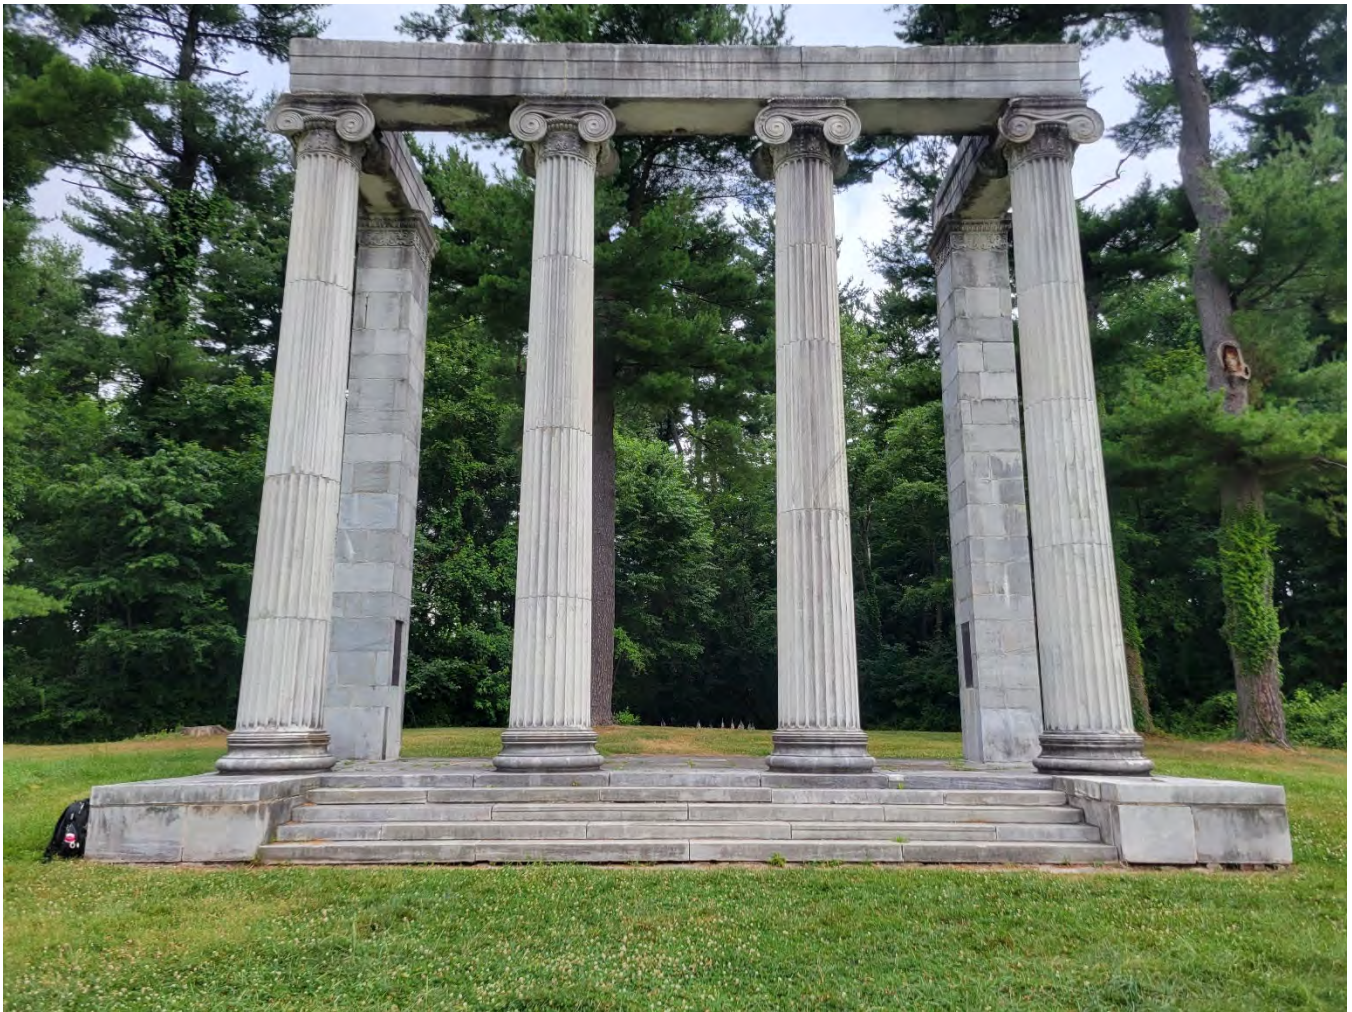
Photo 1: Overall view of the monument from the south (all photos by Lorraine Schnabel unless otherwise indicated).

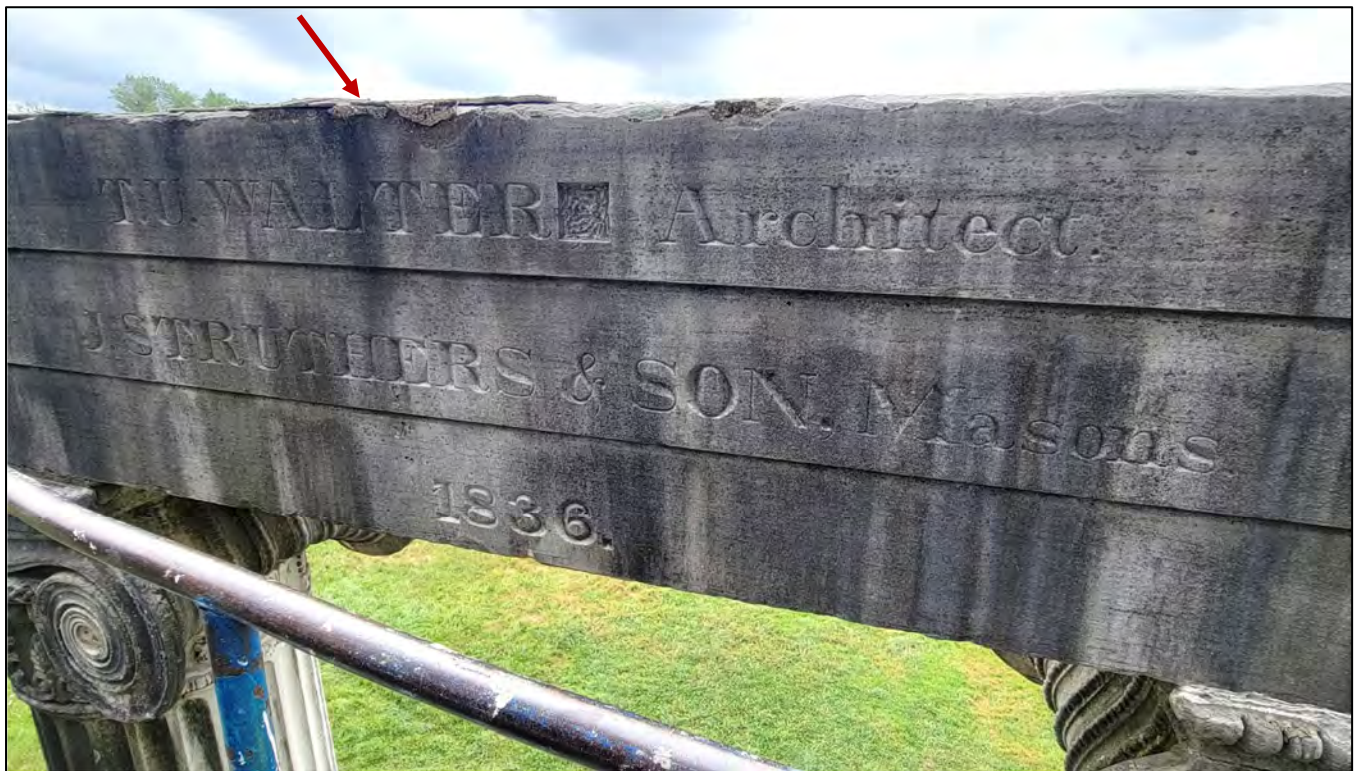
Another condition of concern is the deteriorated cementitious parging that was applied to the top of the architrave, presumably to both level the rough surface and to provide drainage and waterproofing (Photos 2, 10). The parging is detached from the marble, and there are many loose fragments that could be blown off by a strong wind. Removal of all the parging is recommended until a more permanent solution to leveling, waterproofing, and drainage can be made for the top of the structure.

Photo 2: View of the carved inscription at the north side of the center architrave block. The cementitious patch on top of the architrave is visible at the edge (arrow)

The existing parging on the top of the architrave should be replaced with metal roofing to provide drainage slope and protection of the joints; joints in the upper parts of the colonnade that are not disassembled should be repointed (joints between the stones of the column seem sound). A flashing should be considered at the top of the piers to prevent water intrusion at the exposed horizontal joint.

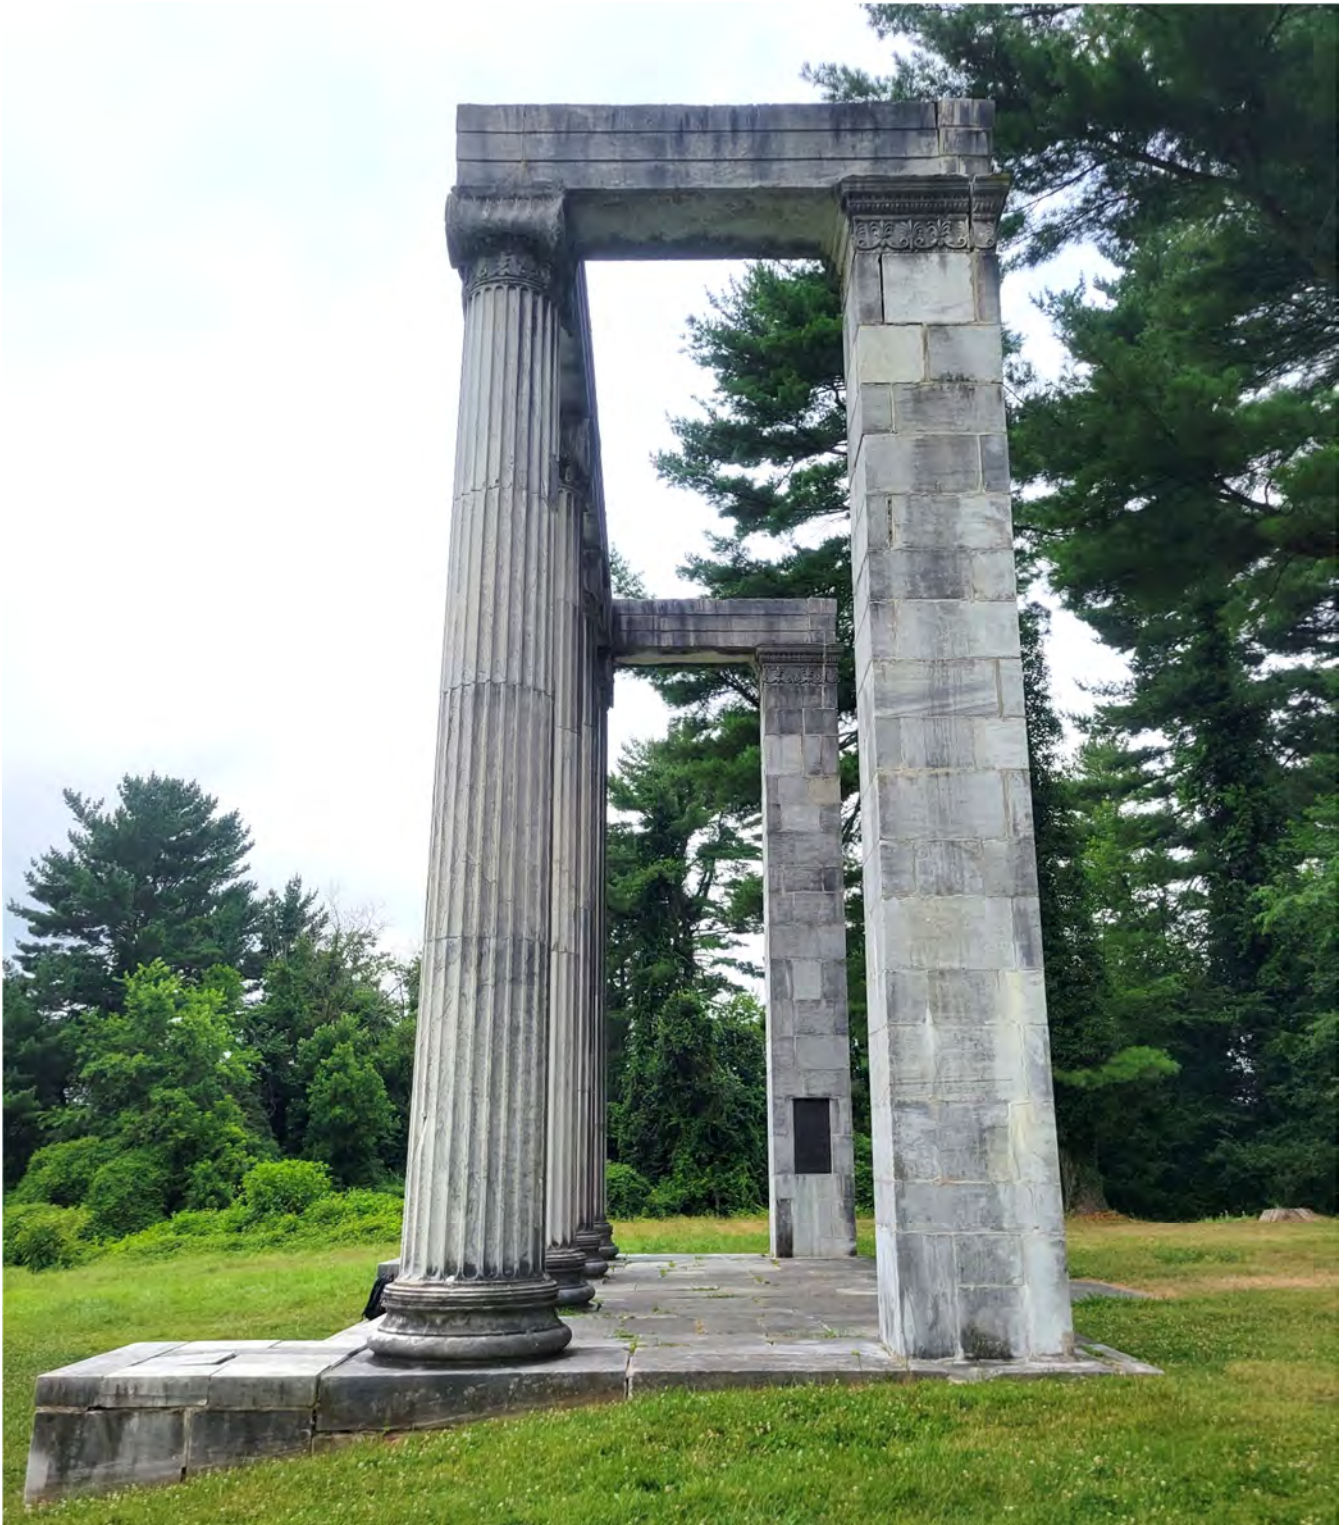
Photo 3: View of the east elevation showing the shape of the structure and the stair cheekwalls and marble pavement.

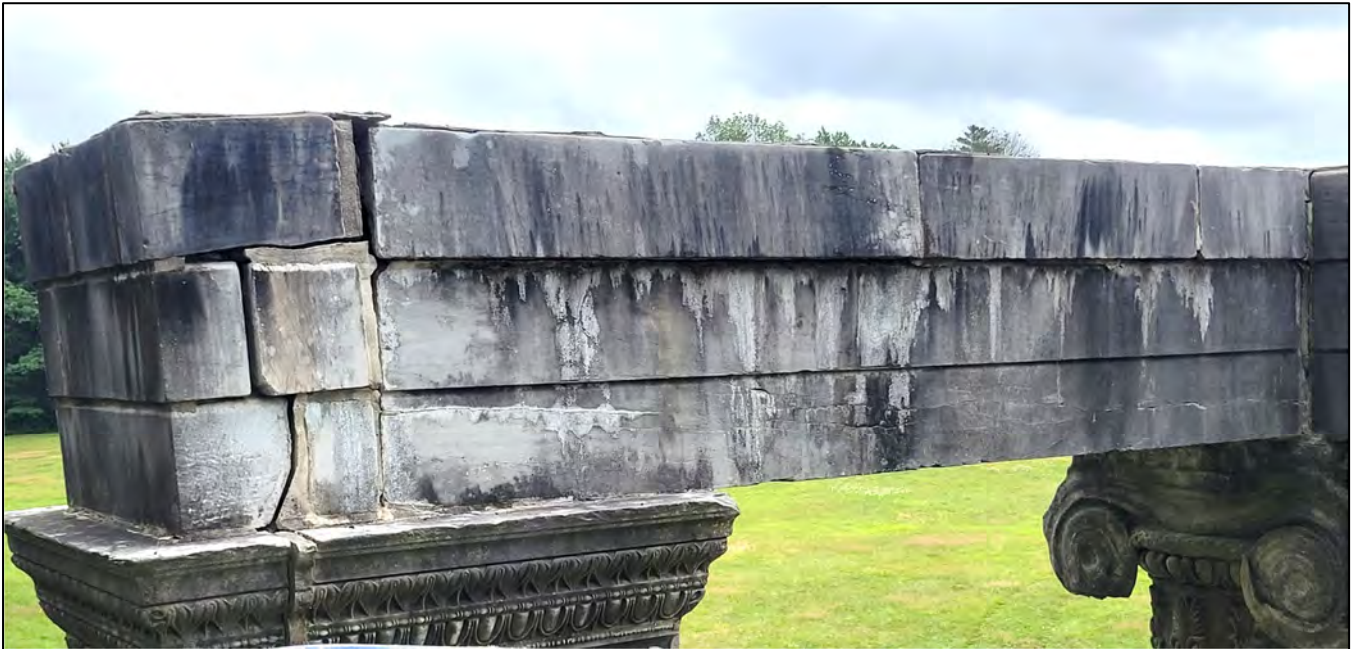
Photo 4: View of the west side of the east architrave block. The top section is comprised of three smaller pieces; note the white streaks below, indicating water is moving through the joints. Note the movement of the small blocks at the end above the square pier. There are horizontal fissures in the bottom section of the architrave stone.

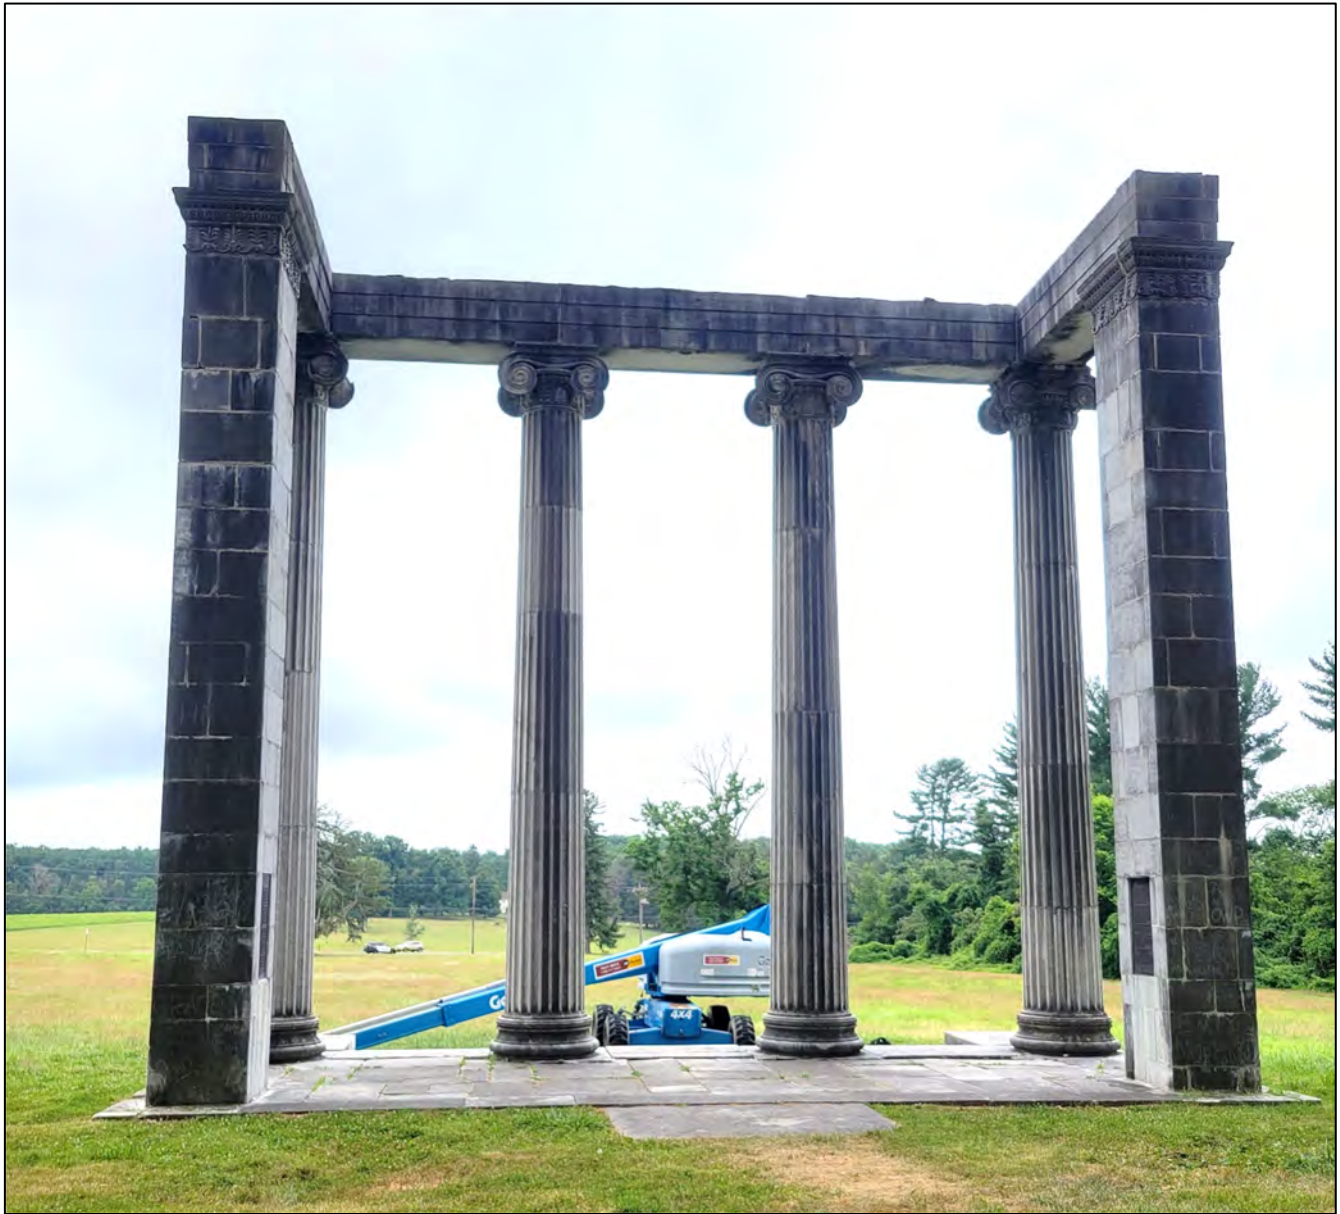
Photo 5: View of the north elevation showing that the construction is open to the rear. The white streaking visible on the piers is indicative of water moving through the masonry.

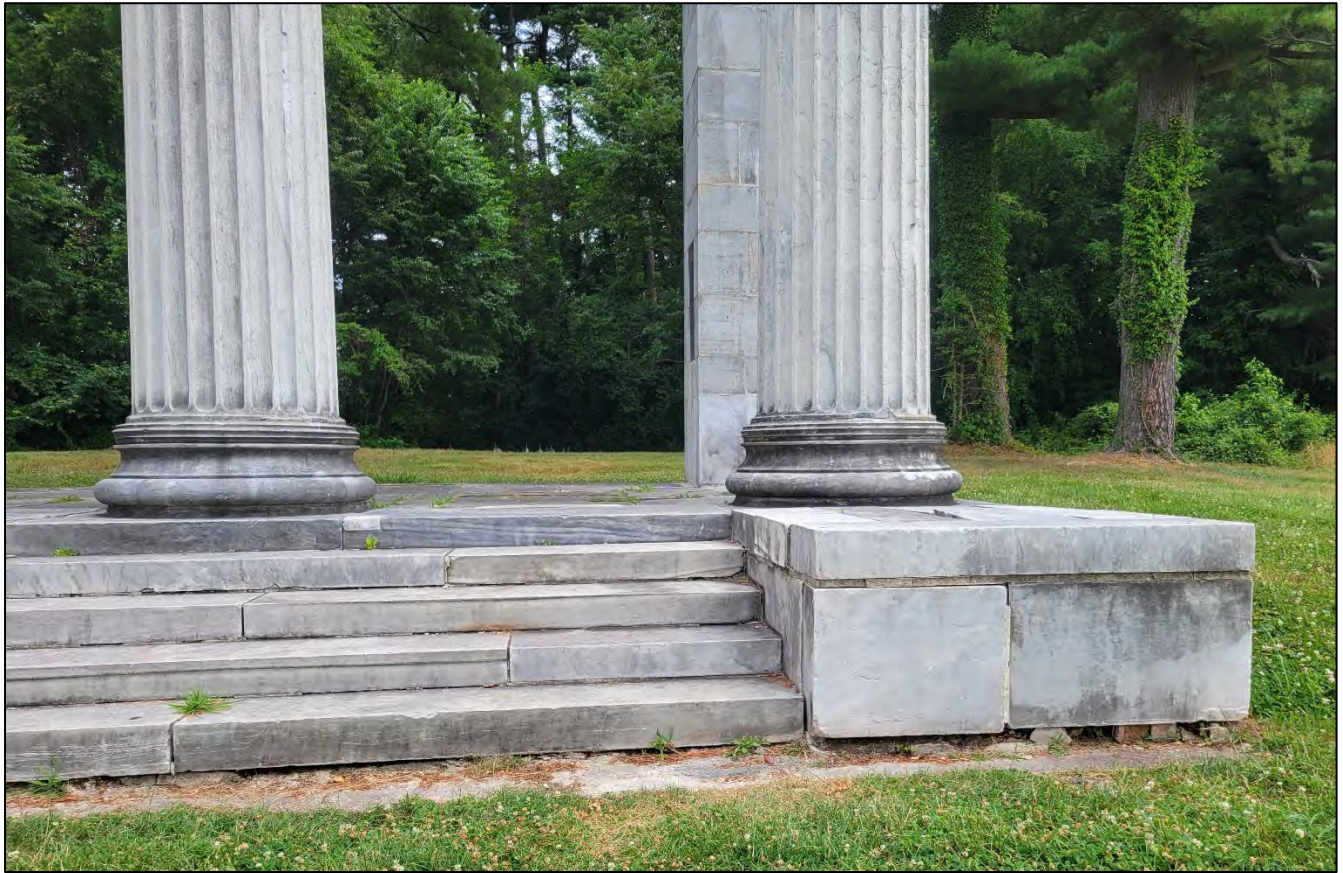
The masonry at the horizontal elements at the base of the colonnade is also in poor condition. Mortar in the paving, stairs, and cheekwall joints is deteriorated or missing (Photos 6, 7, 13, 14). The masonry of the stair cheekwalls is displaced, with the east cheekwall being the most deteriorated (Photos 13, 14); the paving is uneven with many cracked and chipped pavers (Photo 7). The paving is particularly depressed behind the column line (Photo 15); pavers at the perimeter and rear are generally sloped outwards towards the grass. One of the paving stones under the southwest column is cracked (Photo 16). The paving immediately behind the piers is different from the balance, with multiple small stones, and is in particularly poor condition (Photo 17).

Photo 6: View of the east end of the stairs and the east cheekwall. There is concrete along the base of the stair, but also exposed brick at the bottom of the cheekwall.

The paving needs to be lifted and re-set on a properly prepared base. Joints in the paving and stairs should be filled with mortar, even though this is a maintenance item. Use of an anti-freeze additive in the mortar such as Ice Minus 9 manufactured by Edison Coatings is recommended due to the exposure. The cracked base stone at the south column suggests ongoing movement which should be monitored.

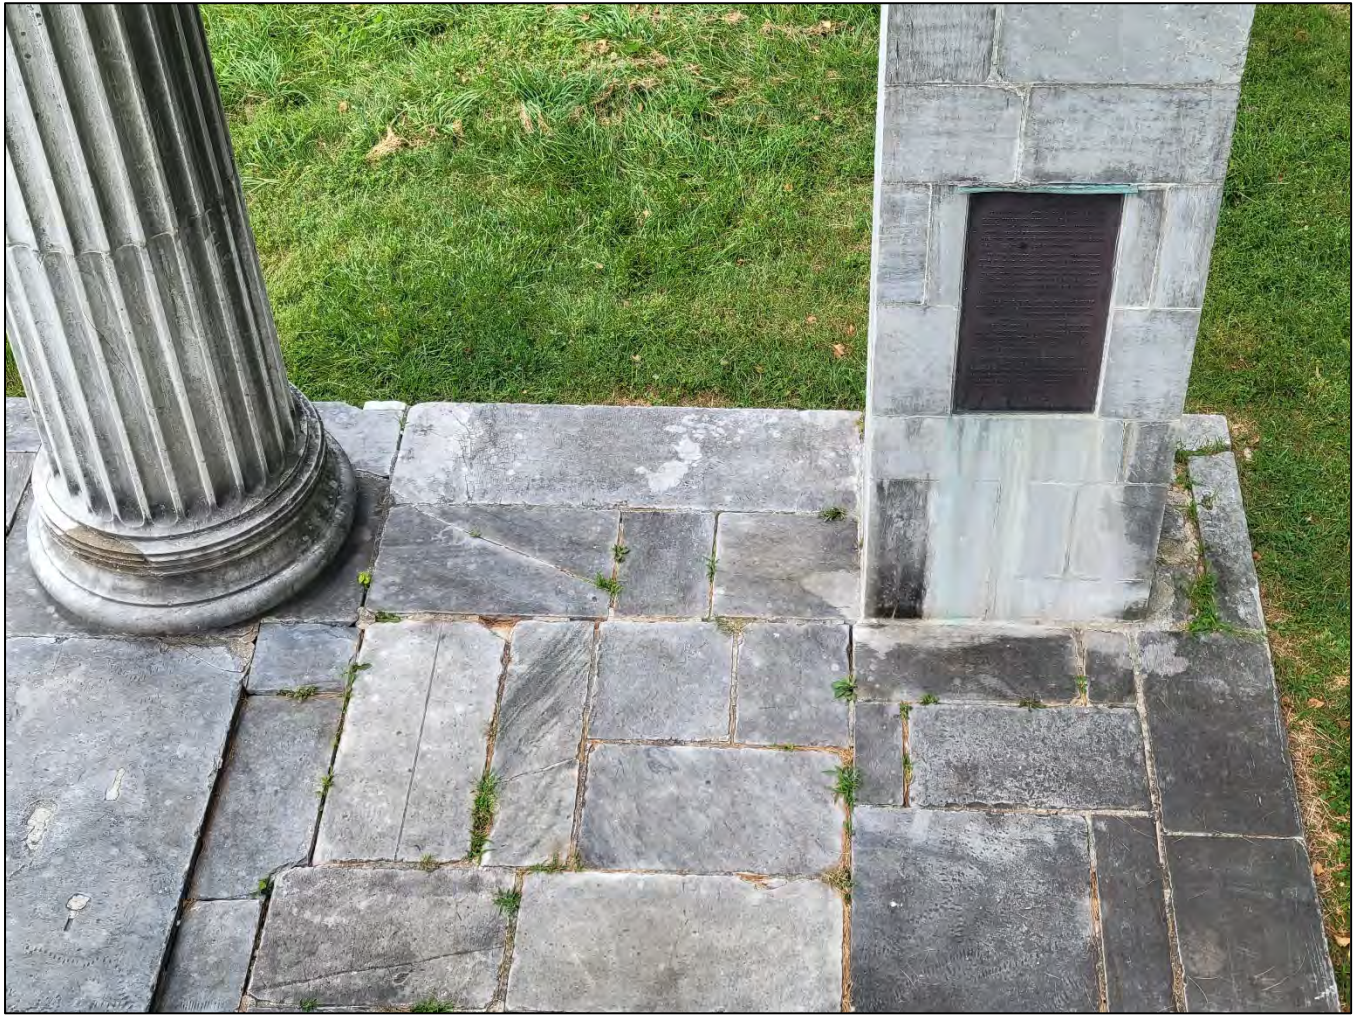
Photo 7: View of the paving at the west side of the construction. Note the cracked blocks, wide joints with vegetation, and the depression immediately behind the stone between the columns.

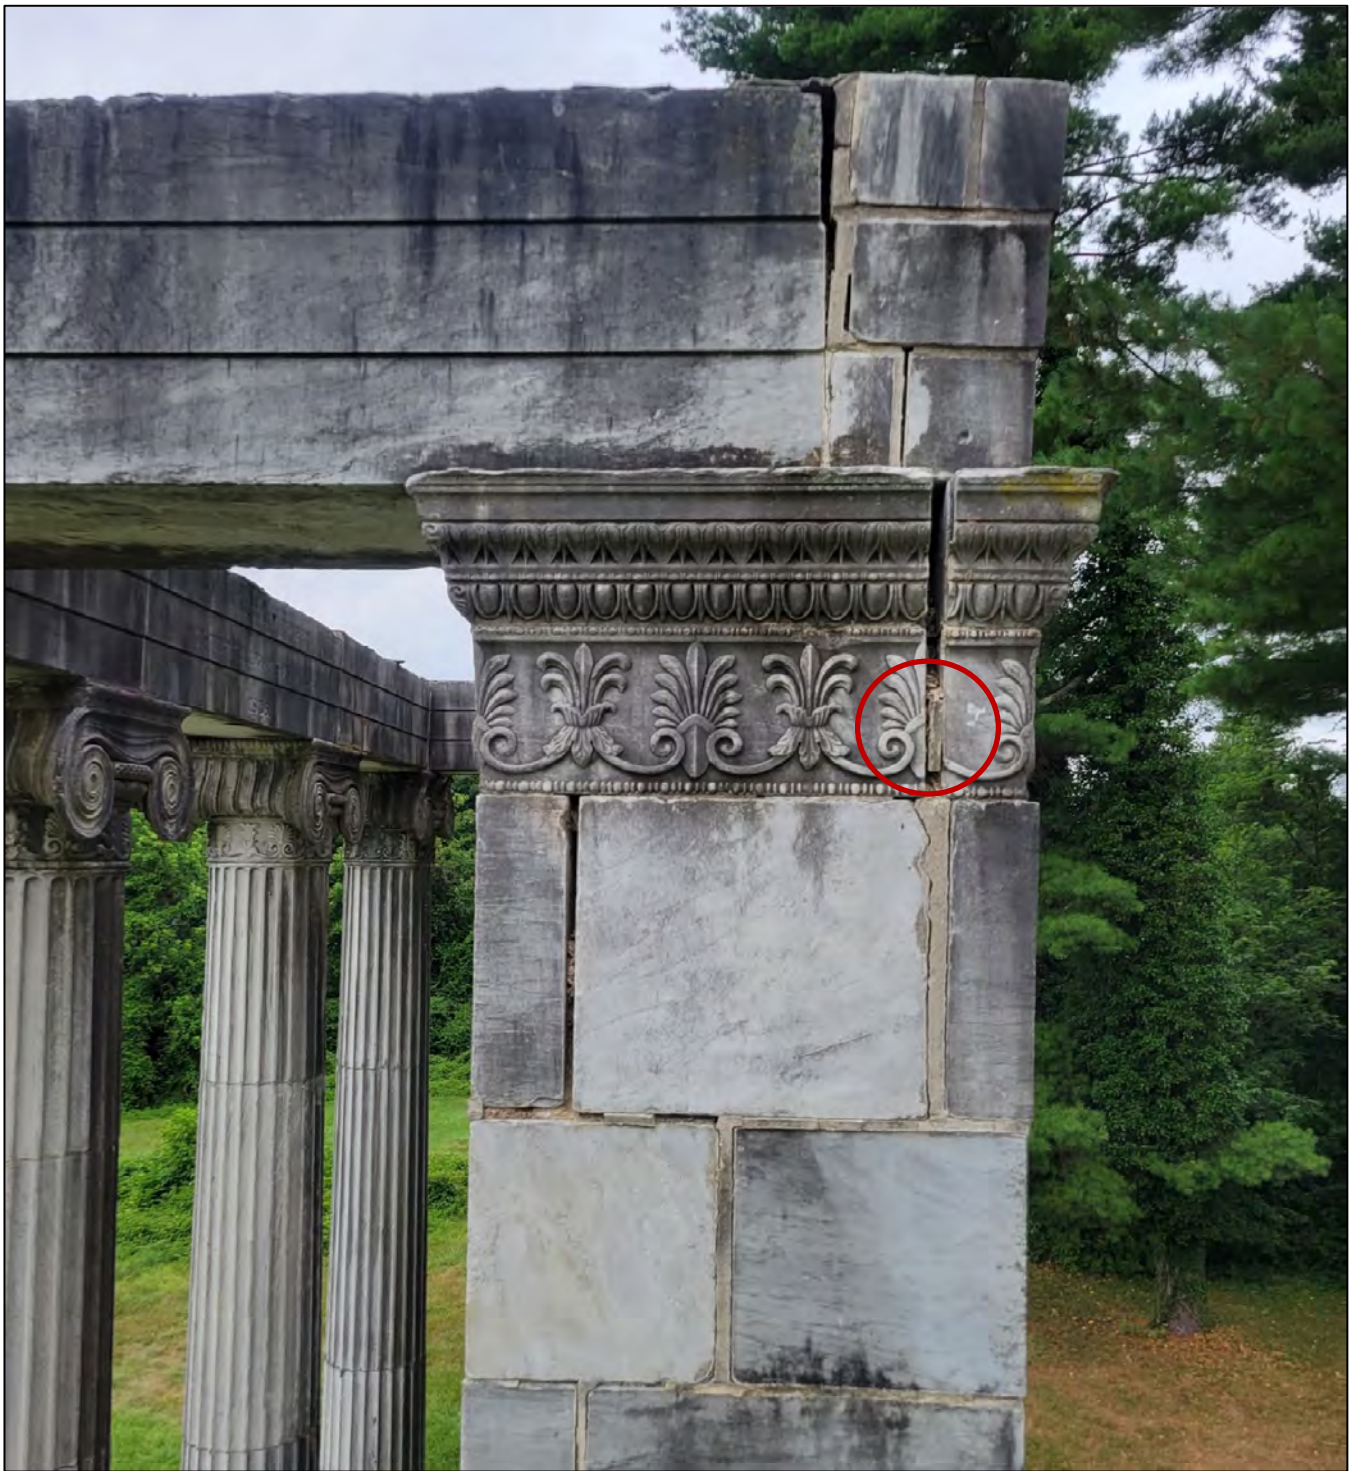
Photo 8: View of the east side of the east pier showing the displaced masonry and deteriorated mortar joints. The condition of the masonry above the west pier is not as severe; see Photo 9. The circled joint was loose and was removed.

The existing conditions of the colonnade are such that disassembly and reconstruction of a significant portion of the masonry is needed, including the square piers and the stairs and cheekwalls. The piers and cheekwalls should be reconstructed with the existing marble mechanically anchored to a new, dimensionally stable core; concrete and concrete masonry are not recommended because of their tendency to shrink with age. Replacement of some cracked stones at the piers may be needed, but the stones should be repaired with adhesive and pins if possible.

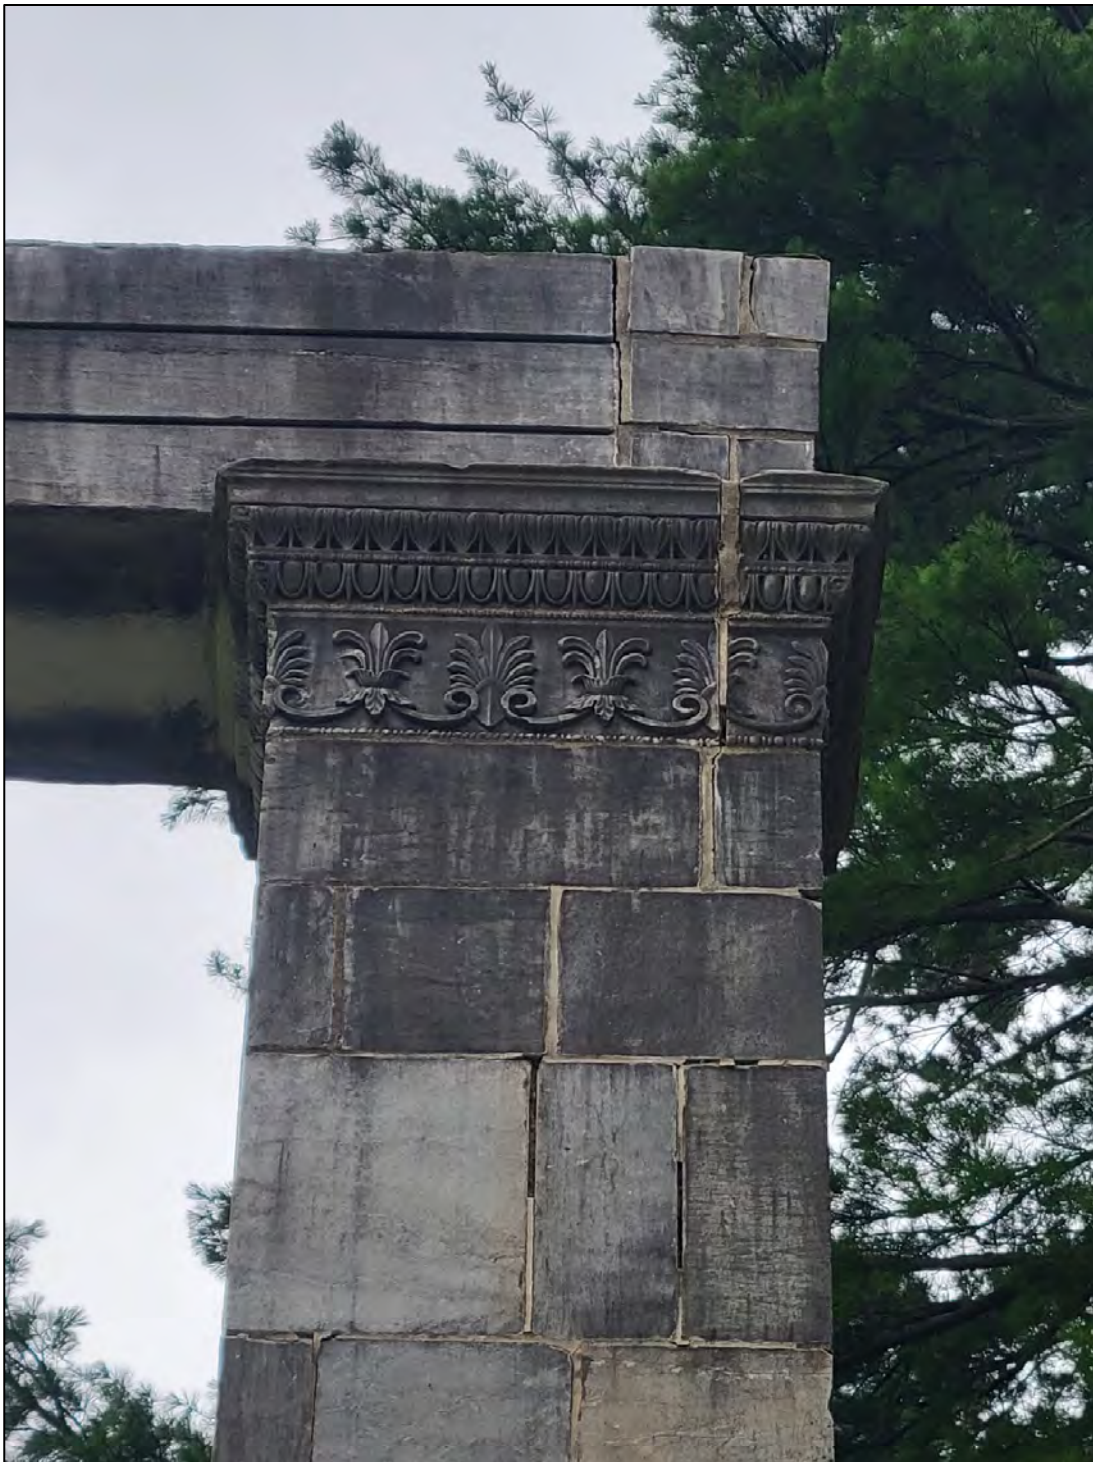
Photo 9: View of the east side of the west pier. Compare with Photos 4 and 8. The conditions at the top of the pier are less severe, but similar deterioration and movement is apparent. The detached parging at the top of the architrave is also just visible. There are also open joints.

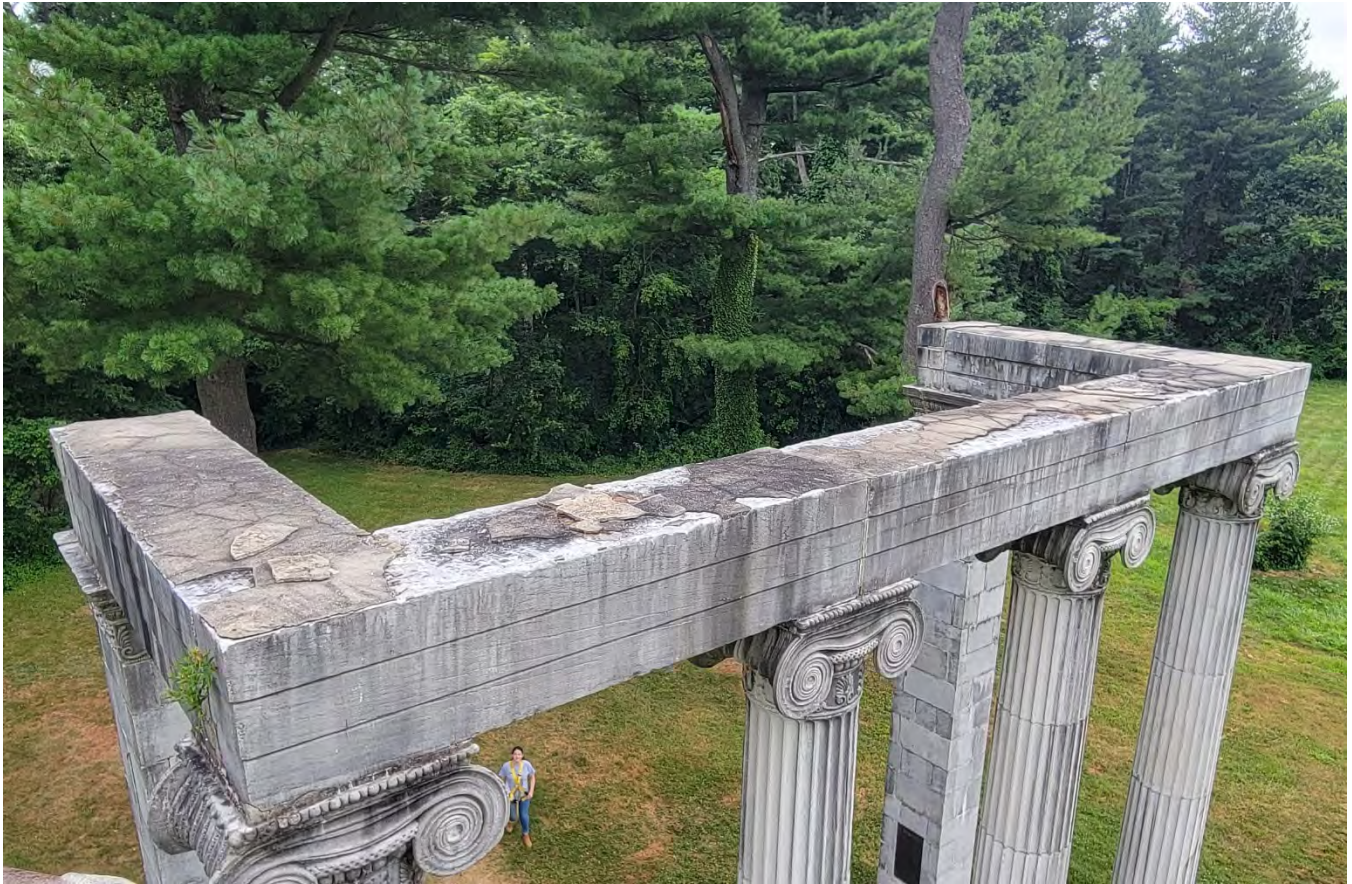
Photo 10: View of the top of the colonnade showing the deteriorated cementitious parging covering the surface. The parging is detached from the surface of the stone and there are many loose, displaced fragments.

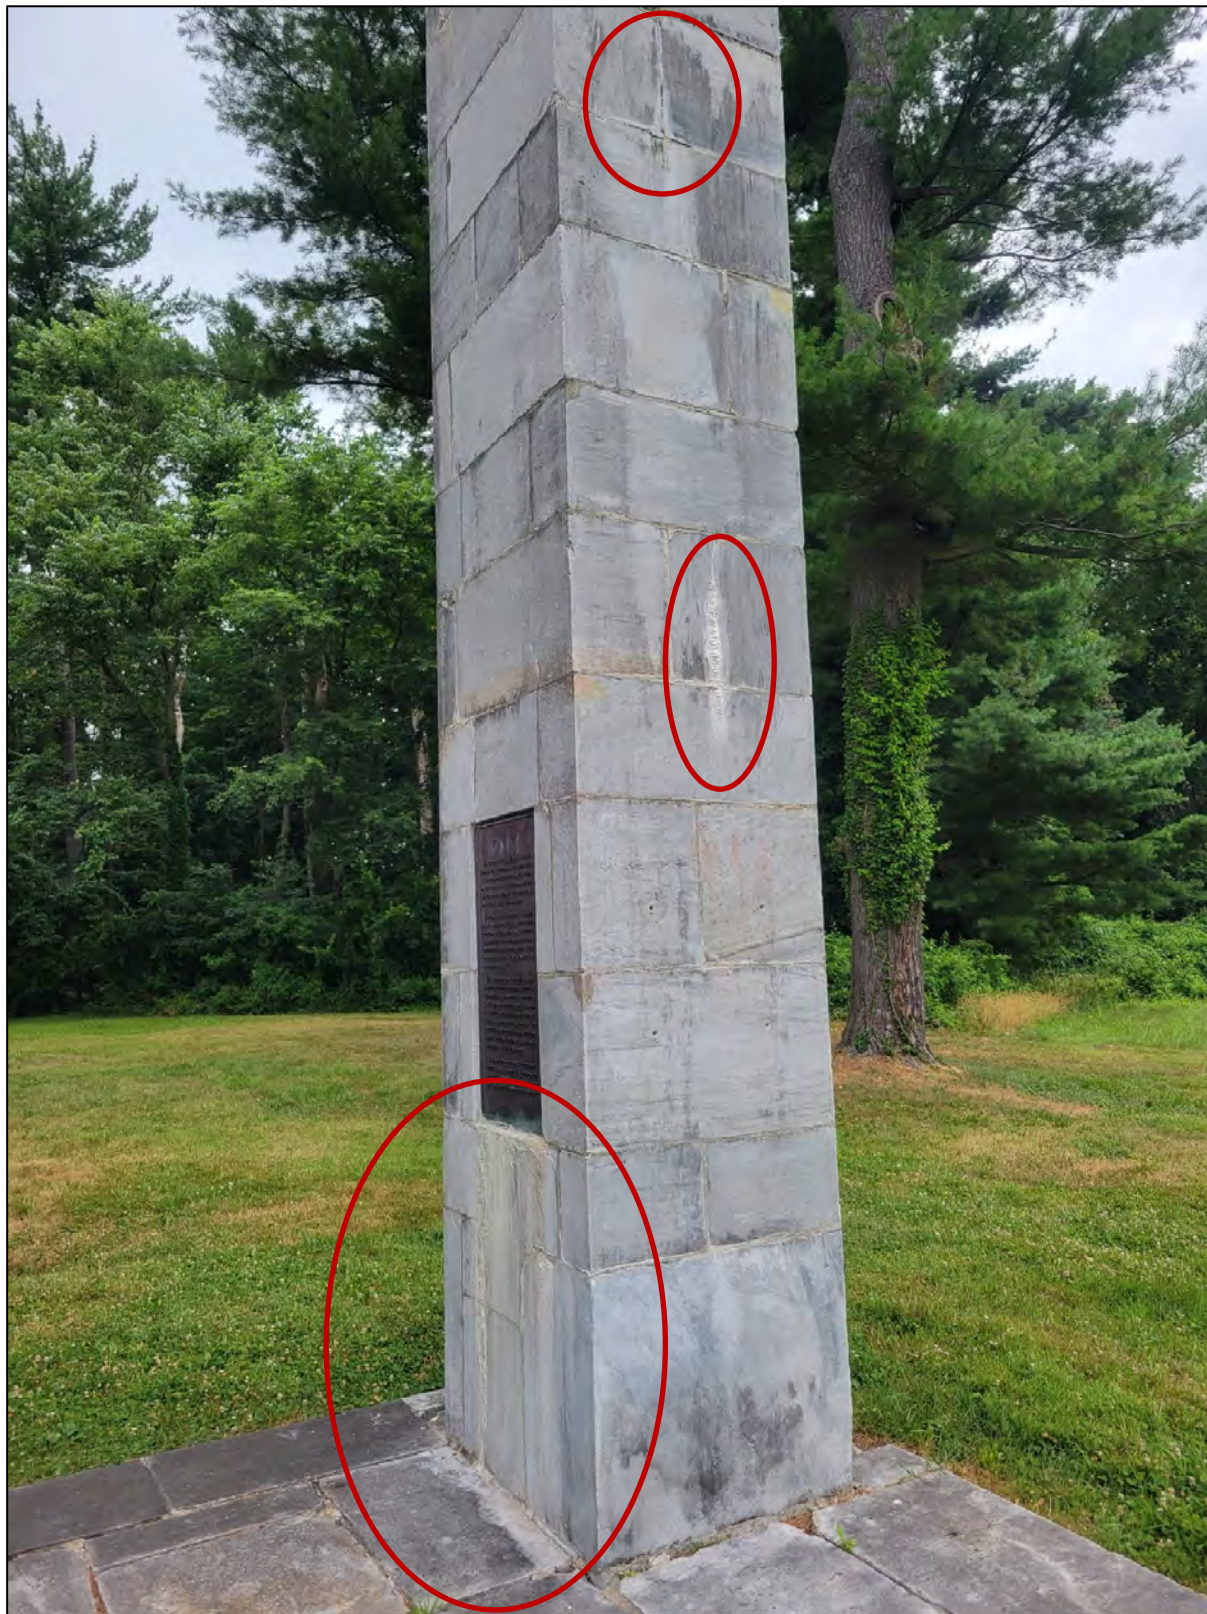
Photo 11: View of the south and west faces of the east pier showing calcium carbonate crusts below the plaque, exuding from a crack in a stone, and coming out of mortar joints.

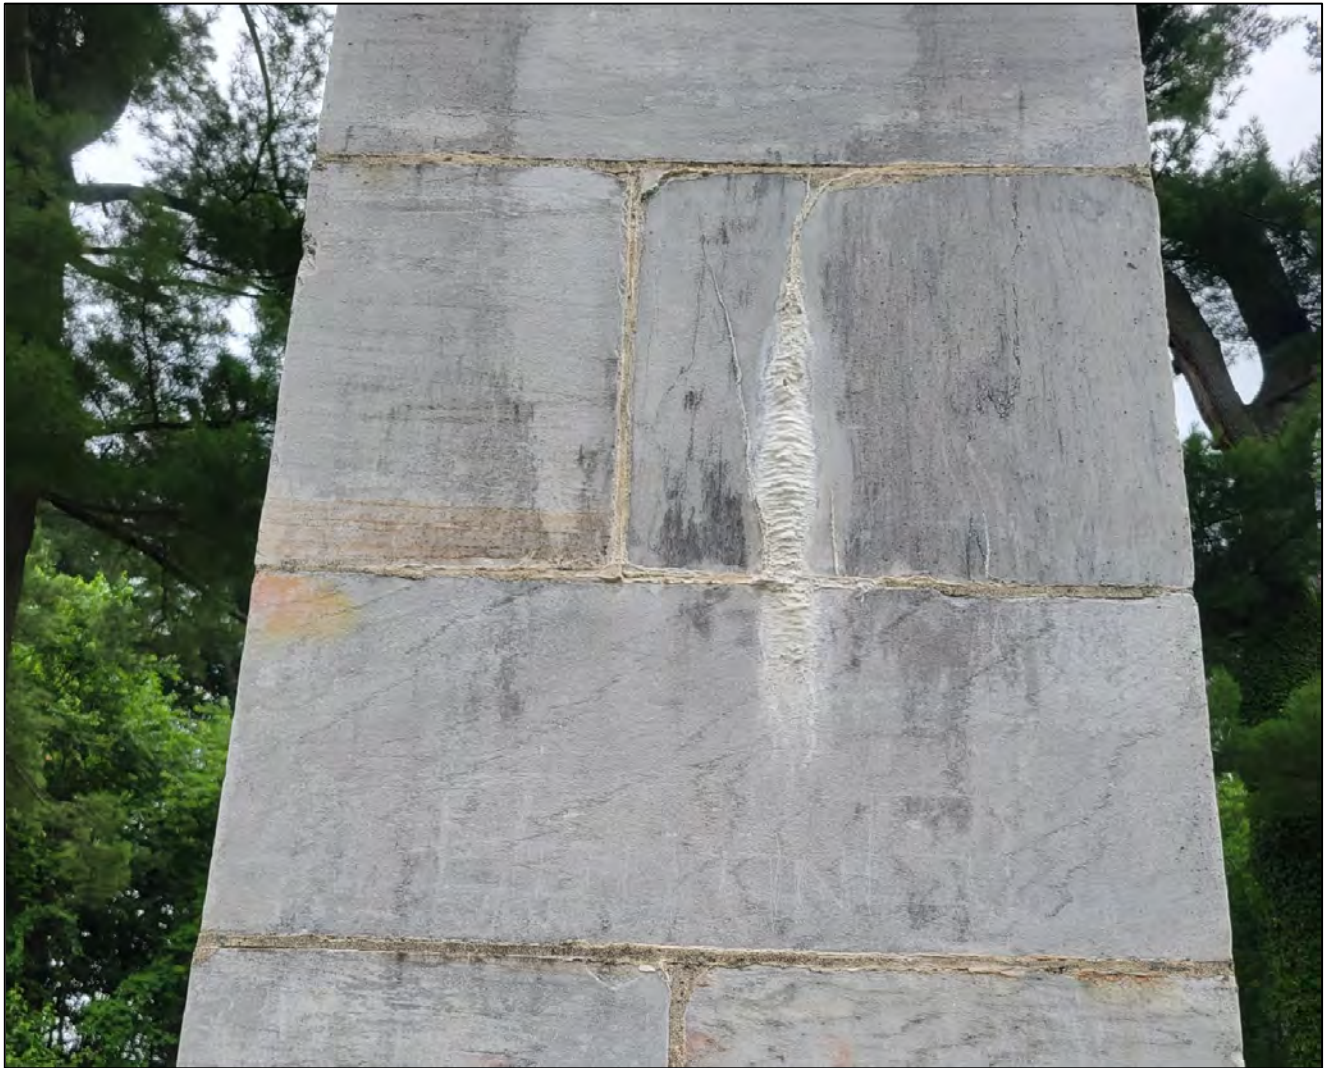
Photo 12: Detail of the cracked stone shown in Photo 10. The orange discoloration is biological.

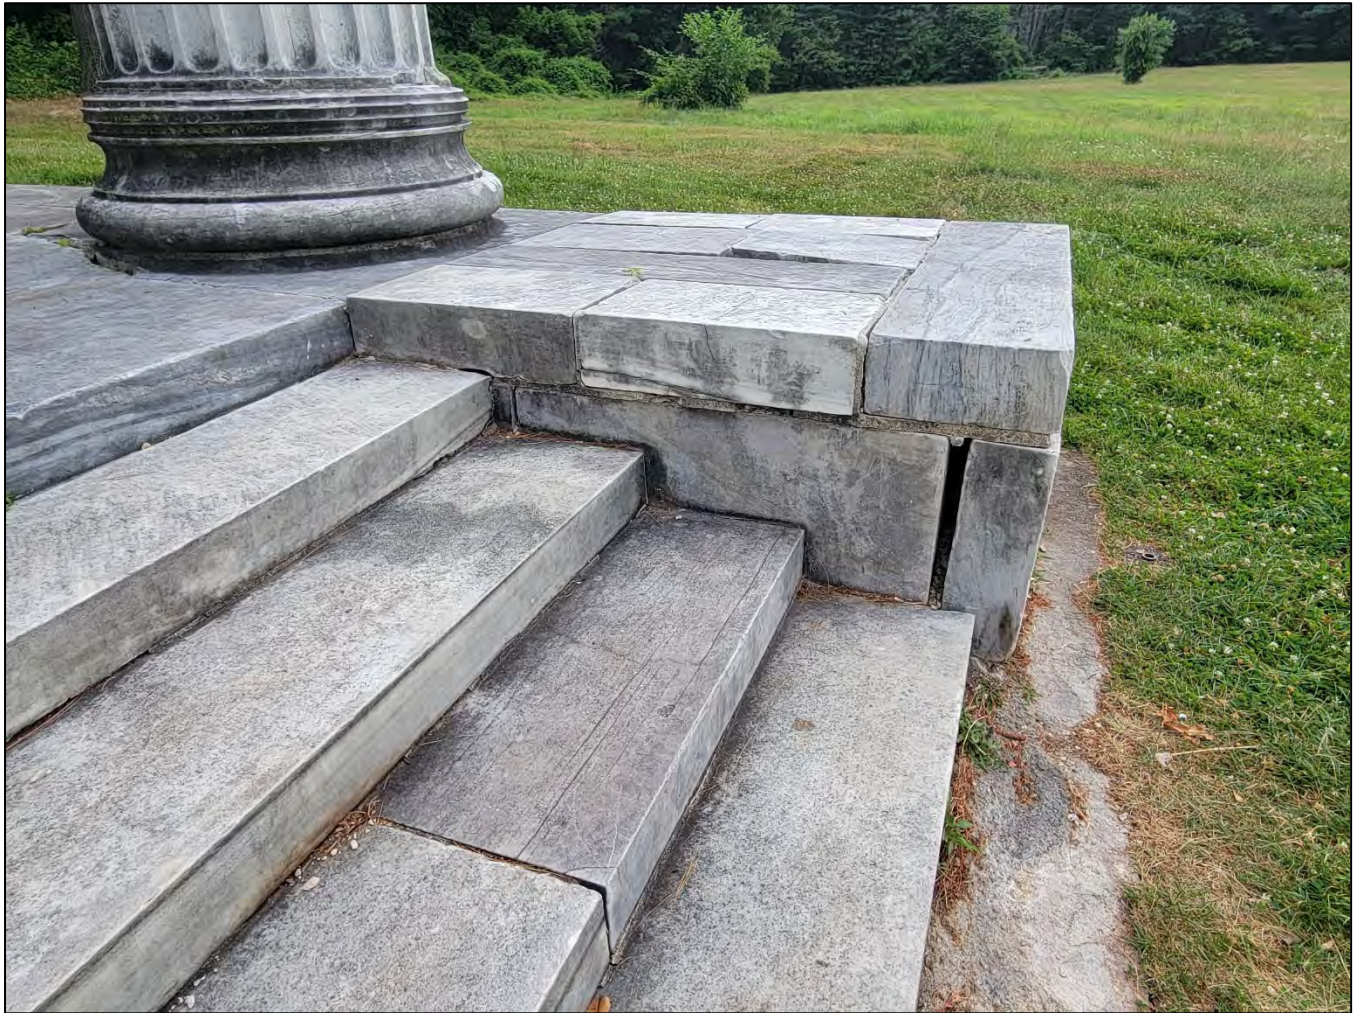
Photo 13: View of the east cheekwall from the west showing the extent of stone displacement and mortar conditions. The mortar joints in the stair are also open.

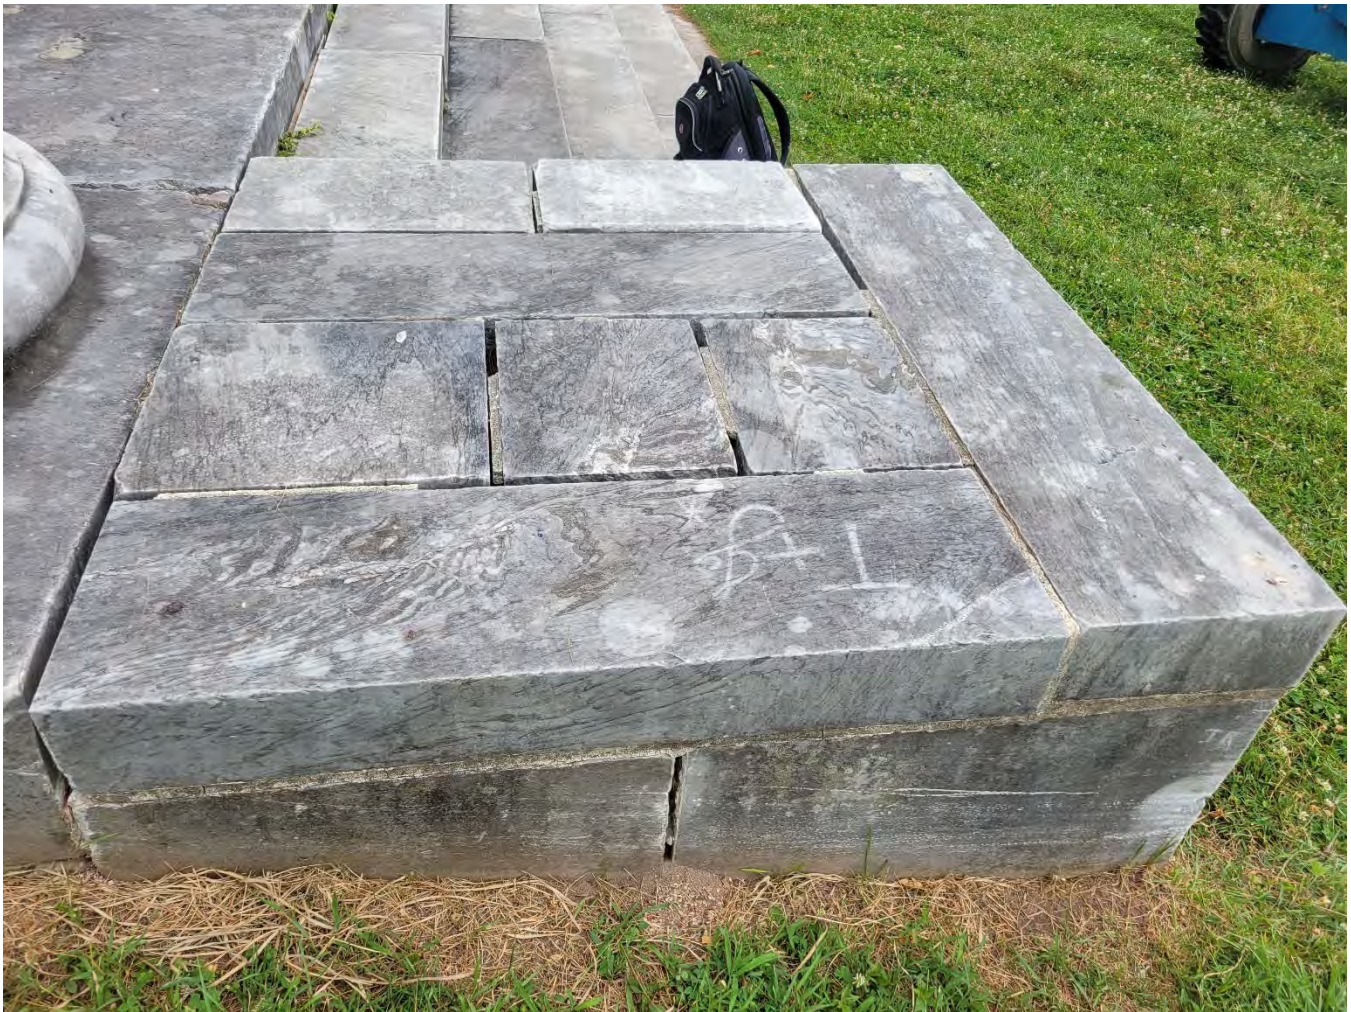
Unfortunately, the most noticeable marble damage is not the product of weathering but of people. Mowers and vandals are both causing damage to the marble. Mowers driven close to the monument are causing scratches around the base and chipping at the corners (Photo 14). Most of the vandalism is graffiti, typically scratched into the marble (Photo 14); the graffiti is particularly noticeable at the rear where the stone is darker, so the scratches show clearly (Photo 17).

Photo 14: View of the west stair cheekwall showing open joints and masonry displacement. The bright white scratches and chip along the bottom edge are probably due to a lawnmower being run against the masonry.
