SCOPE OF WORK

Colonnade Restoration

Princeton Battlefield State Park
Princeton, Mercer County, NJ

PRINCETON BATTLEFIELD COLONNADE CONDITIONS ASSESSMENT

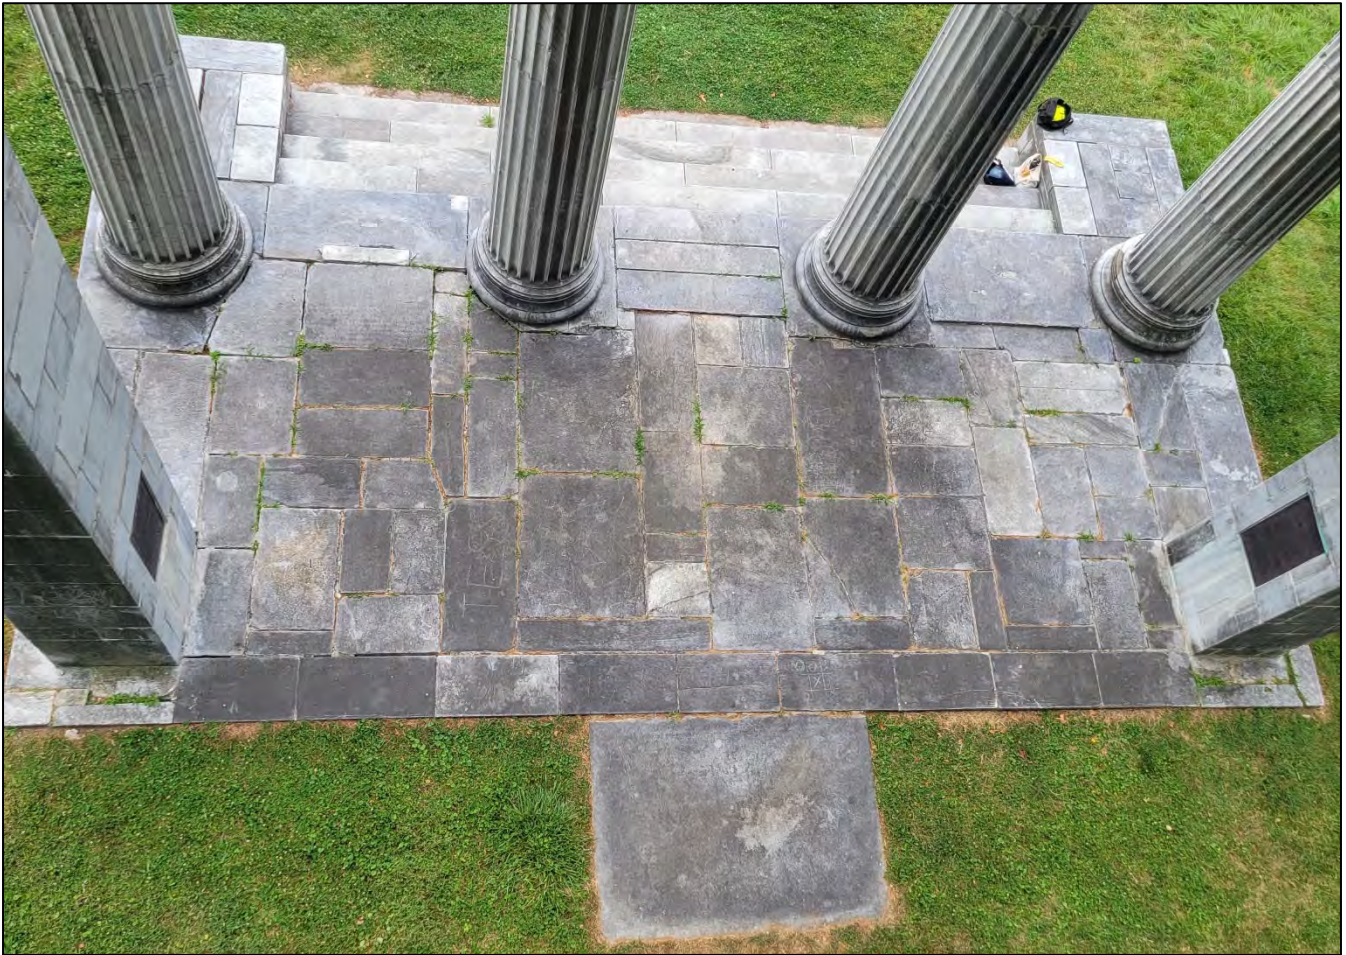
Photo 15: View of the southeast corner from above. Note the numerous open and deteriorated joints. Note also the top stone of the relief panel is pushed out to the east.

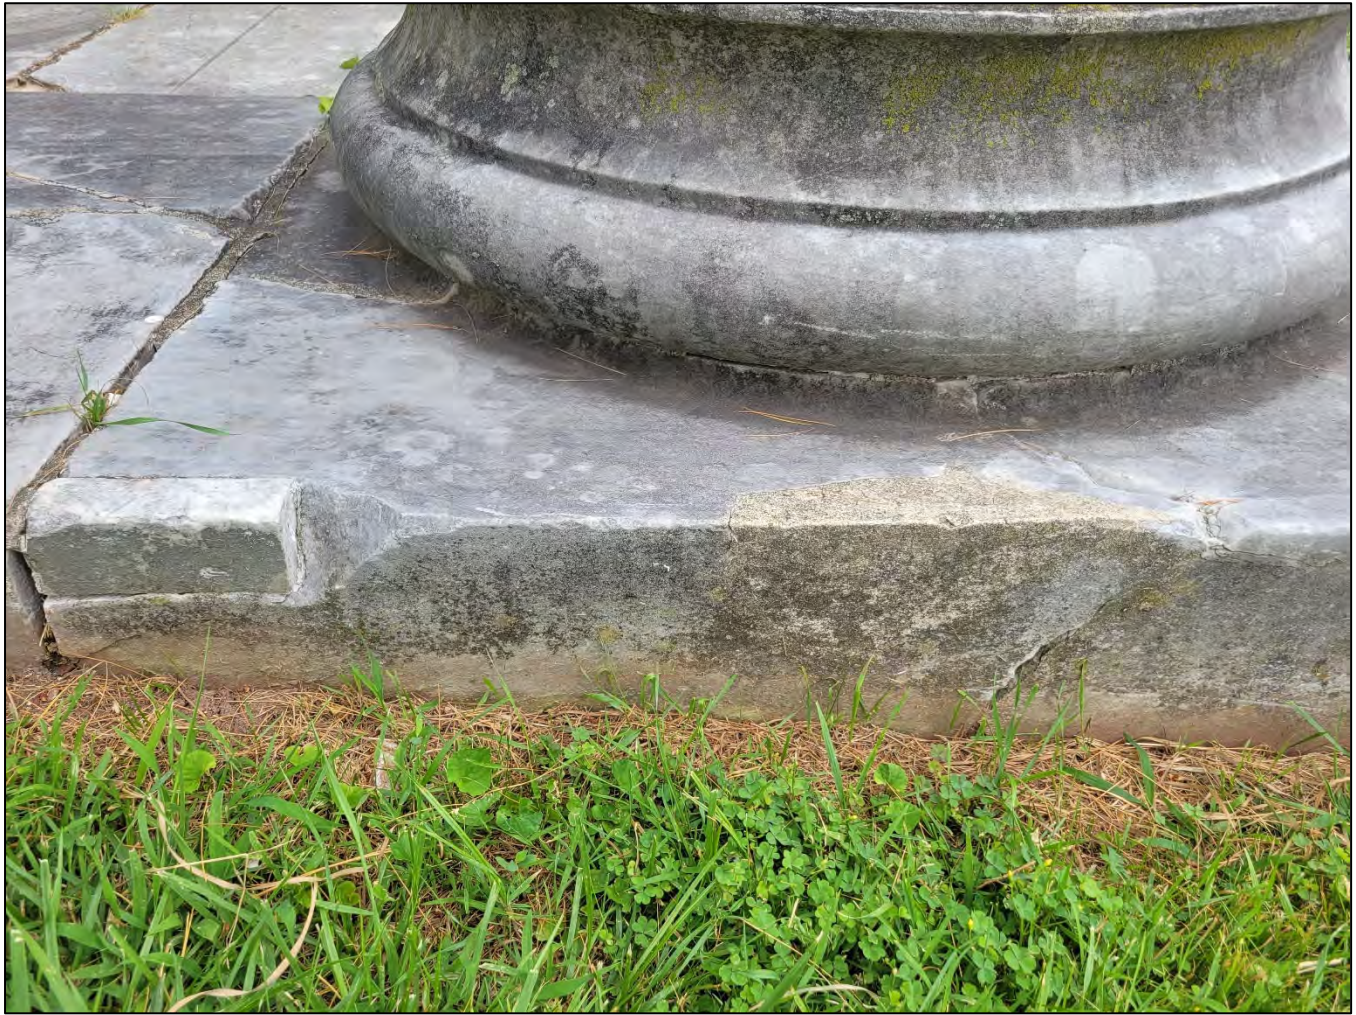
Photo 16: View of the west end of the colonnade showing the cracked column base and the adjacent cracked paver. There are two repairs to this stone: one dutchman and one patch.

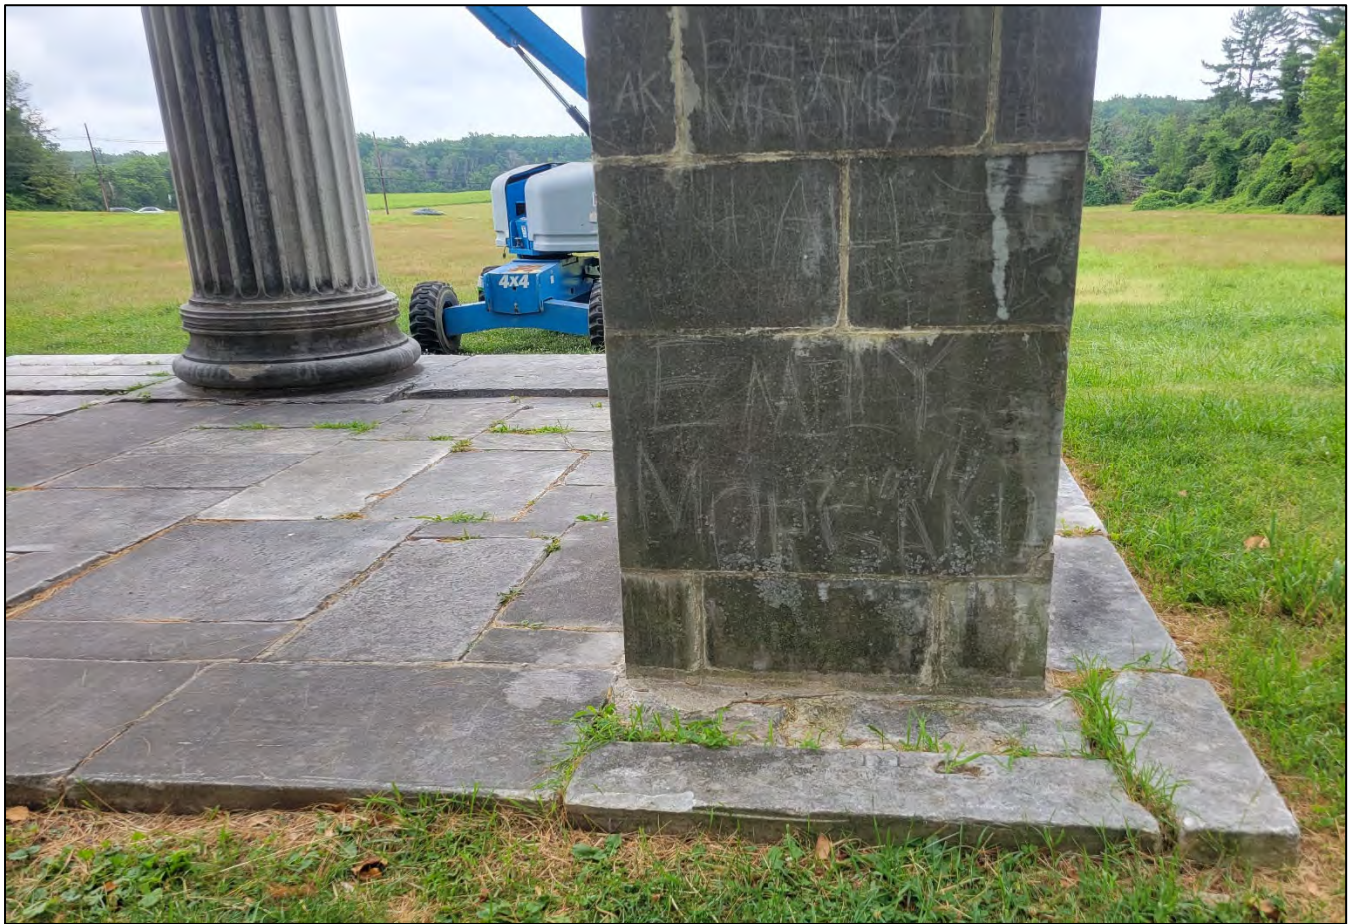
Photo 17: Detail of the paving behind the piers showing general conditions. The stones at this location differ from the others being generally smaller and less regular in shape. The scratched graffiti is pronounced at the rear of the piers but was observed at other locations as well. The unevenness of the pavers is clearly visible.

The paving needs to be lifted and re-set on a properly prepared base. Joints in the paving and stairs should be filled with mortar, even though this is a maintenance item. Use of an anti-freeze additive in the mortar such as Ice Minus 9 manufactured by Edison Coatings is recommended due to the exposure. The cracked base stone at the south column suggests ongoing movement which should be monitored.

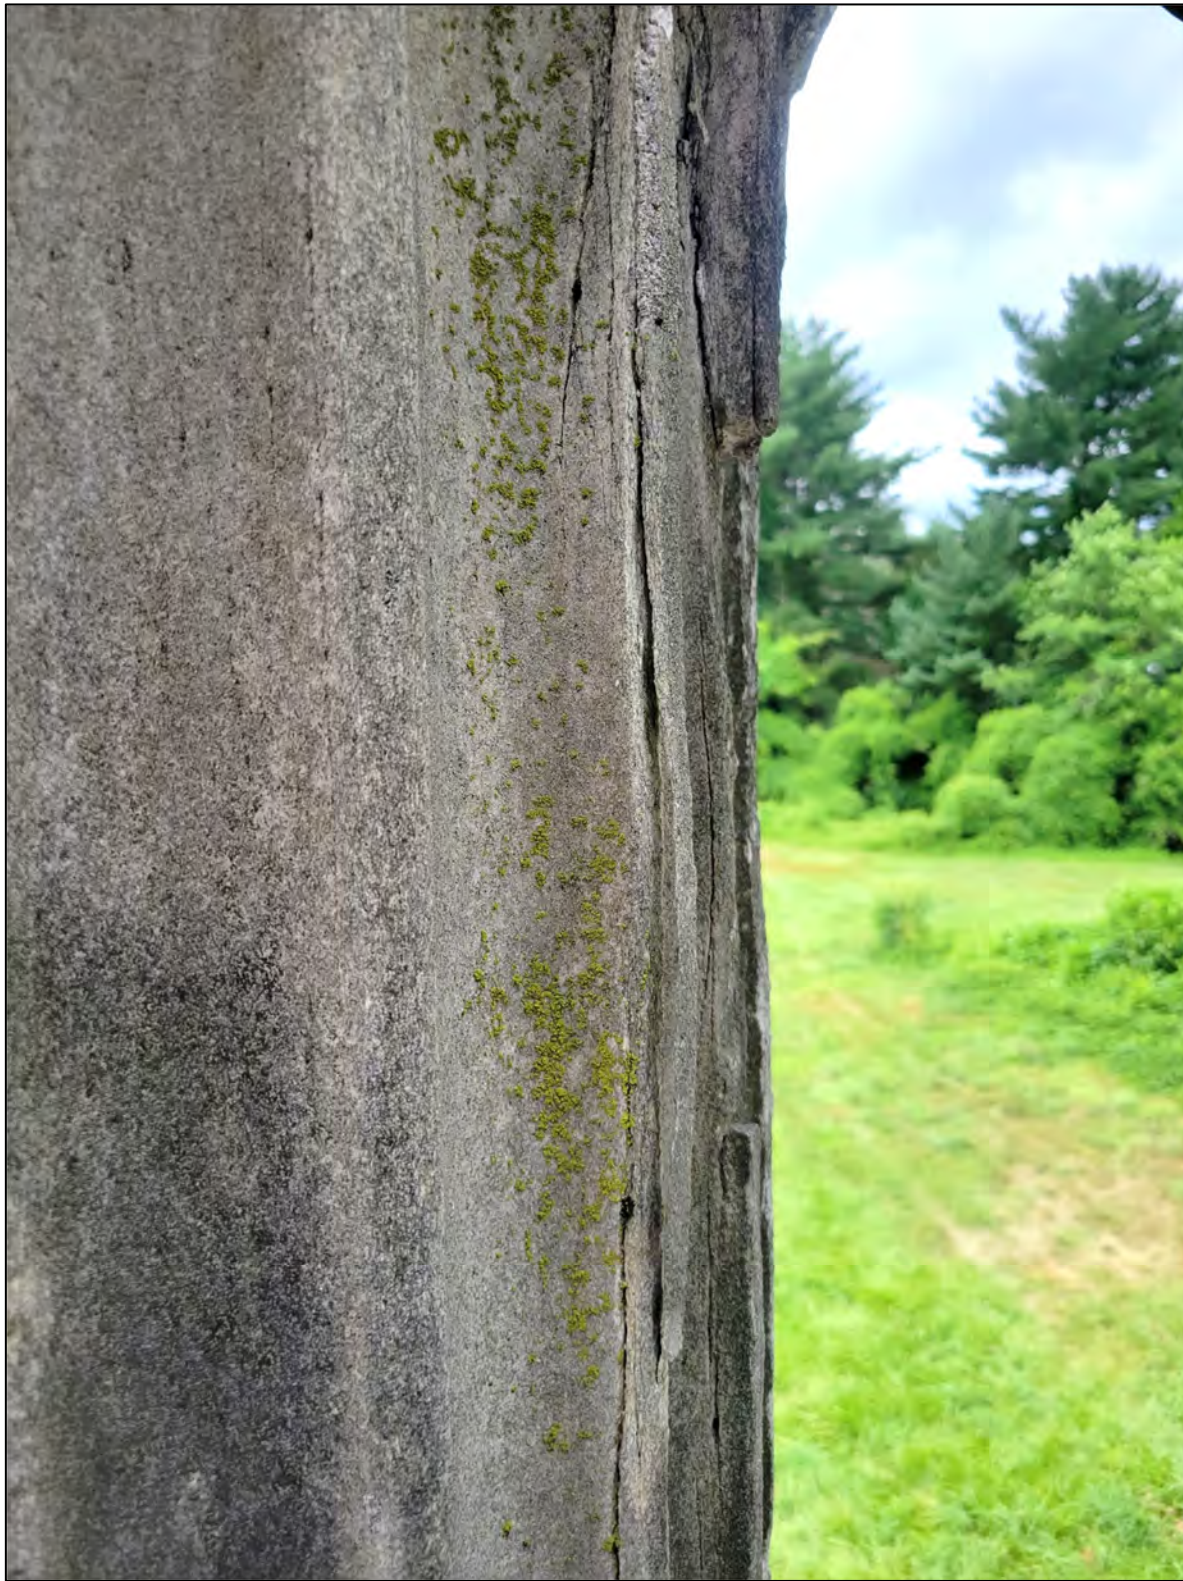
The marble itself is generally in good condition. There is some marble deterioration at the fluting at the west side of the south-center column (Photo 18). Weathering has taken portions of the outer and inner volutes of the southwest and southeast column capitals (Photos 19-21). There are sound repairs at the southeast column capital; the southwest column capital has not been repaired and there is an incipient loss at the inner south volute. There are numerous old repairs to the marble, mostly made with cementitious material but there are also some dutchman that are likely old if not original (Photos 16, 20). The repairs that could be accessed all seem soundly attached. There are deep fissures in the surface of the marble architrave at the south-center (Photo 22) and north (Photo 4) elements, and but the marble appears to be sound. Shallow fissures were noted at other architrave stones along lines of silicate minerals.

Photo 18: Detail of the deteriorated fluting at the west side of the south-center column.

The marble itself requires little work. Hands-on assessment is recommended to remove small, loose pieces of stone and confirm the sound attachment of all previous repairs. Small patch repairs may be required locally to ensure water drains off the stone surfaces and does not find places to collect. Cleaning will be needed to remove carbonate crusts from the pier stones, and cleaning to remove general soiling is recommended if only to prevent the incentive to create scratched graffiti. Microabrasive cleaning by the Quintek method is strongly recommended over chemical cleaning of any kind, but options should be tested. Cleaning the pier stones while the piers are disassembled is recommended. Deep fissures in the architrave stones should be filled with mortar to prevent continued erosion.

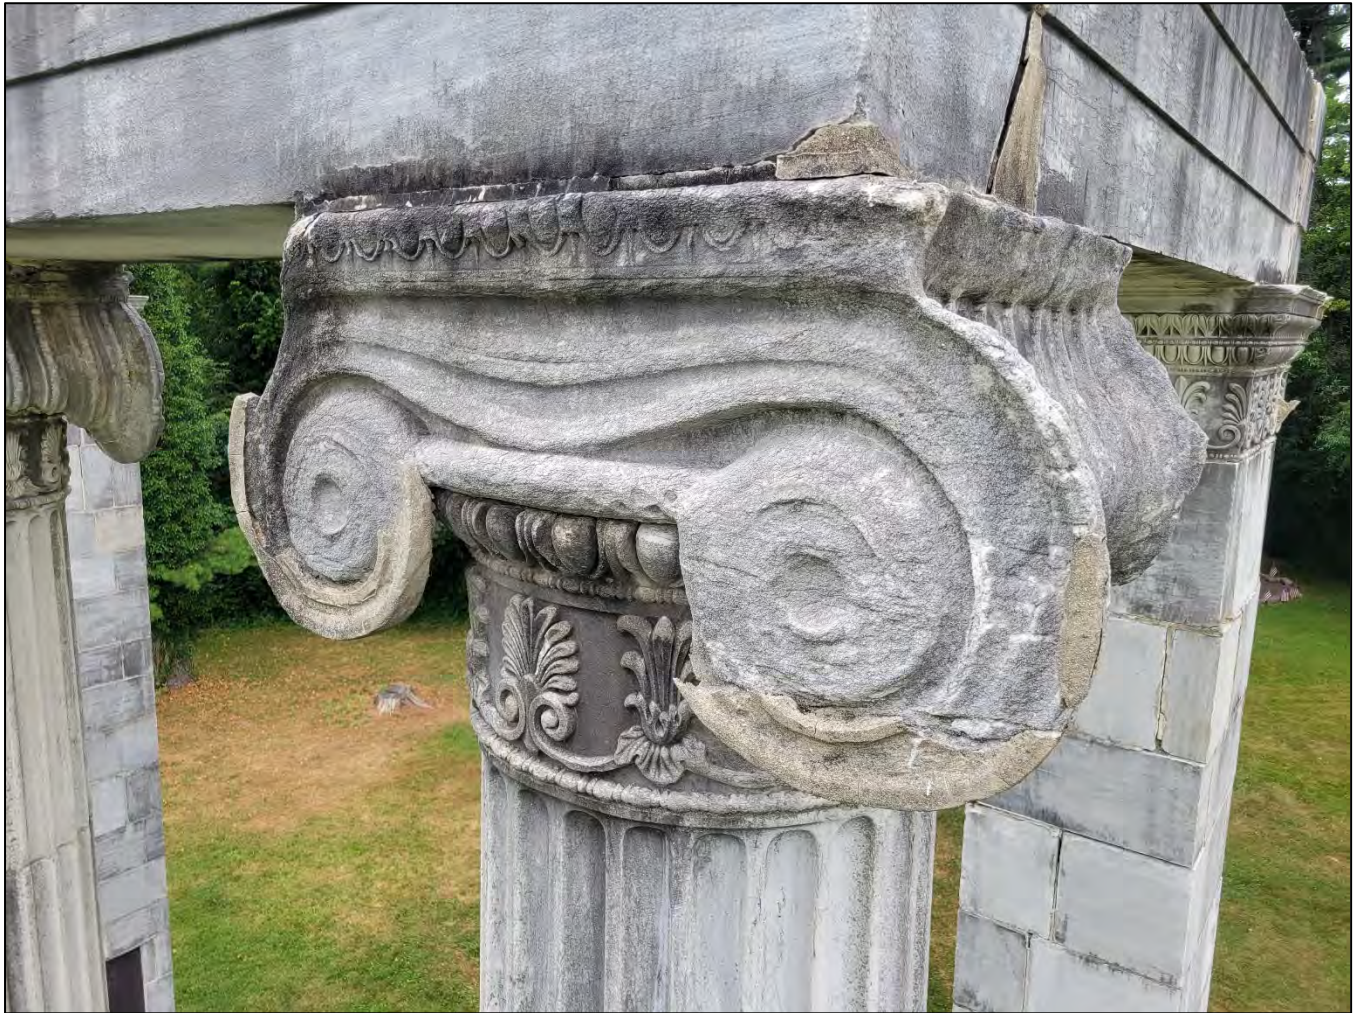
Photo 19: View of the south side of the southeast column capital showing old cementitious patch repairs; these are soundly attached.

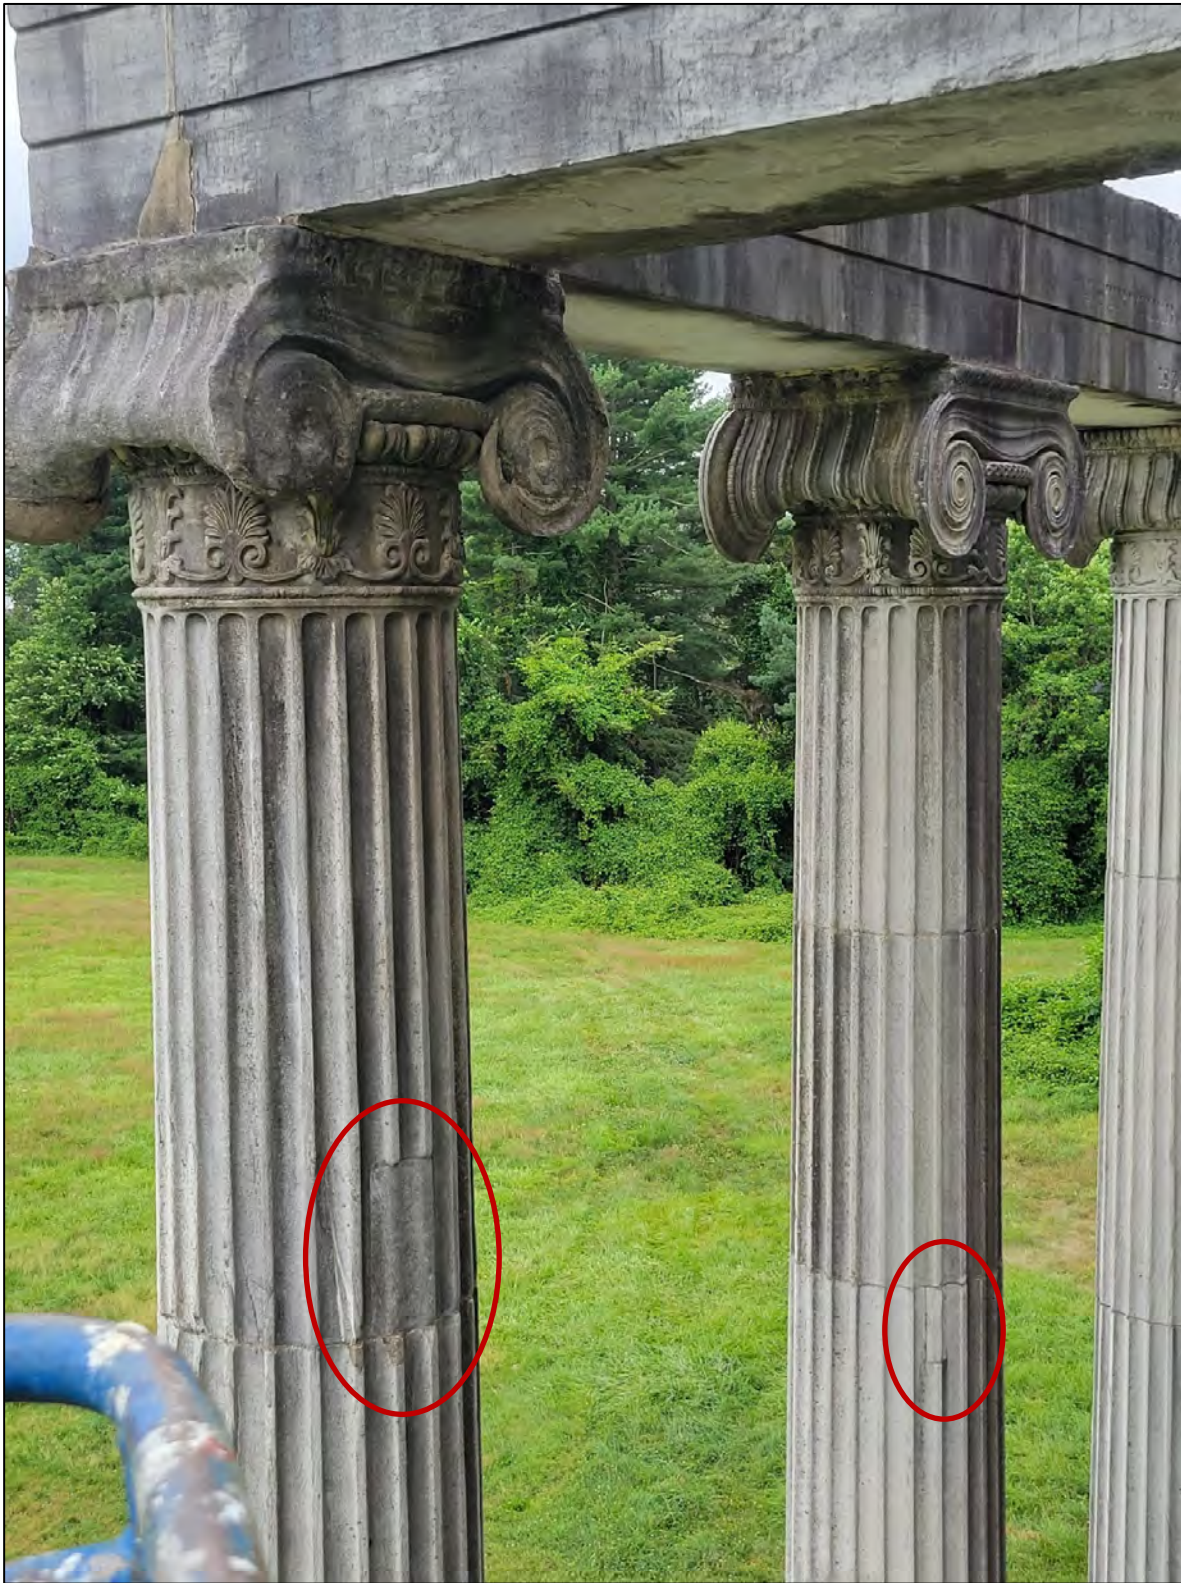
Photo 20: View of the north side of the same column capital as shown in Photo 18 showing loss and old repair of the north side volutes—compare the appearance with those of the adjacent column. Note also the old dutchman repairs at the columns; the dutchman at the southeast column has spall patches to the volutes below.

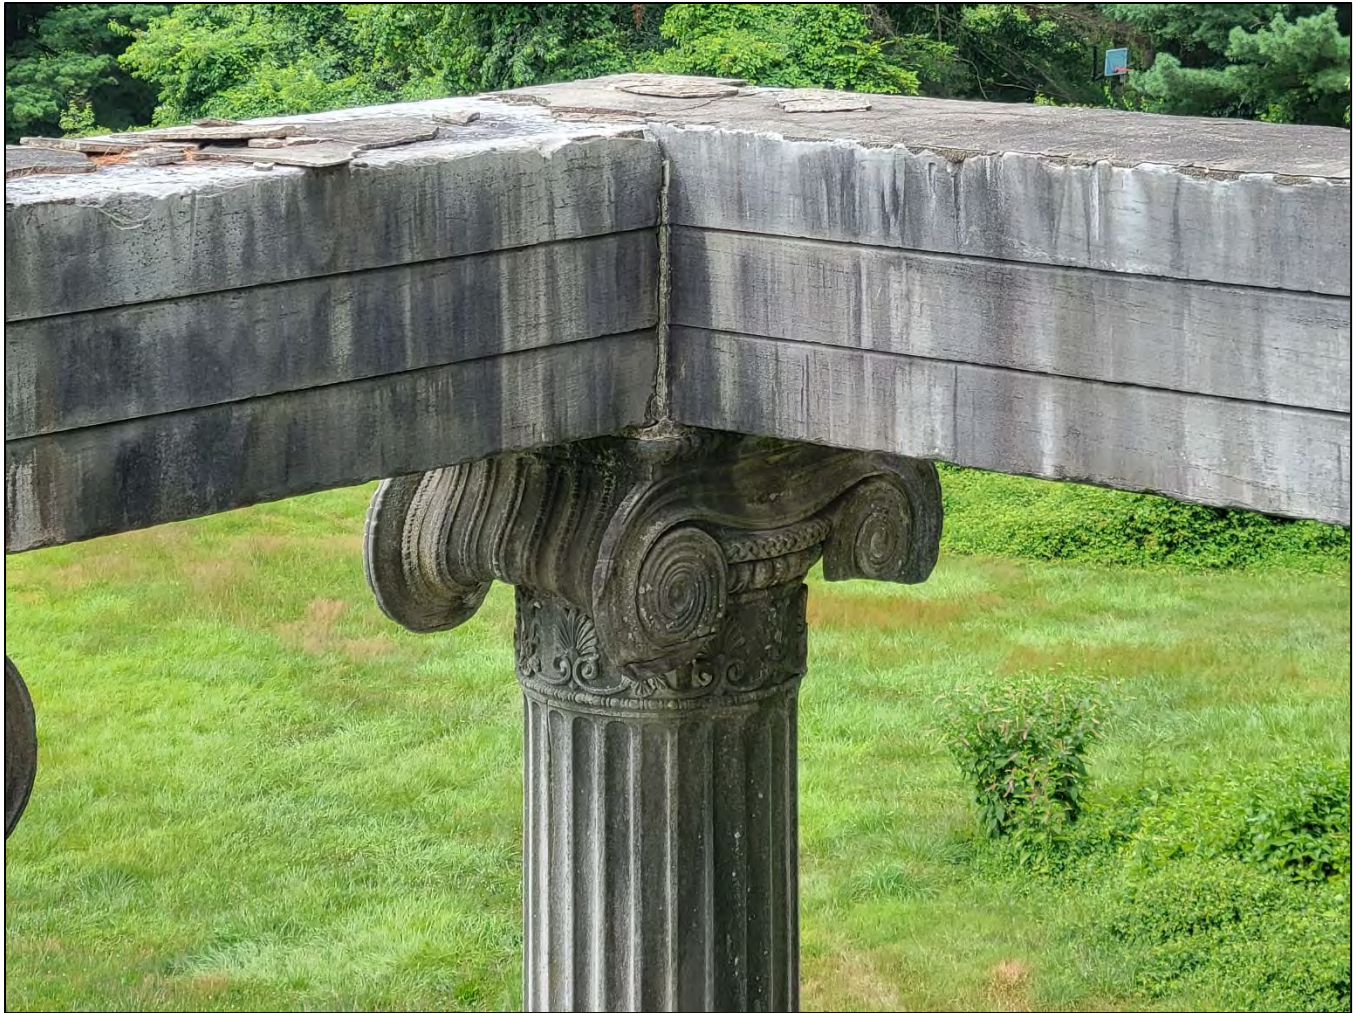
Photo 21: Loss and incipient spall at the north side of the southwest column capital.

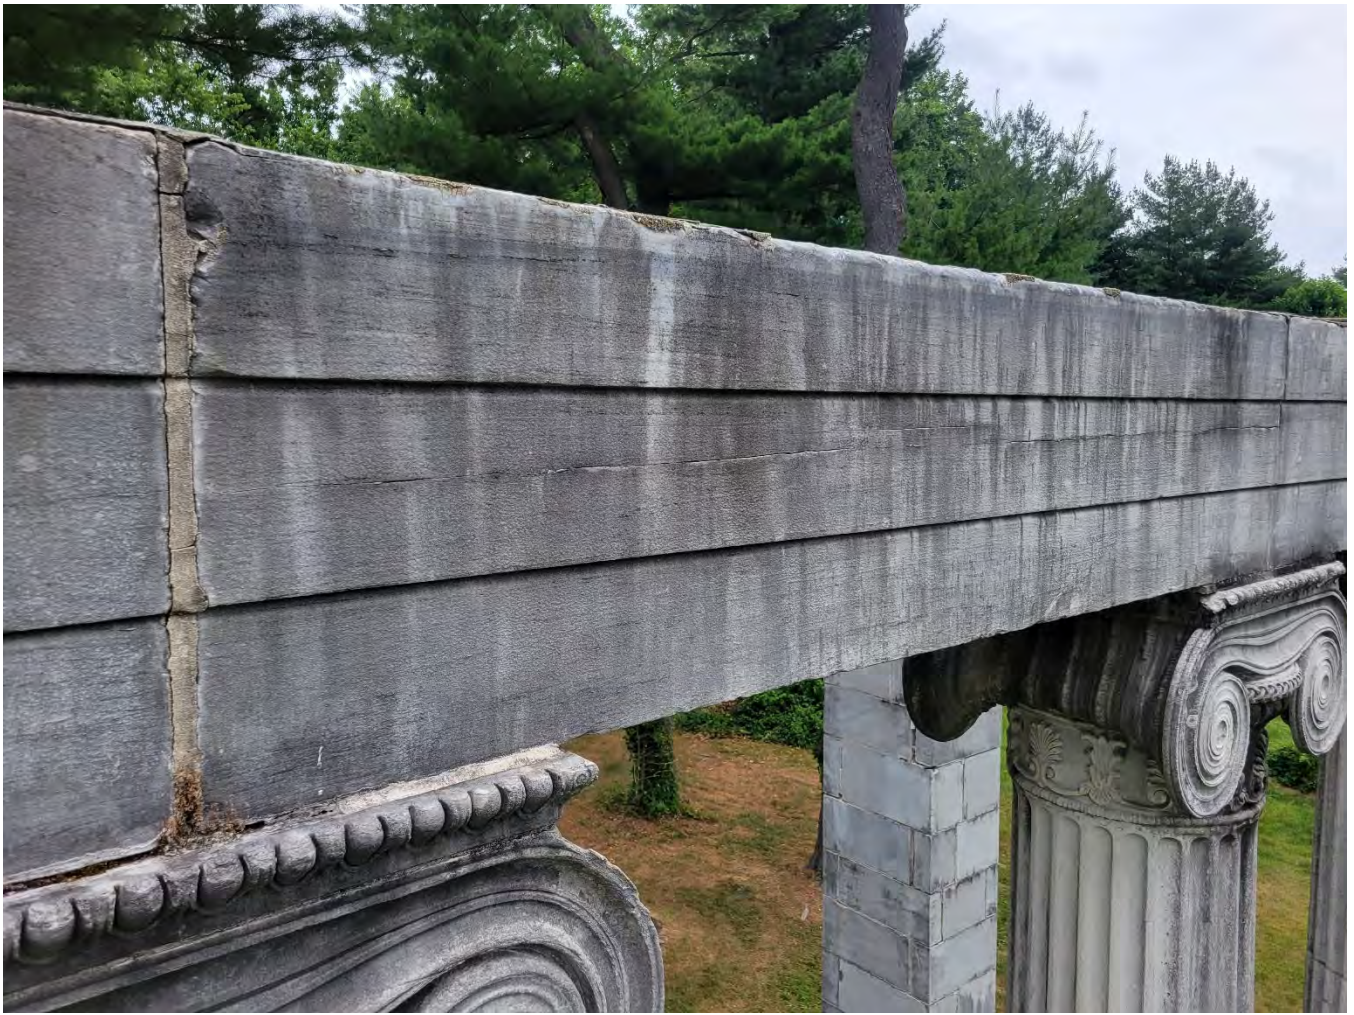
Photo 22: Fissures in the central stone at the south elevation. The condition of the mortar joints in the architrave and between the architrave and column capital is typical.
