NJ FACE INVESTIGATION REPORT

Fatality Assessment & Control Evaluation Project

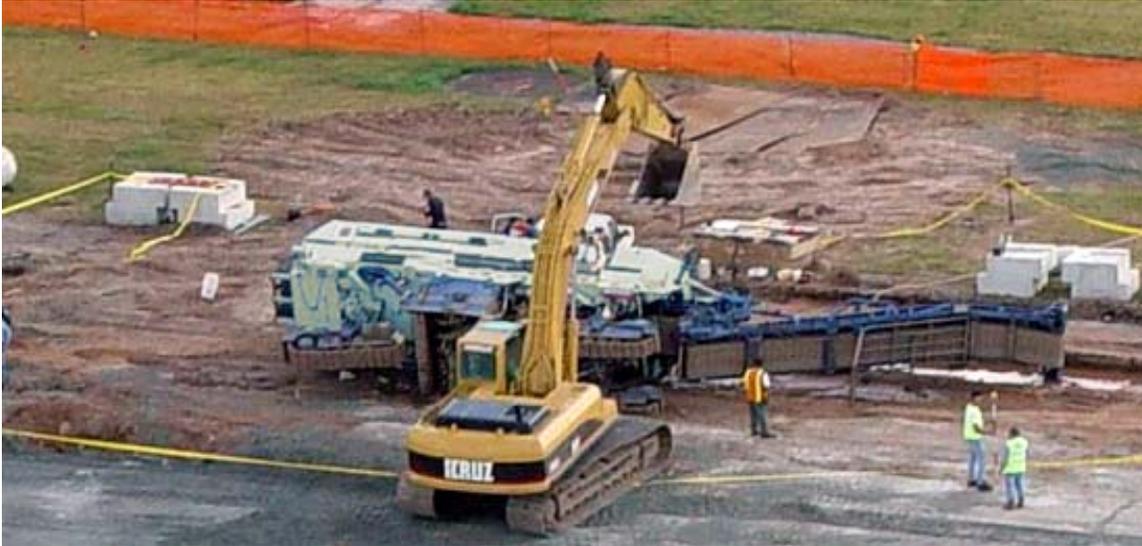
Photo 2
Photo of incident site showing excavator lifting machine
(Port Authority Police)

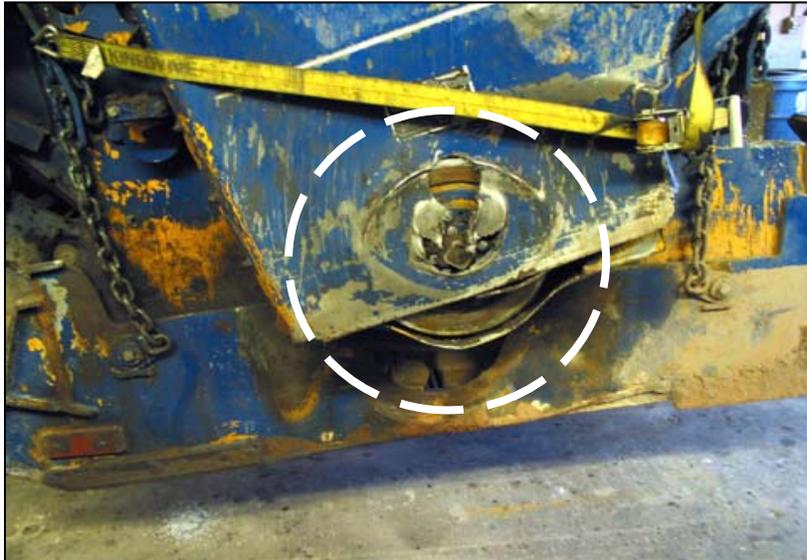
Photo 3
Damage caused by rotating drum bearing cutting through machine's sheet metal during tip-over
