# Essex Hudson Greenway Structures Report

# Arup USA, Inc 77 Water Street

Final 2 | September 28, 2020

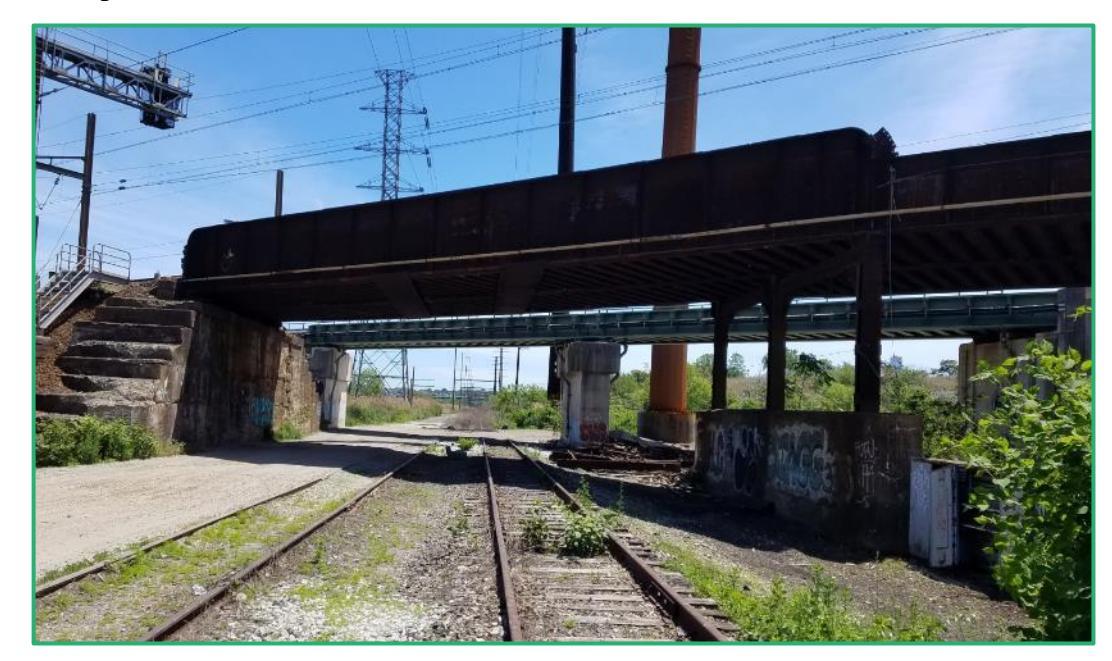
Figure 10 – MP 3.89 Amtrak Northeast Corridor

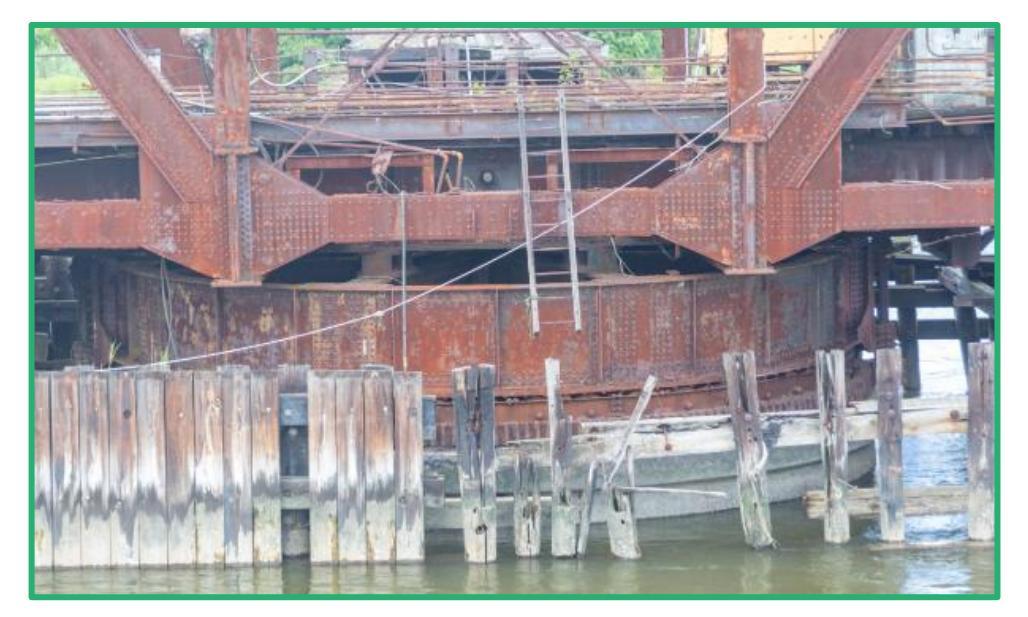
Figure 28 - Hackensack River pivot pier, with rim-bearing rollers partially visible

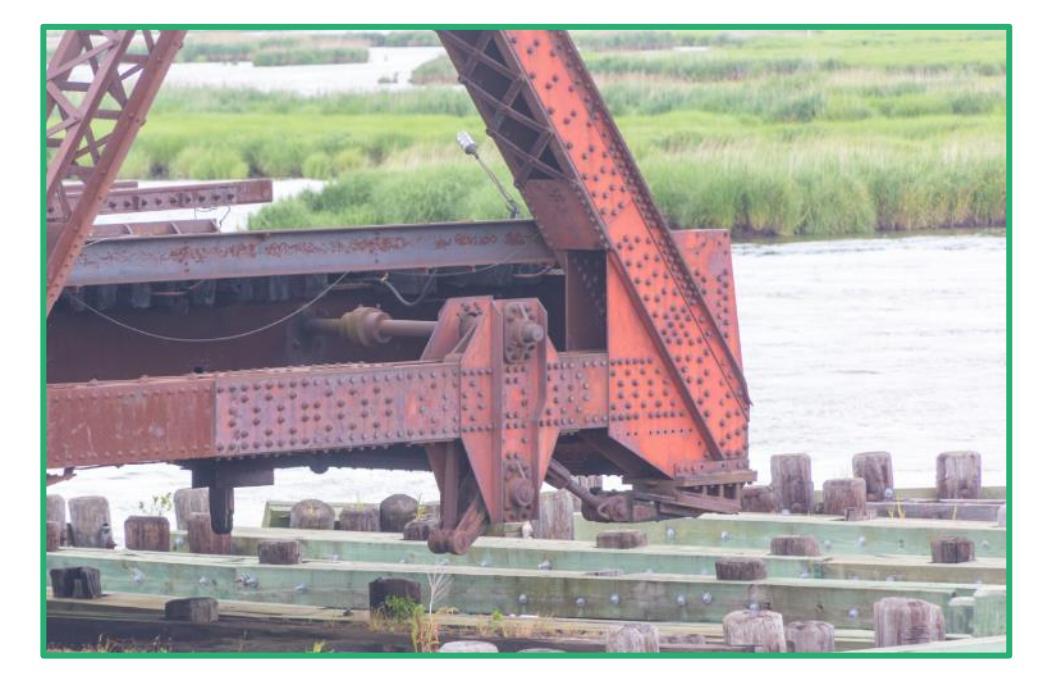
When the bridge is in the closed position, it is locked in place by wedges that extend into a block on the side span piers. It is evident that the wedges at the northeast corner of the truss have been replaced. Photos from the site visits show new steelwork attached to the truss with hex bolts rather than rivets as originally constructed. It is not known why this wedge was replaced or if it provides any indication of the expected condition of the remaining original wedges.

Figure 29 - Wedge at northeast corner of swing truss, with bolted repairs

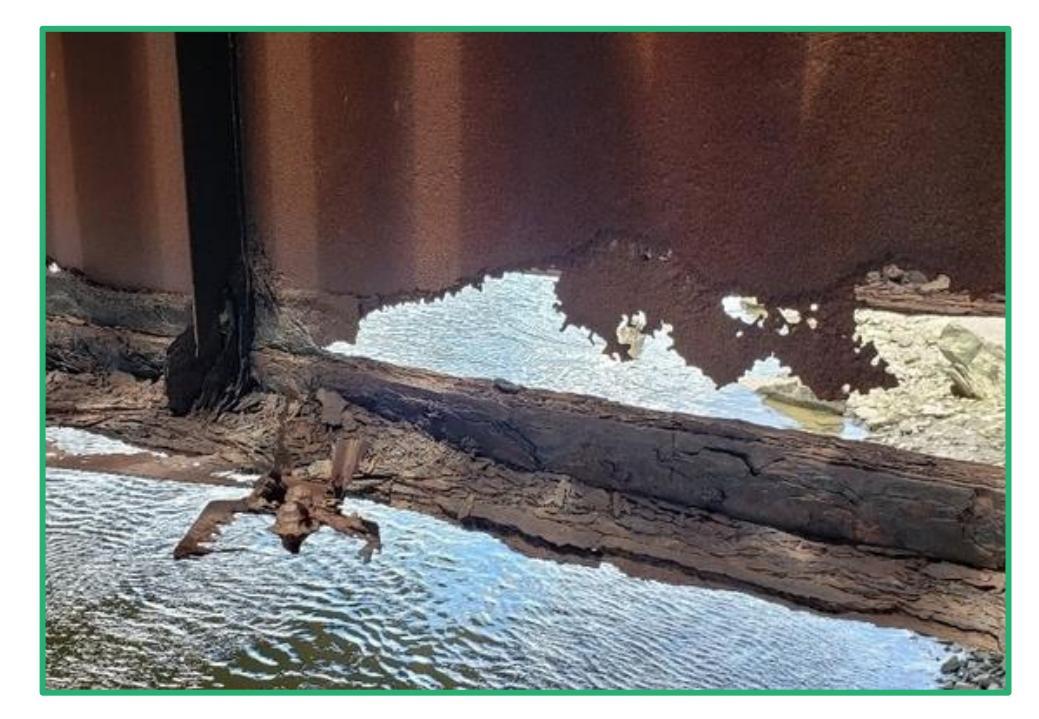
Figure 30 - Complete section loss of girder web and severe deterioration of bottom flange

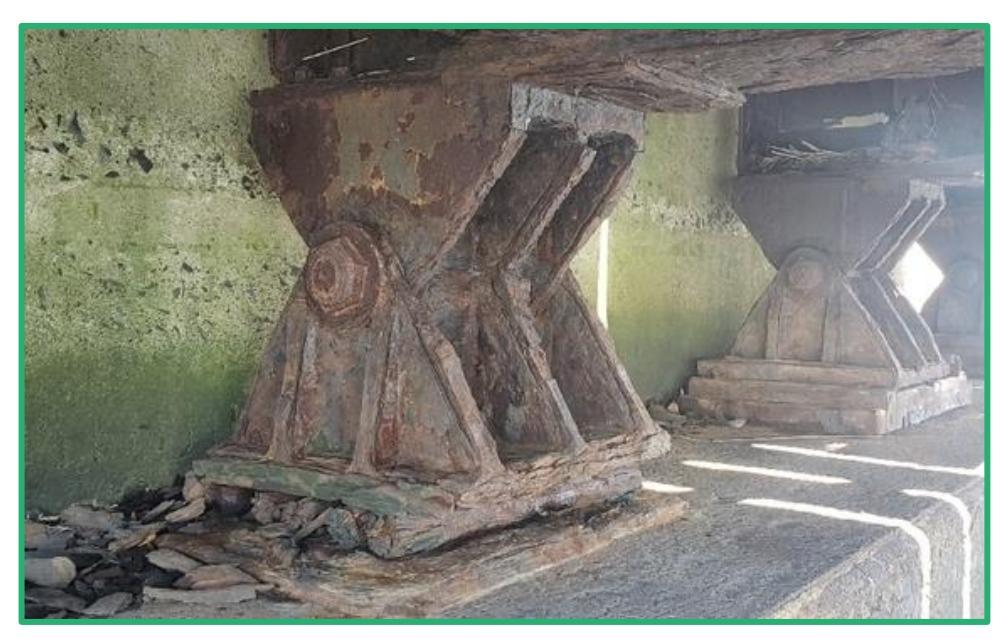
The bridge bearings exhibit significant corrosion. Roller bearings at the abutment show severe corrosion and likely are not performing as designed. Pinned bearings also show signs of corrosion and may be seized due to packing of rust.

Figure 31 - Deterioration of bearings at abutment

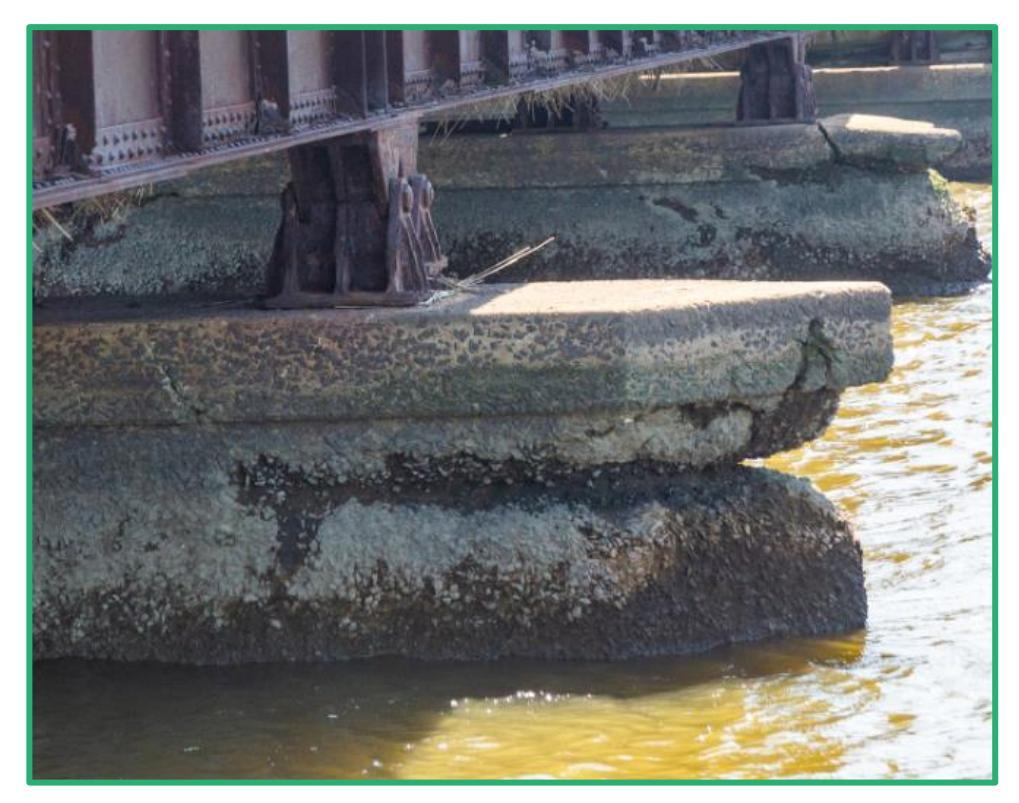
The approach substructure shows signs of significant deterioration at the waterline. The approach piers have large spalls, scoured surfaces, and seams running horizontally across the caps. It is evident that the caps are unreinforced, mass concrete elements. At some locations, significant portions of the piers have fallen away, nearly undermining the bearing locations.

Figure 32 - Cracking and degradation of concrete piers at the waterline

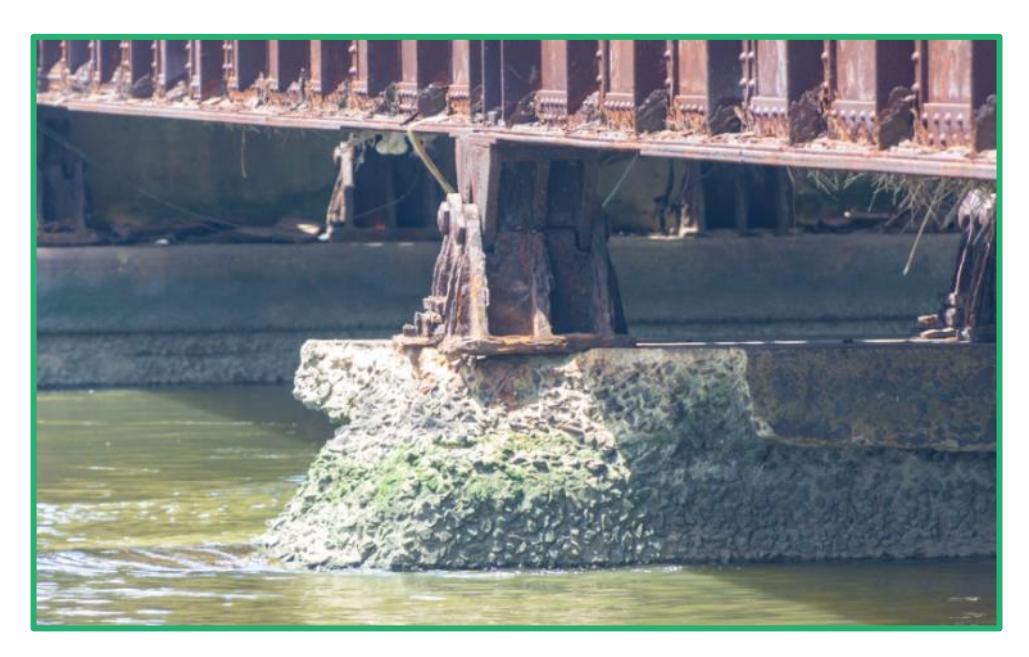
Figure 33 - Significant spall missing from pier, almost undermining a bridge bearing

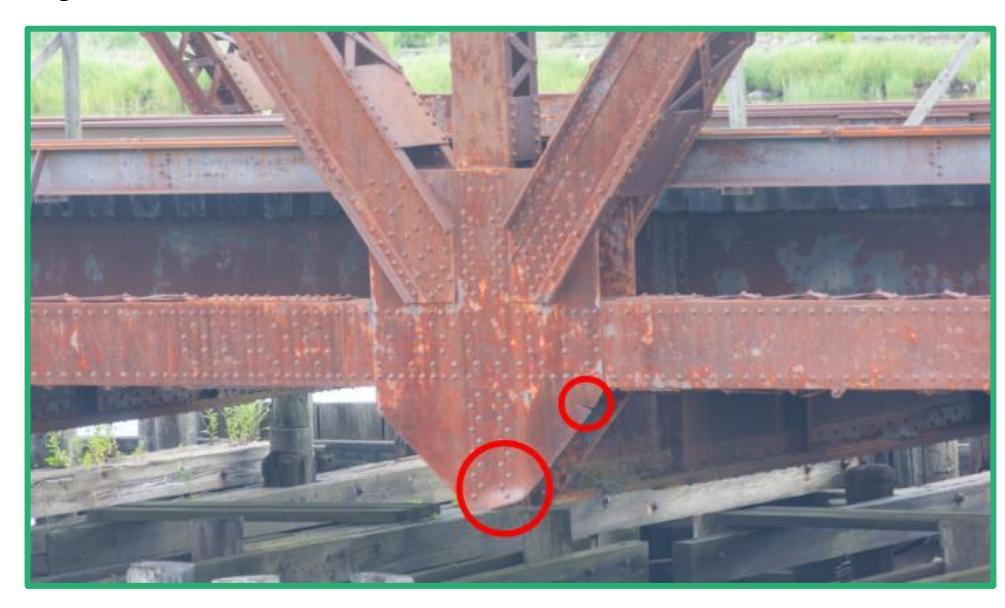
The swing truss appears to be in reasonable condition, with areas of corrosion that would be expected for a bridge of this age. Reviewing the gusset plate nodes identifies some locations with cracked or bent plates that would need to be evaluated and repaired.

Figure 34 - Truss gusset plate southeast side, with crack and bent gusset plate

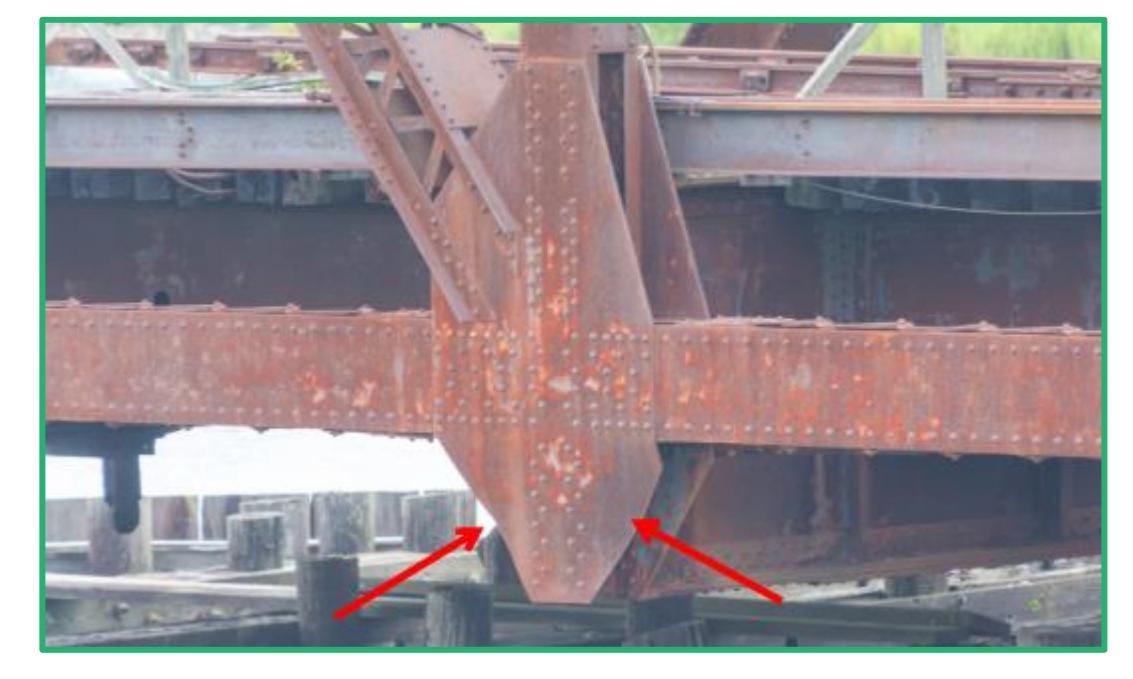
Figure 35 - Truss gusset plate southeast side, with warped or damaged gusset plate

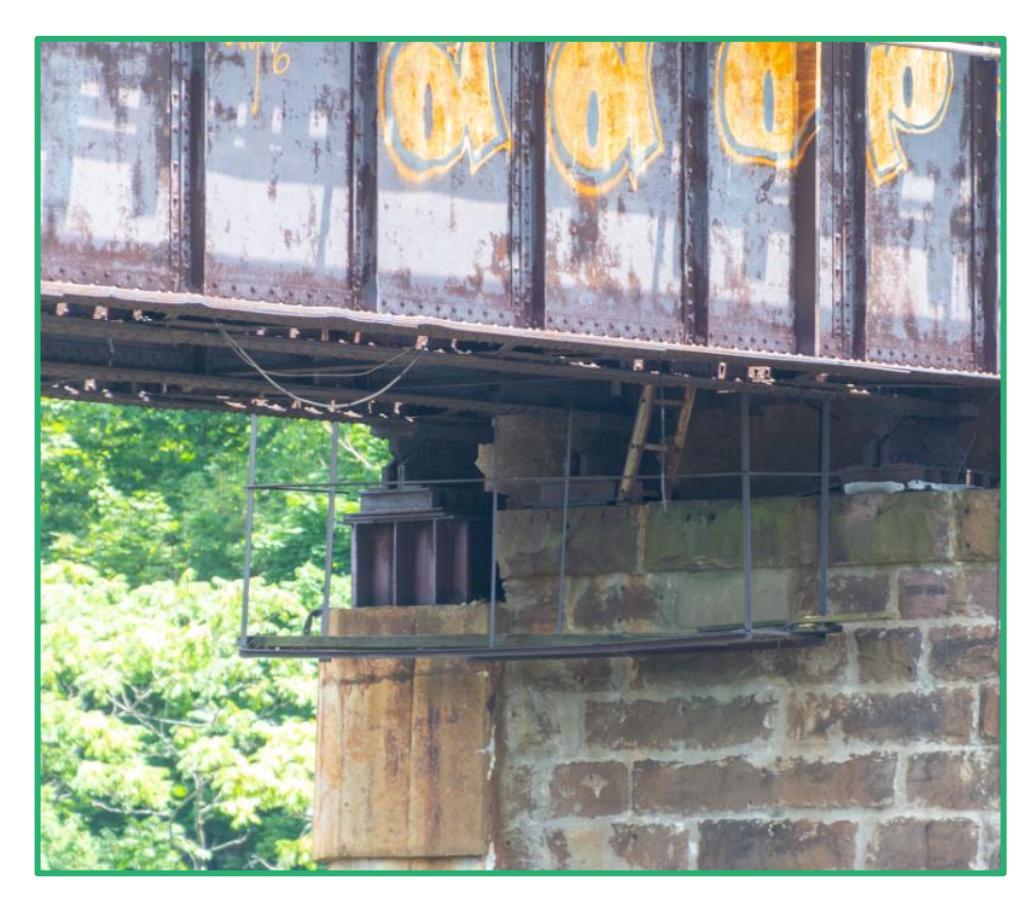
Figure 40 - Repair to north half of masonry pier, replacing the masonry stones with concrete

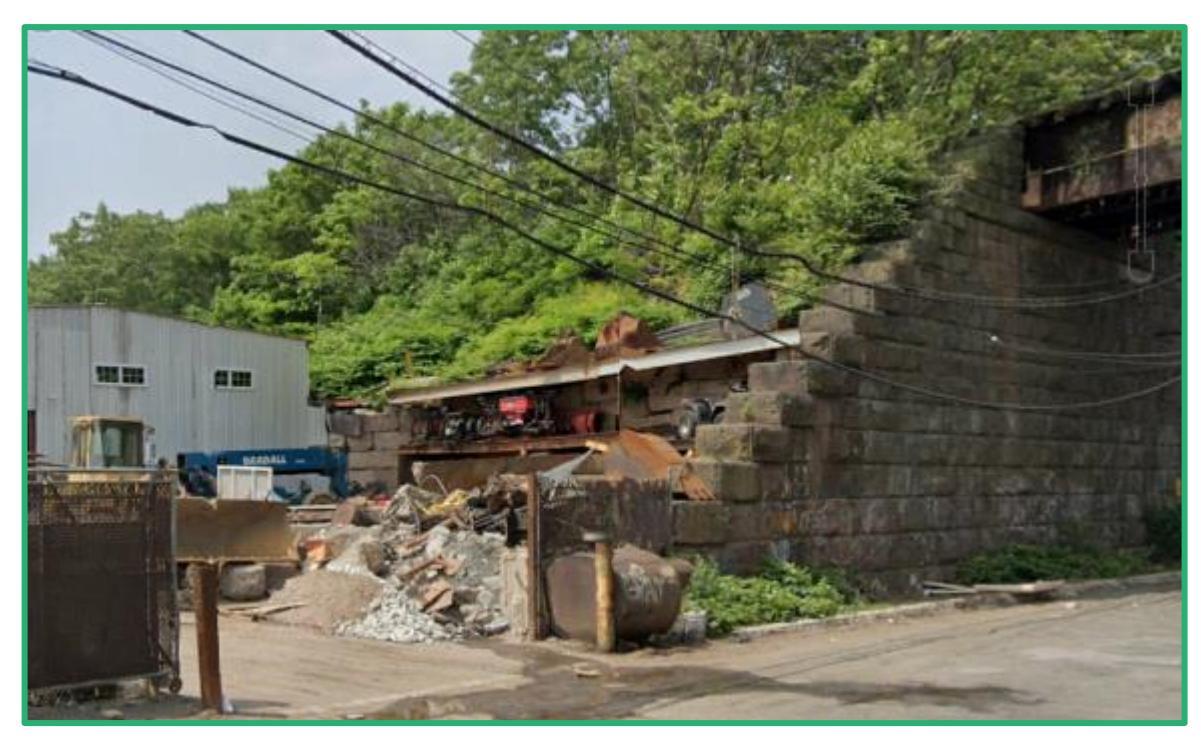
Figure 41 - Cut into railroad embankment directly adjacent to McCarter Highway bridge wing wall

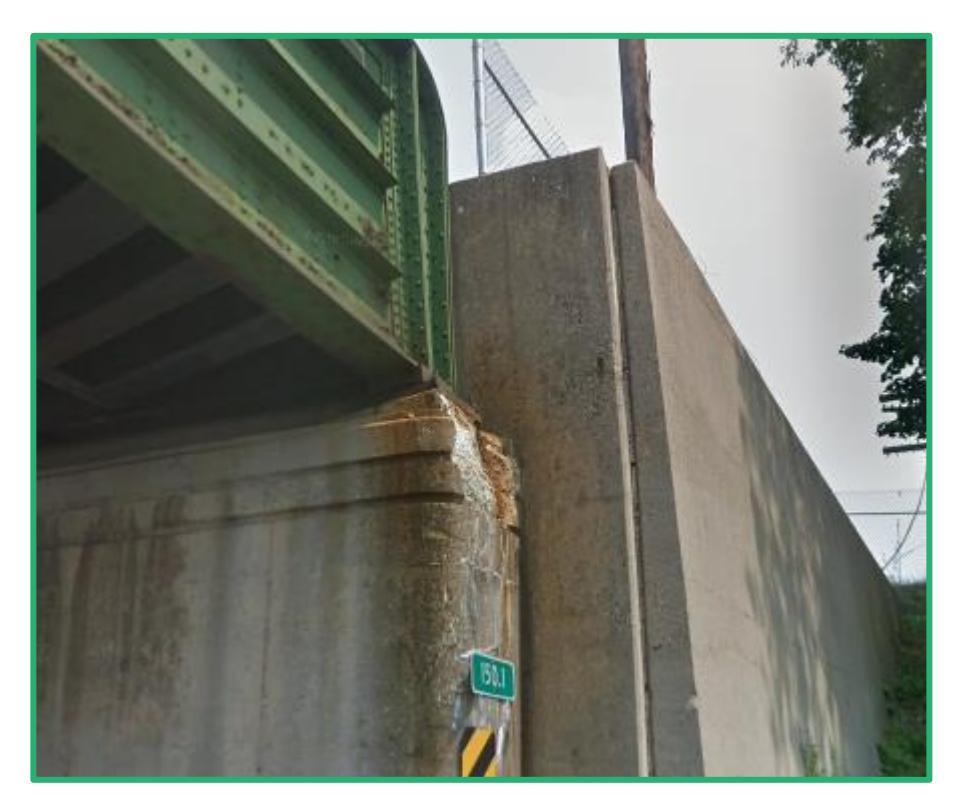
Figure 43 - Southeast bearing in 2012 prior to repair

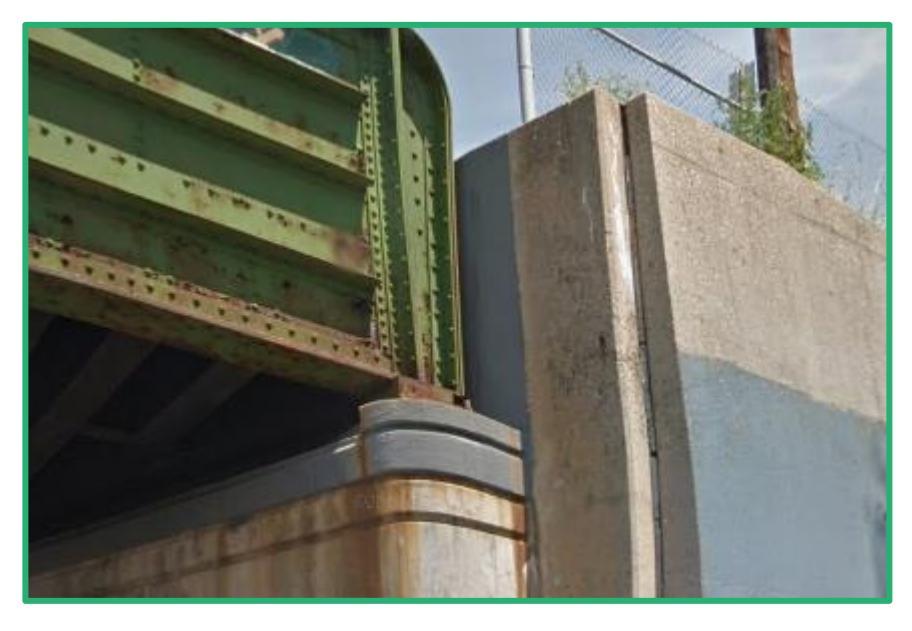
Figure 44 - Southeast bearing in 2013 after repair is complete
