SCOPE OF WORK

Trenton Office Complex Roof Restoration

MVC Central Headquarters Building
225 East State Street
Trenton, Mercer, NJ

Project No. A1382-00

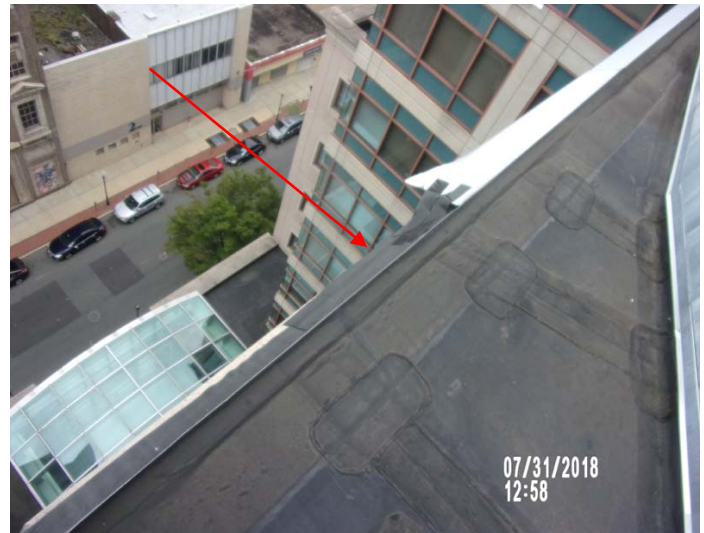
Approximately 30 linear feet of drip edge on Roof Area D was damaged. Drip edge must be removed and replaced with new (see adjacent photo).

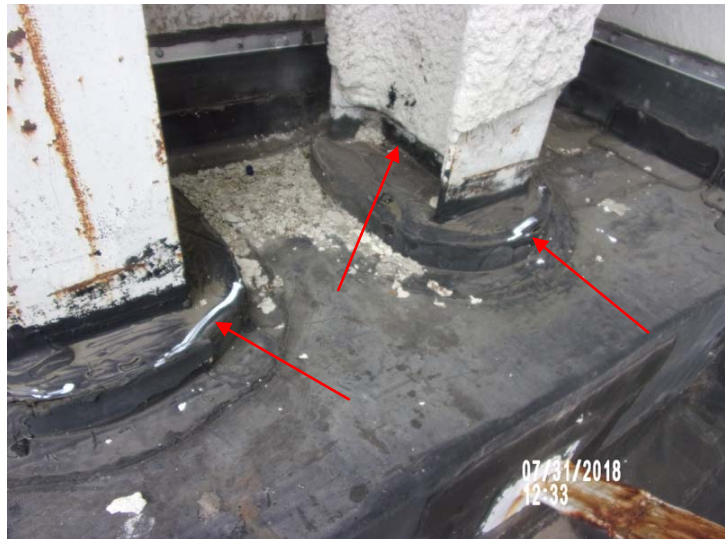
The curtain wall incorporates steel "I" beam supports that are set on raised concrete supports that have pourable sealer pan flashings. All along the base of the inside wall and concrete supports, there were open seams that were marked indicating where repairs were necessary. The sealer pan flashings were also marked for repair. When installing the pan flashing prior to installing the pourable sealer, all penetrations and the inside of the pan itself must be primed. If the priming is not done properly, the pourable sealer will not adhere leaving gaps as shown in the adjacent photograph.

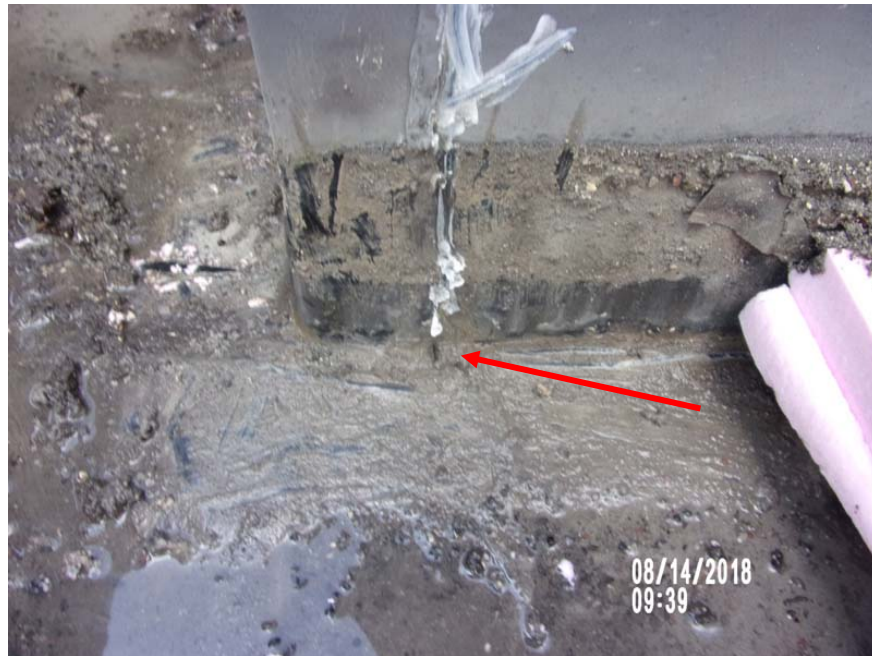
the other roof areas. In this area, an IRMA (inverted roof membrane assembly) system was installed. In this system, the EPDM membrane was attached to the deck followed by insulation and a layer of fabric covered with concrete pavers. All portions of the system were removed to expose the EPDM membrane attached to the deck. A hole was found in the EPDM membrane in the corner at the base of the wall. This location was marked and the roof components were reinstalled. The photograph below shows the hole in the EPDM membrane.

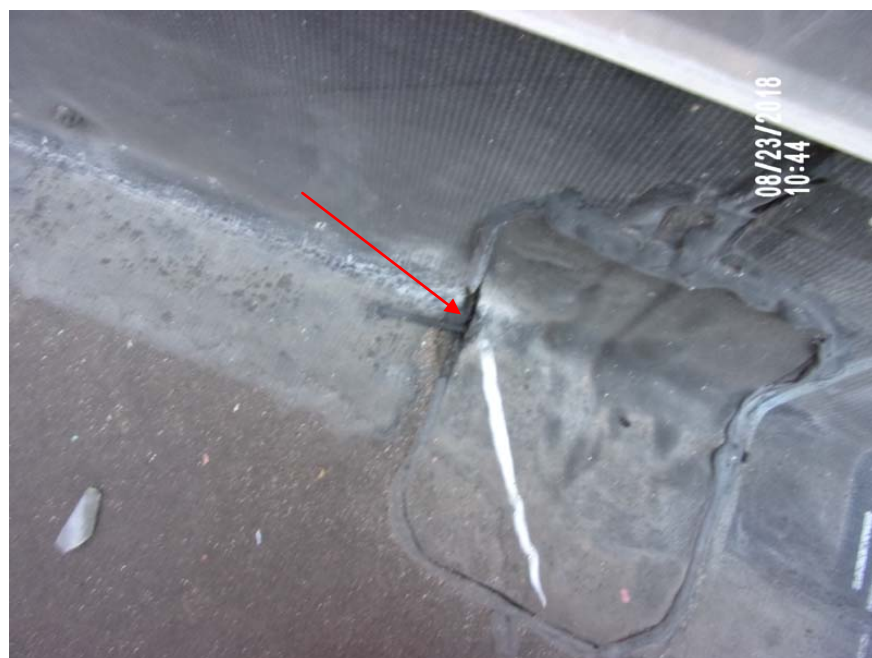
1. Roof Area A: Inside wall EPDM membrane base flashing, vertical lap seams and support patches are open.

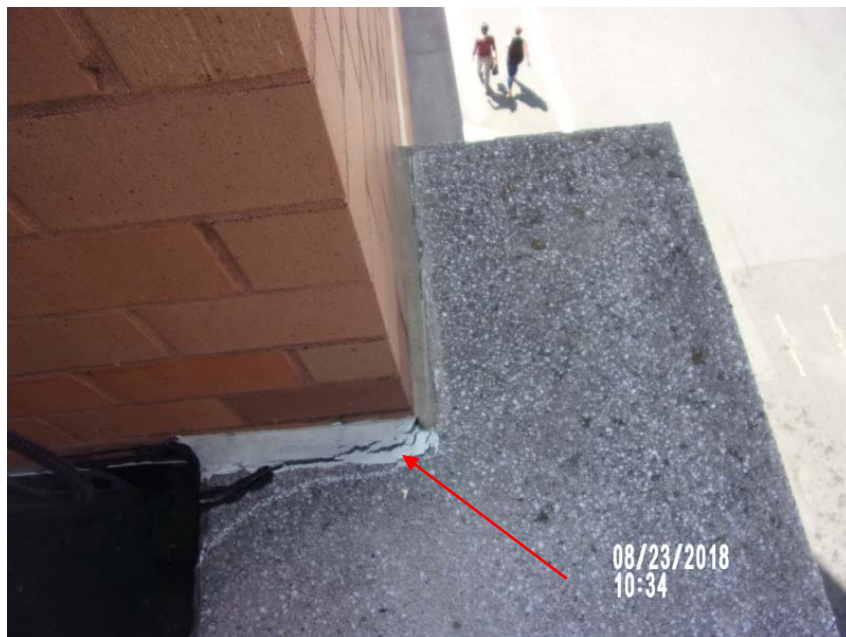
2. Roof Area A: Delaminating lap seam support patch on parapet.

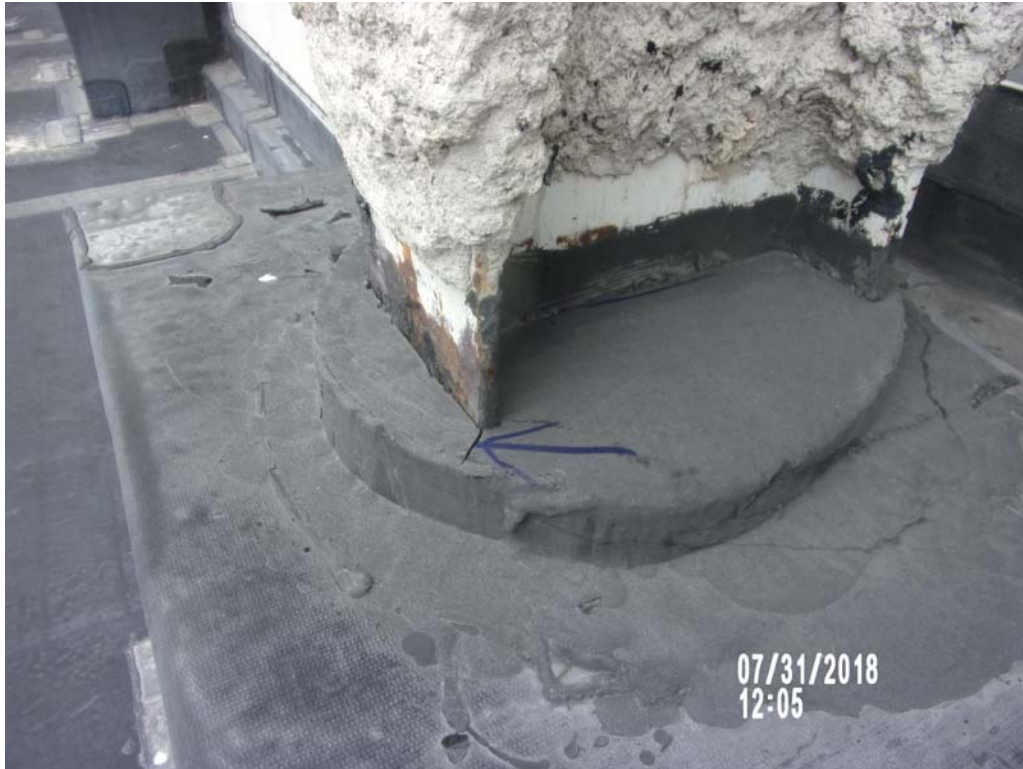
2. Roof Area D: Pencil indicating an opening.

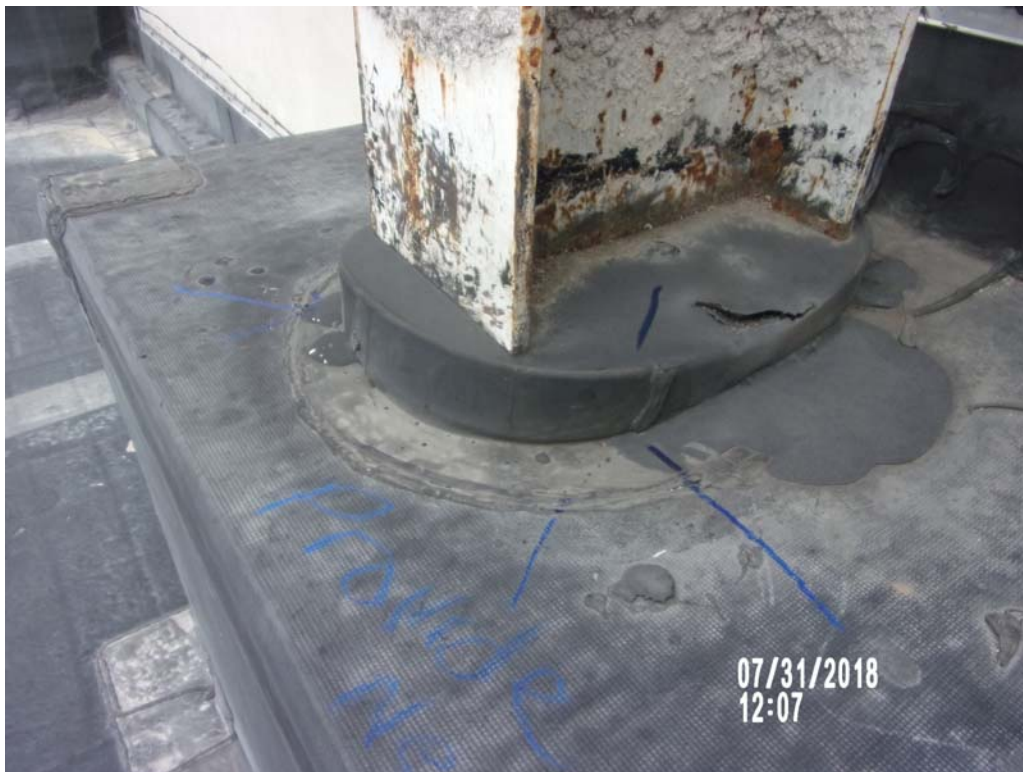
3. Roof Area D: Pourable sealer pan flashing at the base of a steel "I" beam. Gaps were found between the "I" beam and the pourable sealer. There is also a split coming off of the end of the beam.

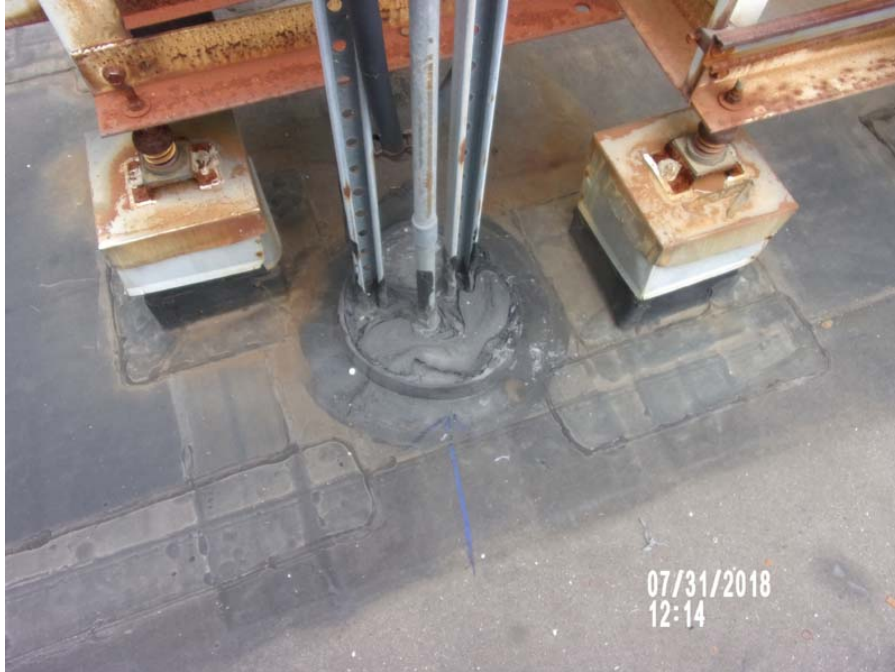
8. Roof Area D: HVAC supply and support line penetrations in a pourable sealer flashing pan. The pourable sealer is in a degraded condition.

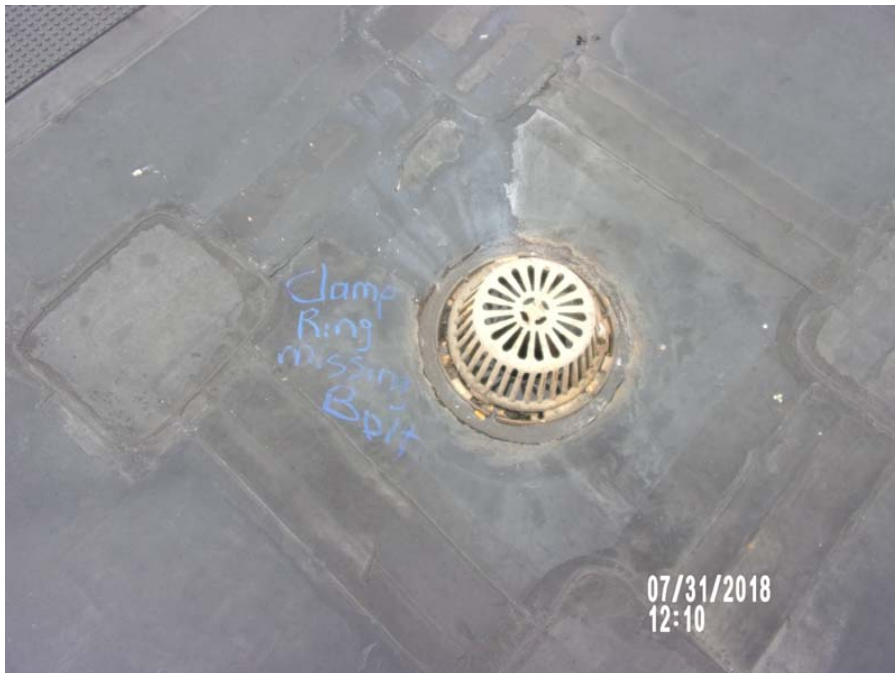
9. Roof Area D: Missing drain clamping ring bolt clamping the EPDM membrane to the drain. A missing bolt could eventually allow the clamping ring to loosen. If this occurs, it will create an opening for water entry.

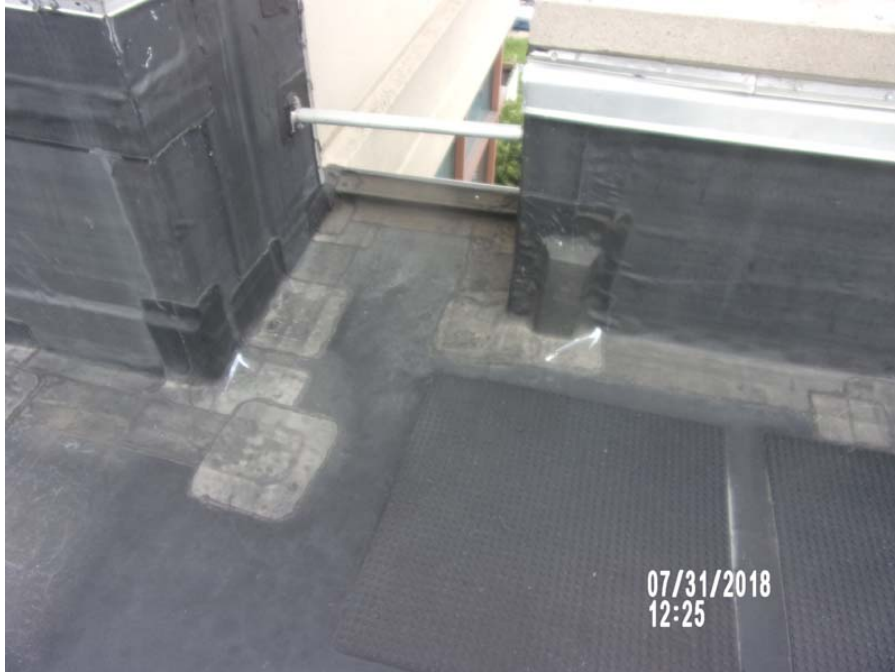
1. Roof Area D1: Typical open EPDM membrane open vertical lap seams on parapet wall.

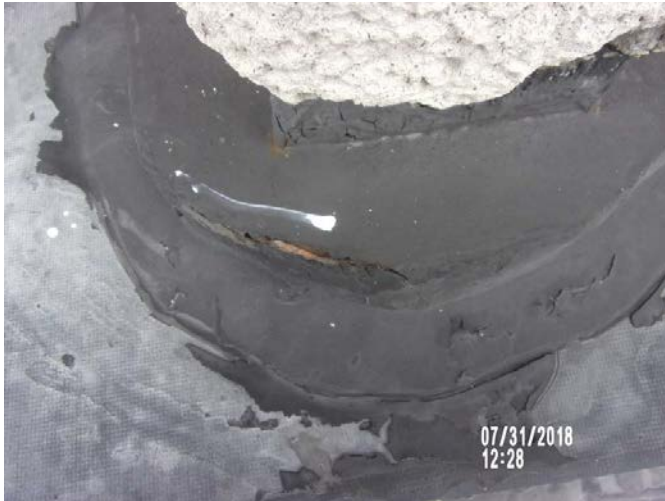
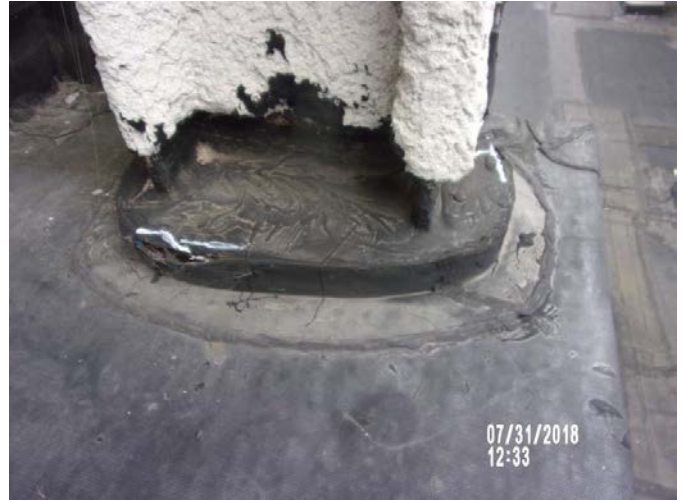
3. Roof Area D1: Typical degrading pourable sealer flashing pans at the base of the curtain wall "I" beam supports.

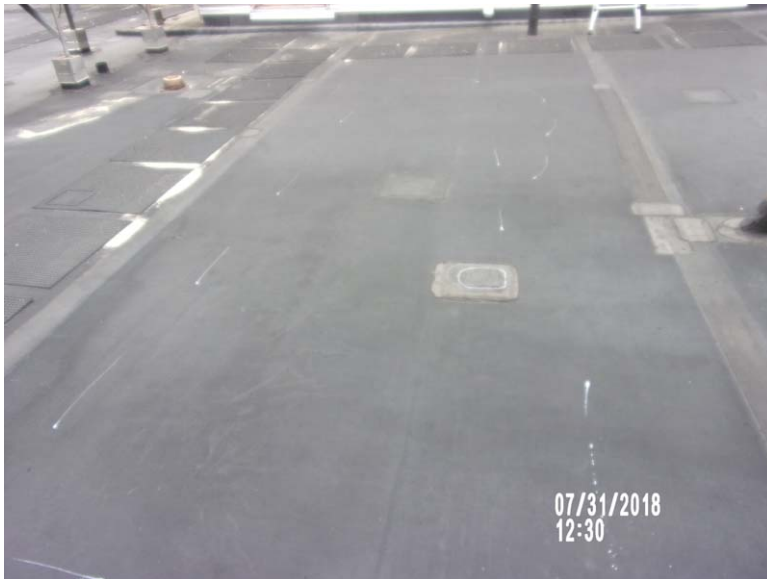
4. Roof Area D1: Area approximately 108 square feet, insulation delaminated from the concrete deck raised the EPDM roofing membrane. This problem did not create openings in the roofing system to create leaks.

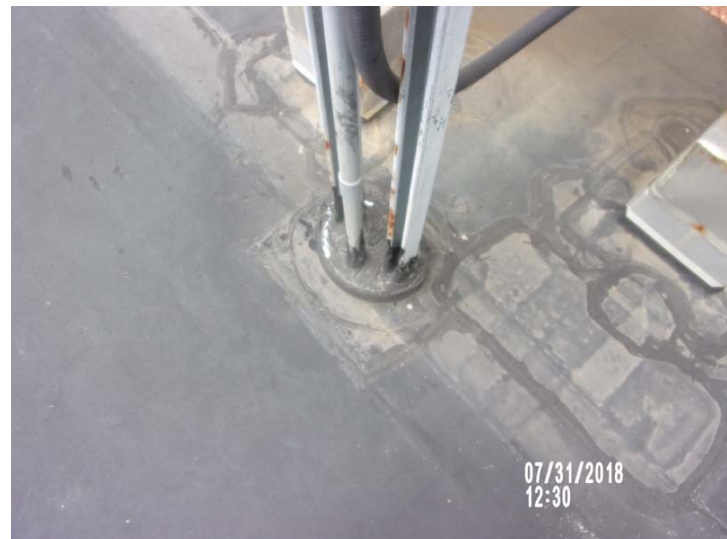
5. Roof Area D1: Typical degrading pourable sealer flashing for HVAC supply and support lines.

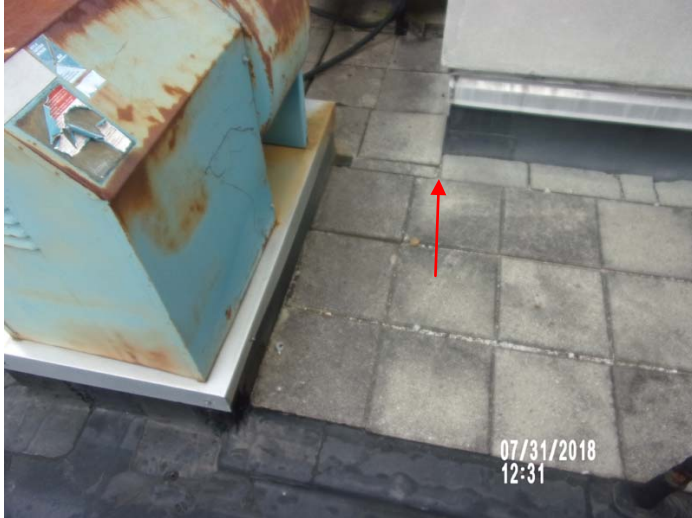
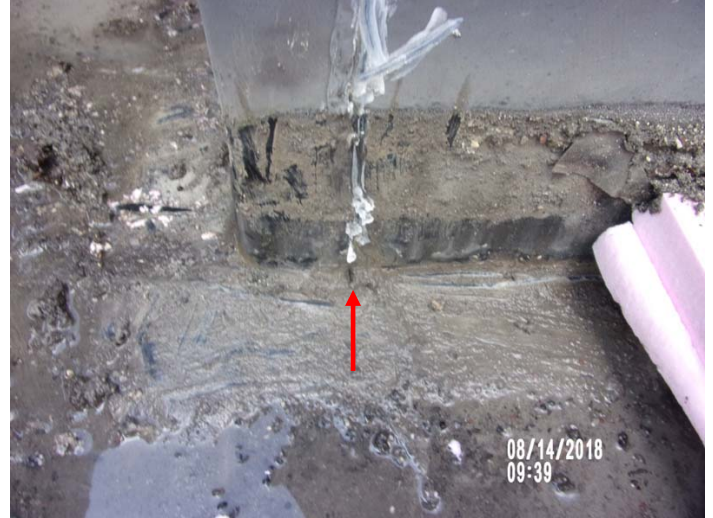
6. Roof Area D1: Arrow at the photograph on left indicates a reported leak location. After removing the concrete pavers the arrow on the right photograph shows location of a hole in the wall EPDM membrane flashing.

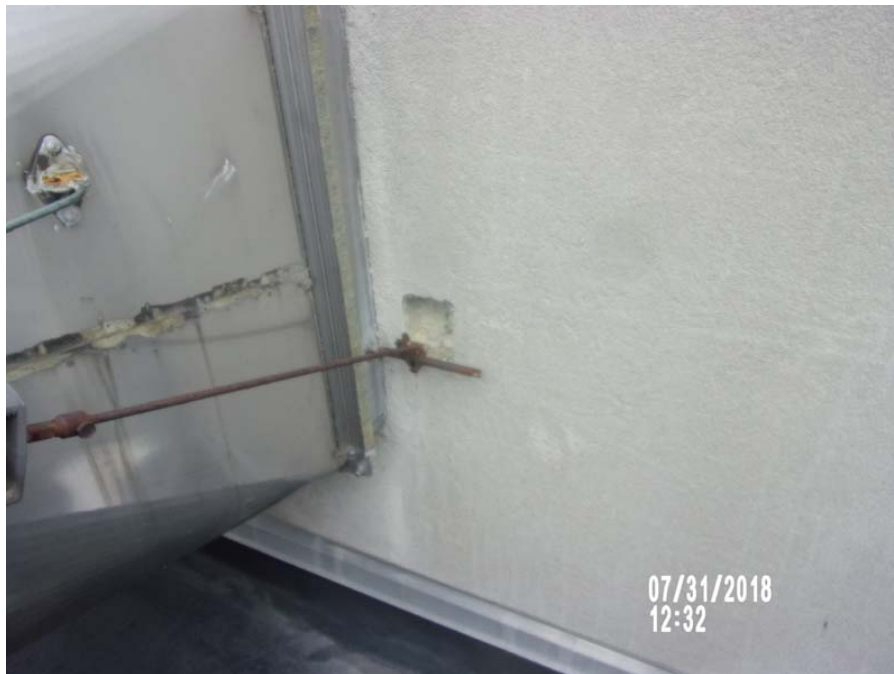
7. Roof Area D1: Hole in the stucco wall leading up to Roof Area D2.

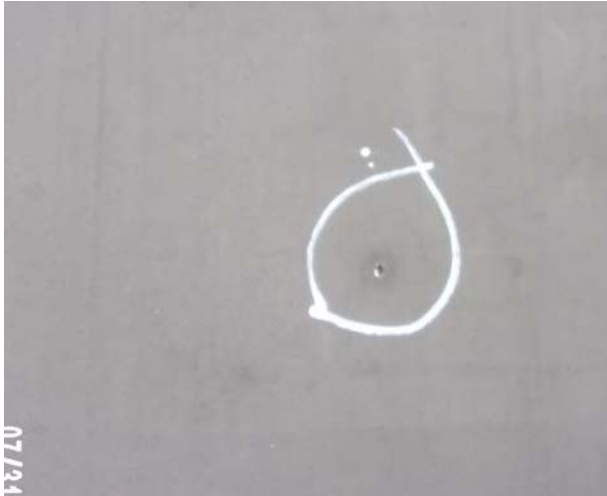
1. Roof Area D3: Hole found in the field of the roof. This hole is in an area that appears to be an elevator motor room/ utility room. An inspection of this room water was found on the floor.

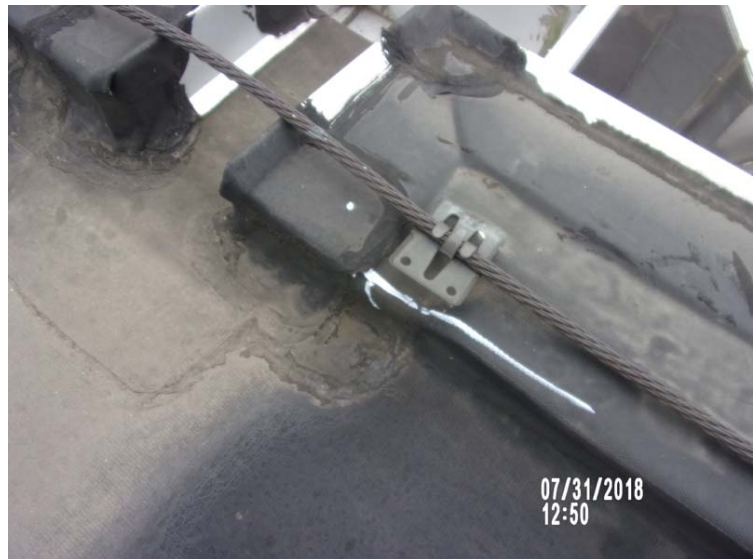
2. Roof Area D3: Typical delaminating corner patches.

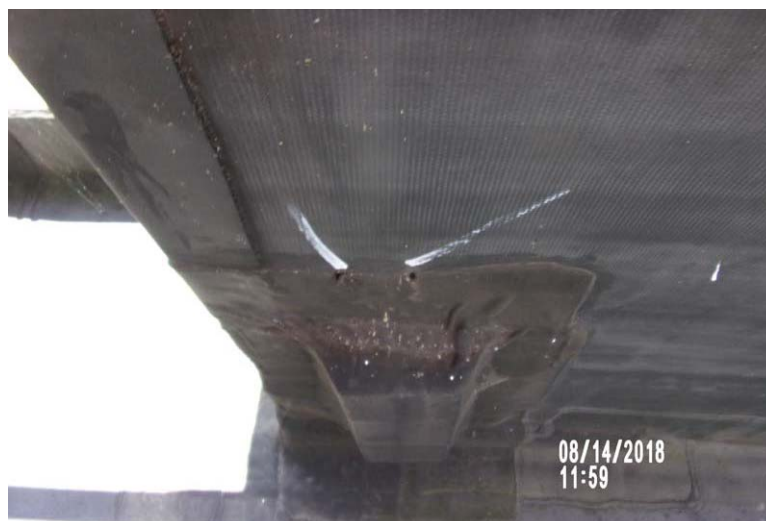
1. Roof Area F: Two (2) openings were found in the EPDM membrane wall flashing.

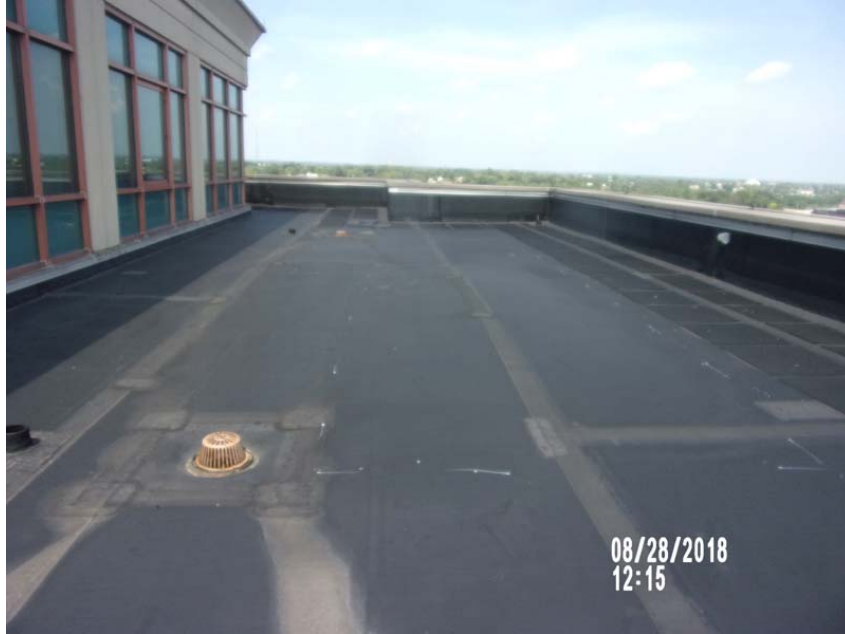
1. Roof Area K: Section of the roof is raised because the insulation delaminated from the concrete deck.

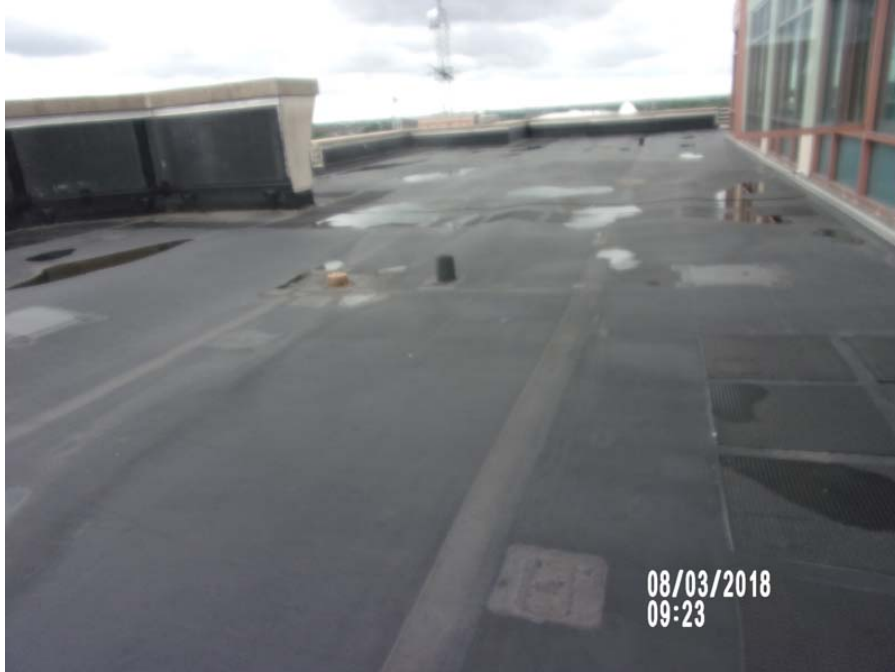
1. Roof Area L: Large section of this roof area (back right of picture) is raised from delaminated insulation from the concrete deck which has buckled. This condition has not created damages that would cause leaks. Sample cuts were performed; a full discussion of our findings can be found within the Roof Cut Analysis Section of this report.

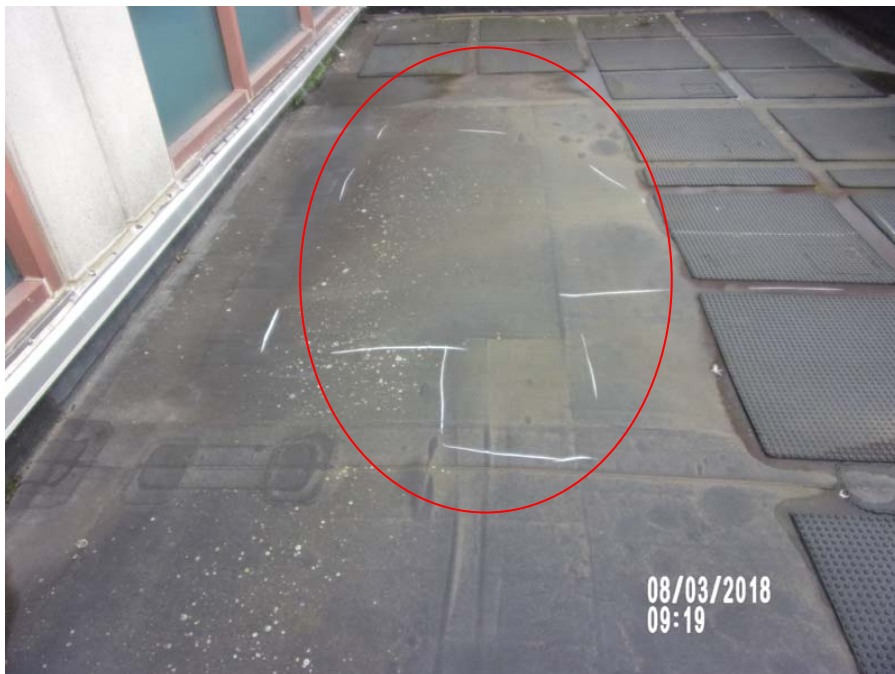
- 2A. Roof Area L: The above photograph shows smaller sections of delaminated insulation raising the EPDM membrane.

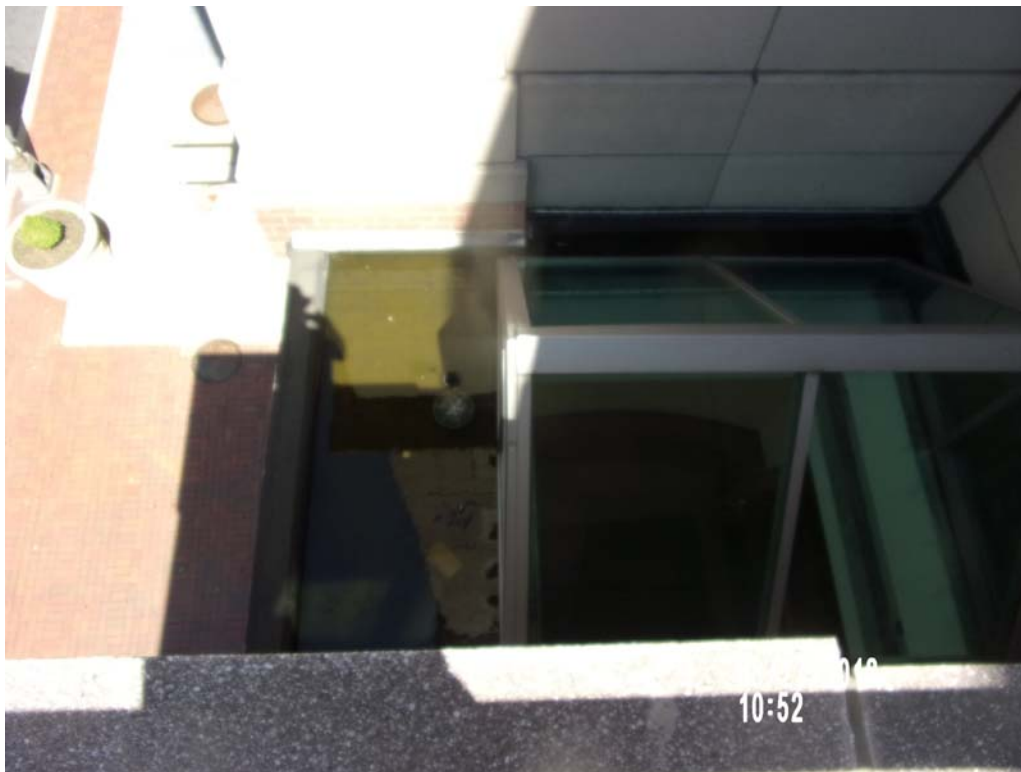
1. Roof Area P: Overall view showing a clogged roof drain. Note the entire roof surface is covered with water. I spoke with Don Nawn from Meridian Property Management who stated that there were no leaks on this roof. Don stated that he would have the drain cleared so that the roof will drain.

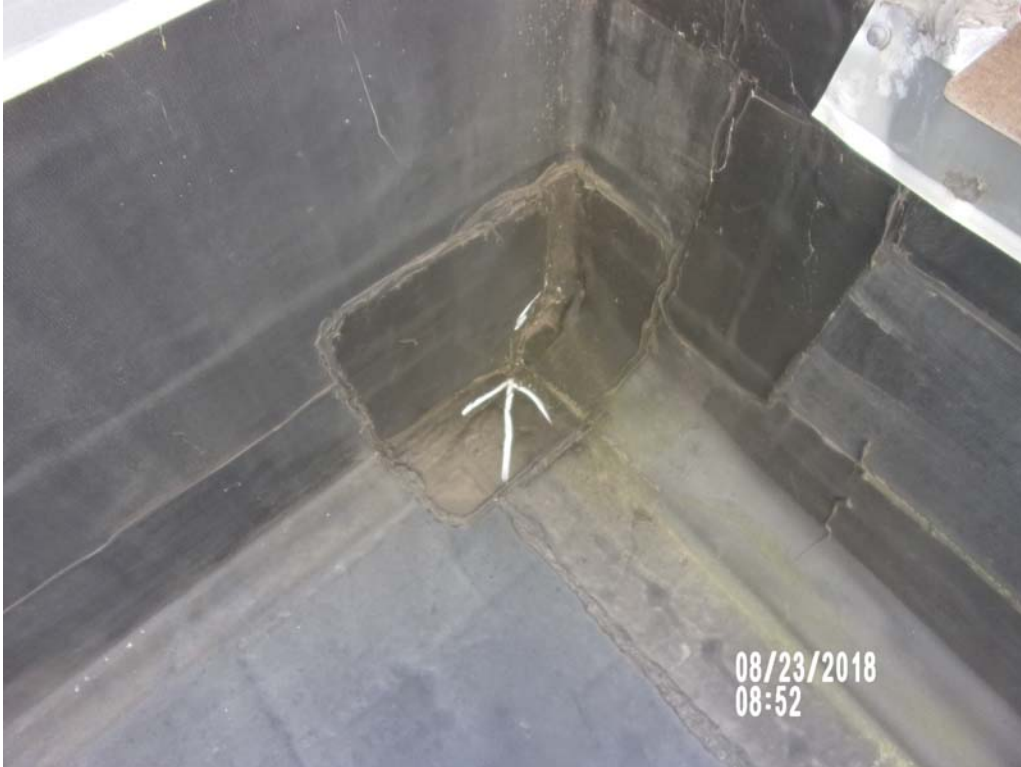
1. Roof Area Q: Typical delaminating inside corner patch.

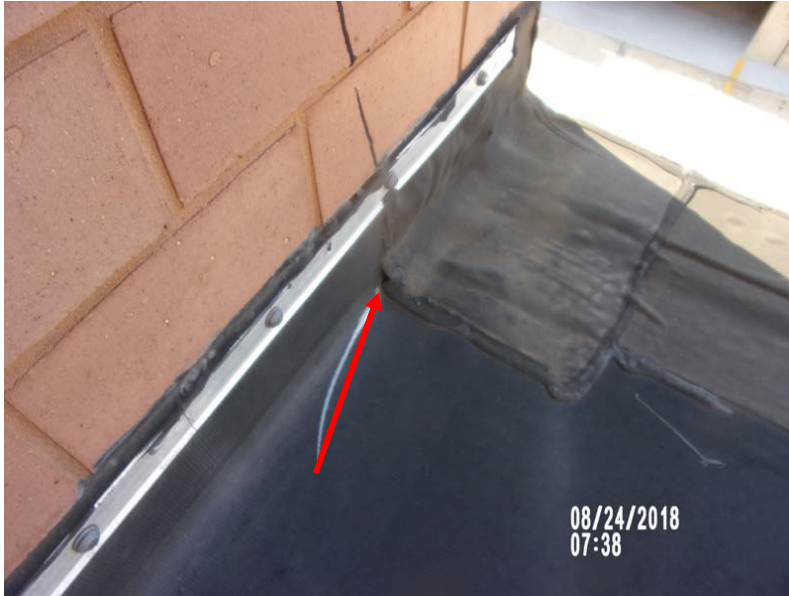
1. Roof Area T: Delaminated wall flashing corner patch.

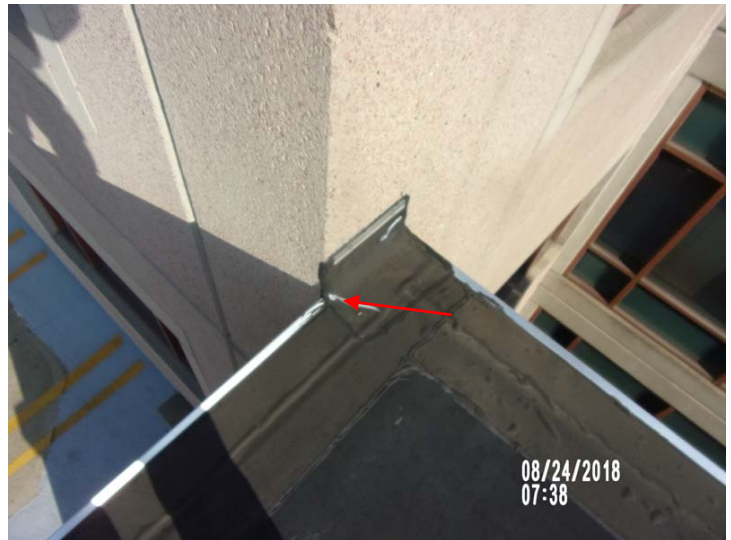
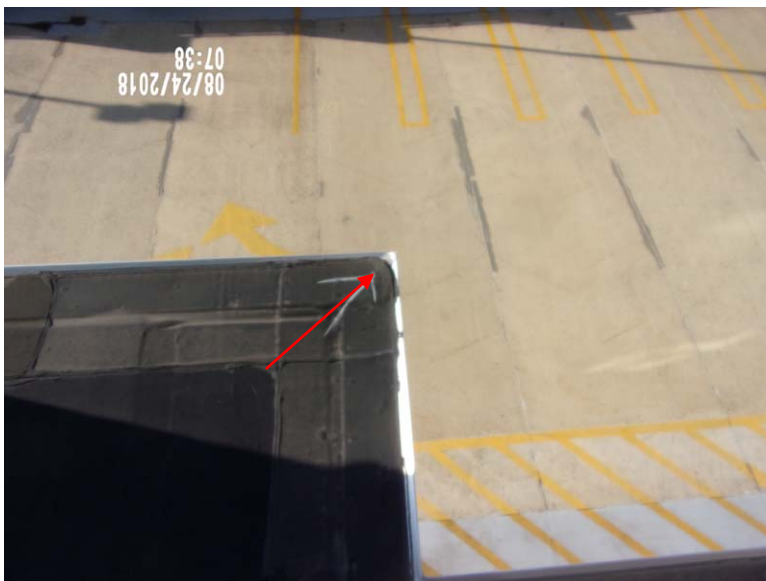
3. Roof Area T: Perimeter metal edge flange stripping delaminated.

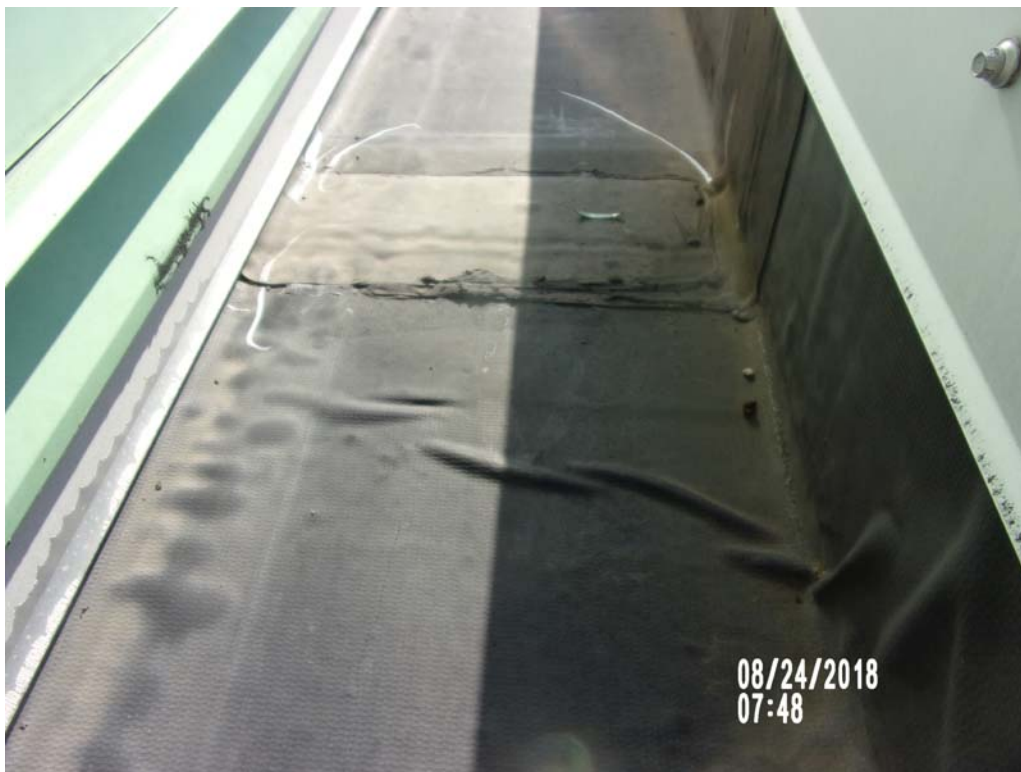
2. Roof Area L1: Field lap seam stripping opening at the base of the elevation change.

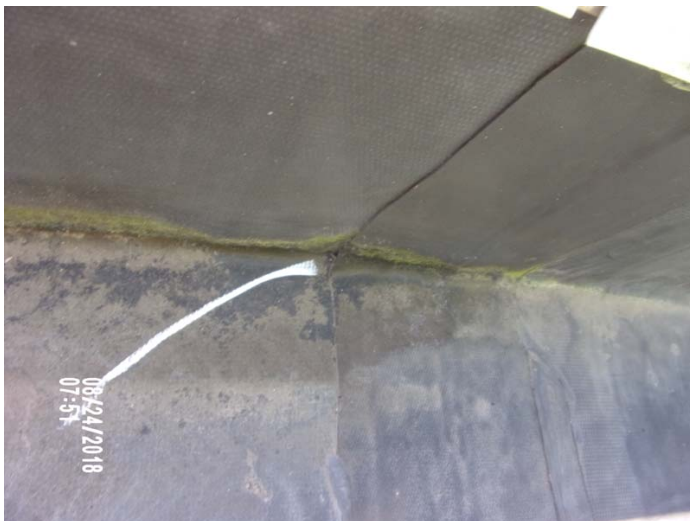
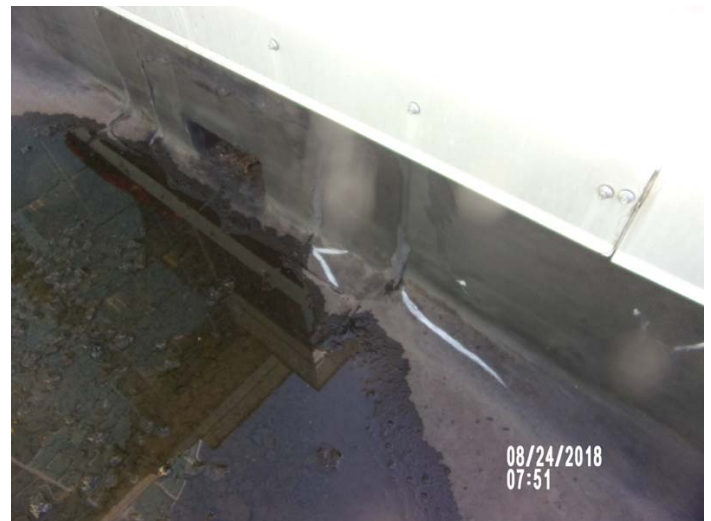
4. Roof Area L1: Photograph showing the delamination of the EPDM membrane (typical at several locations). Note that water lays (ponds) at this location. It appears that water *may have* entered through these openings (open lap seams). If water has not yet entered the system at this location; if left unrepaired, leaks / water infiltration will be realized.

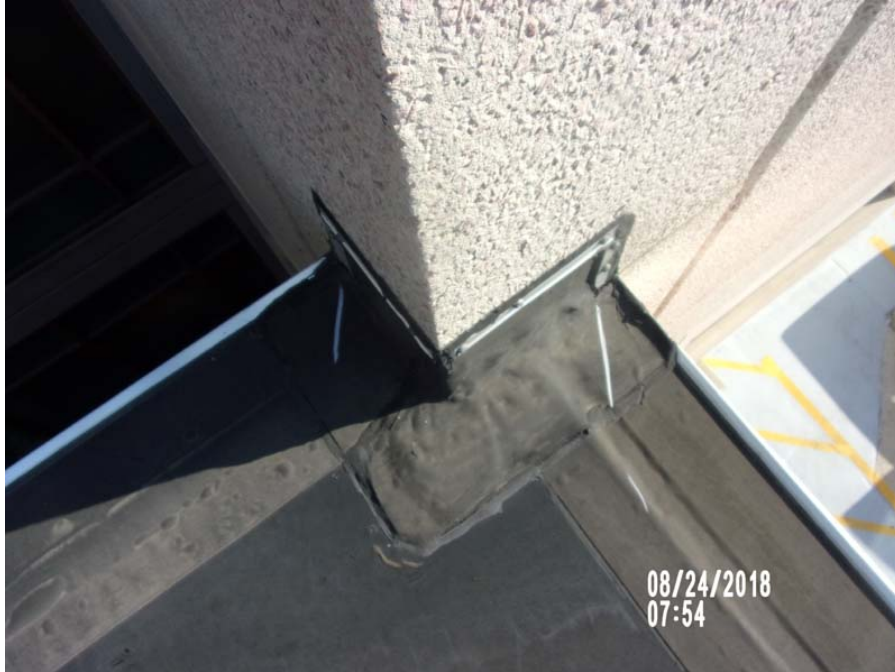
1. Roof Area V: View of an outside corner wall flashing which incorporated termination bars. At the bottom of both vertical termination bars, the membrane was penetrated by the bars.

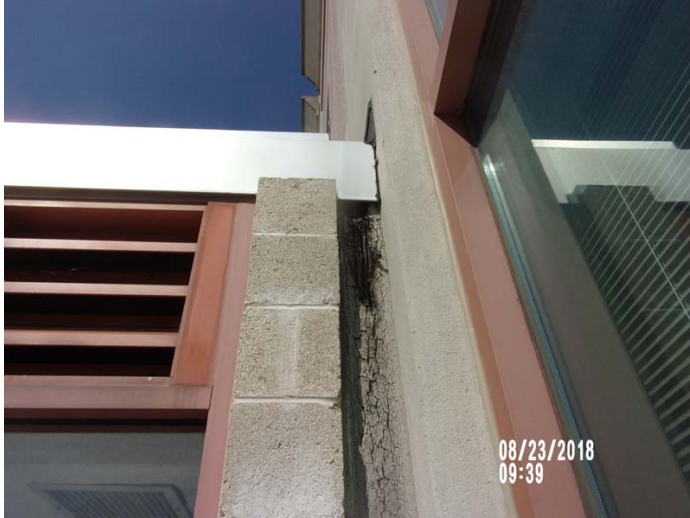
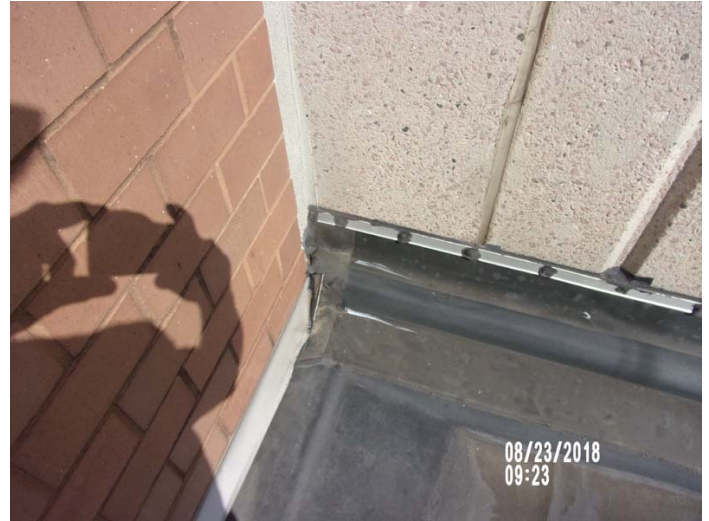
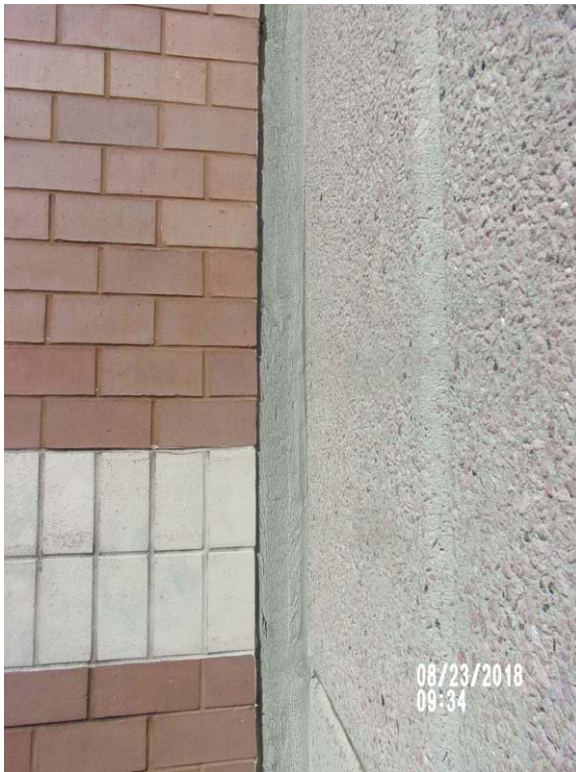
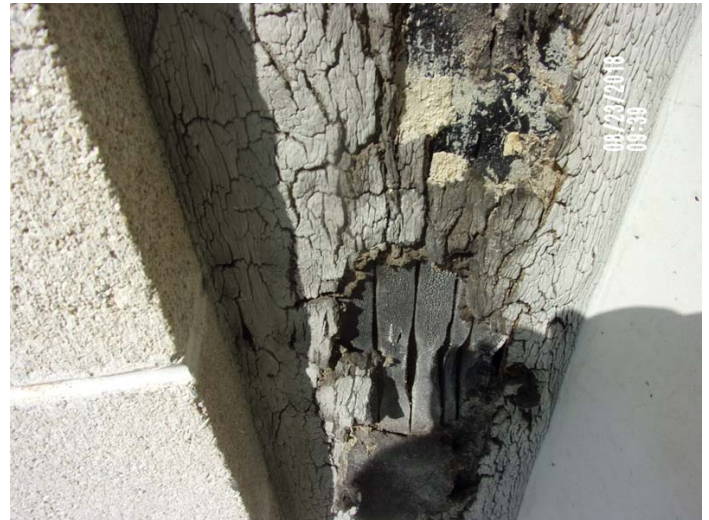
Top Level Parkade: Where the stairwell / elevator shaft extensions meet the main portion of the building the existing expansion joints are in a degraded condition. ARMM was not engaged to inspect exterior wall vertical expansion joints. ARMM is providing these photographs to inform the owner of the current condition so that steps can be taken before problems arise.

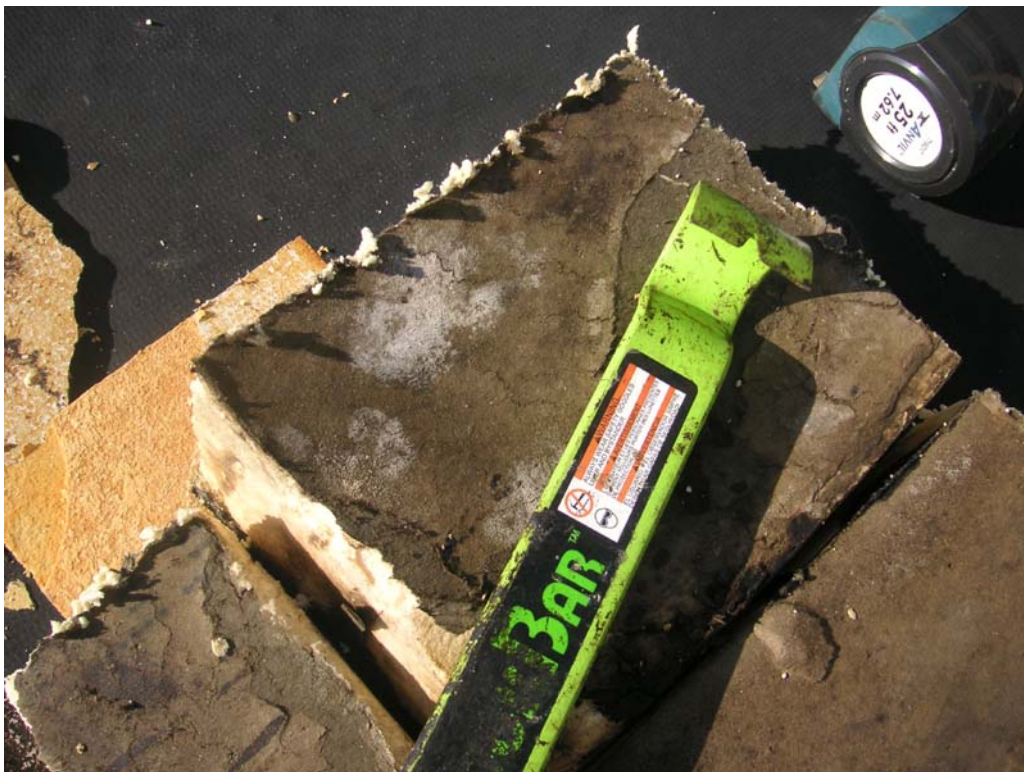
6. Mold in under side of top layer of insulation; facing sheet bloated from moisture

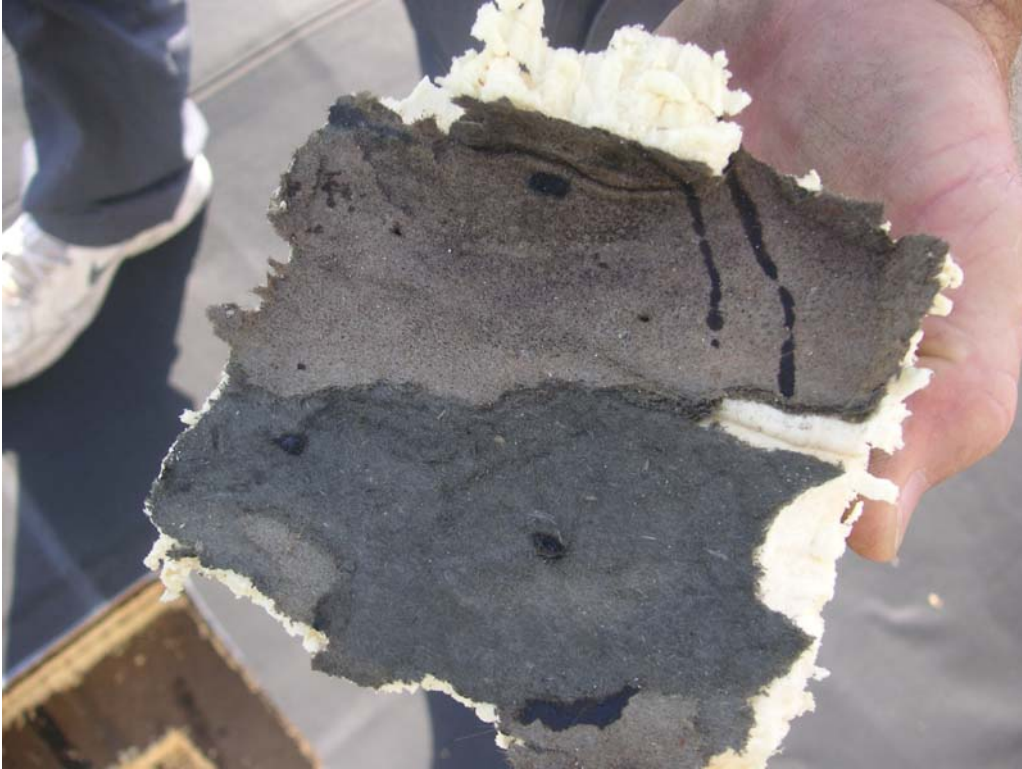
25. Bloating of facing sheet due to moisture

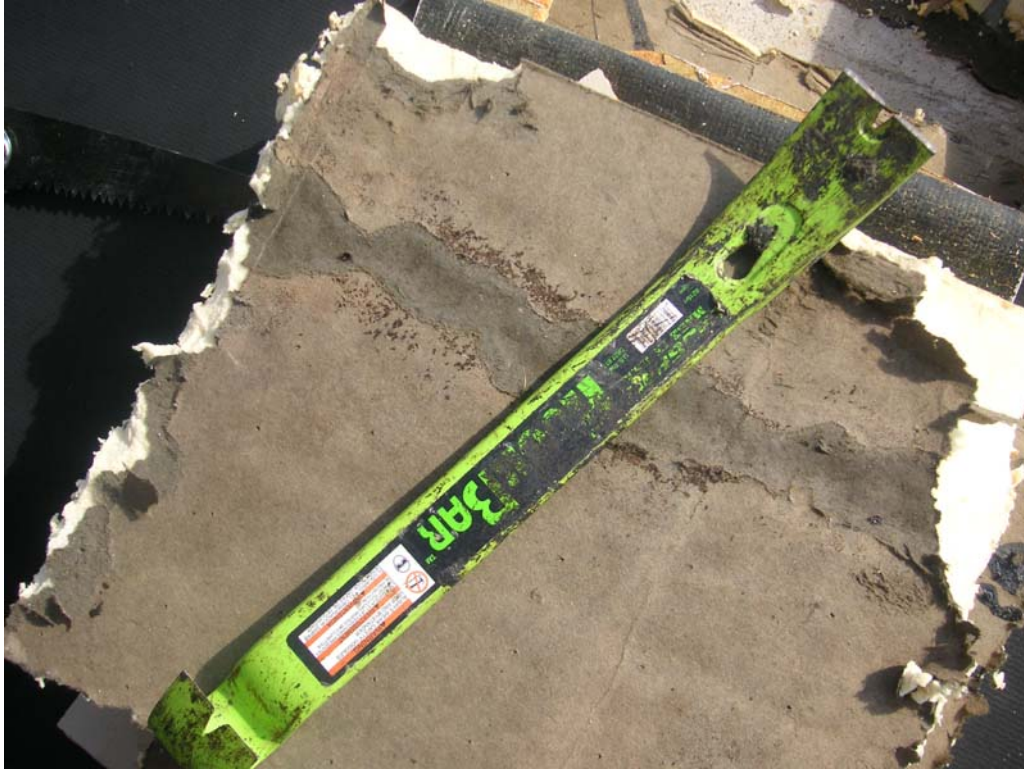
38. Underside of top insulation board has moisture damage

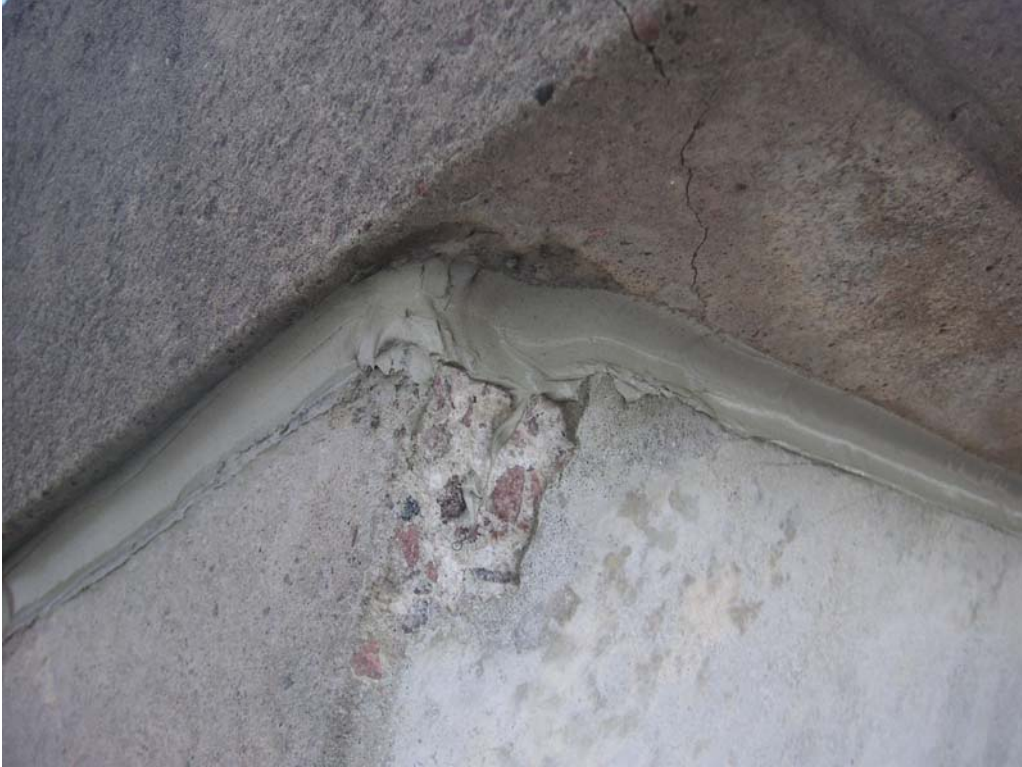
48. Caulking at cast stone – note cracks in stone
