SCOPE OF WORK

Trenton Office Complex Roof Restoration

MVC Central Headquarters Building
225 East State Street
Trenton, Mercer, NJ

Project No. A1382-00

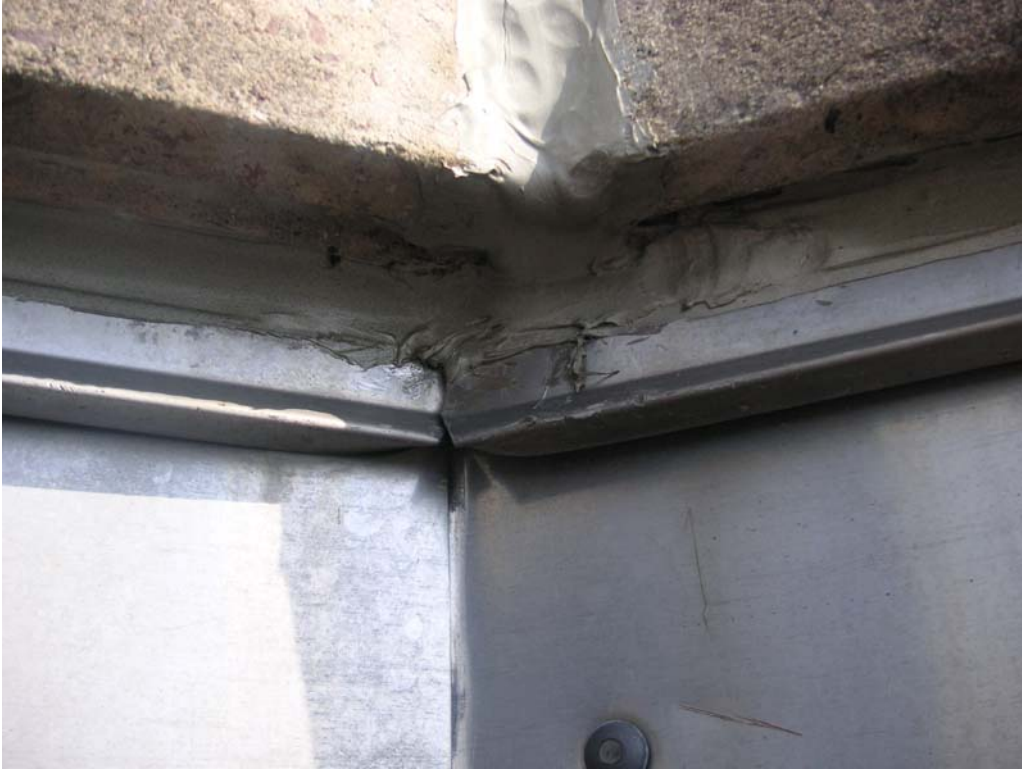
52. Leakage point for wall systems

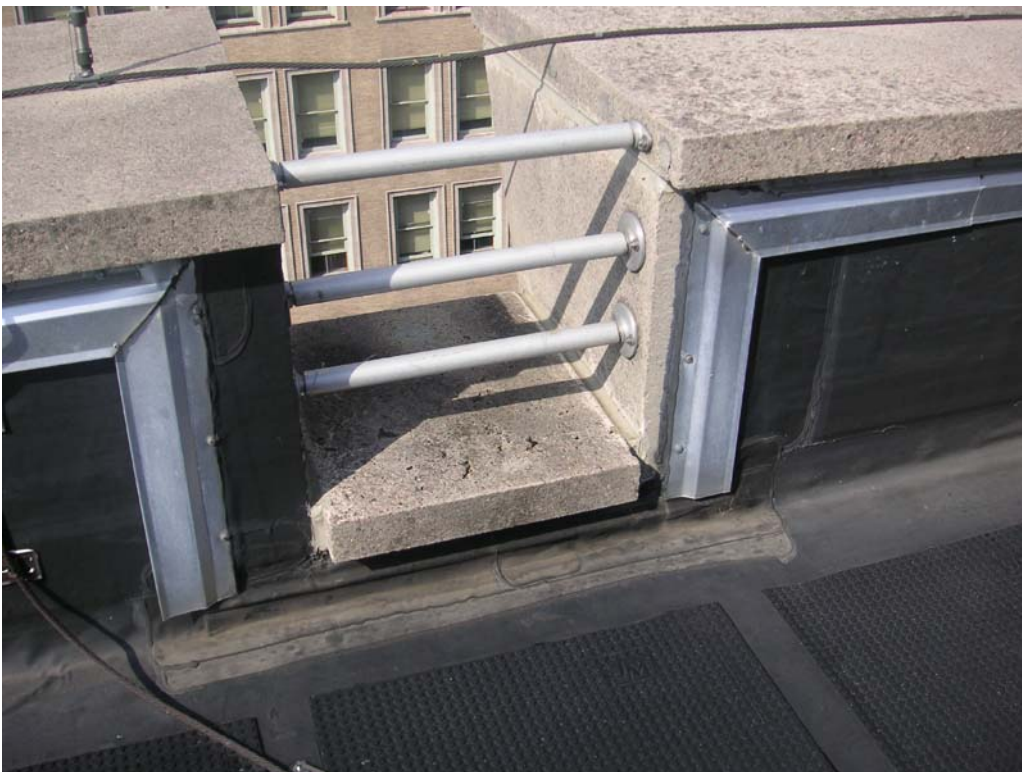
57. Crenel sections that leaked

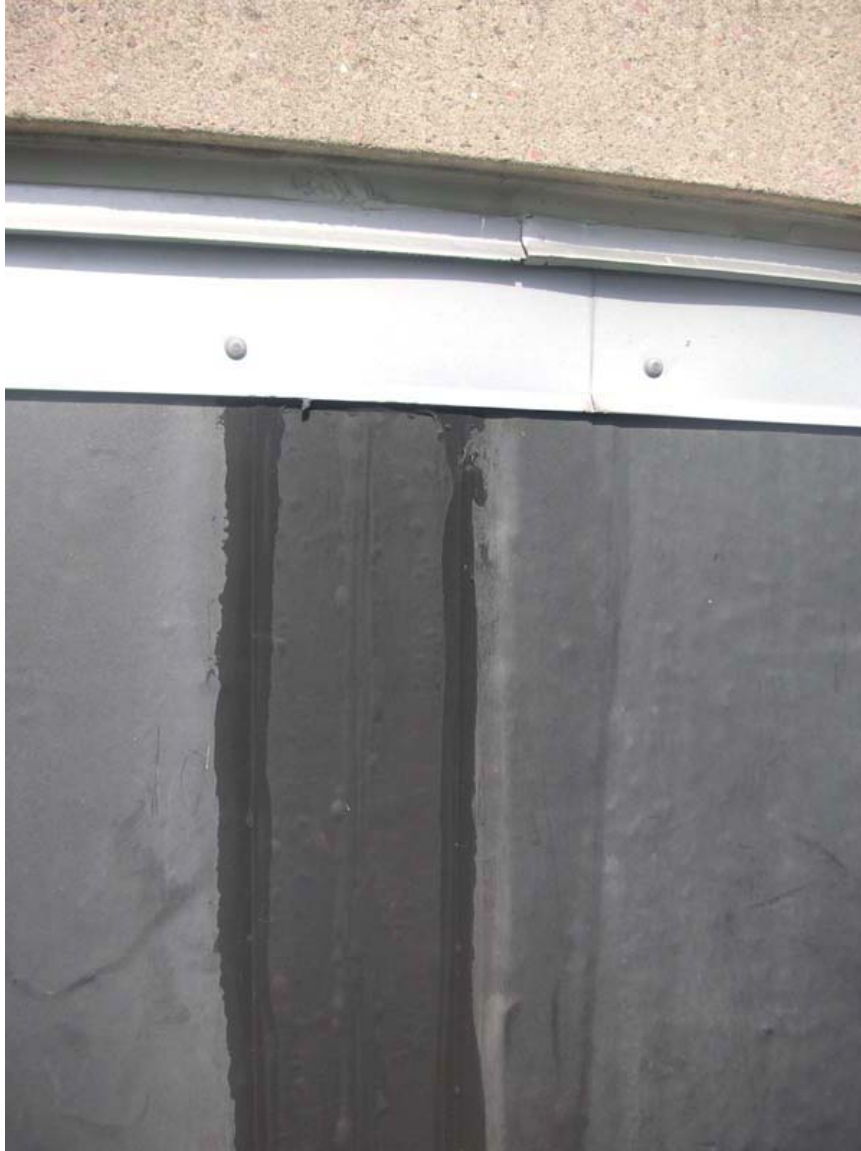
58. Extensive leakage at wall and metal connections

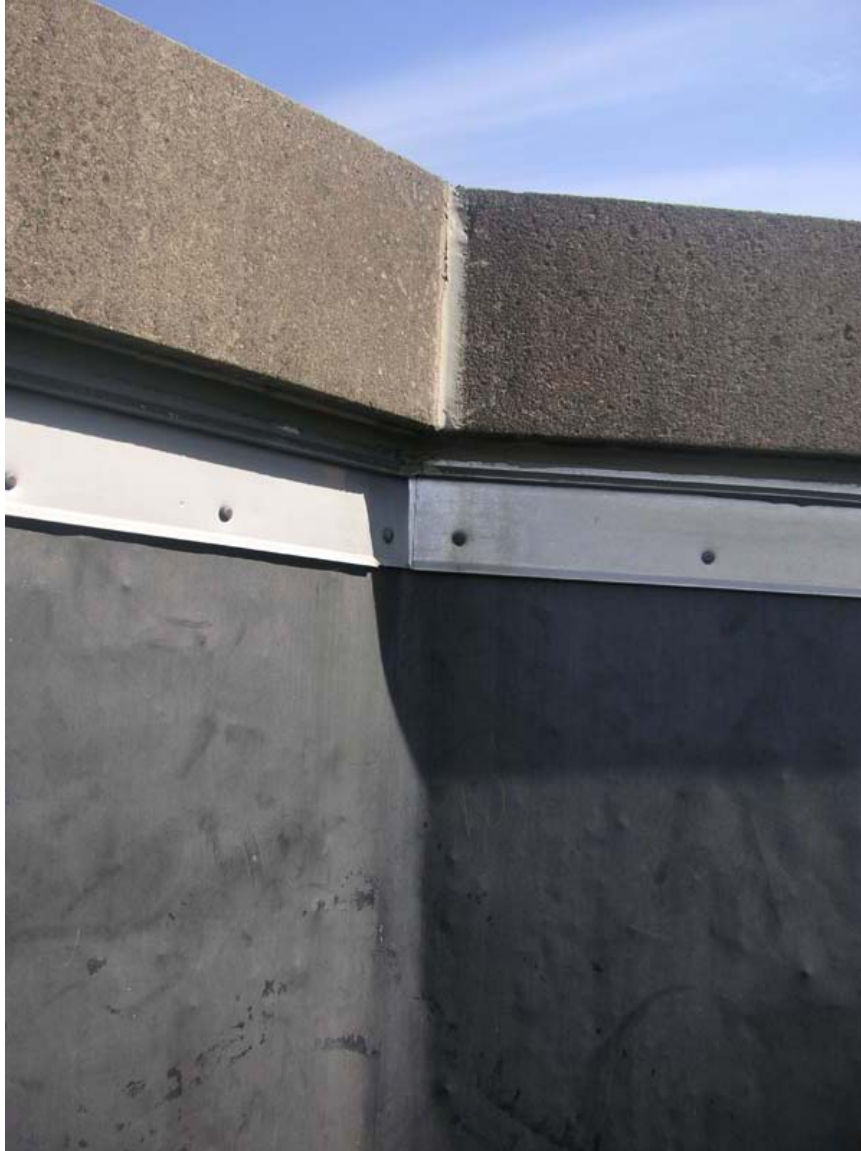
59. Constant leaking of water from stone work

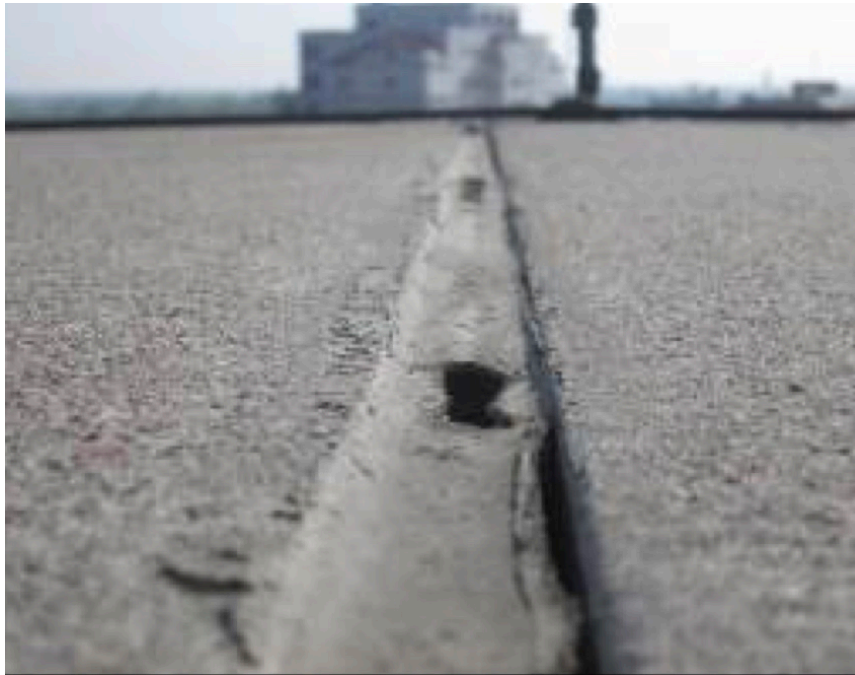
4. Caulking at coping stones.
Expansion of joint over width as cohesive failure of caulk.

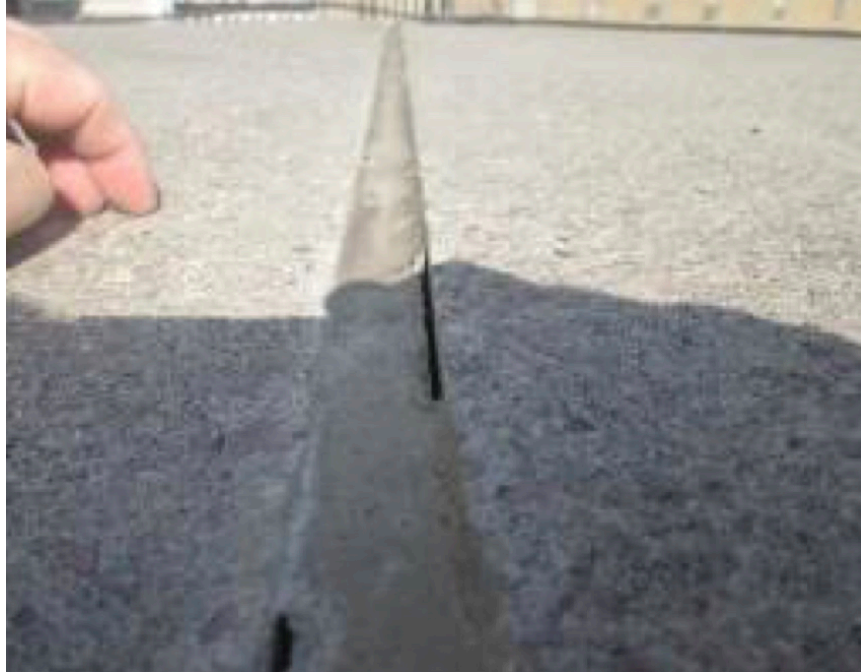
5. Coping.
All stone work is sloped back to the roof surface. Splits in the side shoulder of the caulk joint allow water to migrate into the system.

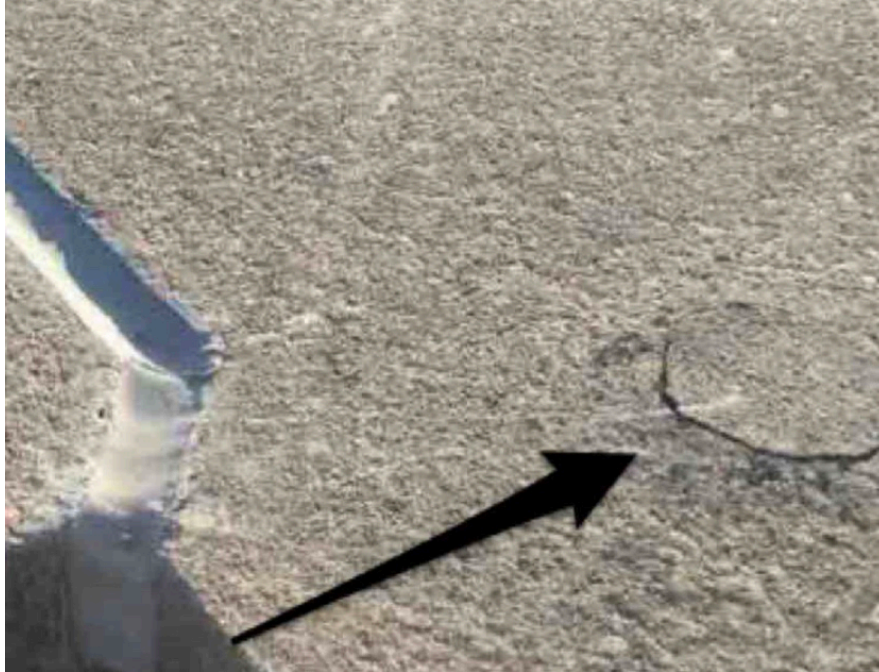
13. Ridging Points.
Lifting plug not secured or waterproofed allowing moisture intrusion. Cast stone mortar installed after cast plank installation.

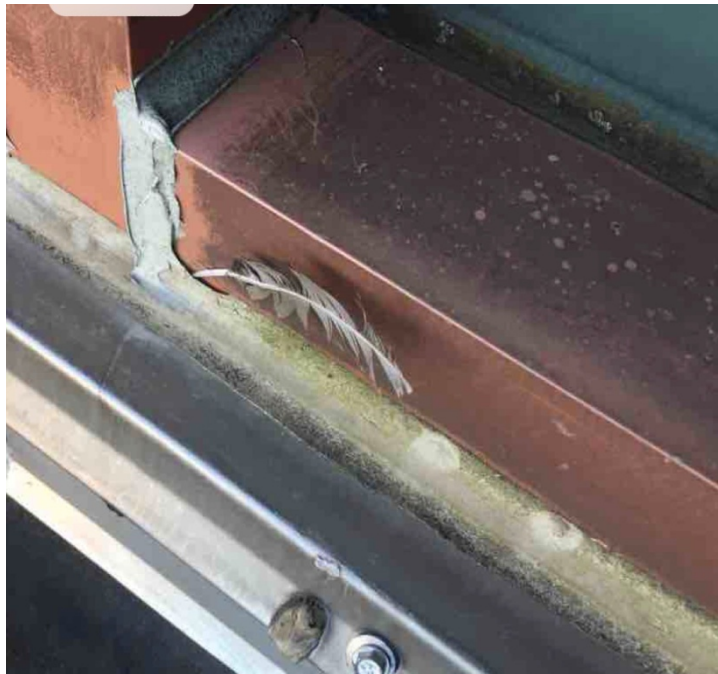
14. Caulking at Windows.
Remedial efforts with open joint.
