PHASE IB ARCHEOLOGICAL STUDY
BEAR TAVERN ROAD BRIDGE OVER JACOBS CREEK
HOPEWELL TOWNSHIP, MERCER COUNTY, NEW JERSEY

PREPARED FOR
MERCER COUNTY
OFFICE OF THE ENGINEER
TRENTON, NEW JERSEY

APRIL 2010

**BEAR TAVERN ROAD BRIDGE OVER JACOB'S CREEK
HOPEWELL TOWNSHIP, MERCER COUNTY, NEW JERSEY
PHASE IB ARCHEOLOGICAL STUDY**

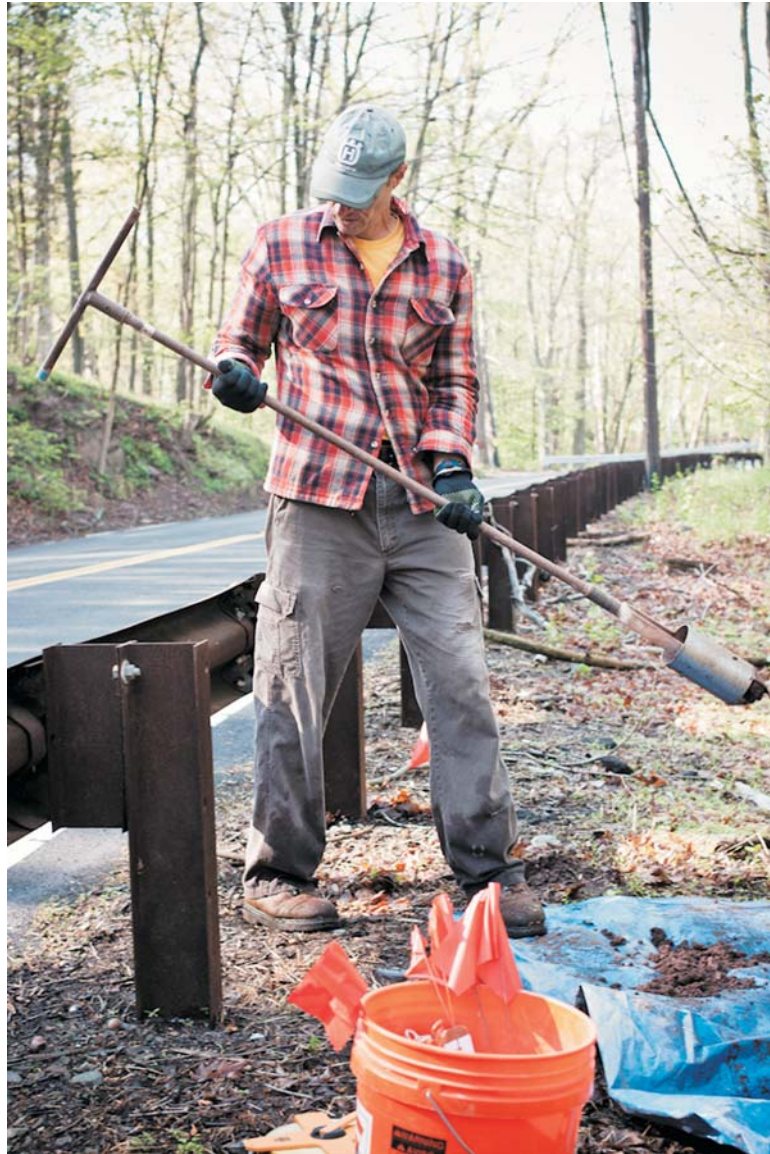
Plate 1. Auger hole excavation at beginning of transect; alongside Jacob's Creek Road.

The auger holes, designated AHs 1–16, were placed at 30-ft. (9.1-m) intervals along the approximate centerline of the proposed reroute of Jacob’s Creek Road. AHs 1 through 12 were located across the upland and alluvial landforms east of the stream, with AH 1 at the top of the embankment adjacent to Jacob’s Creek Road, while AHs 13 through 16 were located west of the stream, across the corresponding landforms on the opposite side of the valley (Figure 1).

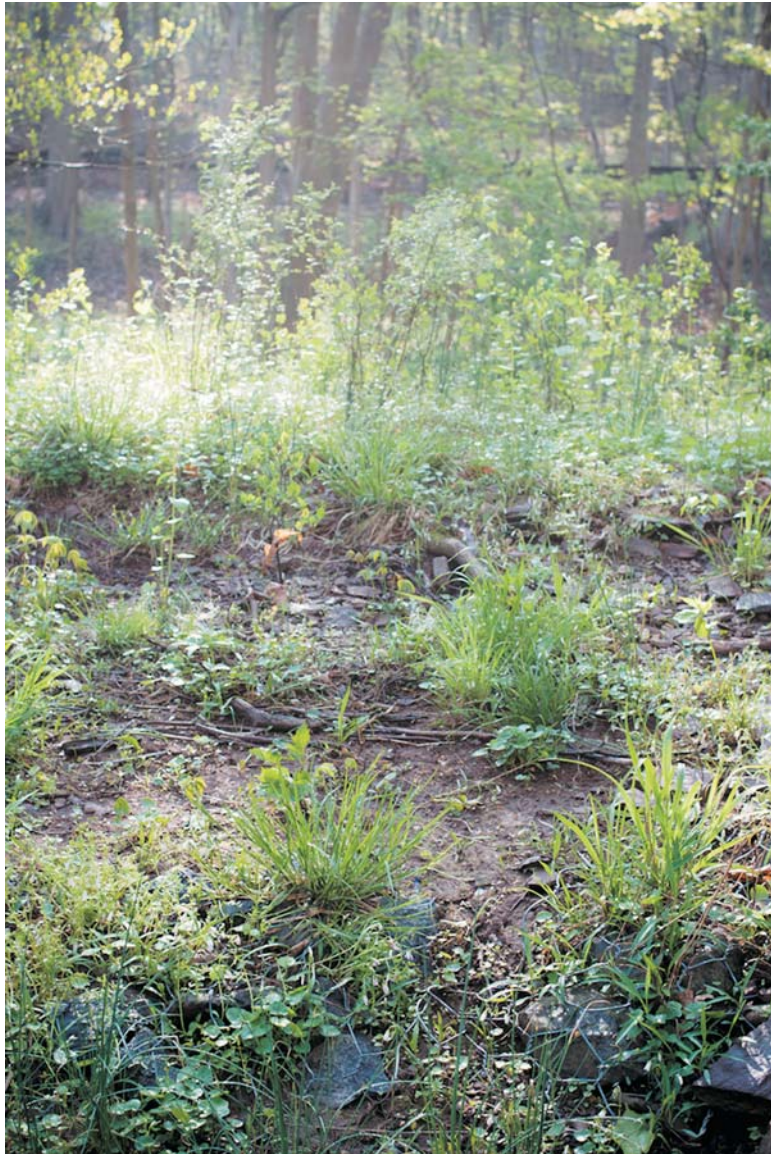
Plate 3. Exposed riprap on eastern bank of Jacob's Creel, looking east.

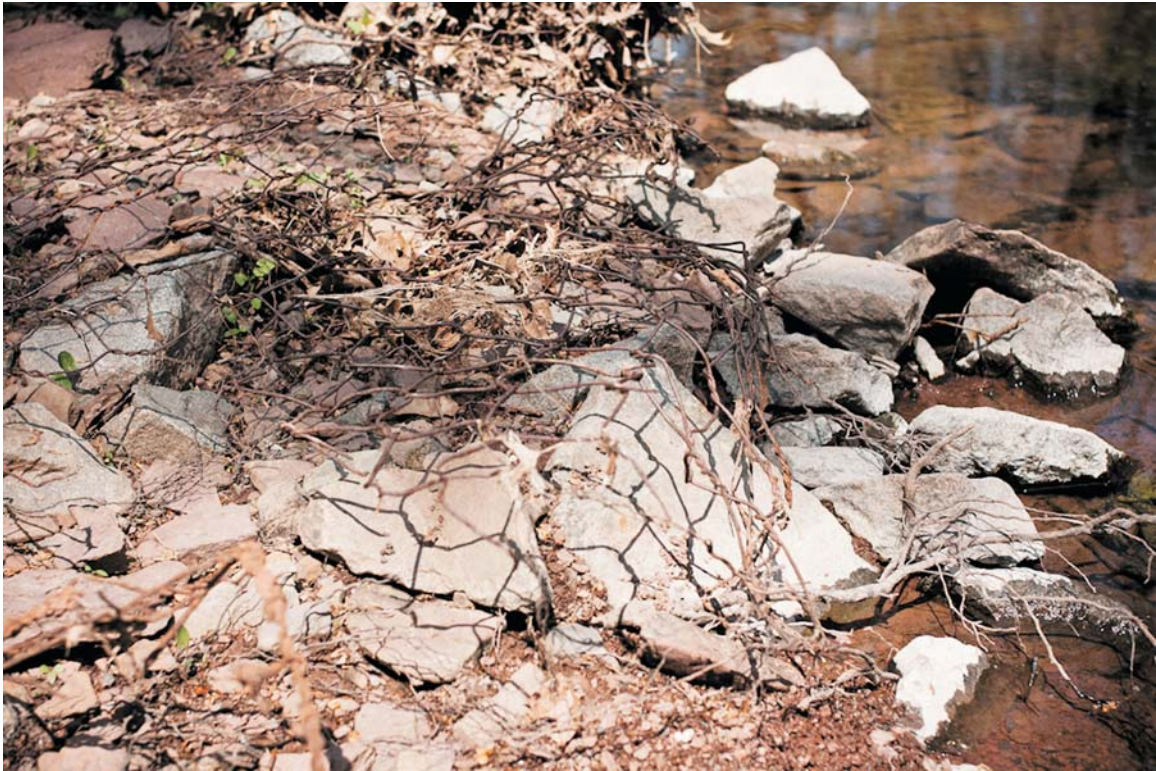
Plate 4. Exposed riprap on western bank of Jacob's Creek, looking north.

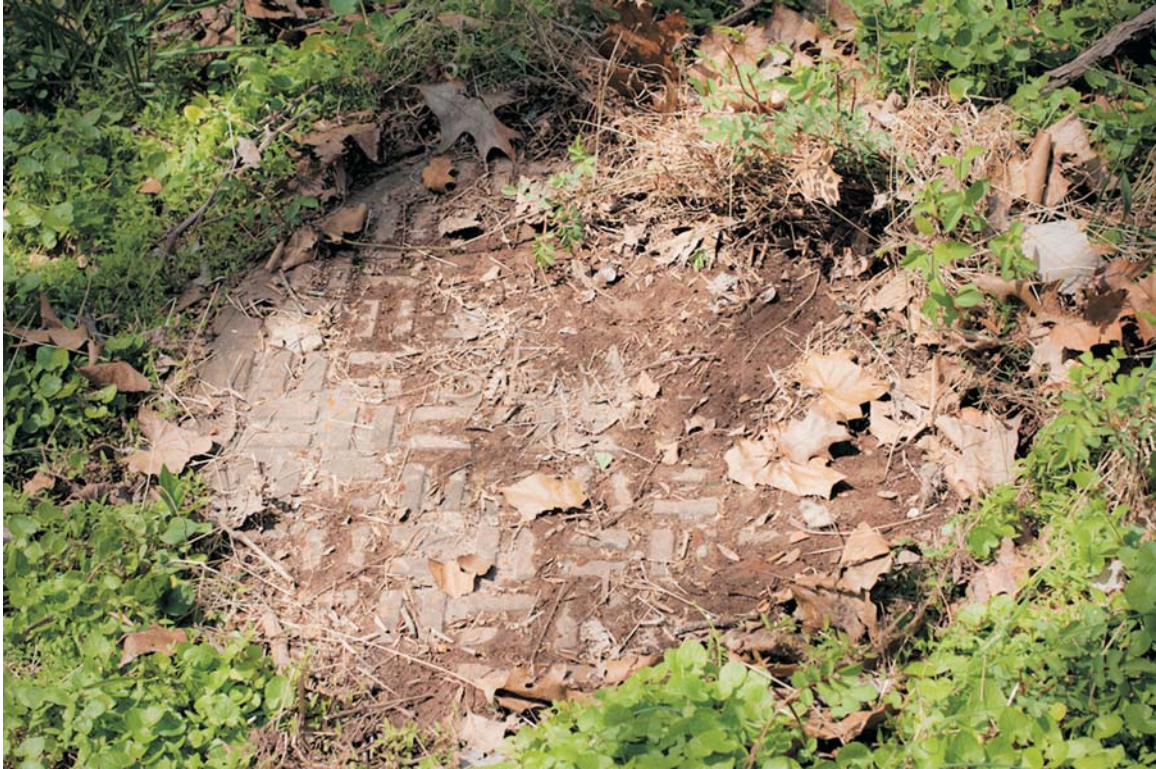
Plate 5. Manhole cover for sewer line crossing Jacob's Creek.

The project area is confined to a small strip of floodplain and hill slope situated to the west of Jacob's Creek Road and south of the extant Jacob's Creek bridge (Plate 2). For much of the project area, Jacob's Creek serves as its western boundary except for a small portion that extends west of the creek near the bridge. Known disturbances to the project area include a large sewer line that crosses the creek roughly 100 feet south of the bridge. Bucket auger tests, soil profiles, and observations of the creek banks indicate that the sewer trench has had a large impact on the integrity of the floodplain within the project area. Wire bound cages of crushed rock, commonly referred to as riprap, are buried in the banks of the creek on either side of the sewer crossing (Plates 3 and 4). Evidence of dynamite blasting in the way of tags from detonator wire was noted on the bank near the riprap. The proximity of bedrock to the surface (at the surface to one meter below the surface) likely required the use of explosives to achieve the grade necessary for the sewer line. A large sewer manhole cover is present on the western banks for the creek (Plate 5). Auger test numbers 10, 11, and 12 encountered shallow obstructions and disturbed profiles reflecting sewer trench fill (Figure 1). In addition to the sewer trench, an access road branched off Jacob's Creek Road and continued north towards the base of the bridge (Plate 6). This road apparently relates to recent construction. Its surface is well packed, flat, and level. Little erosion or displacement of the steep edges of the road has occurred. The road cross cuts a large pile of dumped rubble and bedrock which also does not show much erosion given its steep sides. Finally, the cultural debris, including bottles, cans, car parts, and general trash alongside the access road and Jacob's Creek Road is all recent. It is very likely that the road functioned as the access road for the heavy machinery needed to dig the sewer trench and lay the sewer pipes.

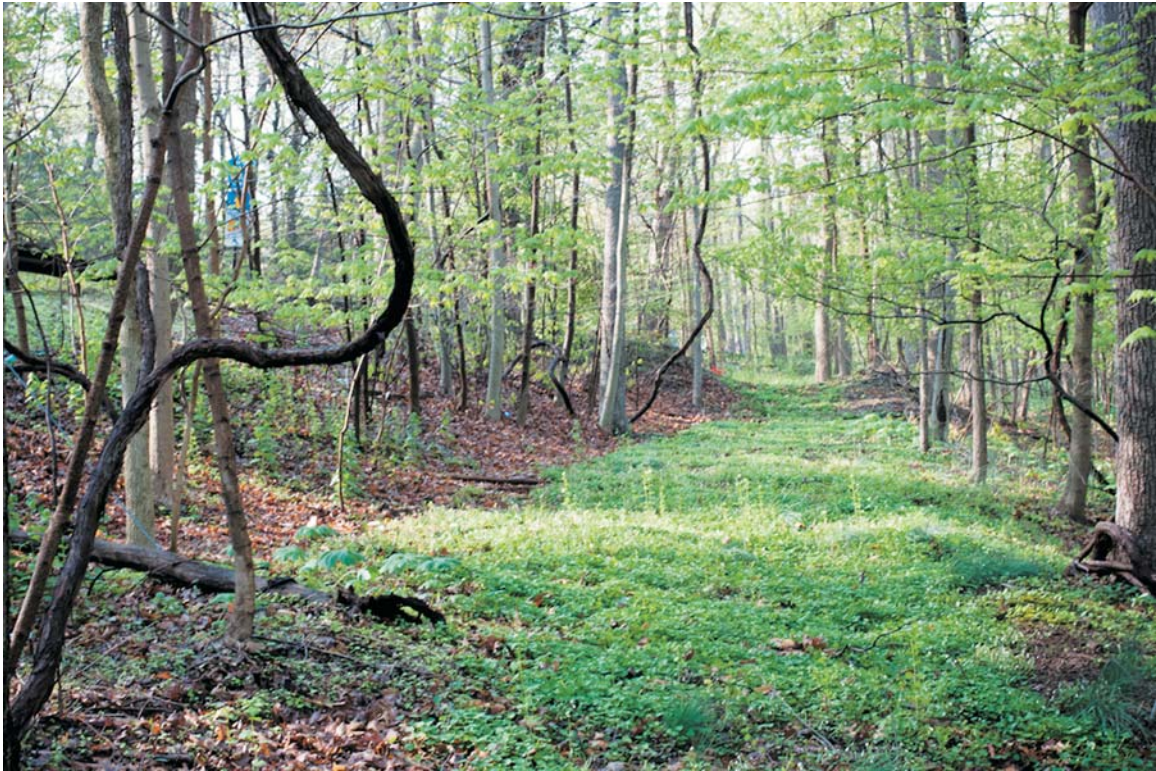
Plate 6. Construction access road alongside Jacob's Creek Road, looking south.

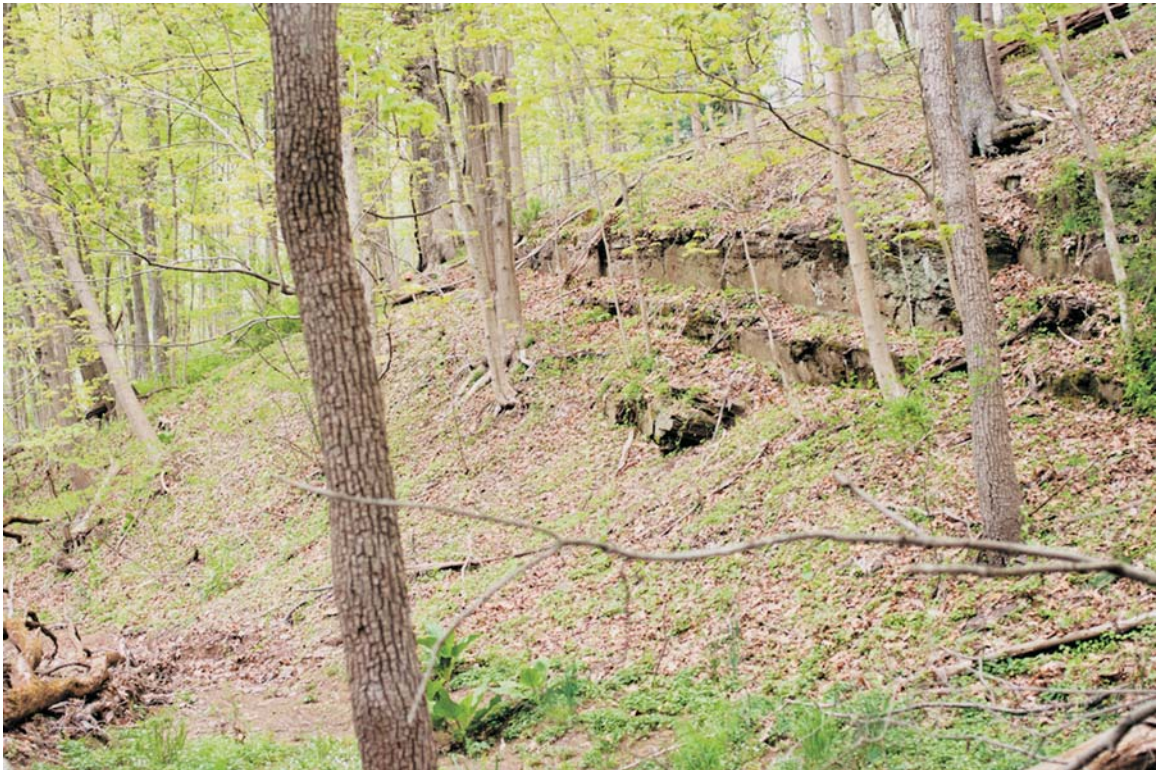
Plate 7. View along strike of quarried rock outcrop; looking southwest.

A rock outcrop was noted along the western valley slope that likely once served as a rock quarry. The outcrop, which may well have been the source of the rock for the bridge abutments, is located roughly 450 feet south of the bridge well outside the project area. Plates 7, 8, and 9 show the hill slope position of the outcrop and the tool marks found across the outcrop. The type of stone derived from this outcrop of Passaic Formation is very similar to the lithology of the cut stones in the bridge abutments.

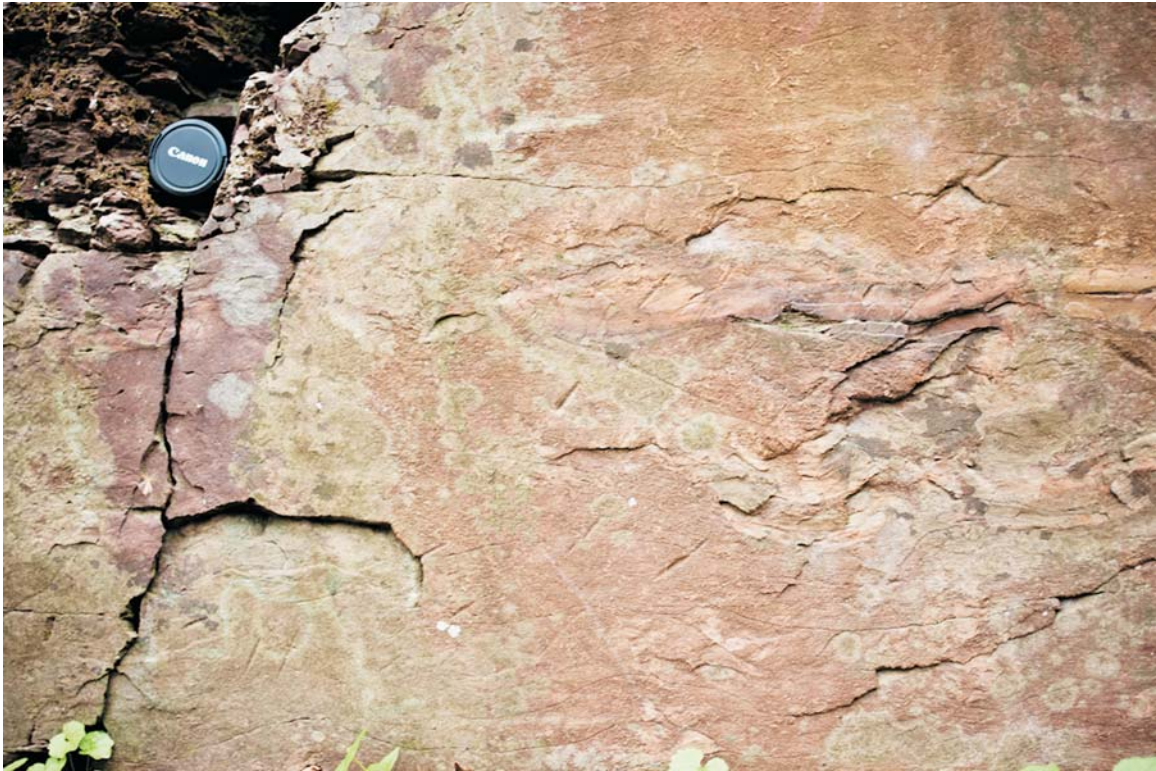
Plate 8. Evidence of pick and chisel marks along quarry face, looking west.

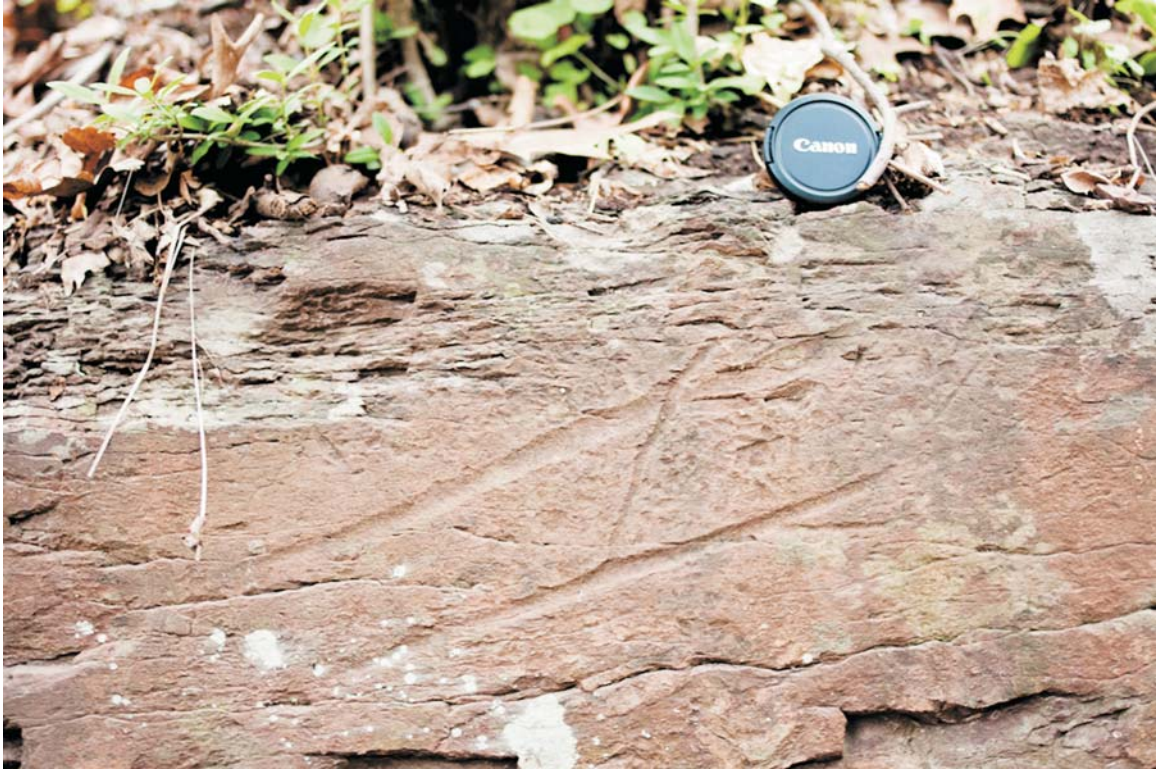
Plate 9. Evidence of pick and chisel marks along quarry face, looking west.

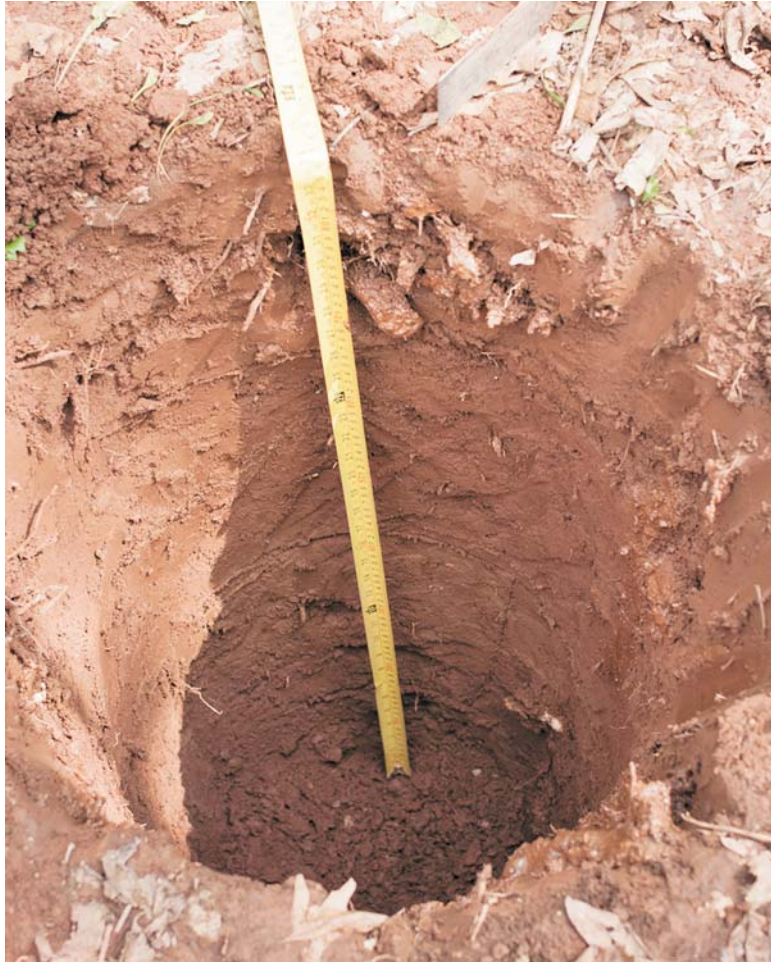
Plate 10. Profile of STP 1, looking north.

A shovel test unit (STU 1) measuring roughly 60 cm in diameter was excavated 3 m northeast of AH 7 to examine a larger sample of the intact alluvial soils at this location, which were deeper and drier here than elsewhere in the vicinity. The A horizon, 22 cm thick, was dark reddish brown silt loam with weak, granular structure, while the underlying cambic (Bw) horizon, reddish brown silt loam with weak, sub-angular blocky structure, extended from 22–52 cm below surface. A slight lightening of the soil, though still registering as reddish brown, occurred between 52–77 cm, corresponding to a BC or C horizon, and a basal deposit of moist, reddish brown, shaly silt loam, a probable 2C horizon, was exposed between 78–86 cm. No artifacts were present in any of the horizons.

Excavation within the project area did not encounter any prehistoric or historic period archeological artifacts, subsurface features, or buried land-surfaces. A small area of intact soils was identified (AUs 7-9 and STP 1), but the soil profile in this area (Plate 10) suggested a recent age and alluvial origin. Given the disturbance caused by the sewer pipe, access road, recent soils, and high degree of scouring by Jacob's Creek, it is extremely unlikely that any in situ artifacts or features are present within the proposed impact area of the new bridge and its approaches. JMA does not recommend any further archeological testing.
