NEW JERSEY DEPARTMENT OF COMMUNITY AFFAIRS  
DIVISION OF FIRE SAFETY  
OFFICE OF THE STATE FIRE MARSHAL

SAFETY ALERT 09-1

## Large Diameter Hose Appliance Failure Issued April 23, 2009

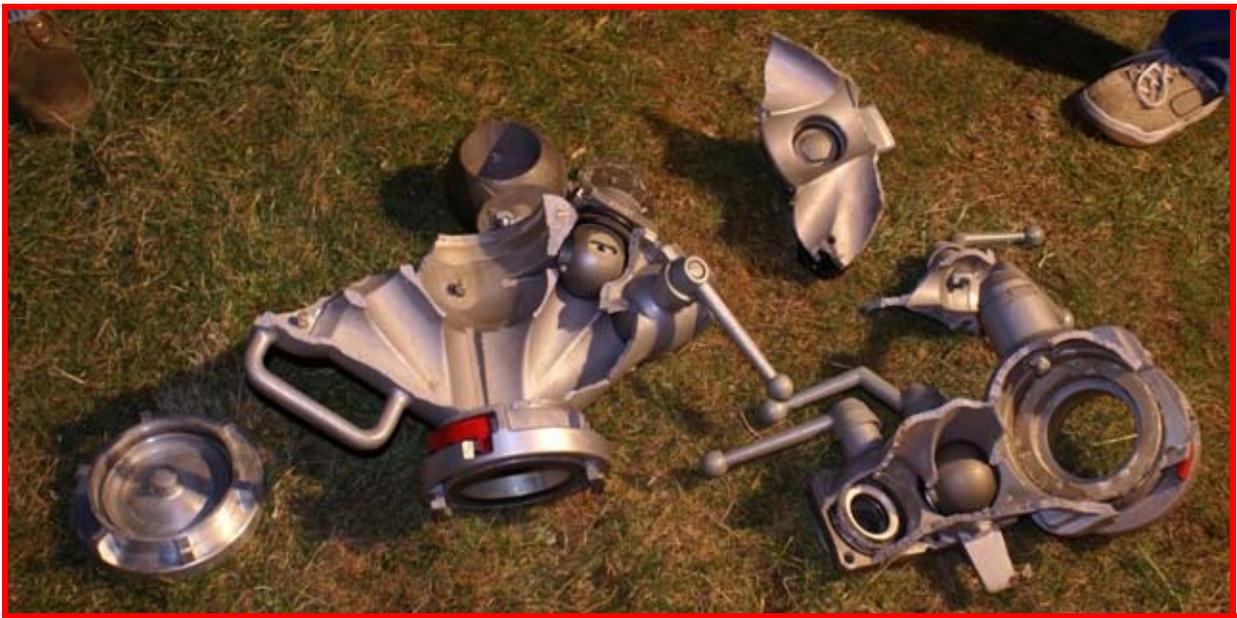
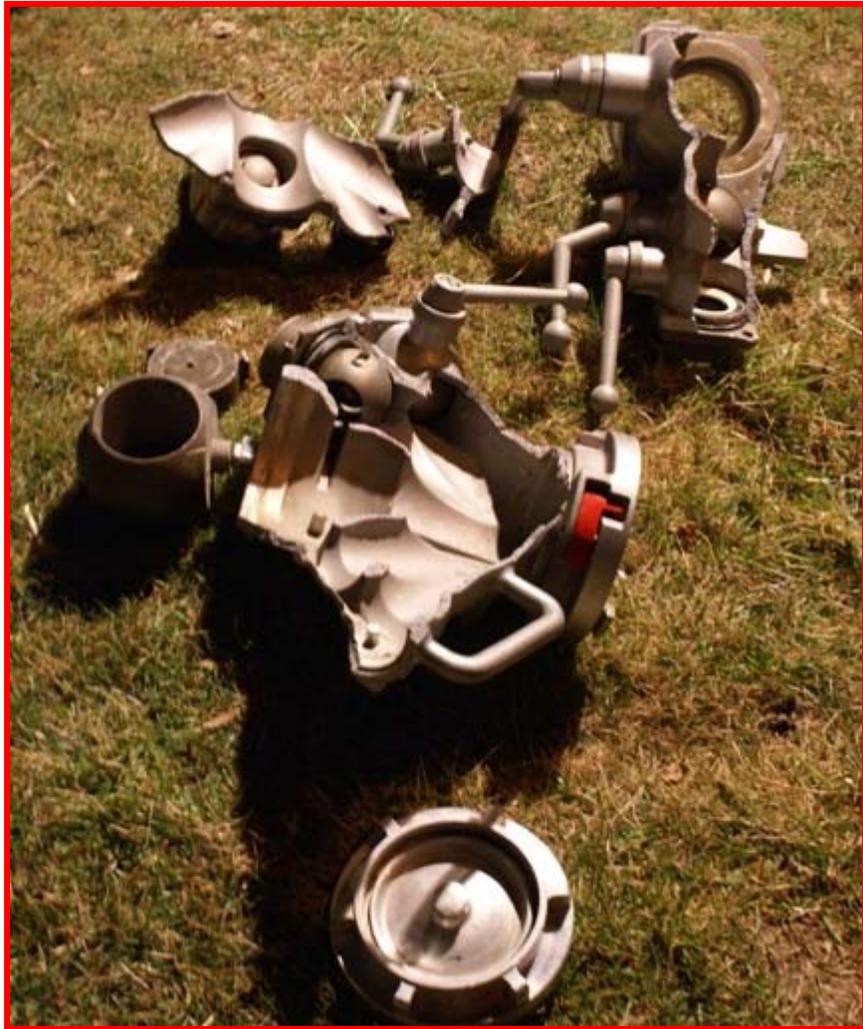
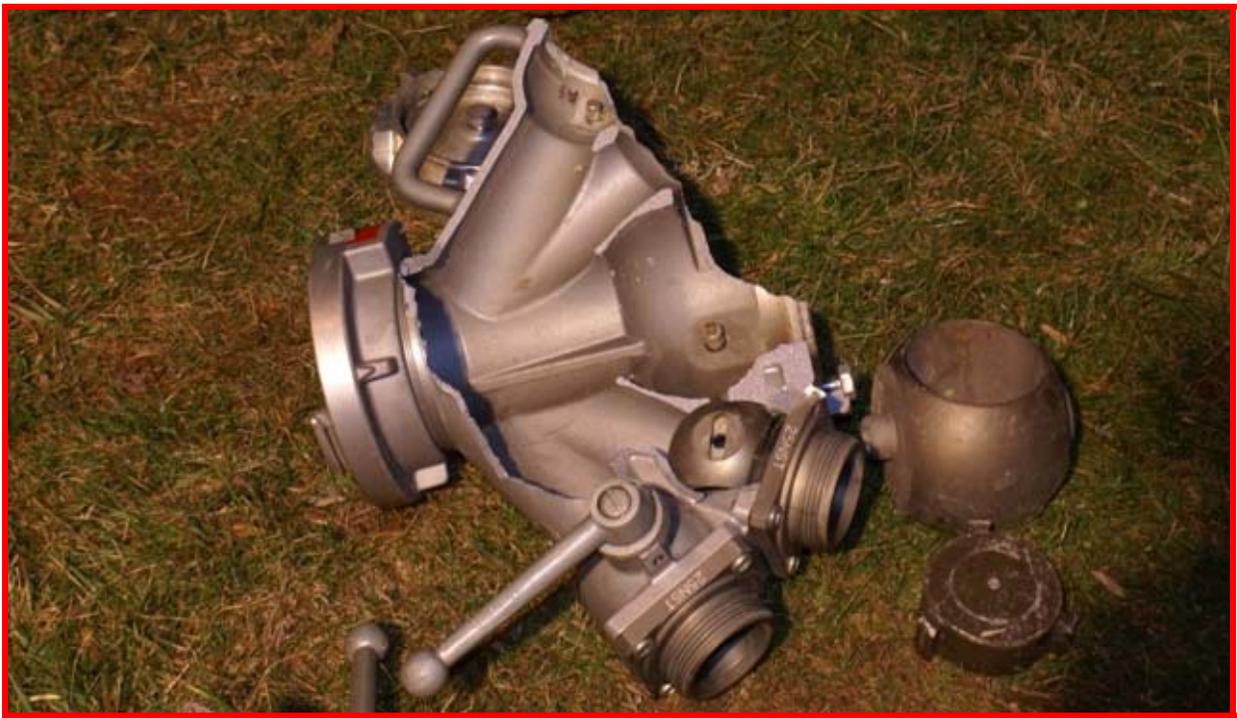
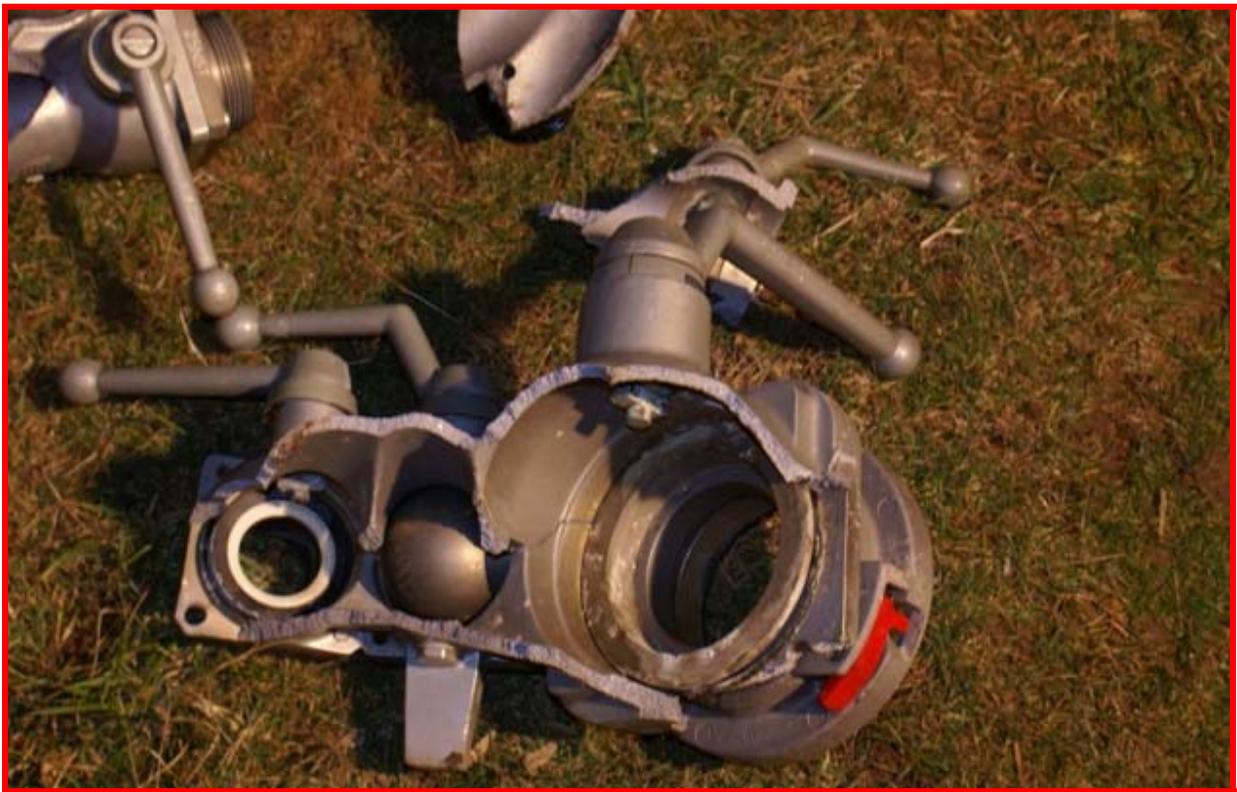
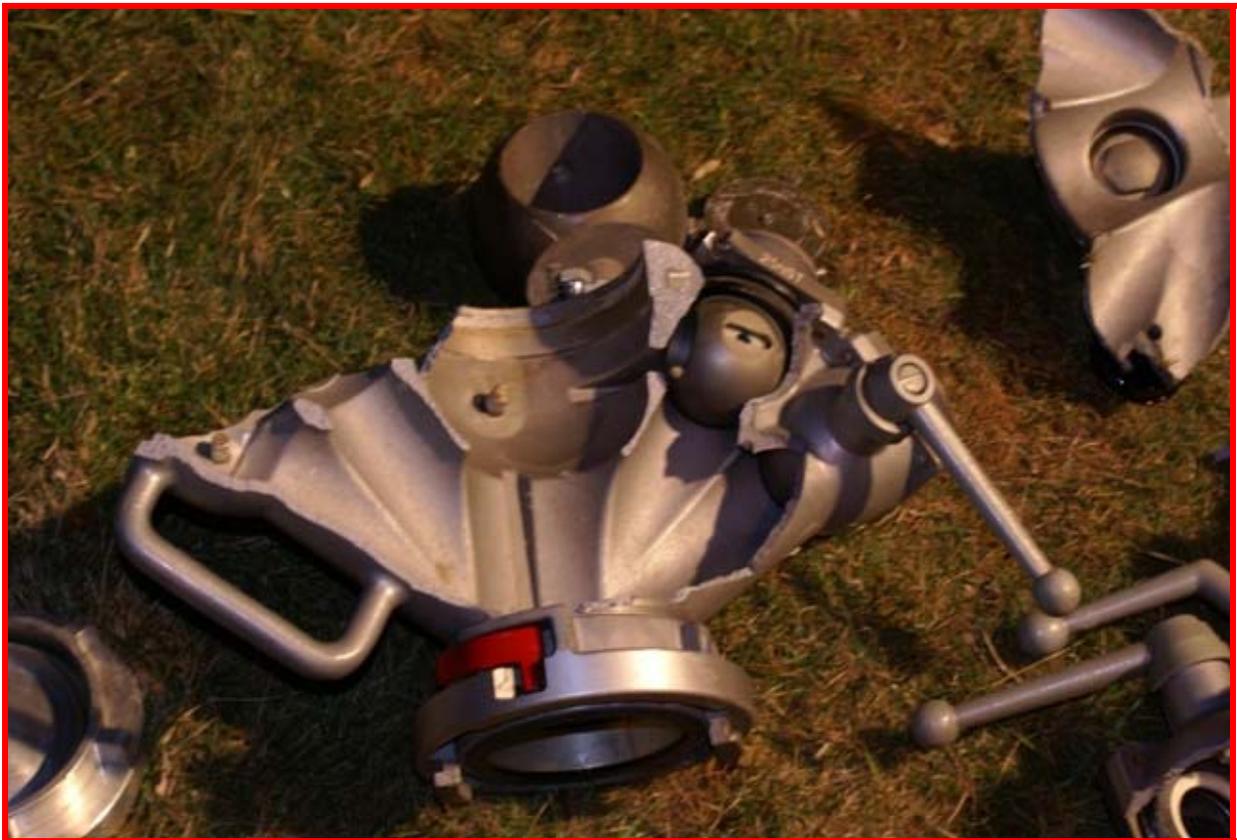
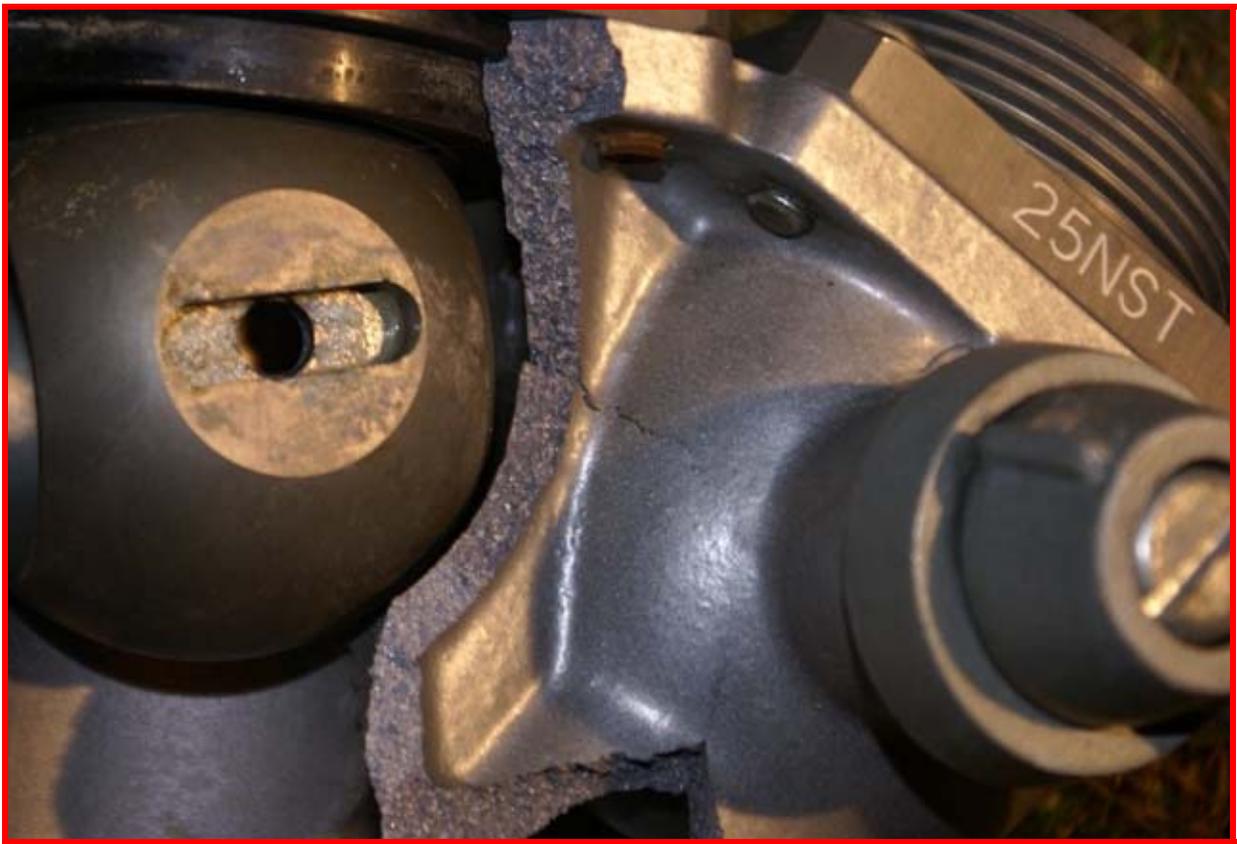
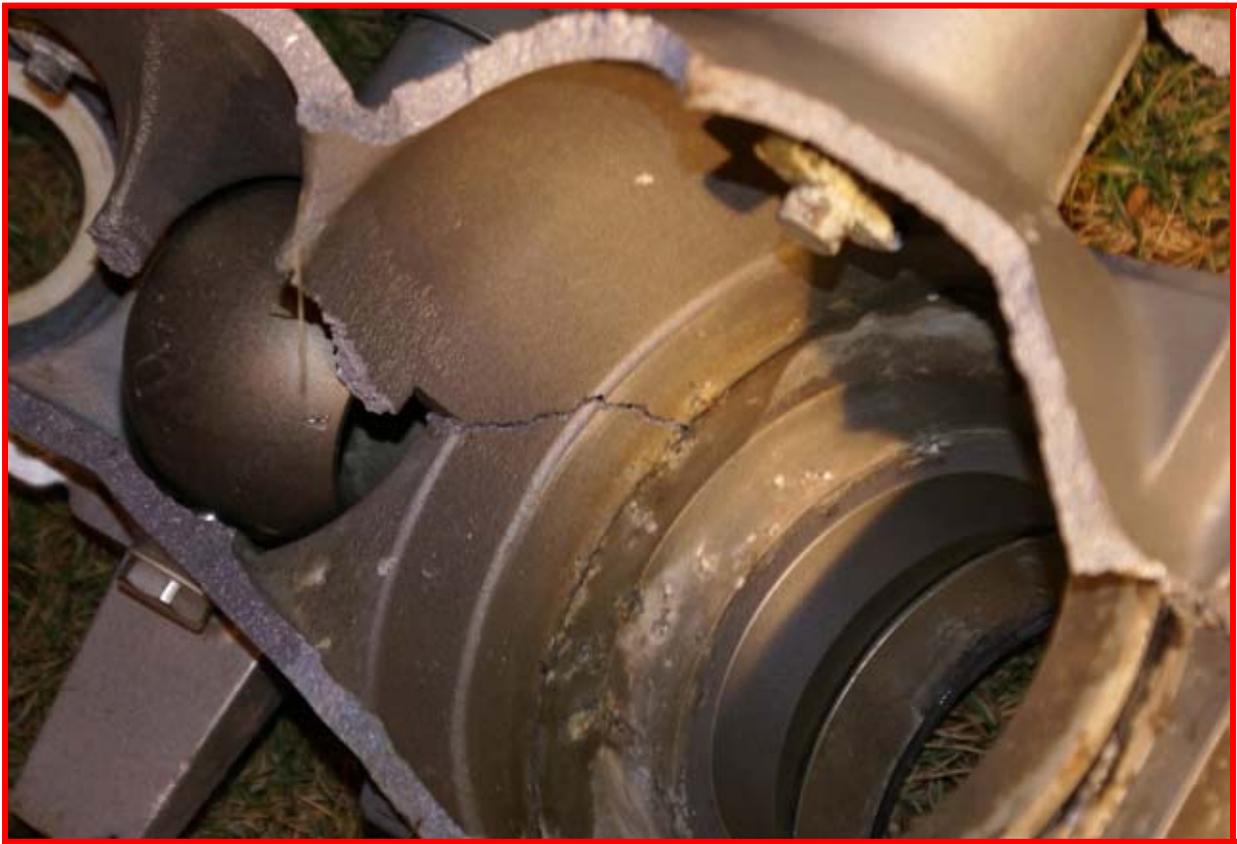
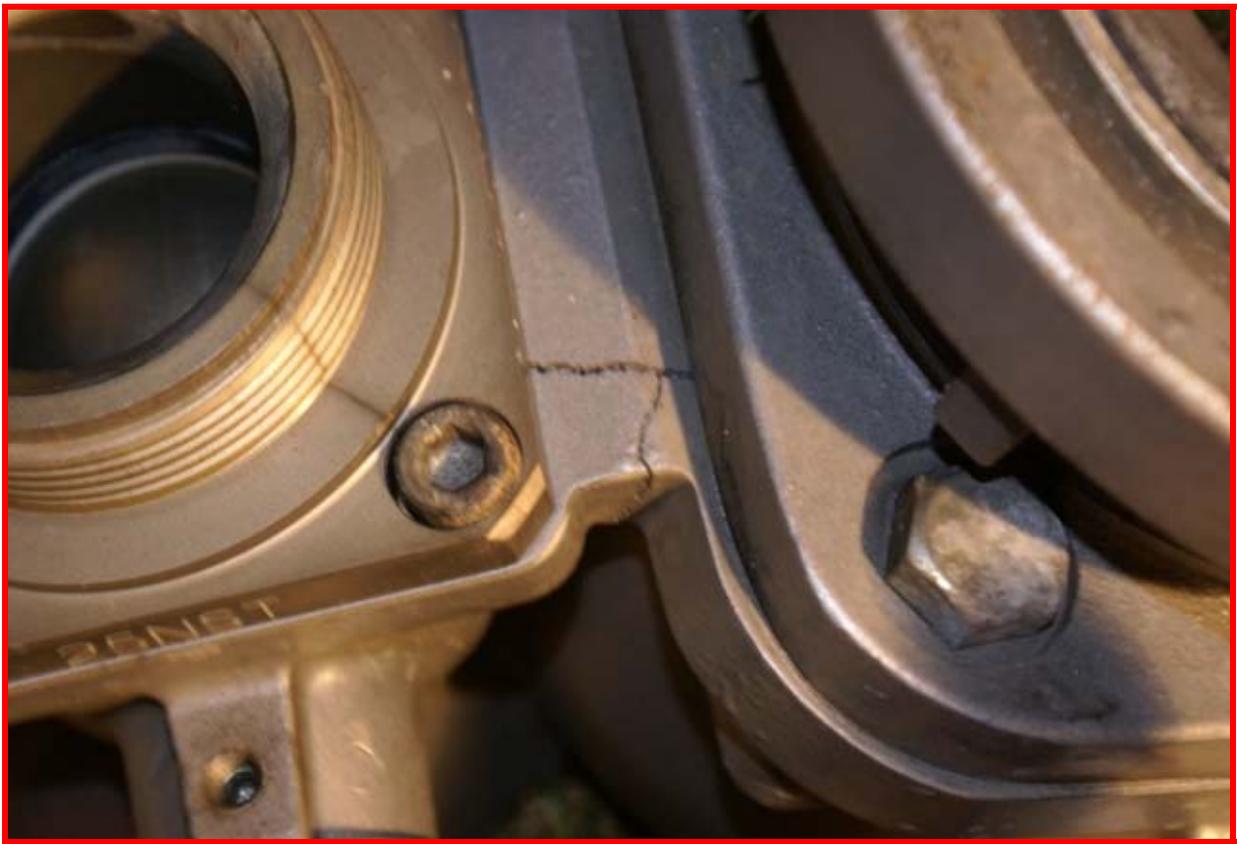
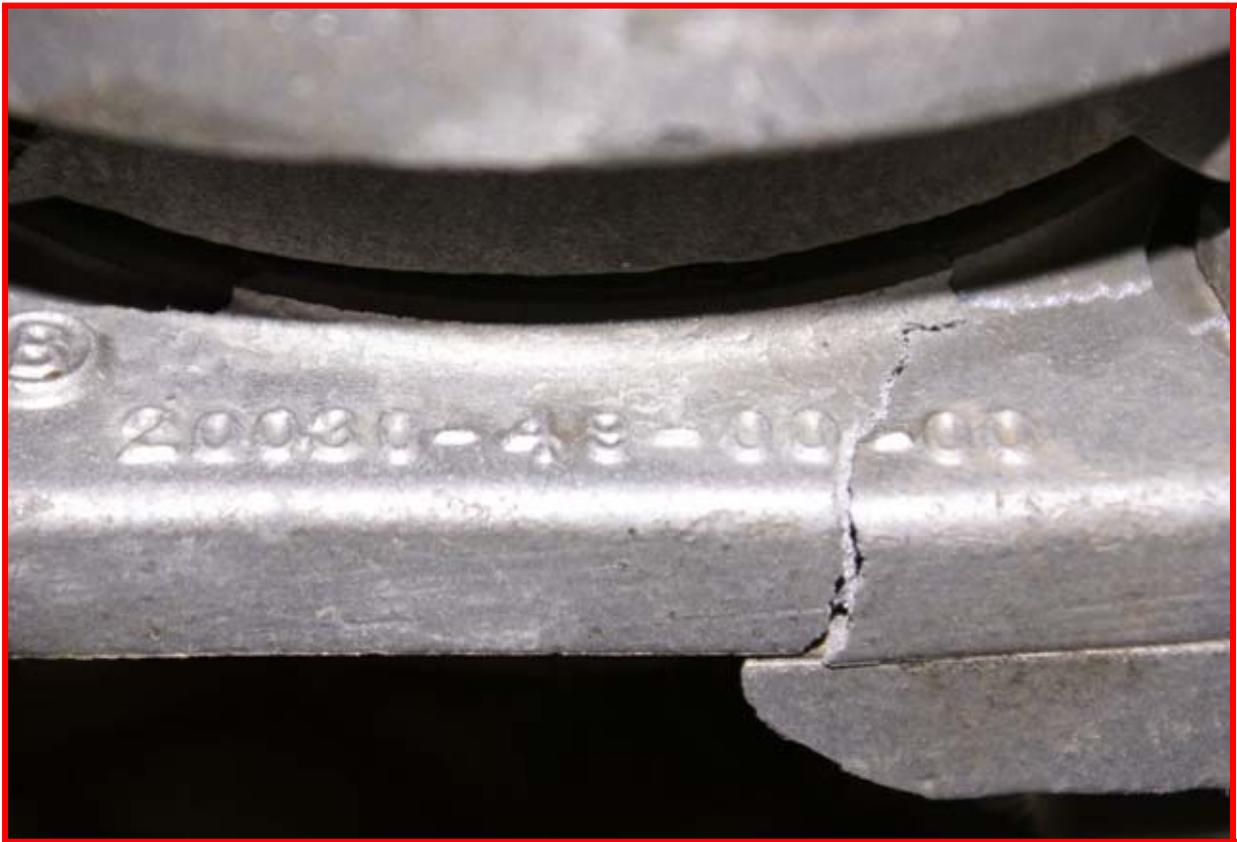
Approximately one month ago, a fire department in Hunterdon County, NJ experienced a failure of a cast aluminum large diameter hose appliance. This appliance was set up with a LDH inlet and outlet and four gated 2.5-inch outlets. The appliance, commonly known as a street hydrant or manifold, was equipped with a pressure relief valve and was being used to fill tenders at the time of the failure. The appliance was sent back to the manufacturer for further investigation and analysis.

As a result of the analysis by Snap-tite Hose, Inc., it was determined from the evidence provided that the cause of this failure was a severe over-pressure condition, such as water hammer. Fire department personnel stated that they were careful not to create any conditions that might result in water hammer. However, the local water authority stated that they had caused an overpressure in the water system. Improper operation of a valve in their system could have set up a water hammer condition that travelled through the hydrant and to the manifold. It was also found that the relief valve on the manifold had not been maintained or tested as suggested by NFPA 1962, Chapter 8. Periodic testing of the valve would have detected that it was non-operational.

It should be noted that the relief valve would likely not have prevented damage to the manifold in this situation since it appears that the manifold was subjected to a sudden, significant pressure increase. As stated in NFPA 1965, par.A.4.4, relief valves are not designed to relieve water hammer, which is described as a sudden pressure increase in the system.

1. Water hammer is an extremely destructive force and must be prevented at all costs.
2. Due to the significant damage caused to this appliance, Snap-tite Hose highly recommends a thorough inspection of components that may have been subjected to pressure spikes. This would include appliances, hoses, connectors, adapters, and perhaps truck piping and pumps.
3. Relief valve maintenance is critical to the safety of personnel and equipment. The guidelines for appliance maintenance and testing as established in NFPA 1962 are highly recommended. It is recommended that all relief valves be immediately tested for proper operation, and that a schedule be created, maintained and documented.
4. All appliances should be service tested annually as recommended by NFPA 1962.
