NEW JERSEY DIVISION OF FIRE SAFETY

Firefighter Fatality and Serious Injury Report Series

Firefighter Runs Out of Air and Loses Consciousness While Operating at a Structure Fire

**Englewood, New Jersey
December 12, 2003**

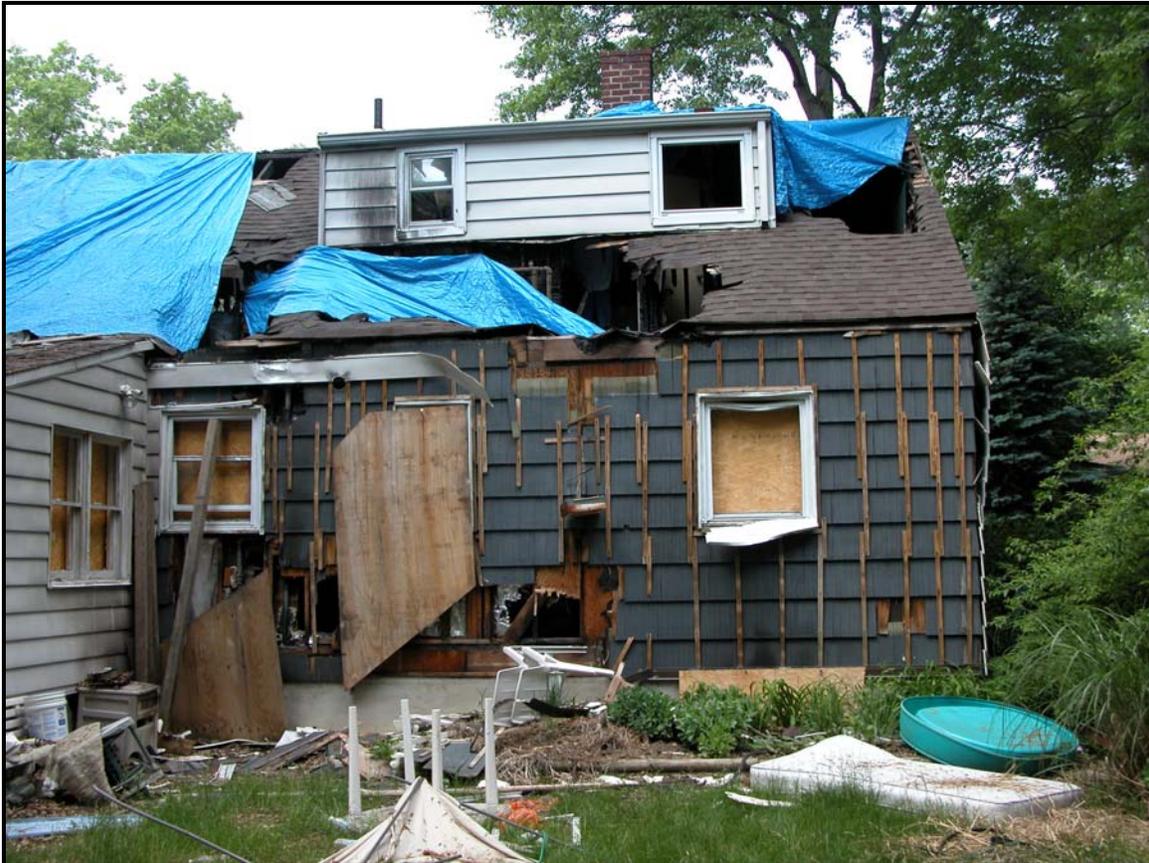
Figure 2

View of side “C” of the dwelling. Note the 1st floor window nearest to side “B” of the structure. This is the window where Lt. Ryland and FF Escobar escaped and where FF Sternesky was rescued from.

At 0019 hours, 16 minutes after the dispatch time, the third dispatch for the recall personnel went out over the fireground frequency. Lt. Ryland and FF Escobar were now together in a room at the rear of the structure; they soon found a window to escape, but had great difficulty due to the size of the window. Both had to remove their SCBAs to fit through the opening with the assistance of personnel on the exterior. During this time period, R-1 and a mutual aid unit from the Teaneck FD arrived on the scene. FF Escobar exited first, followed by Lt. Ryland; as he exited, he felt something hit his leg, possibly someone's hand. Upon exiting, he told Capt. McLoughlin that there was still someone inside the room. Three personnel: FF Robert Heller, FF Darius Hunt, and Lt. Michael Marino immediately entered the window for the rescue operation. They quickly

located FF Sternesky on the floor of the room. They had difficulty moving him due to furniture and debris partially on top of him. Minutes later, they removed FF Sternesky through the window, with the assistance of personnel on the exterior.
