NJM Hammonton Regional Operations Facility

NJM Insurance
Group

Princeton Hydro

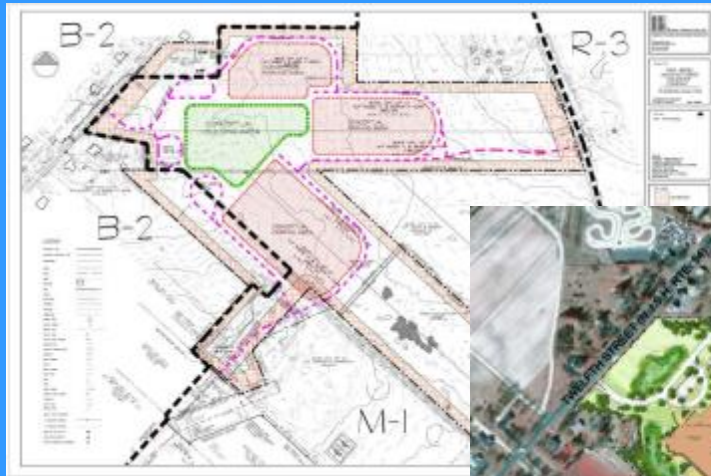
From concept to reality

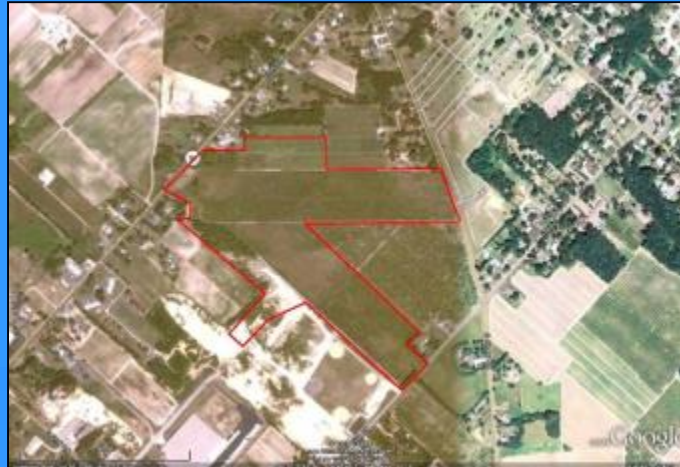
Site Layout and Constraints

- 55-acre site.
- Historic peach orchard (remediated for historic pesticides, 26,000 cy removed from the site).
- Adjacent to historic gravel mine.
- Limited stormwater infrastructure in vicinity.
- Within the NJ Pinelands.
- Required to infiltrate difference between 10-year pre- and post-development runoff.

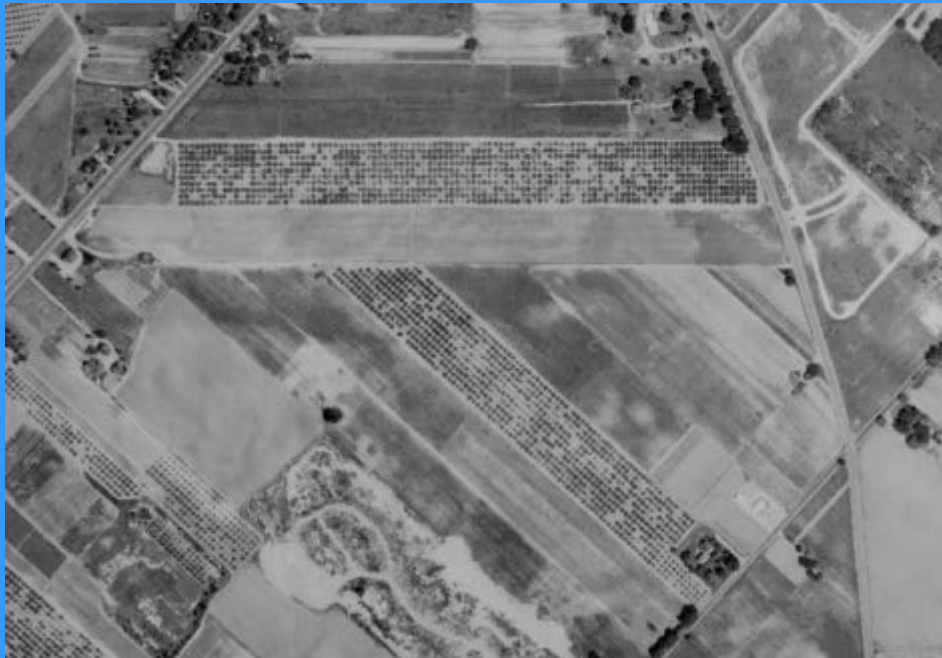
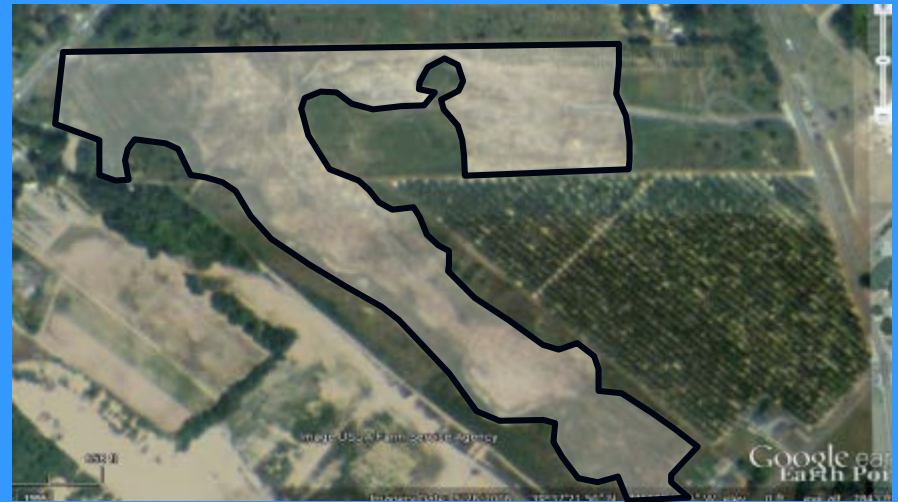
Historic Pesticides

- NJM first remediated site to the residential standard.
 - Historic peach orchard
 - Dieldrin and arsenic contaminated soils
 - Removed 26,000 cubic yards of soil

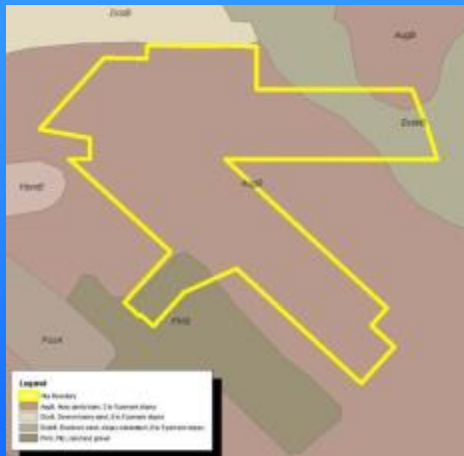
Look into site's ability to manage stormwater

- Client did something that should be considered by others:
 - Asked us to determine the maximum area of impervious cover that the site could handle in relation to the regulations.
 - Then backed into zoning to see what size building they could construct.

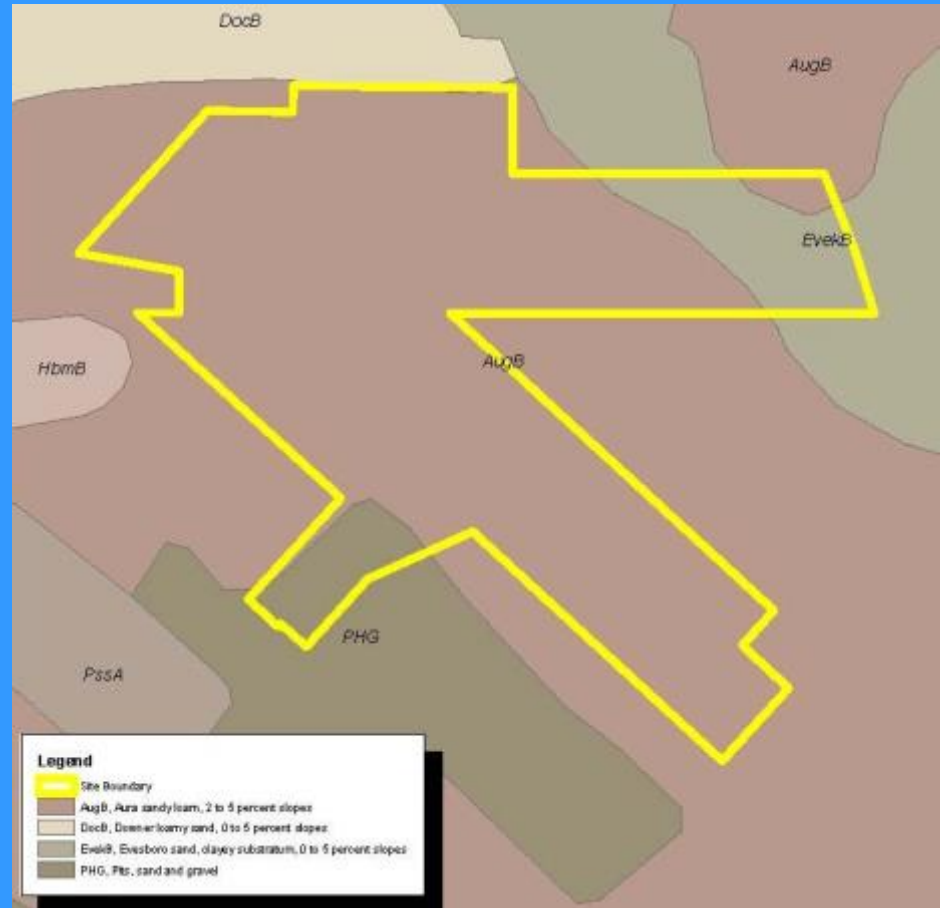
Conducted appropriate on site testing

- Desktop review of on-site soils
 - Aura soils limitations revealed
 - Clay bridging between soil particles
 - Fragipan located between 22 and 60 inches.

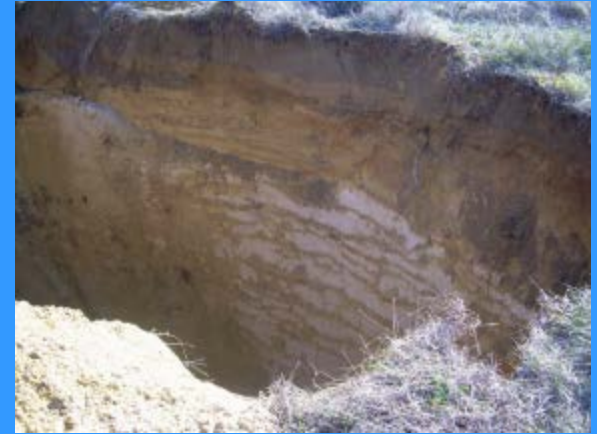
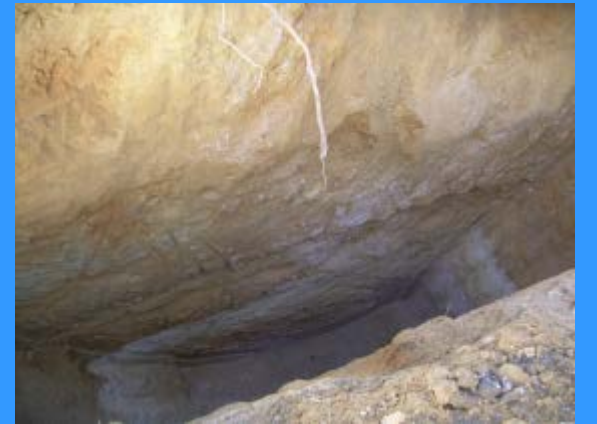
Field Work

➤ Test pits and borings followed a 2 step process:

- Step 1: General investigation to determine appropriate locations for basins and other facilities
- Step 2: BMP Specific Investigation
- Installed 5 wells on site to assess regional groundwater and fluctuations

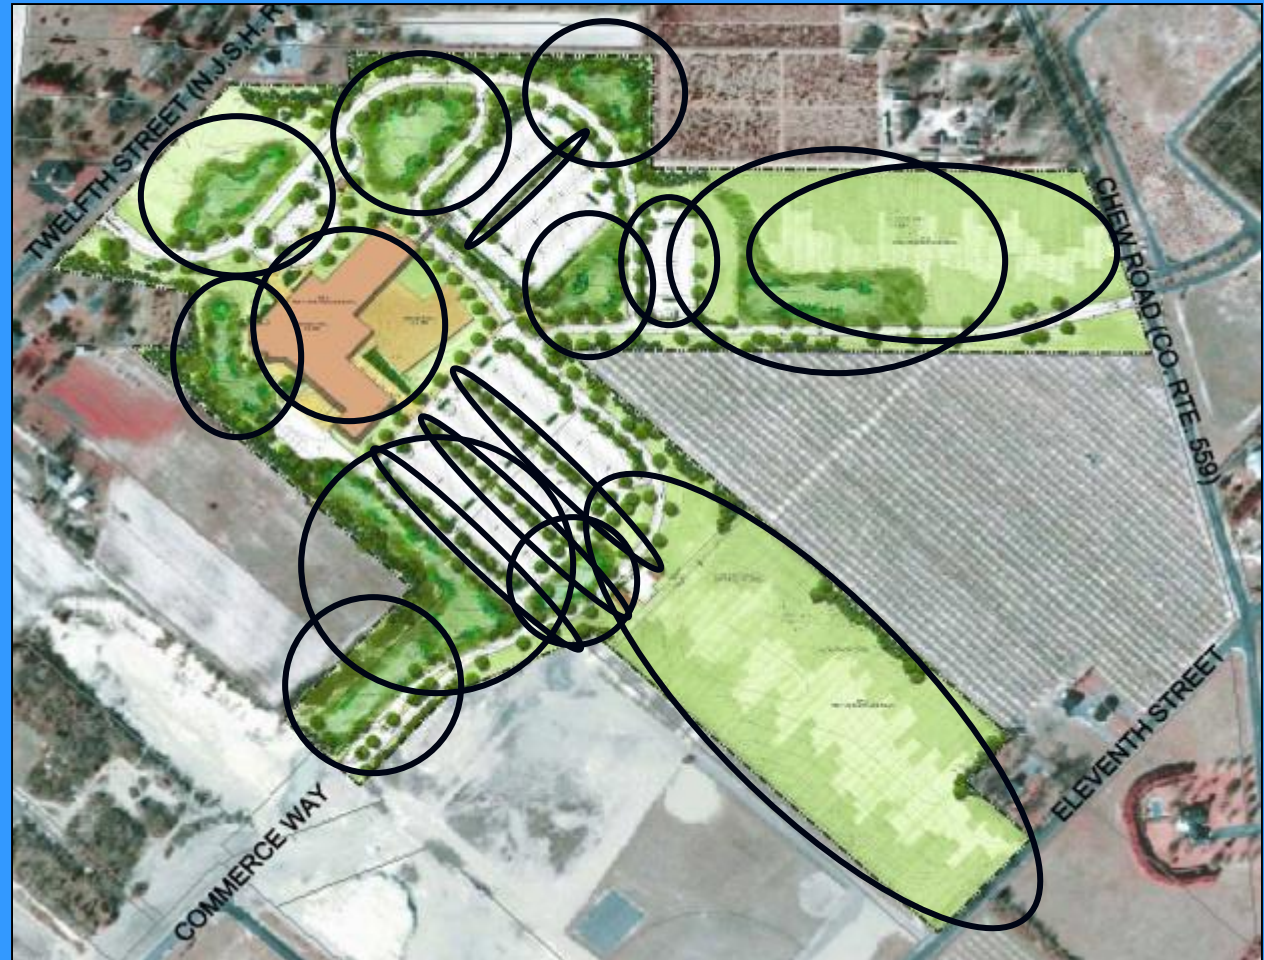
Final Layout and Integration of BMPs

8 Bio-Infiltration Basins

1 Wetland Basin

6 Bio-Infiltration Islands

1 Bio-Retention Swale

Roof rainwater
harvesting (120k gallons)

(Phase II) Pervious
pavement

Meadow
creation/preservation

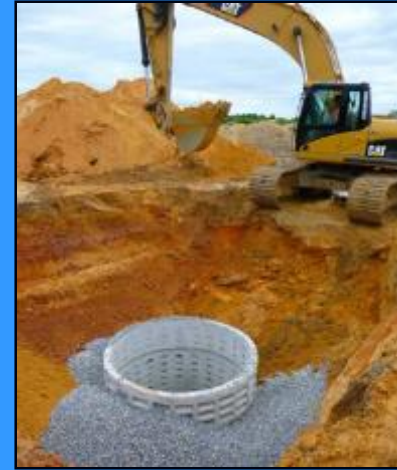
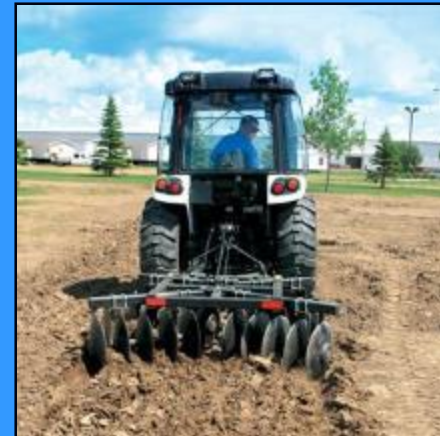
Addressing at the source

- Seepage pit/sumps for pre-treatment
- All areas disturbed to remain non-impervious were roto-tilled and where necessary, compost amended.

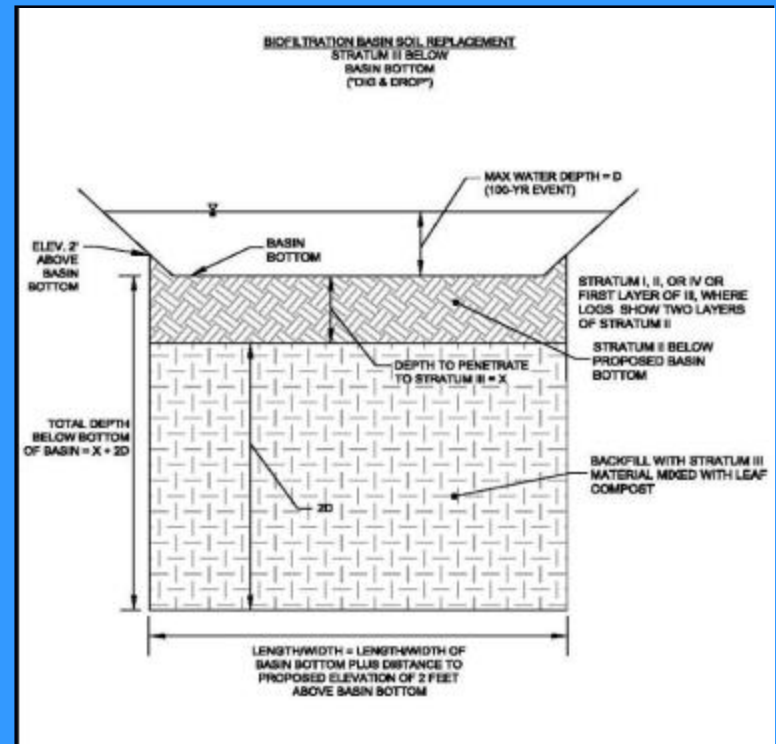
Proposed Methods for Preparation of Infiltration Zones

- Need to break-up clay bridging and layers.
- Need to penetrate soils with fragipans.
- Need to reduce bulk density of infiltration zones to achieve higher permeability rates and increase temporary subsurface storage.
- Need to understand underlying aquifer.
- Mounding Analysis was critical in determining effectiveness of infiltration areas.

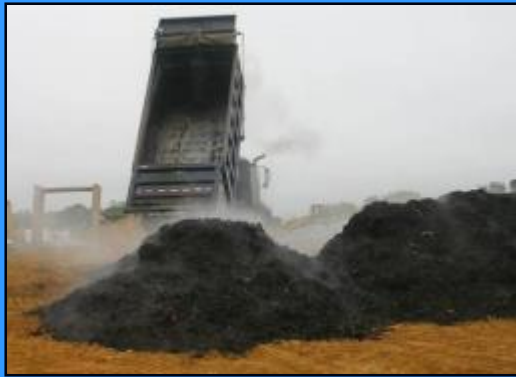
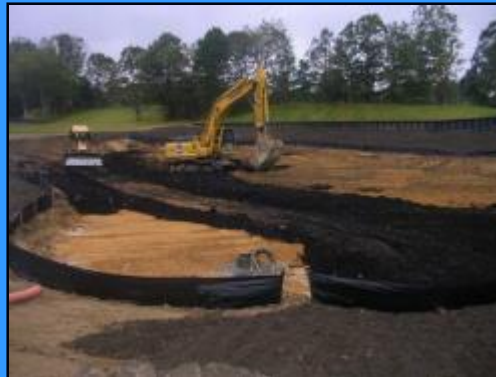
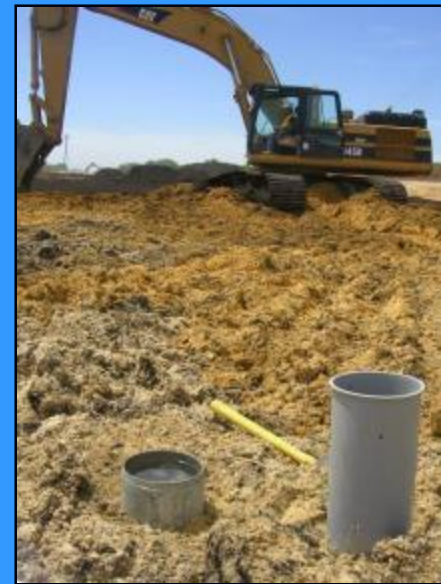
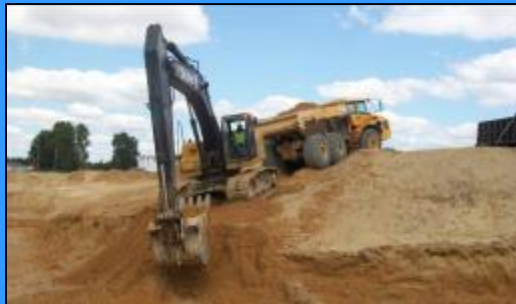
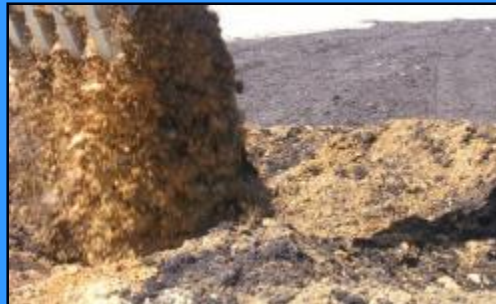
Solutions for Preparation of Infiltration Zones

- Excavate and remove all fragipans and materials classified as clayey sands and silts.
- Dig and drop all areas to a depth of 2x maximum expected water depth and at least 2x water depth into underlying sandy stratum
- Top 3 feet mixed with organics (i.e. whole leaf/fine leaf composite).

Infiltration can be optimized by excavating and backfilling the subgrade to a depth of 2 times the expected maximum water depth in the basin.

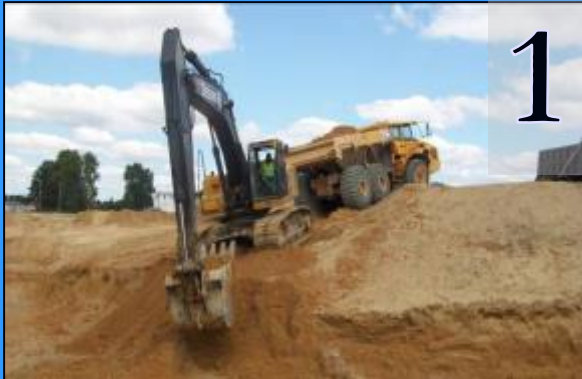
1

Remove deleterious soils

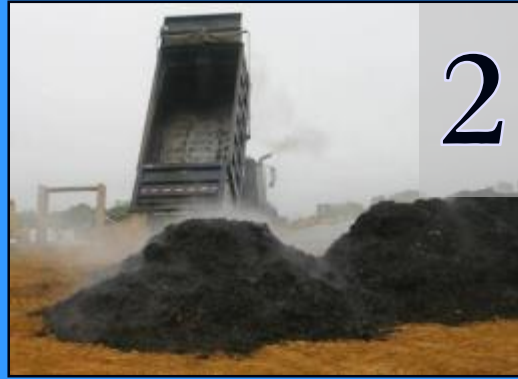
2

Deliver organics

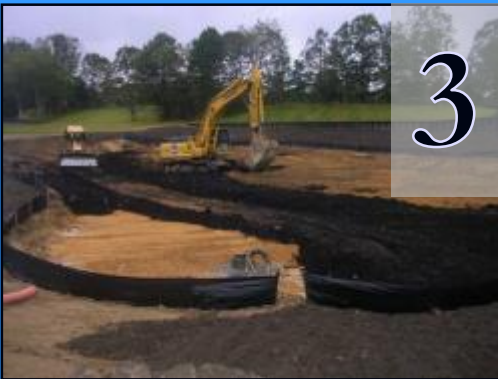
3

Spread organics

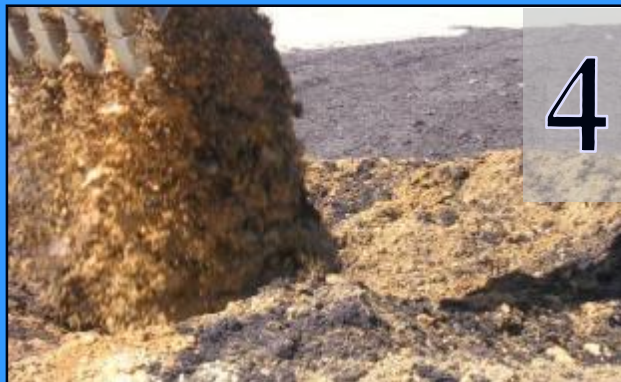
4

After deep mix, mix in organics to 3 feet

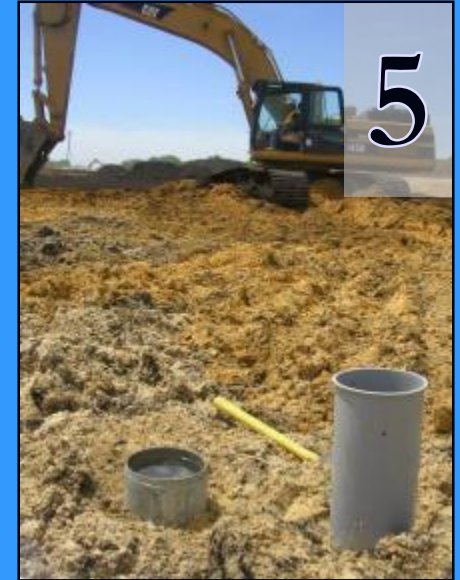
5

Test to ensure infiltration rate goals

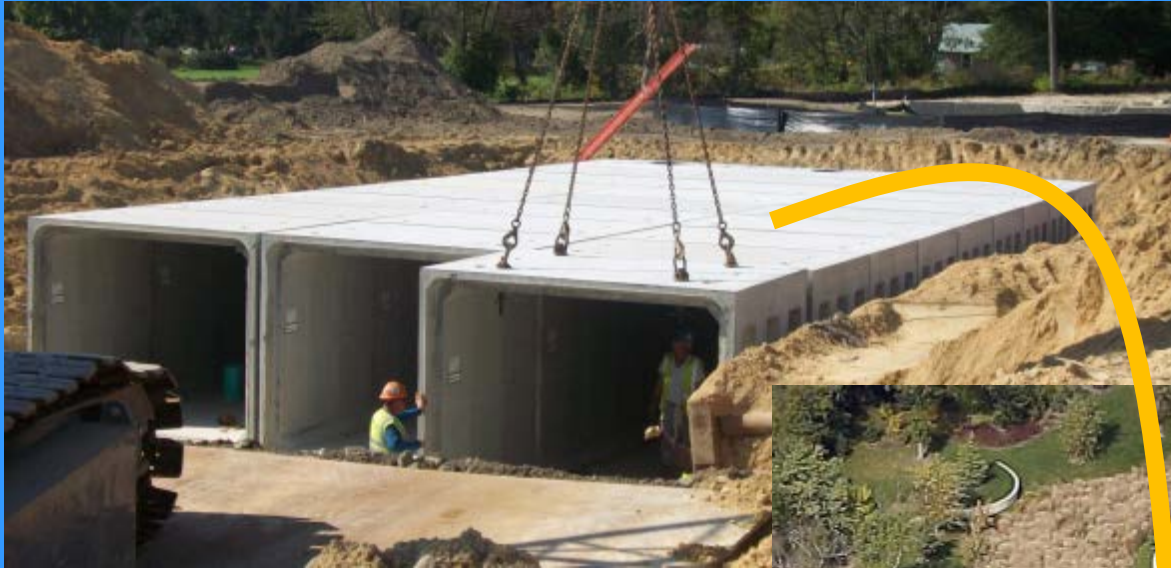
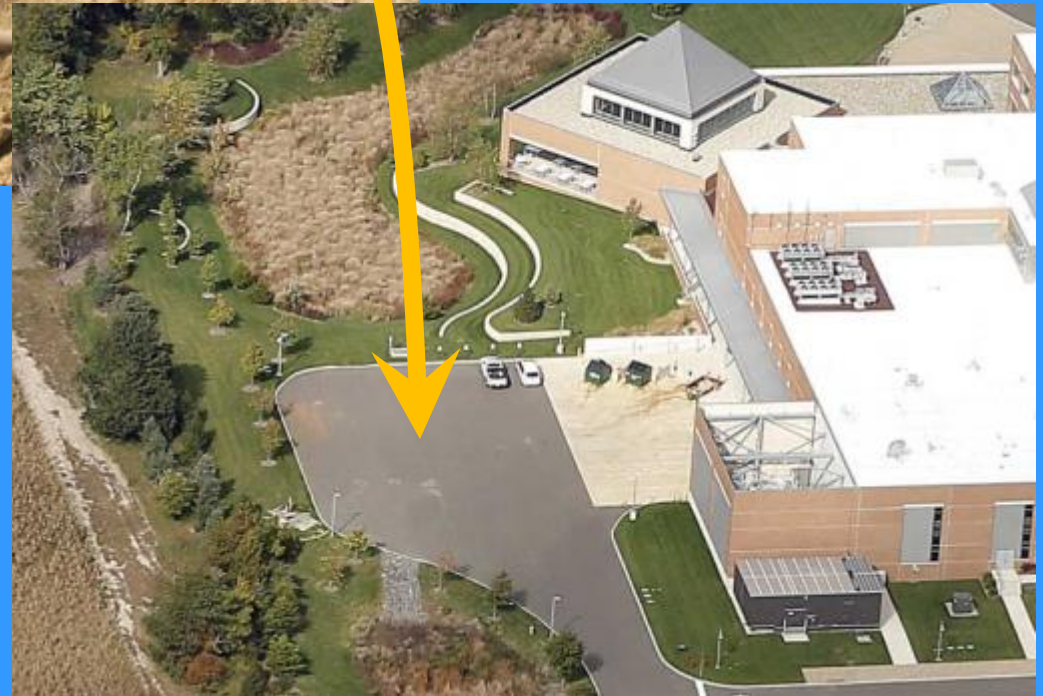
120,000 gallon cistern to collect roof runoff and use for landscape irrigation
