Stormwater Monitoring at Beachwood Beach West and West Beach of Pine Beach

A Closer Look at Water Quality within Barnegat Bay

Rutgers University

August 12, 2011

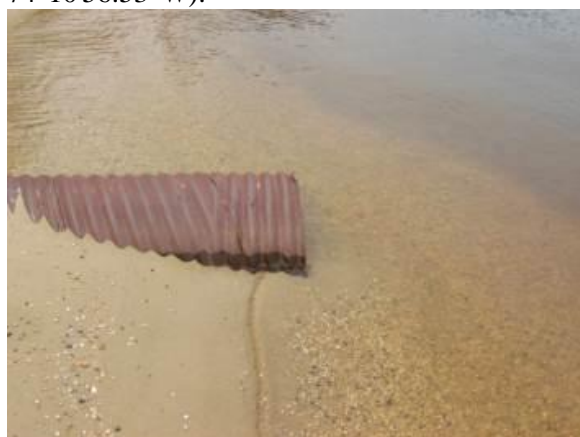
Figure 2. Storm pipe at Site 2 of Beachwood Beach West.

Prior to this project, the NJDEP identified hot spots along the Toms River with known water quality issues. Beachwood Beach West and West Beach near Avon Road of Pine Beach were selected from this list because they were located close to one another and thus would provide the most feasibility for stormwater monitoring. After touring both locations, the sites were chosen. Four sites were set at Beachwood Beach West (See Fig. 1), known as Location 1, including: Site 1 by a walkway near boat slips, Site 2 at an outfall pipe, Site 3 near the dock, and Site 4 at another outfall pipe. To note, during storm events samples were also taken within the storm outfall pipes at Sites 2 and 4 (See Figs. 2 and 3).

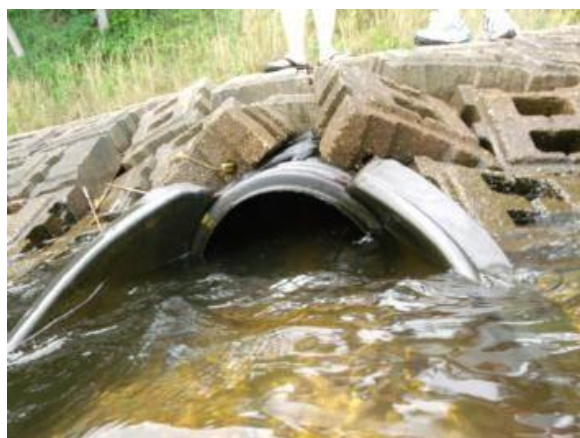
Figure 3. Storm pipe at Site 4 of Beachwood Beach West.

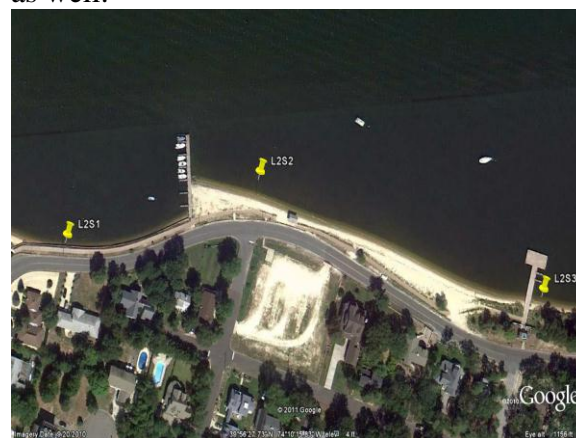
Figure 4. Sites at Location 2, West Beach, Avon Road in Pine Beach. From left to right: Site 1 (39°56'27.47"N, 74°10'22.82"W), Site 2 (39°56'28.46"N, 74°10'17.09"W), and Site 3 (39°56'26.62"N, 74°10'8.61"W).

Three sites were also selected at West Beach of Pine Beach (See Fig. 4), known as Location 2, including: Site 1 near boat slips, Site 2 at an outfall pipe, and Site 3 off the dock. Additional samples were taken within the storm outfall pipe at Site 2, as well.

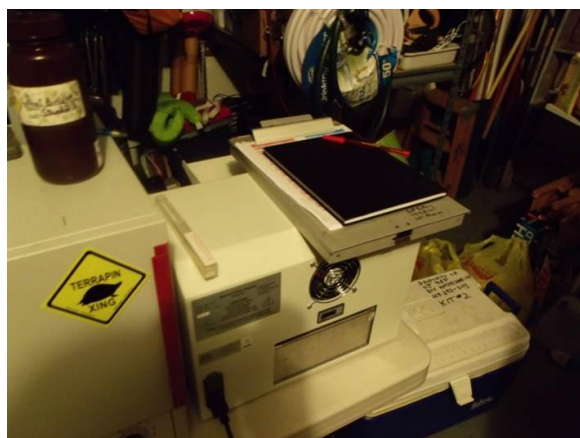
Figure 5. Lab station. Incubator, IDEXX sealer, and cooler.

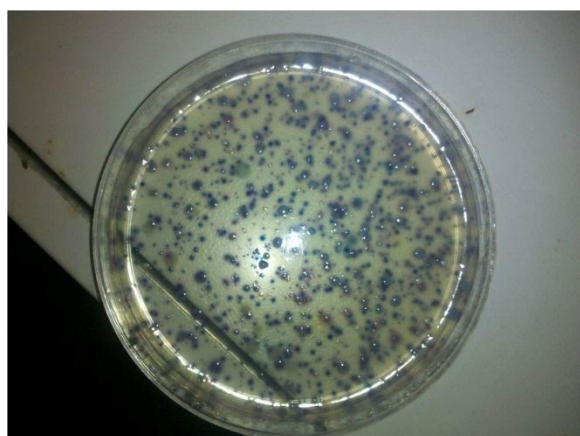
Figure 6. Coliscan Easygel plate containing *E. coli* indicated by dark blue colonies in a sample collected from a problematic storm pipe at Beachwood Beach West on July 8, 2011.

Samples were plated with ECA Check Easygel media using 1 mL of sample water with the Coliscan Easygel® method (Micrology Labs). Samples were also plated with the IDEXX Enterolert® method (IDEXX) using the marine water standard of 10 mL sample water to 90 mL deionized water. Baseline samples were plated in the IDEXX Quanti-Tray wells and stormwater samples were plated in the IDEXX Quanti-Tray 2000 wells. After plating both methods, the samples incubated in separate incubators for a 24-hour period and were analyzed for bacteria colonies the following day. Petri dishes containing dark blue or purple colonies (See Fig. 5) indicated *E. coli*, which were counted and multiplied by 100 to obtain the number of colonies per 100 mL water. The IDEXX trays were analyzed underneath a UV light because wells will glow if containing *Enterococcus* (See Fig. 7). According to which specific tray was used, the Quanti-Tray and Quanti-Tray 2000 Most Probable Number (MPN) tables were referred to when determining the MPN corresponding with the number of positively glowing wells for each sample. The actual MPN was then multiplied by a dilution factor of 10 to keep within marine water standards (IDEXX).

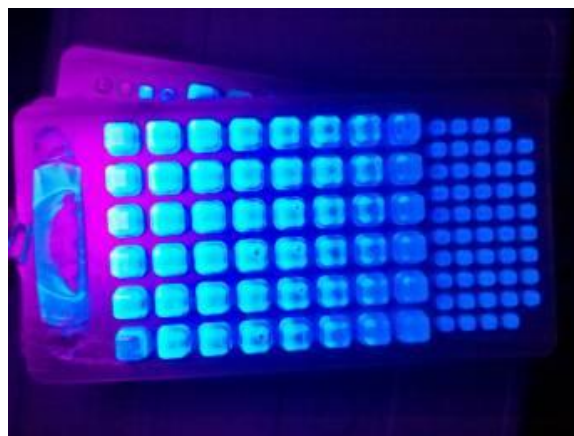
Figure 7. IDEXX Quanti-Tray 2000. IDEXX Quanti-Tray 2000 containing *Enterococcus* indicated by many fluorescing wells of a sample collected from Beachwood Beach West on July 29, 2011.

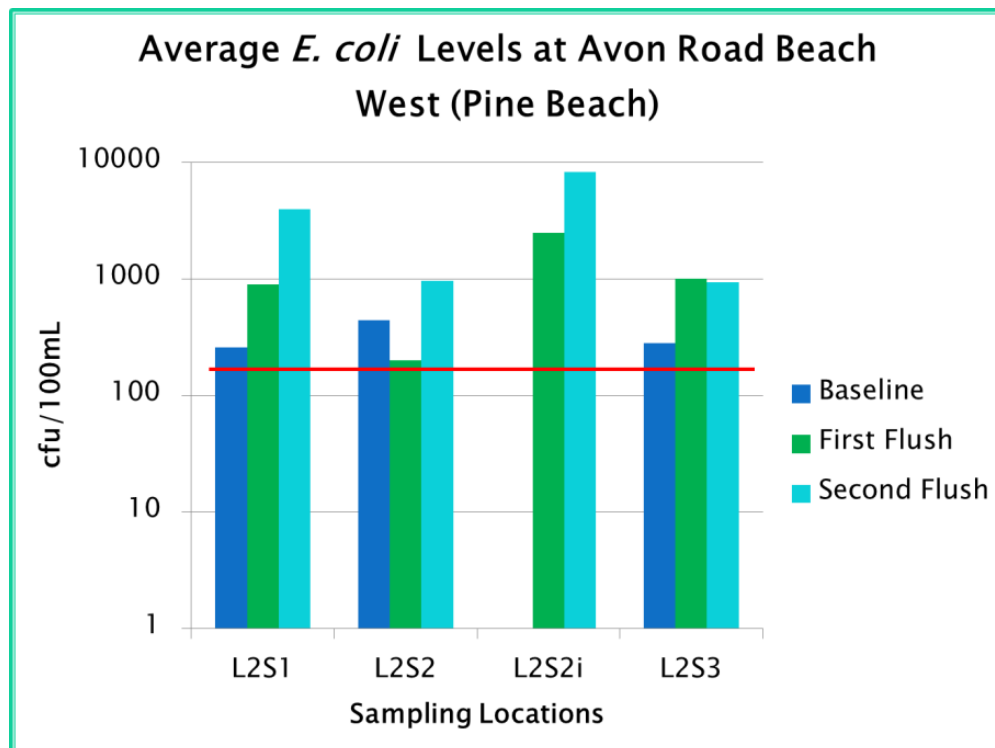
Figure 9 displays the average *E. coli* levels at West Beach of Pine Beach. Similarly, averages of all of the samples taken at this location tested over the freshwater bacteria standard with results between 260 - 8333.3 colonies per 100mL. At both locations, the highest levels of *E. coli* occurred during the second flush of a storm.

Figure 9. Average *E. coli* levels at West Beach of Pine Beach.

According to Figures 8 and 9, *E. coli* was found in exceedingly high numbers at both Beachwood Beach West and West Beach of Pine Beach during all weather conditions. The average baseline readings taken during dry weather at each location tested well over the standard for fresh waters. This indicates that *E. coli* is present in these waters on a daily basis without stormwater discharge; therefore, raising concerns of health risks. At both locations,

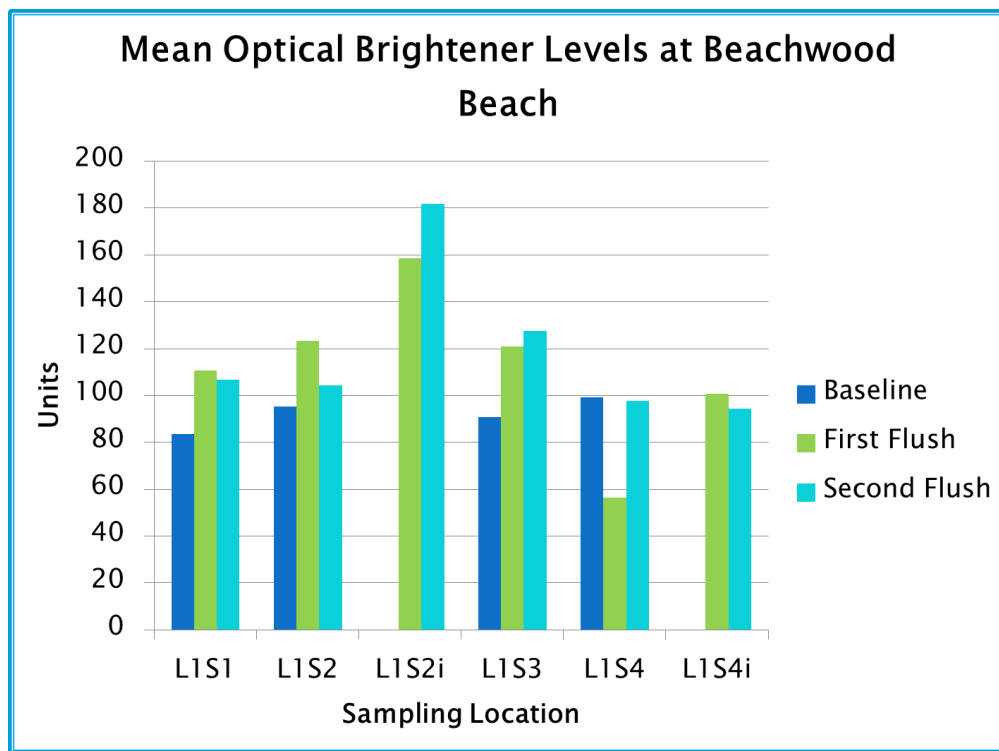
The mean optical brightener readings were graphed according to their sampling interval to determine when significant readings occurred at both Beachwood Beach West and West Beach of Pine Beach (See Figs. 14 and 15). On average, levels ranged as low as 56.45 at Site 4 of Beachwood Beach West during the first flush and as

high as 181.13 inside the pipe at Site 2 of Beachwood Beach West. Of all the data, the highest optical brightener reading of 1322 occurred at Site 2 of Pine Beach's West Beach during baseline sampling on one occasion, which accounted for the high average of optical brightener readings at this particular site.

Figure 14. Average Optical Brightener levels at Beachwood Beach West.

Optical brightener readings taken inside both of the storm pipes at Beachwood Beach West and West Beach of Pine Beach during rainfall noticeably increased between the first and second flushes (See Figs. 14 and 15). This data, in conjunction with the high bacteria counts found within the storm pipes during storm events (See Figs. 10 and 13), suggests human influence. Since optical brighteners are found in laundry detergents, their elevated presence in storm pipes implies that the laundry effluent is found in the sewage or septic systems (Floresguerra, 2003), therefore, hinting at the possibility of sewage leaking into the water of Beachwood Beach West and West Beach of Pine Beach. During a rainfall event on July 8, one of the team members observed a black cloud of matter discharging from the storm pipe at Beachwood Beach West accompanied by an unpleasant odor. Samples taken from this storm pipe during the second flush contained
