Stormwater Monitoring of Beachwood Beach and Avon Road West Beach

A bacteriological and anthropogenic analysis of stormwater

Monmouth University

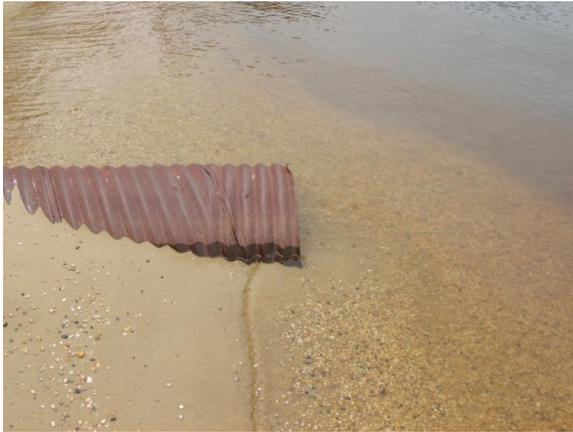
Figure 1: The stormwater pipe at Beachwood Beach.

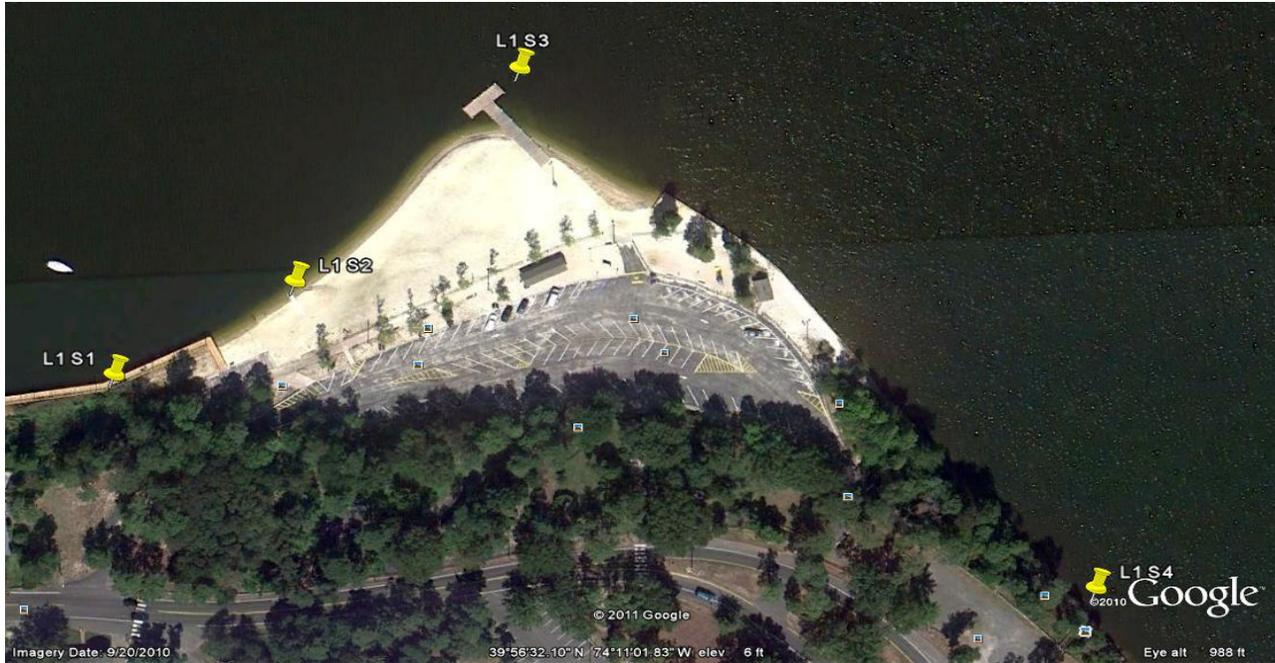
Figure 4: This exhibits the Beachwood Beach site with each sampling site: L1S1 ($39^{\circ} 56' 31.75''$ N, $74^{\circ} 11' 08.08''$ W), L1S2 ($39^{\circ} 56' 32.29''$ N, $74^{\circ} 11' 06.36''$ W), L1S3 ($39^{\circ} 56' 34.39''$ N, $74^{\circ} 11' 03.27''$ W), and L1S4 ($39^{\circ} 56' 29.21''$ N, $74^{\circ} 10' 56.65''$ W).

Beachwood Beach, Beachwood, NJ, 08722 and Avon Road West Beach, Pine Beach, NJ, 08741 were the study locations due to their high bacteria levels. Beachwood Beach was deemed Location 1 and had four sites. With each site, a code was created. For Location 1, Site 1, the code was L1S1. For Location 1, Site 2, the code was L1S2. This followed suit for the rest of the sites. Avon Road West Beach was Location 2. This location had three sites and the code names followed suit (e.g. L2S3 is Location 2, Site 3).

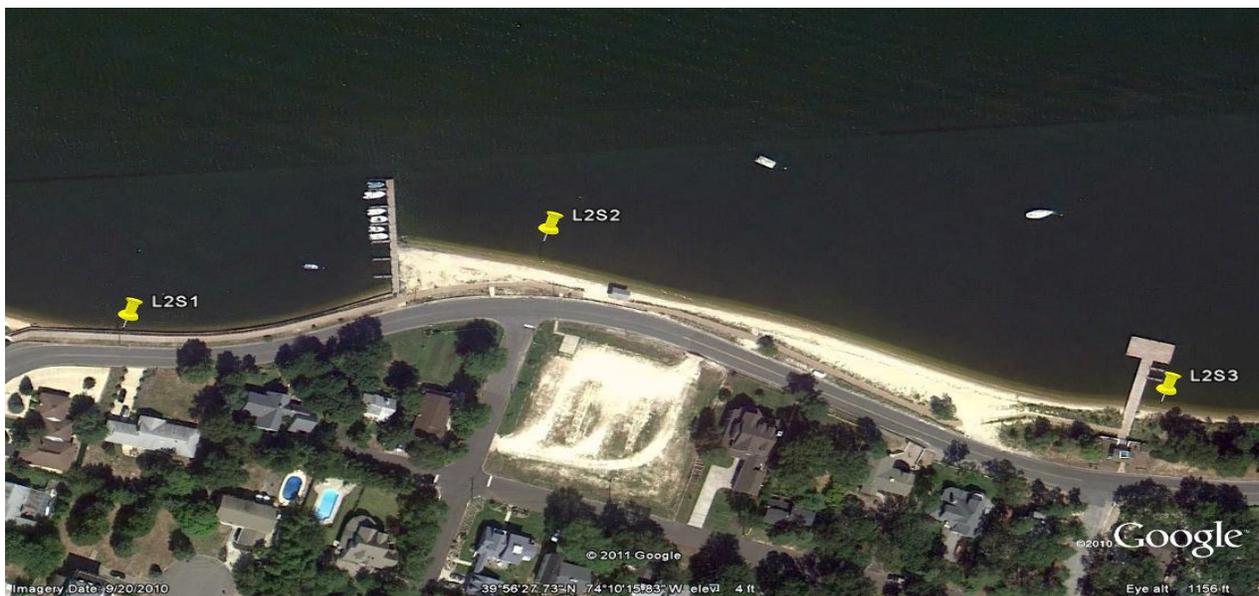
Figure 5: This exhibits the Avon Road West Beach Site with each sampling site: L2S1 ($39^{\circ} 56' 27.79''$ N, $74^{\circ} 10' 20.24''$ W), L2S2 ($39^{\circ} 56' 28.66''$ N, $74^{\circ} 10' 17.07''$ W), and L2S3 ($39^{\circ} 56' 26.60''$ N, $74^{\circ} 10' 08.59''$ W).

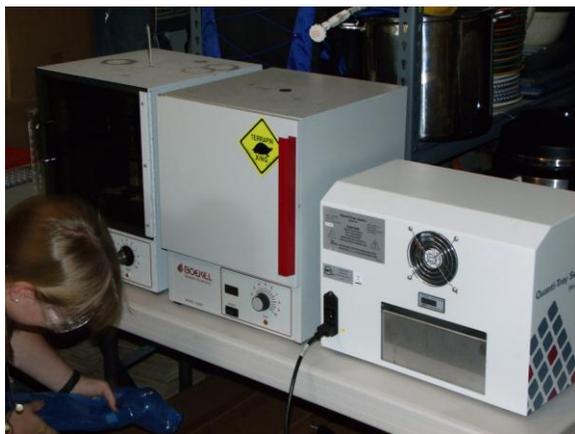
Figure 6: The two incubators (on left) and the IDEXX® Quanti-Tray Sealer (on right).

The equipment utilized included two incubators, IDEXX® Quanti-Tray Sealer, IDEXX 51-Well Quanti-Tray®, IDEXX Quanti-Tray/2000, Enterolert® media, treated petri dishes, pipettes, Coliscan Easygel® media, YSI 85, Turner Design AquaFluor™ Handheld Fluorometer, disposable cuvettes, 10 nalgene laboratory bottles, sodium thiosulfate treated WhirlPaks®, nitrile gloves, kimwipes, and deionized water. Before any sampling session (unless sampling sessions were within 24 hours of each other), the equipment was calibrated. The AquaFluor® Handheld Fluorometer was calibrated for optical brighteners using a standard that the Department of Environmental Protection provided: 5% detergent. This fluid was intended to read 50 on the meter. Another calibration solution was provided for the DEP for turbidity. The solution was 100 NTU.

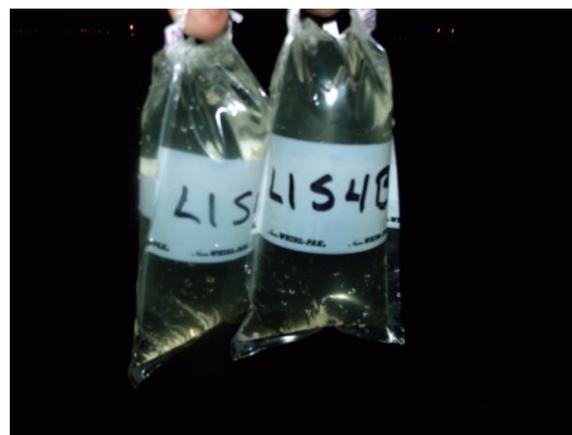
Figure 7: Two full WhirlPaks® from Beachwood Beach.

For water sampling, chest waders and gloves were used. The water samples were taken in water that was approximately up to the sampler's waist or thigh area. The samples were taken about 8-12 inches down from the surface of the water. Then the WhirlPak® was opened and filled up. The WhirlPak was closed and then whirled and tied up. This was done at each sampling site. Once the water sample was collected, the Whirlpak® was deposited into a cooler filled with ice. Samples were collected according to the procedures set forth in NJDEPE, Field Sampling Procedures Manual (Chapter 7, Section F, and Bacteriology), Trenton, NJ, 1992; and in Chapter IX (Public Recreational Bathing) of the State Sanitary Code, N.J.A.C. 8:26-1 et seq. (revised May 2000).

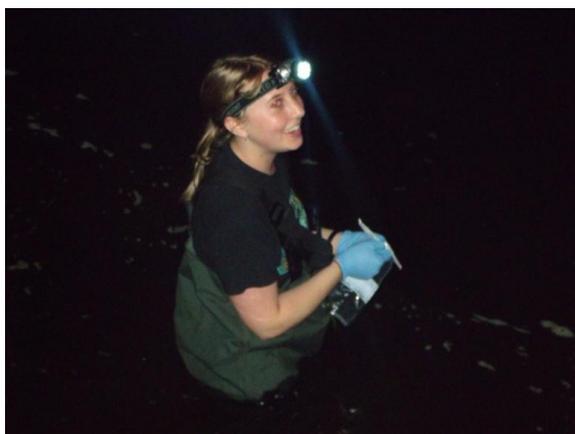
Figure 8: A researcher with gloves on collecting a WhirlPak®.

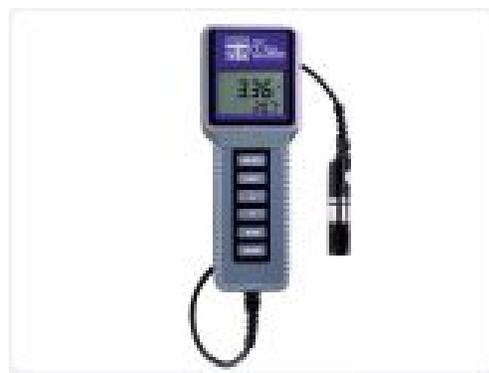
Figure 9: The YSI 85 model that was used in the study.

The parameters collected from the samples were salinity (YSI 85), conductivity (YSI 85), dissolved oxygen (YSI 85), percent saturation (YSI 85), temperature (YSI 85), optical brighteners (AquaFluor™ Handheld Fluorometer), turbidity (AquaFluor™ Handheld Fluorometer), *E. coli* (Coliscan Easygel®), and *Enterococcus spp.* (IDEXX®). Each of the parameters was collected according to the protocols of their respective methods and devices.

Using the National Oceanic and Atmospheric Administration's Doppler Radar, storm monitoring could be done. If a storm seemed substantial (having at least a dark green color on the radar) then sampling was done. Water sampling was done within the first flush of the storm. On 6/28/11 and 7/3/11, only Beachwood Beach was sampled. During this time, the YSI 85 was taken into the field and used directly in the

water. After these storm sampling events, the water samples were collected and then transported to the laboratory. There the YSI 85 and the other equipment was used. This was done for baseline as well starting on 7/7/11. By doing this method, both Beachwood Beach and Avon Road West Beach were able to be sampled in the same storm. Due to time constraints, travel time, and storm intensity, the first flush was not sampled on 6/28/11, 7/3/11, and 7/29/11; however, the second flush was always sampled. Due to the measures taken in this study and the Quality Assurance Plan, this sampling was placed under the Tier B level of the NJDEP's Volunteer Water Quality Monitoring Program. In this tier, planning the study, training for the techniques used, and calibrating the equipment correctly and according to NJDEP guidelines are required.

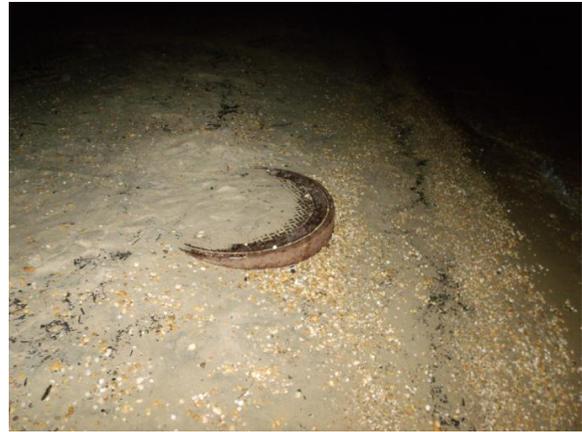
Figure 21: The manhole cover for the pipe at L2S2 at Avon Rd. West Beach.

The main problems at Avon Road West Beach are from the pipe at L2S2. This pipe does have high levels of *E. coli* and *Enterococcus*. The average amount of *E. coli* at L2S2i was 8333.33 CFU/100 mL during the second flush. During the first flush, the average was 2500 CFU/100 mL (Tables 2 – 4). Both of these counts are above the limits for *E. coli*. For *Enterococcus sp.* levels, on average, the baseline and first flush data was under the 104 CFU/100 mL limit; however, the second flush levels were above the amounts (Figure 13). This could mean that the issue with the storm pipes in Pine Beach could be farther away from the outfall pipes.

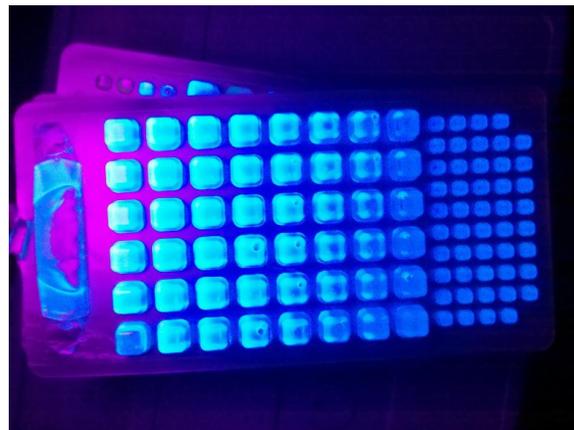
Figure 22: The entire glowing IDEXX Quanti-Tray/2000 for L1S2iB on 7/29/11 with >24196 MPN for *Enterococcus sp.*
