Capoolong Creek Streambank Restoration

The photos below document aspects of the Division of Fish and Wildlife's streambank restoration project at Capoolong Creek Wildlife Management Area, located in Franklin Township, Hunterdon County. For details visit www.njfishandwildlife.com/wma_restoration-capoolong.htm.

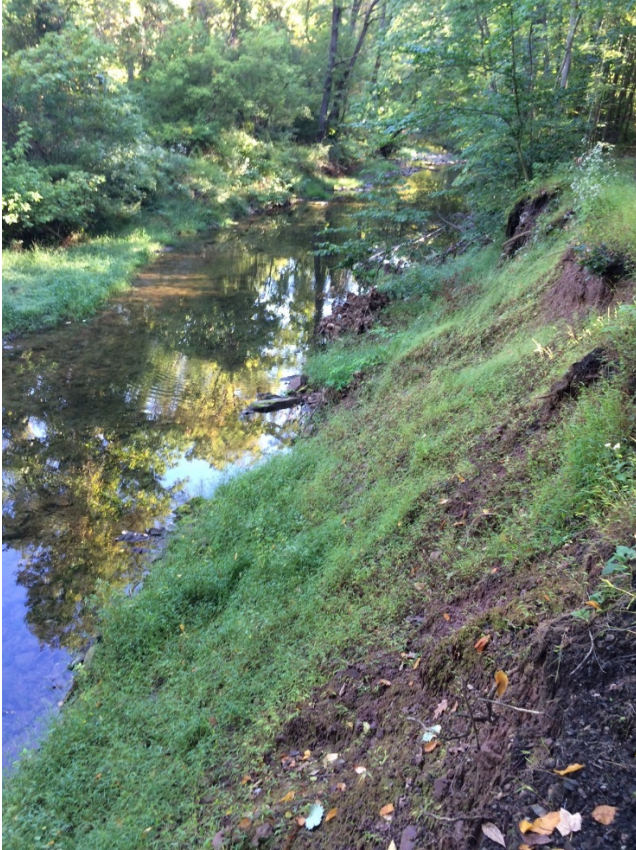
Eroded section of Capoolong Creek, looking downstream. Bank is mostly vegetated by Japanese stiltgrass.

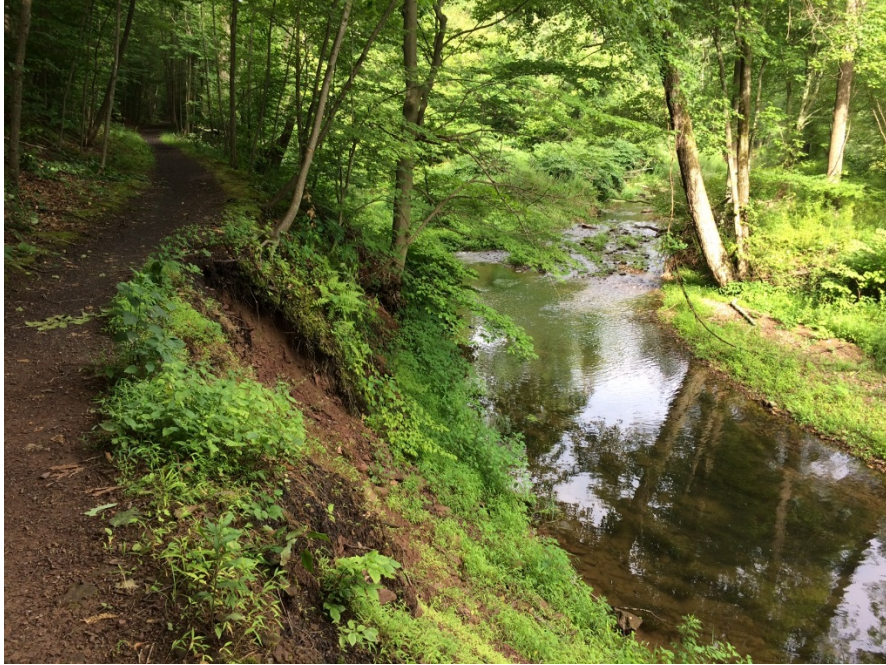
Eroded section of Capoolong Creek, looking upstream. The public trail can be seen in the left of the photo, as well as where erosion is threatening the trail.
