Dam Removal and Restoration: A Volunteer Monitoring Approach

**Musconetcong Watershed Association
Beth Styler Barry and Nancy Roberts-Lawler**

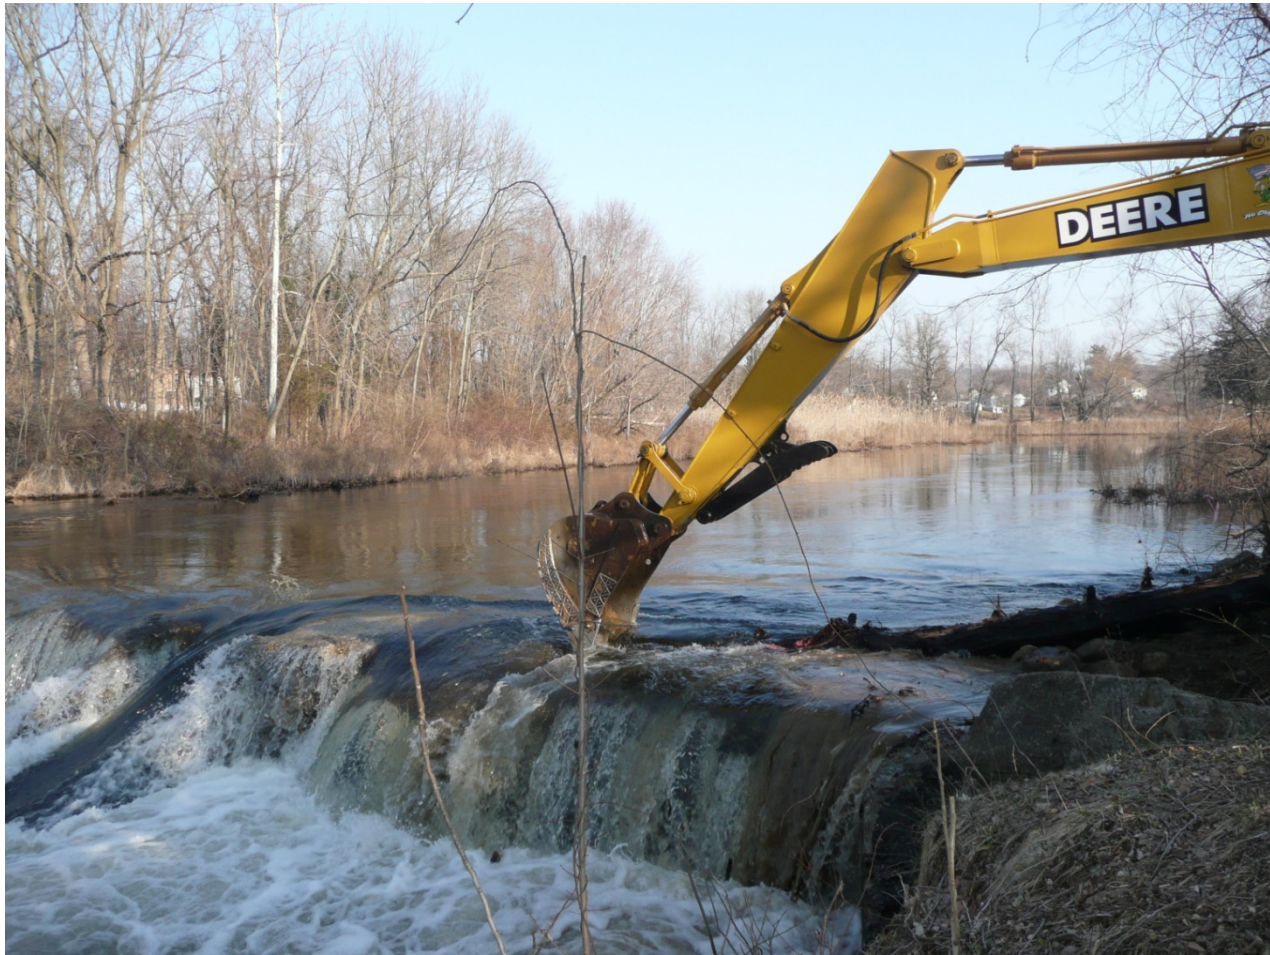
Gruendyke Mill Dam Removed

March 13, 2008

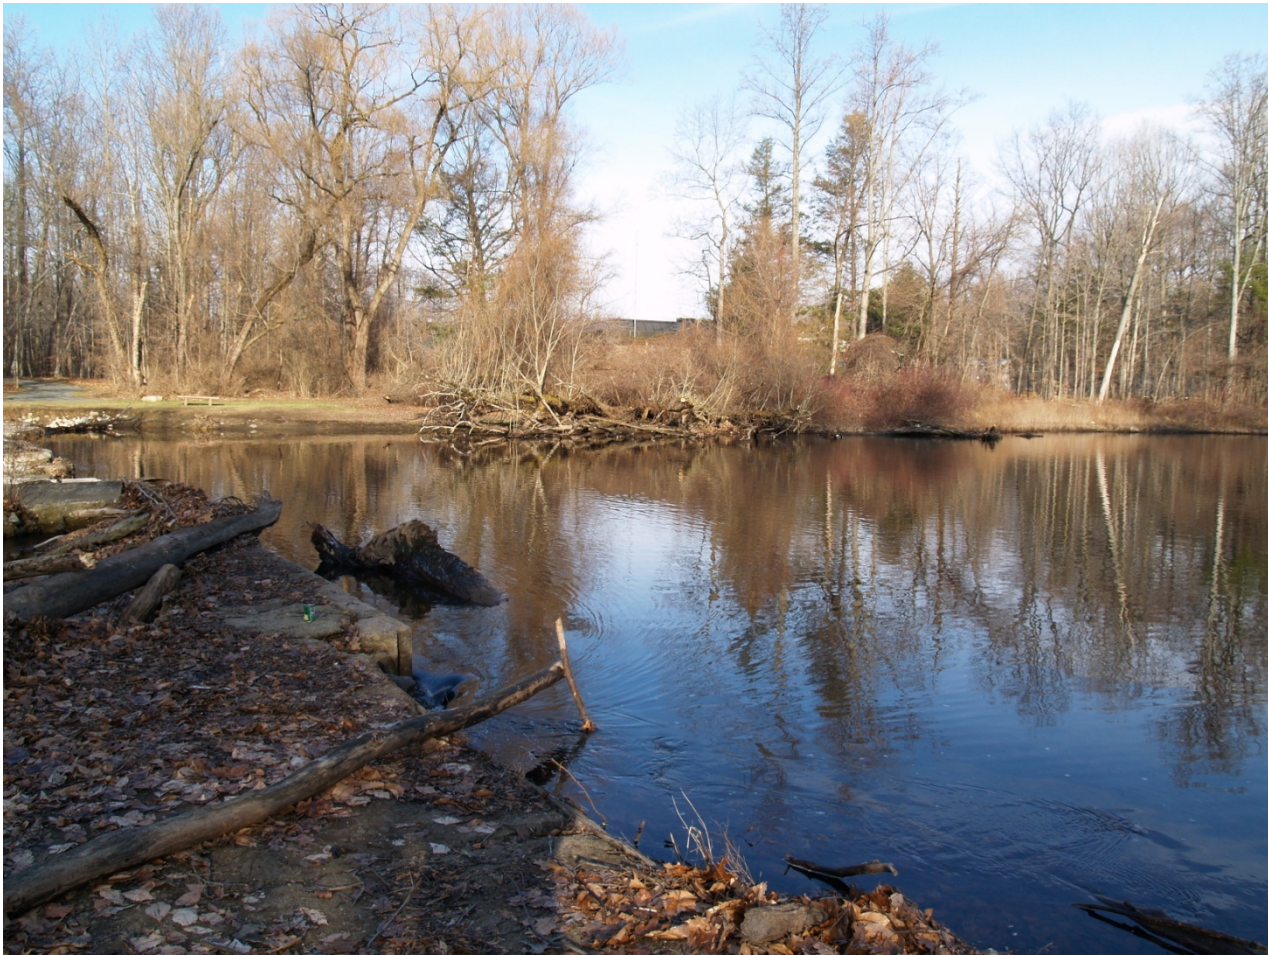
Musconetcong Watershed Association Seber Dam – Upstream View

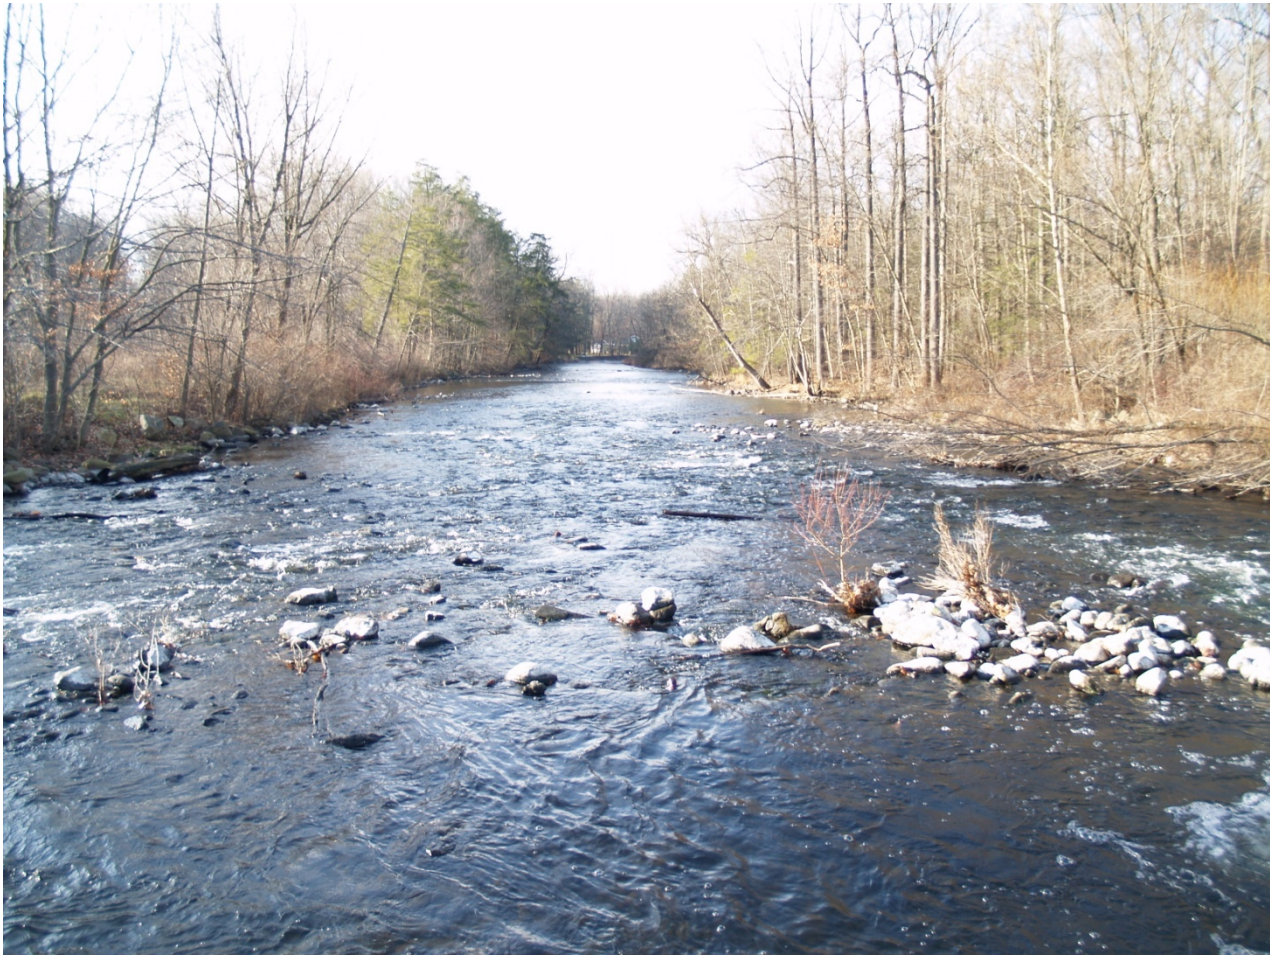
Musconetcong Watershed Association Seber Dam - Downstream View

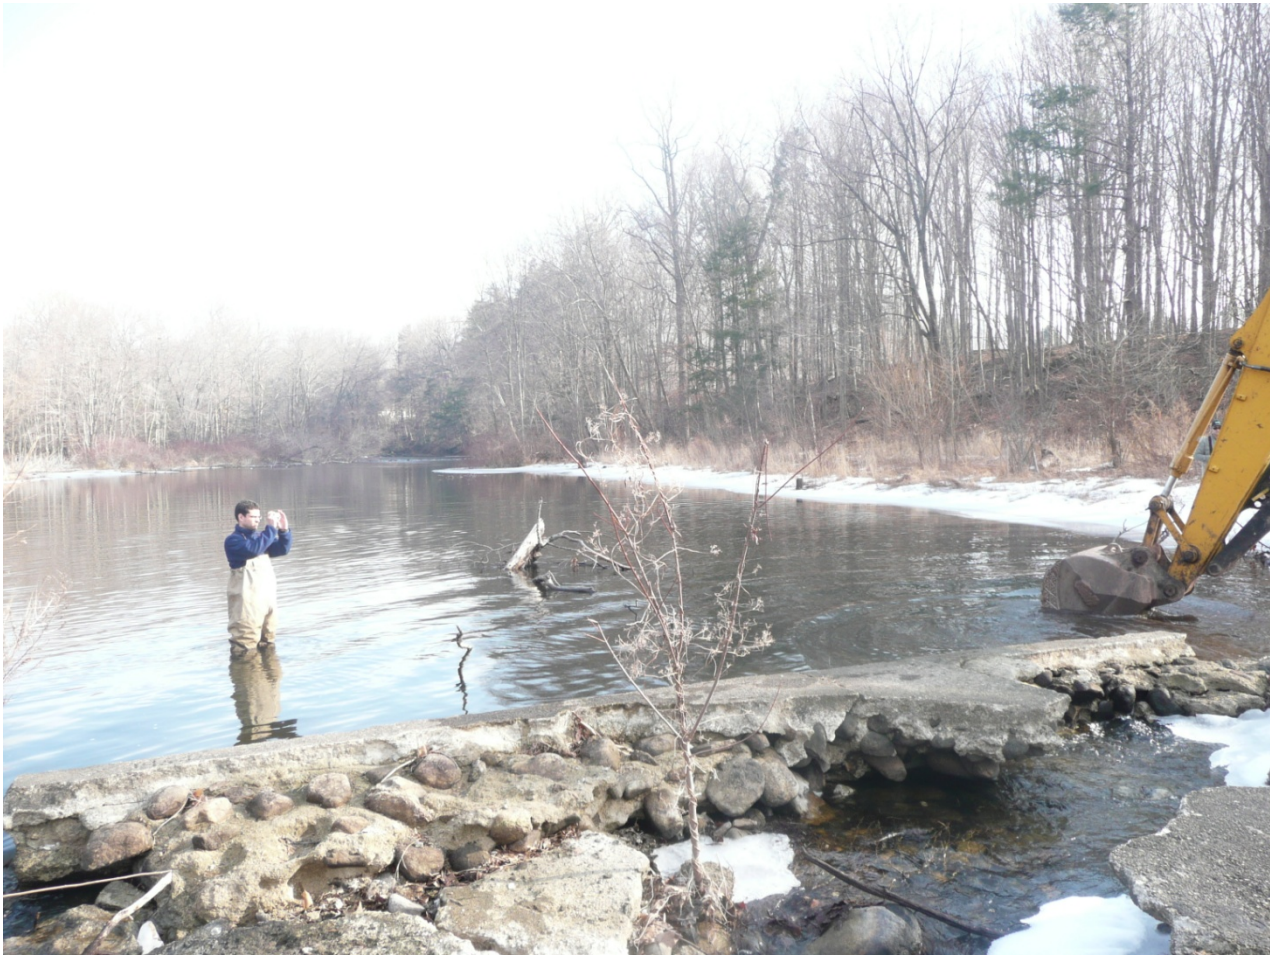
Musconetcong Watershed Association Seber Dam Breach February 2009

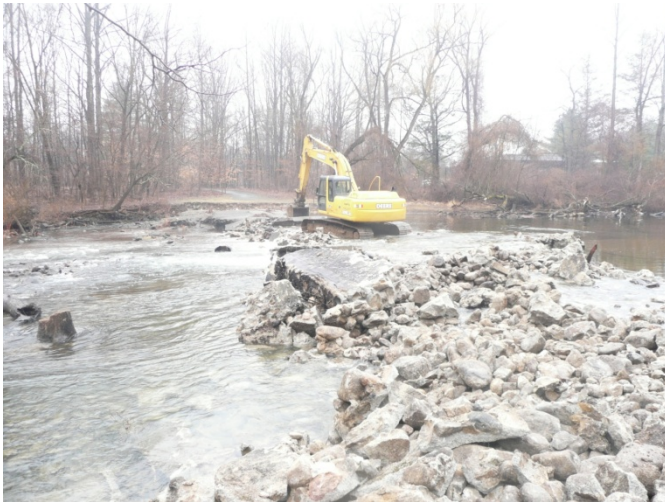
- Before

- Width at bank full=160ft
- Depth at bank full=7 ft

Physical Changes to Seber Site

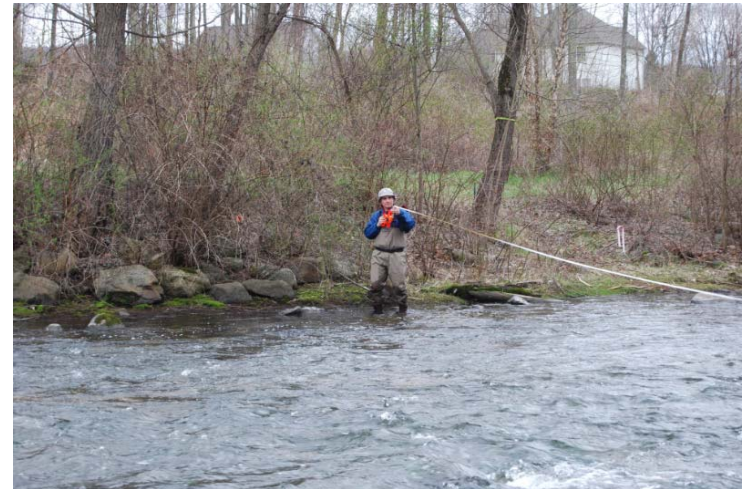
- After

- Width =80-102 ft
- Depth =14-22”

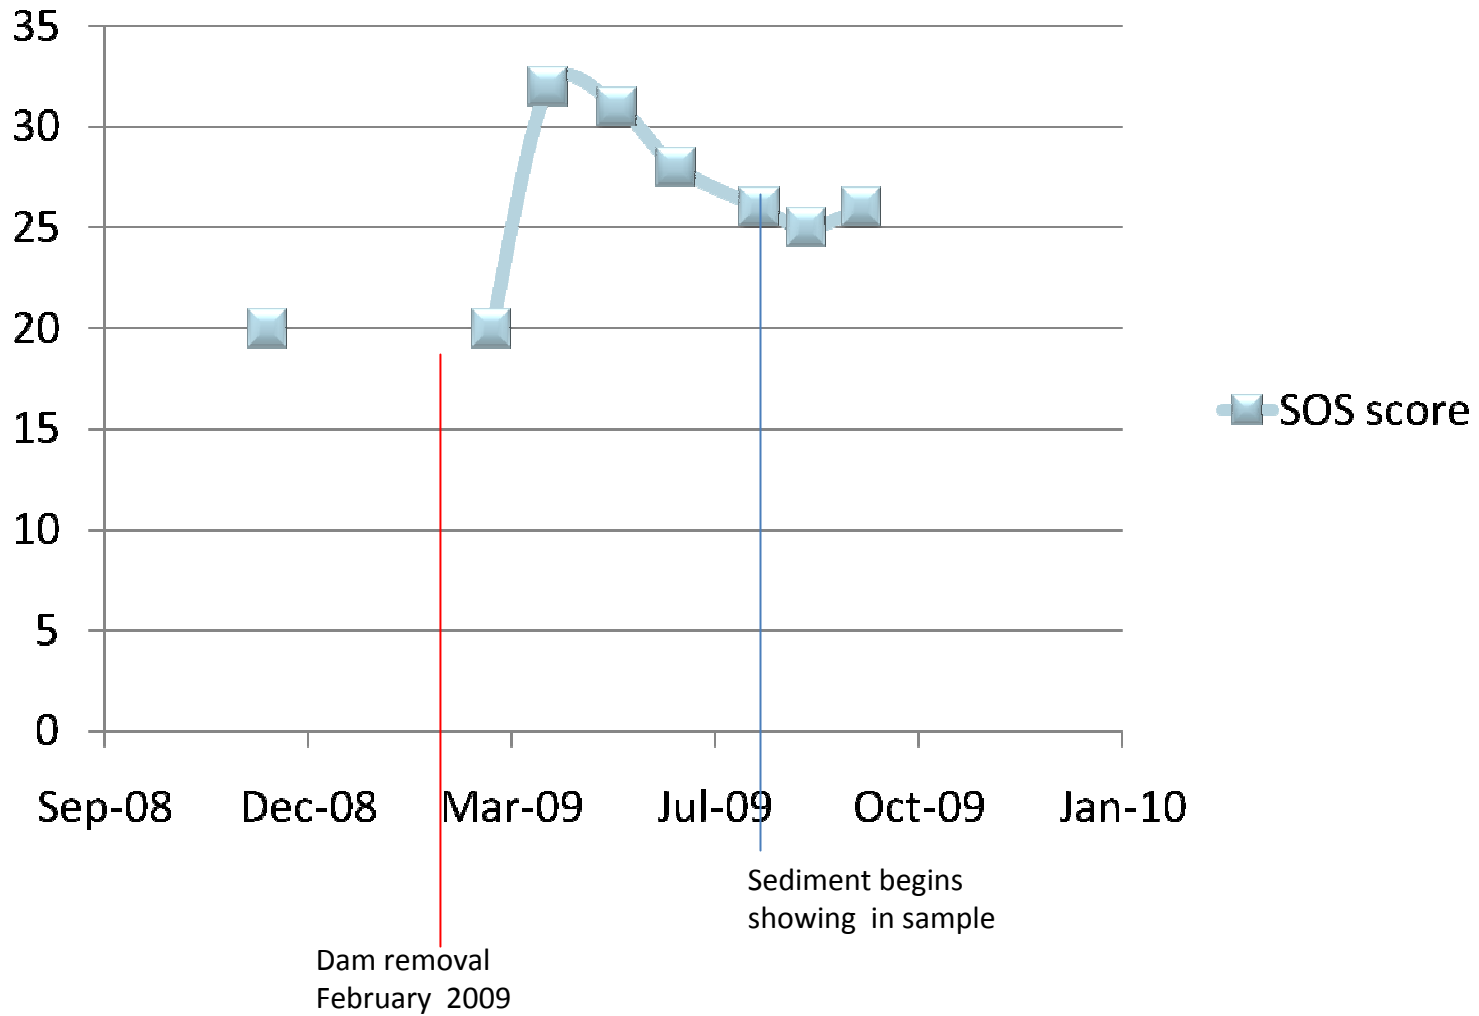
Biological Assessment Scores at Seber (SOS)

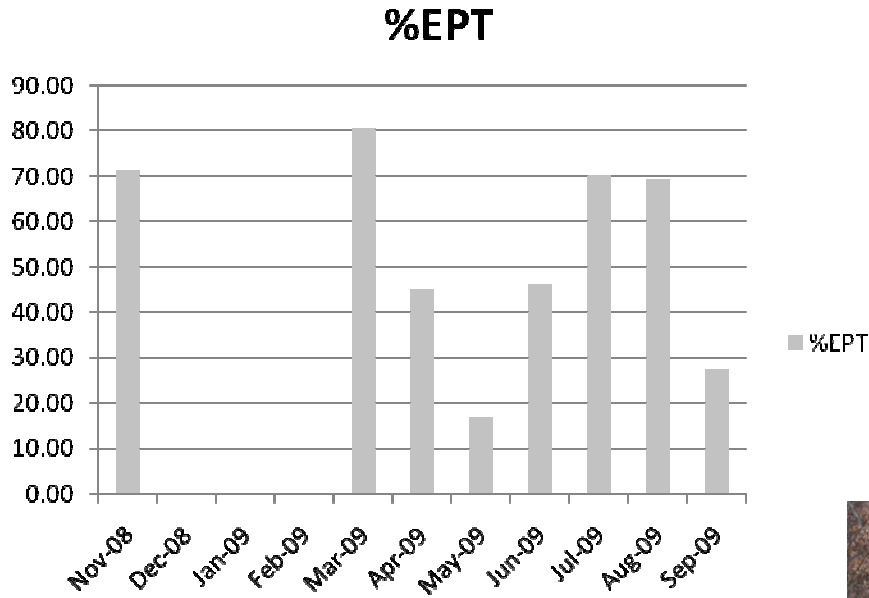
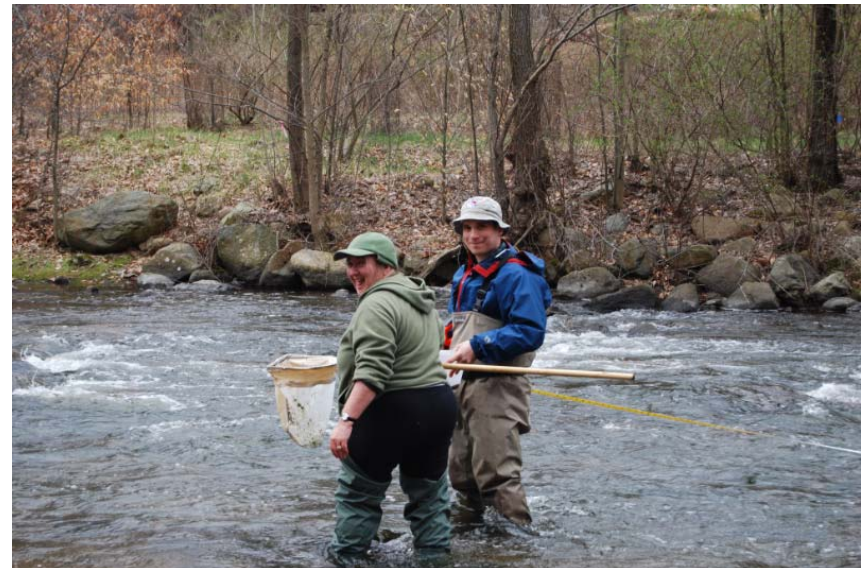
EPT at Seber

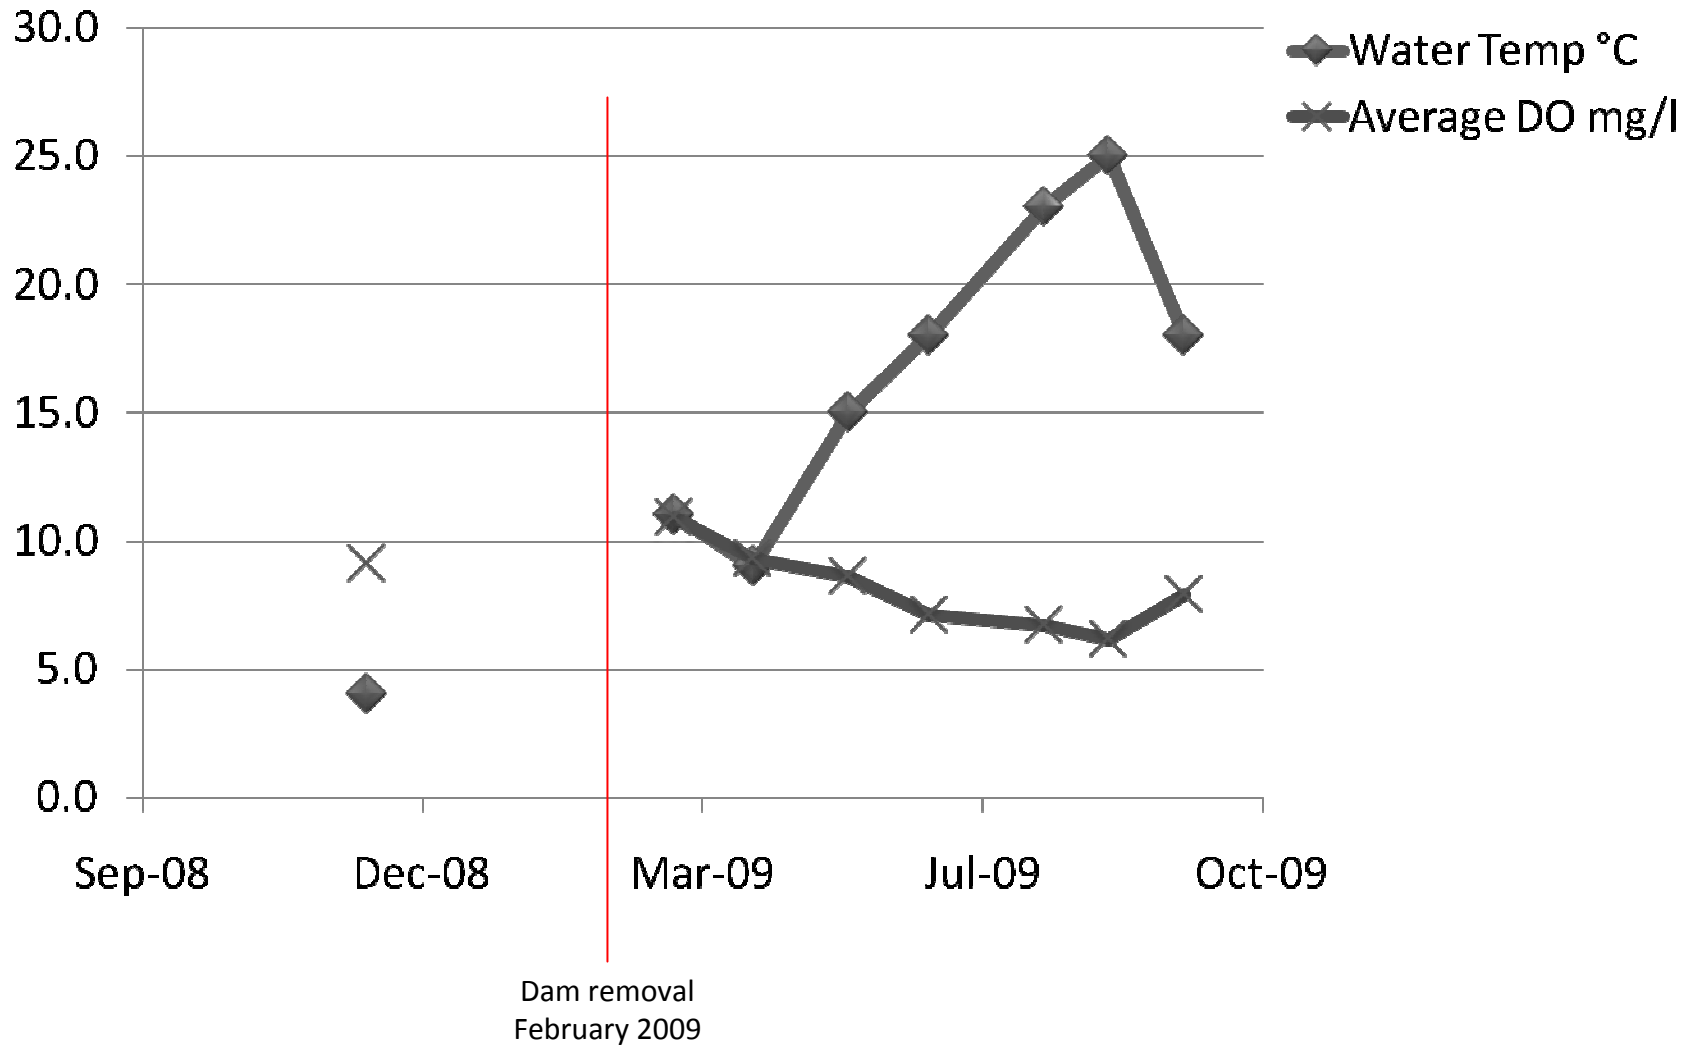
Water Temperature vs Dissolved Oxygen at Seber Dam site

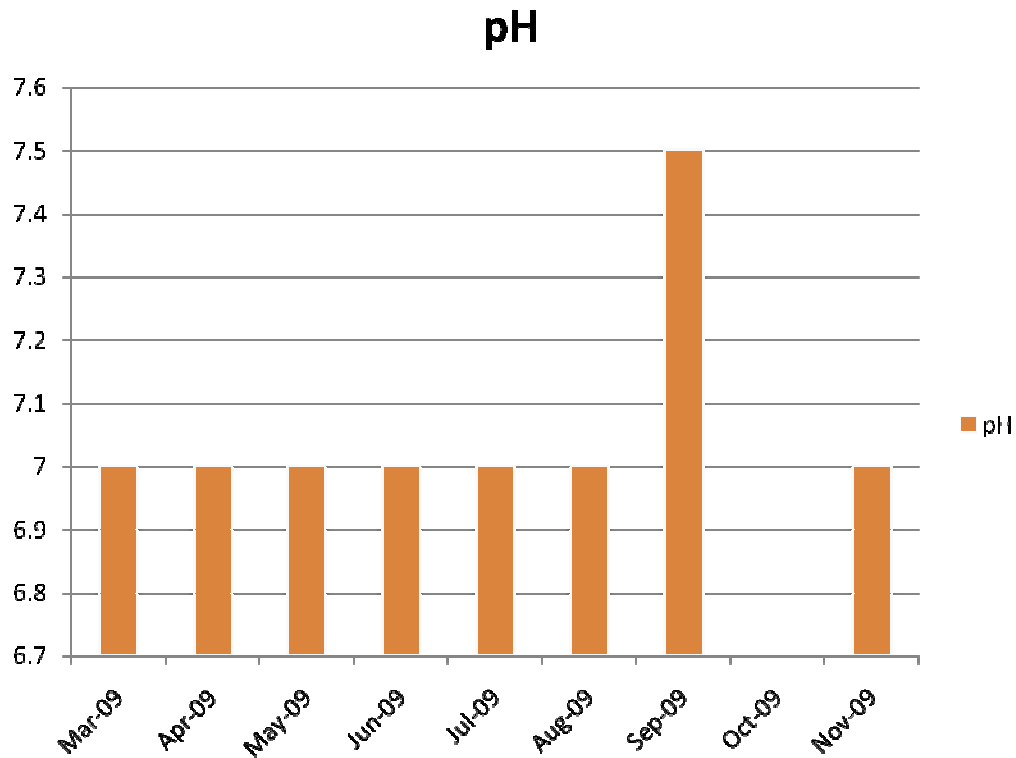
pH at Seber Dam site

Almost no change is pH at dam site

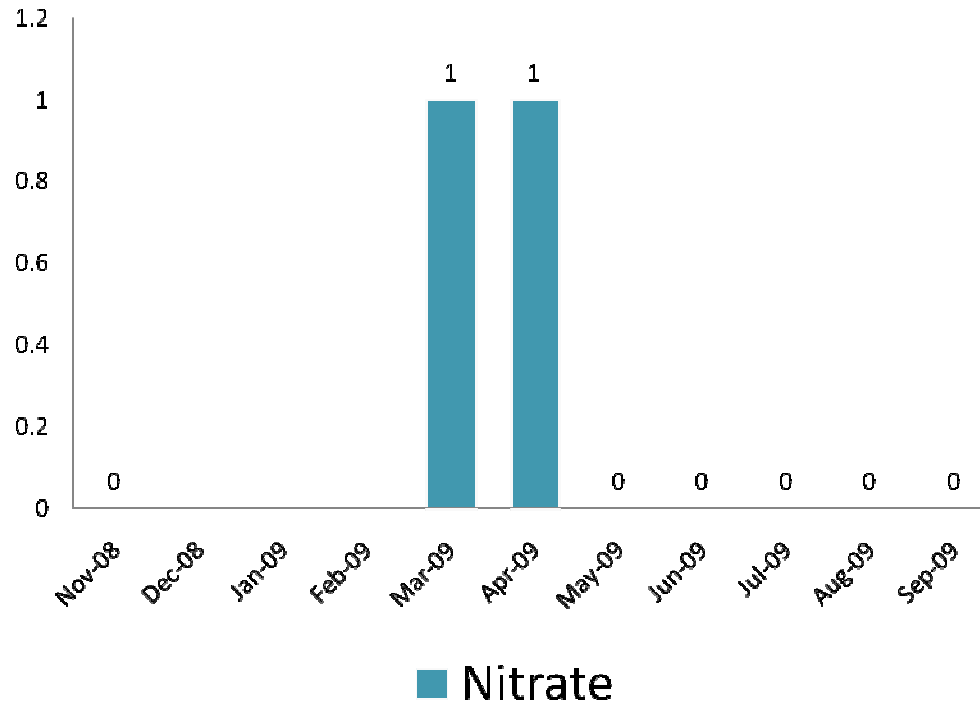
Nitrates at Seber

Nitrates do not appear to be a significant factor at the dam site

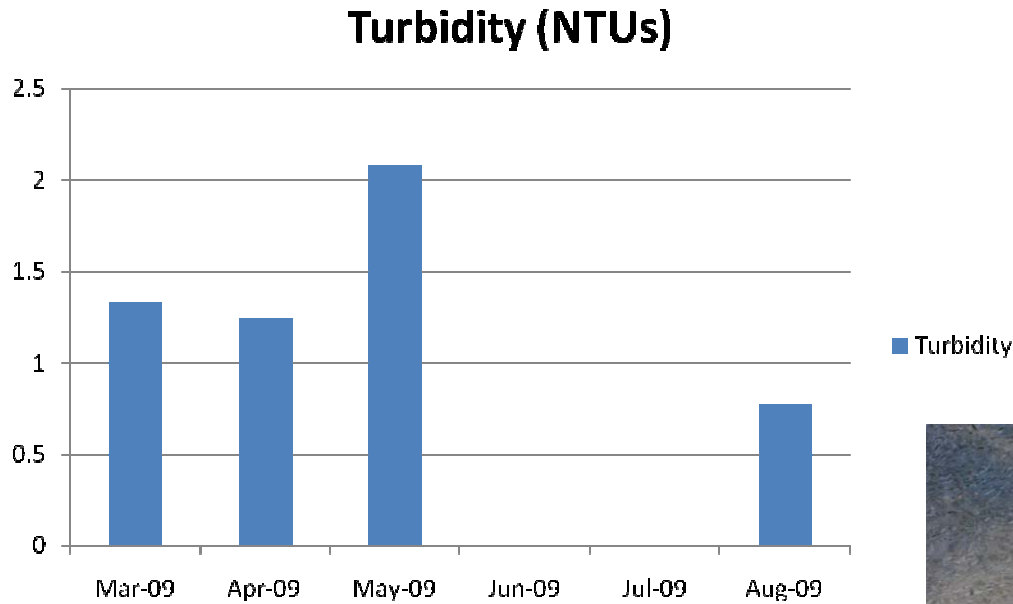
Turbidity at Seber-NJDEP VM Program

Turbidity appears in the normal range during study time

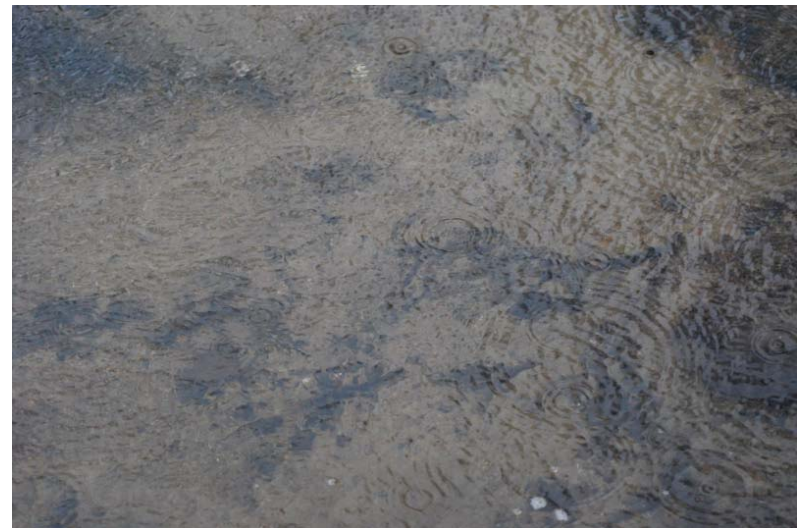
Abundance of sediment above site in May 2009
