Health Consultation

PRESCHOOL/DAYCARE AT THE
MCCANDLESS FUELS SITE

FRANKLINVILLE, GLOUCESTER COUNTY, NEW JERSEY

SEPTEMBER 28, 2007

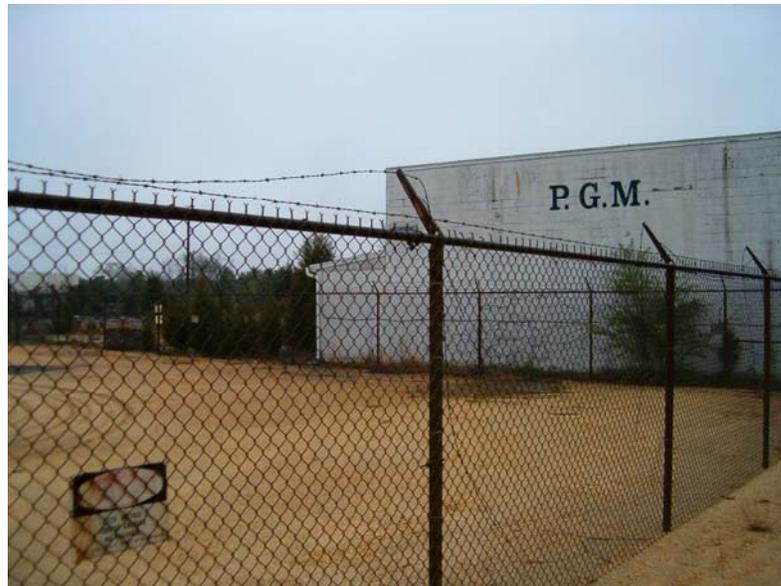
The NJDEP representative discussed the site history and the current status of the McCandless Fuels site. The central portion of the site (also referred to as the “operational area”) was secured by a chain link fence with a locked gate. The doors to each building (including the Faith Fellowship Center) were locked (see Photograph 1). The western portion of the site was undeveloped; the NJDEP representative indicated that various types of debris have been found during subsurface investigation in this area. This portion of the site was also secured by a chain link fence in May 2003 (see Photograph 2). Two residences were located directly downgradient from the site on Porchtown Road. These properties were located approximately 2,000 feet from the site on the far side of the Little Ease Run.

Photograph 2: The chain link fence around the operation area

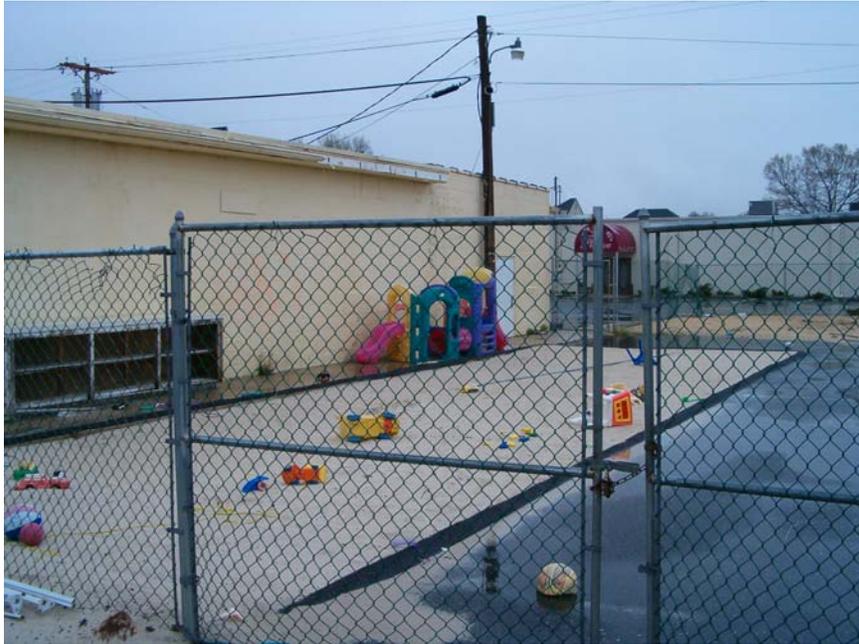
The Faith Fellowship Center building was located at the southeast part of the site. The recreational area was paved and contained a large sandbox (see Photograph 3). The

Photograph 3: Former recreation area of the daycare center

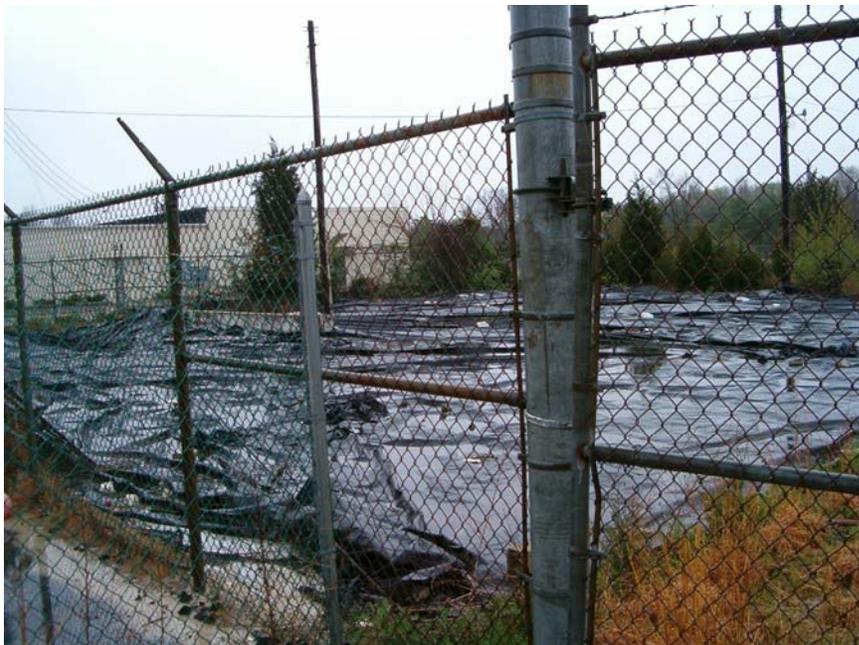
PCB-contaminated area was covered with a black synthetic liner and was located across a chain link fence (see Photograph 4).

Photograph 4: Plastic cover on the PCB contaminated area
