NJ FACE INVESTIGATION REPORT

FACE 02-NJ-081

Forklift Operator Dies After Backing his Forklift Off a Loading Dock

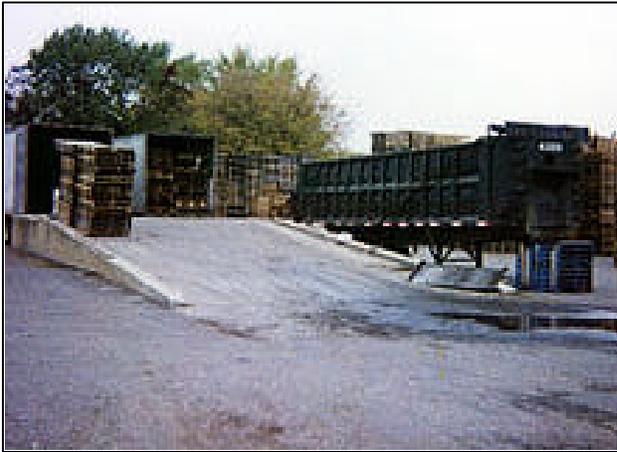
Material is moved through the plant with three identical 8,600 pound, seated-rider forklift trucks. Each forklift is propane-powered with a maximum lifting capacity of 1,000 pounds and a maximum lifting height of 15 feet, 7 inches. All three forklifts in the plant were leased new about two years ago. The plant maintains an outdoor loading dock at the rear of the plant. The 45-inch-high concrete dock is 35 feet 2 inches long by 13 feet 11 inches wide, which is large enough to accommodate two tractor trailers. A concrete ramp provides access to the top of the dock. Except for the ramp, the dock does not have

Photo 1
Front of Loading Dock
Showing Entrance Ramp

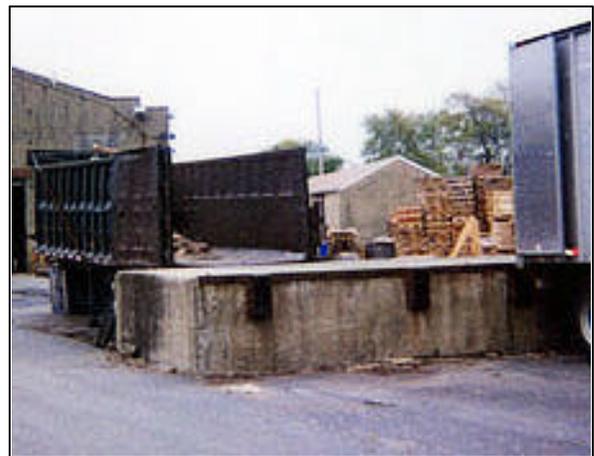
Photo 2
Rear of Loading Dock
Showing Dumpster

curbs or safety rails, which would block a forklift's access to place material on the sides of the dock. A large, trucked-in waste container (dumpster) is staged at the dock beside the entry ramp. Scrap lumber and other waste are collected in metal bins inside the plant. A forklift operator transports the waste bins up the ramp and into the dumpster where the bin is overturned and dumped. The operator leaves by backing out of the dumpster onto the loading dock with the empty bin.

Discussion: The dock in this incident did not have raised curbs or railings around the perimeter of the dock. The employer explained that this was done to allow material to be moved on and off the dock using two forklifts: a lift on the dock would set a load near the edge of the dock where it would be removed by a second lift on the ground. Although OSHA considers this an acceptable procedure, it leaves the entire perimeter of the dock unguarded. NJ FACE recommends that outdoor docks should be provided with a raised curb high enough to keep a forklift within the dock. A safety railing would not normally be strong enough to contain a forklift, but would provide a visual warning of the dock edge to an operator. It should be noted that plant management installed a heavy-duty railing that can be moved away to allow forklift access.

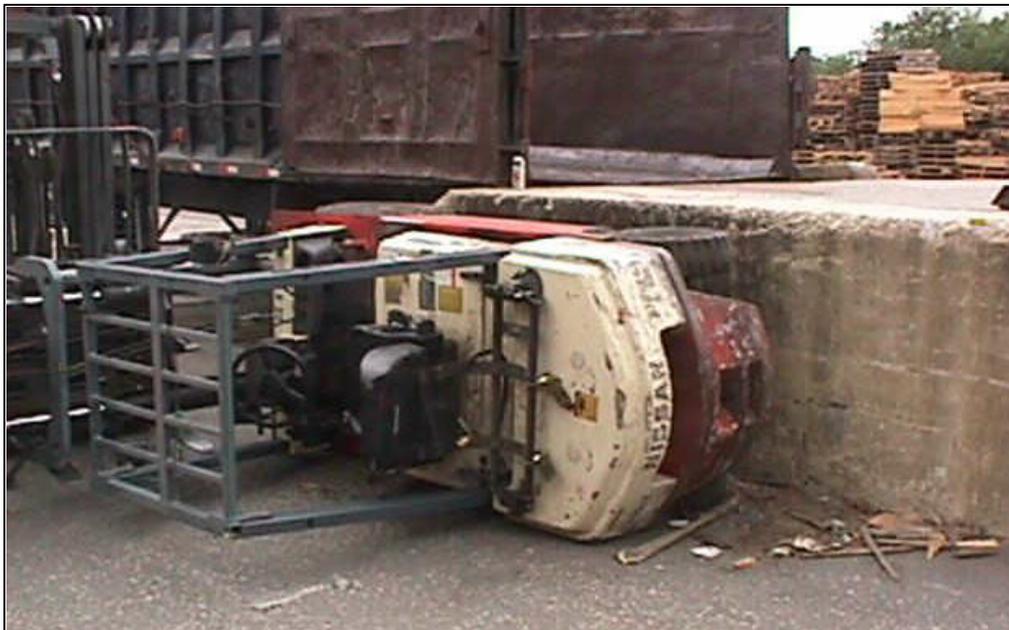
The incident occurred on Friday, August 30, 2002 at 2:48 p.m. The victim arrived for work between 6:30 to 7:00 a.m. and started his duties on his forklift truck. Work proceeded uneventfully during the day, with the victim moving material and loading/unloading pallets onto the trucks. There were no witnesses to the incident. At about 2:45, the victim returned to work after taking his afternoon break. He was reported to be the first to come back from break and was alone in the yard. He moved a large steel bin of waste into the dumpster and tipped the bin to dump it. Leaving the bin in the dumpster, he then backed the forklift out, possibly grazing the side of the dumpster as he exited. He apparently backed out at too much of an angle, and the forklift backed off the side of the dock where it turned over on its side.

Photo 3
Photo of Incident Scene

The victim, who was not wearing his seat belt, was partly thrown from the lift and pinned under the rollover cage on his hip and leg. No one heard the crash, but a truck driver walking across the yard saw the victim and called for help. His co-workers came out to assist, lifting the forklift off the victim using one of the plant's other forklifts. The police and EMS arrived to find the victim badly injured and ordered a helicopter to med-evac him to a nearby NJ Level I Trauma Center where he was admitted. He remained at the hospital where his condition declined despite treatment. He died of complications related to his injury on September 9, 2002, nine days after the incident.

Discussion: The forklift operator in this incident was not using a seatbelt, which would have secured him to the seat and prevented him from being crushed under the rollover cage. NJ FACE recommends that all forklift owners train their employees to use seat belts and enforce a policy requiring seat belt use. OSHA also requires that all operators use seatbelts in forklifts or other industrial trucks that are equipped with them. Although not a factor in this case, it should also be noted that OSHA may cite an employer who has not taken advantage of a manufacture's retrofit program to install seatbelts on older industrial trucks that are not equipped with seatbelts.
