NJ FACE INVESTIGATION REPORT

FACE 03-NJ-085

Hispanic Construction Worker Killed When Struck by Excavator Bucket

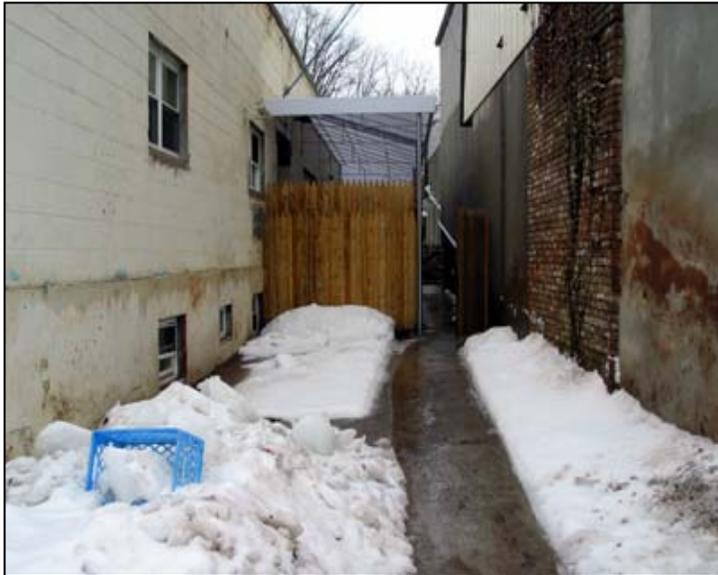
Photo 1
Driveway between two buildings. Incident occurred behind the new fence.

Discussion: This worksite was extremely hazardous in that heavy machinery was being operated in the close quarters of the driveway between two buildings. In addition, a supervisor was not present to oversee and direct the work. NJ FACE recommends that a supervisor inspect the worksite for hazards and restrict access by marking off the area with warning barriers or tape. The work should be closely supervised to prevent workers and others from entering the restricted area.

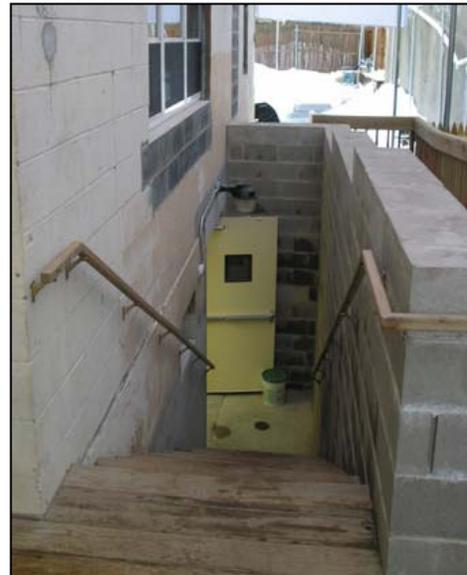
Photo 2
Completed stairway leading to the basement.

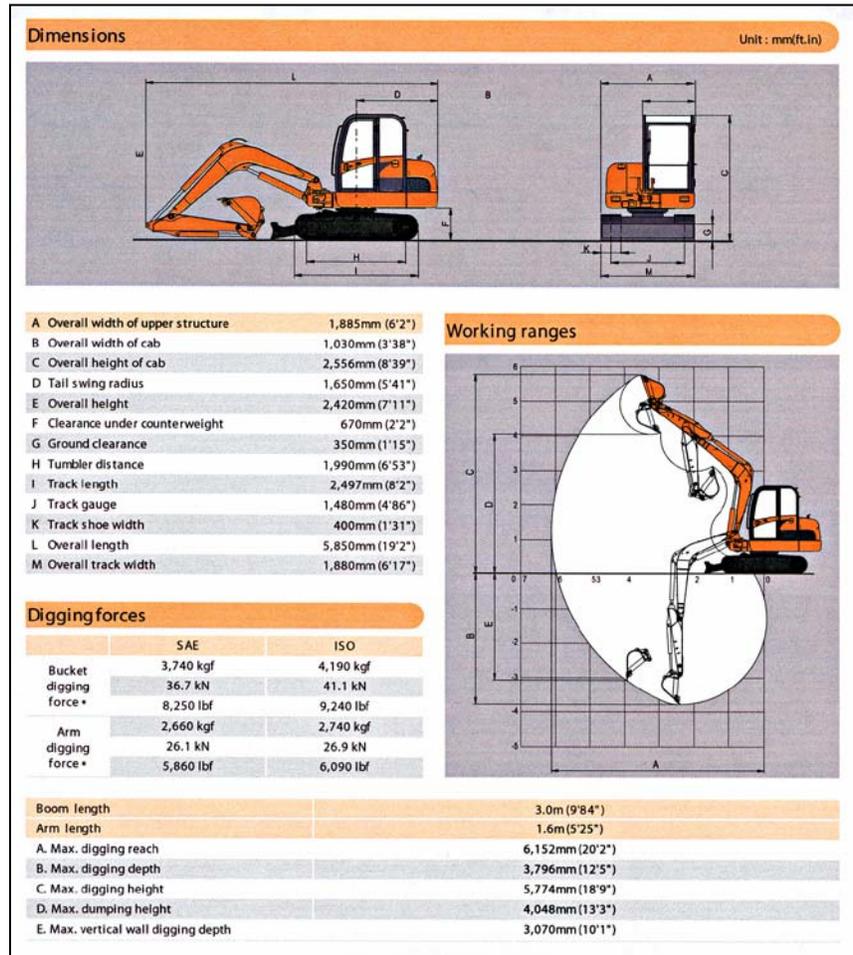
Illustration 1
Manufacturer's specifications for excavator
