NJ FACE INVESTIGATION REPORT

FACE 03-NJ-091

Hispanic Construction Worker Dies After Fall from an Improvised Scaffold

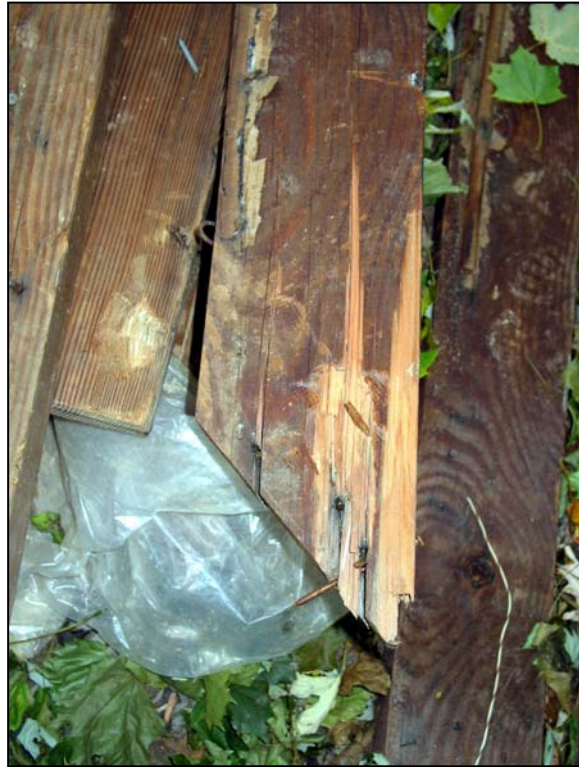
Photo 1
**Damaged wood used to make the
improvised scaffold**

Prior to the incident, the contractor and his crew had already demolished and rebuilt most of the rear section of the house. The crew removed the entire back section of the peaked roof, which had been built at a slope of approximately 45 degrees. All the discarded wood trusses and surrounding lumber from the rear roof was piled in the backyard of the house. They then rebuilt the roof at a pitch of approximately 10 degrees, effectively raising the roof of the house and greatly increasing the interior space. The rear wall was raised to support the new roof, and new windows were installed in the wall. This part of the project was done quickly to reduce the time the house was open to the weather. Once the new addition was built, the crew started installing vinyl siding on the outside of the house. The crew also started work on the interior of the addition. During the project, the crew built an improvised, homemade scaffold with the discarded lumber from the back yard. This scaffold was poorly built, using wood that had been damaged during the demolition (See Photo 1).

Discussion: The scaffold used in this incident was an improvised, homemade scaffold made with scrap wood left over from the demolition work. This scaffold was unsafe and could have collapsed at any time. The unguarded wood plank from which the victim fell was an extension of this scaffold and was inherently unsafe. NJ FACE recommends that employers and employees always use properly designed and assembled commercial scaffolds and/or ladders when working at heights. The employer did own a commercial metal scaffold, but it was not in use at this jobsite.

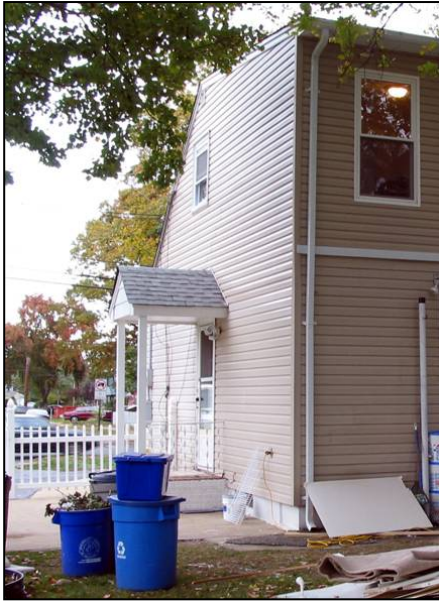
Photo 2
Porch roof peak used to support the scaffold plank

The incident occurred on Wednesday, October 1, 2003. The weather was clear with a reported temperature of 75 degrees. The company owner and a crew of three workers arrived at 8:00 a.m. to continue work on the house, which they had started the week before. The day went uneventfully, with the workers installing vinyl siding on the house. At approximately 4:30 p.m., the victim arrived at the jobsite after just having flown in that day from Costa Rica. The company owner (his son) was away from the work site to get a gutter, so the victim started installing siding on the side of the house. He was standing on a 2" by 6" wood plank set 10" 5" above a concrete walkway. One end of the plank was placed on the peak of a small porch roof, and the other end rested on the improvised scaffold at the back of the house.
