NJ FACE INVESTIGATION REPORT

FACE 08-NJ-052

55-Year-Old Communications Tower Worker Killed After Falling 60 Feet

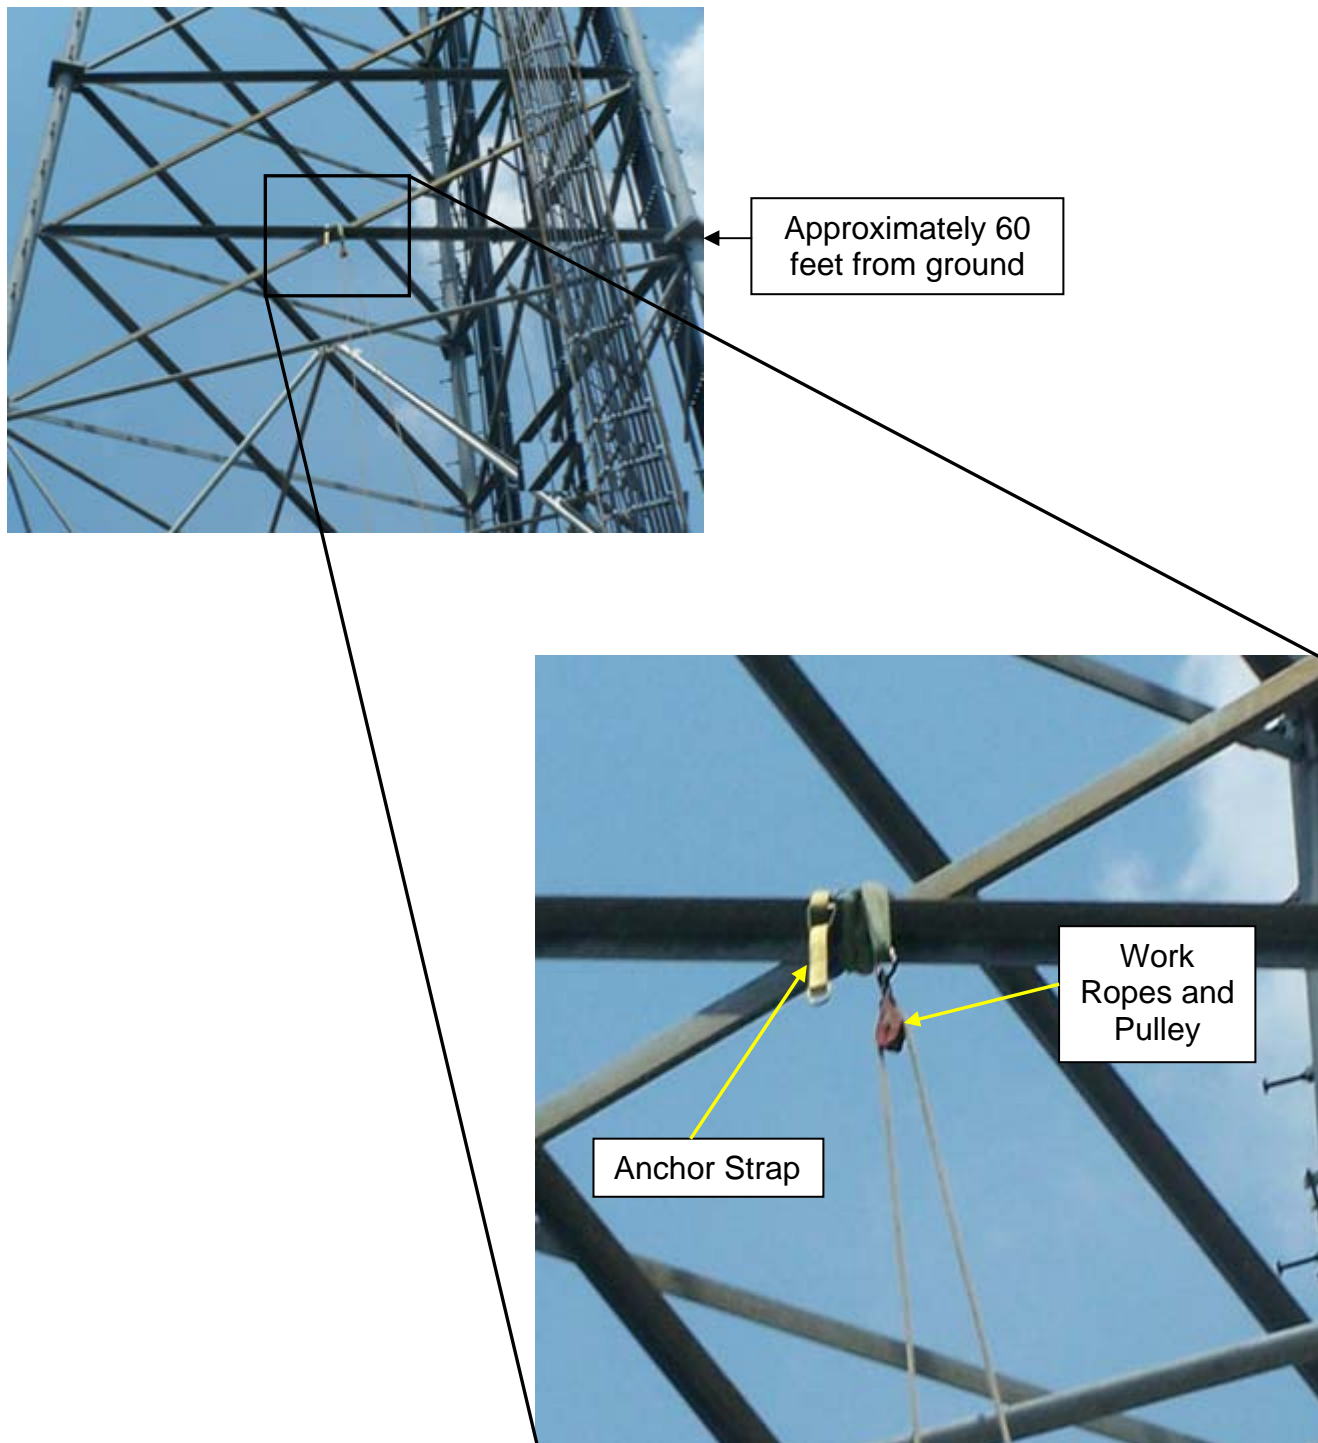
As noted above, the anchor strap was affixed to one of the horizontal beams of the tower, and was used as the connection point of the lifeline and harness strap. The victim had on a harness with various pieces of equipment attached; a lifeline was connected that also contained an in-line Fisk (the controlled descent device; see Figure 2). One end of the lifeline had a loop knot which is connected directly via carabiner to the anchor strap. The other end of the lifeline has a slip knot which was also connected via carabiner to the anchor strap. The line was fed through the worker's harness and through the Fisk, which he used to control his descent. When ready to descend, a worker would unhook the slip knot to allow the line to move through the Fisk, providing the ability to lower to the working elevation.

According to Worker #2, as the victim was preparing to lower himself into position, he unhooked the harness strap carabiner from the anchor strap instead of the slip knot carabiner. Then when he sat into position, the weight pulled his lifeline free from the anchor strap, and he fell backwards 60 feet to his death.

FIGURE 1: Work site on tower. Note the anchor strap and work ropes at the 60 foot elevation point where the deceased was working.

A separate fall arrest system (e.g., a separate lifeline with rope grab) could have prevented this incident. As per OSHA 29 CFR 1926.502(d), *Fall protection systems criteria and practices, personal fall arrest systems*, employers are required that, "...where vertical lifelines are used, each employee shall be attached to a separate lifeline."

Recommendation #1: Tower workers should utilize a separate fall protection system when employing vertical lifelines or controlled descent devices.

In this incident, the controlled descent device (Fisk) was being used as fall protection. Fisk descenders were developed by rock climbers for intermittent rappelling, or episodes of free falling followed by brief periods of control. This is not recommended for safe working conditions on a communications tower. If a proper fall arrest system is appropriately rigged, a worker cannot fall more than 6 feet before the system activates. Fisks are sometimes used because they are easier to master than other descent tools. The preferred method of descent device, however, is the rope grab or rope brake, which enable the automatic repositioning of the connection to the separate fall protection system. These devices lock onto a line under stress, are generally attached to a static lifeline, and have either shock absorbers or the ability to stretch. In this case, a Fisk was used in place of a rope grab because the rope grab was considered by workers to be an encumbrance, and “where wind would blow, it would hit us in the head.” If a manual descending system such as a Fisk is used, a separate fall protection system must be in place. The OSHA *Fall Protection Standard*, 29 CFR 1926.502(d)10i, requires that, “...where vertical lifelines are used, each employee shall be attached to a separate lifeline.” Proper fall arrest systems should also conform to ANSI/ASSE Z359.1-2007, *Safety Requirements for Personal Fall Arrest Systems, Subsystems and Components*, which, “Establishes requirements for the performance, design, marking, qualification, instruction, training, inspection, use, maintenance and removal from service of connectors, full-body harnesses, lanyards, energy absorbers, anchorage connectors, fall arresters, vertical lifelines and self-retracting lanyards comprising personal fall arrest systems for users within the capacity range of 130 to 310 lb (59 to 140 kg).”

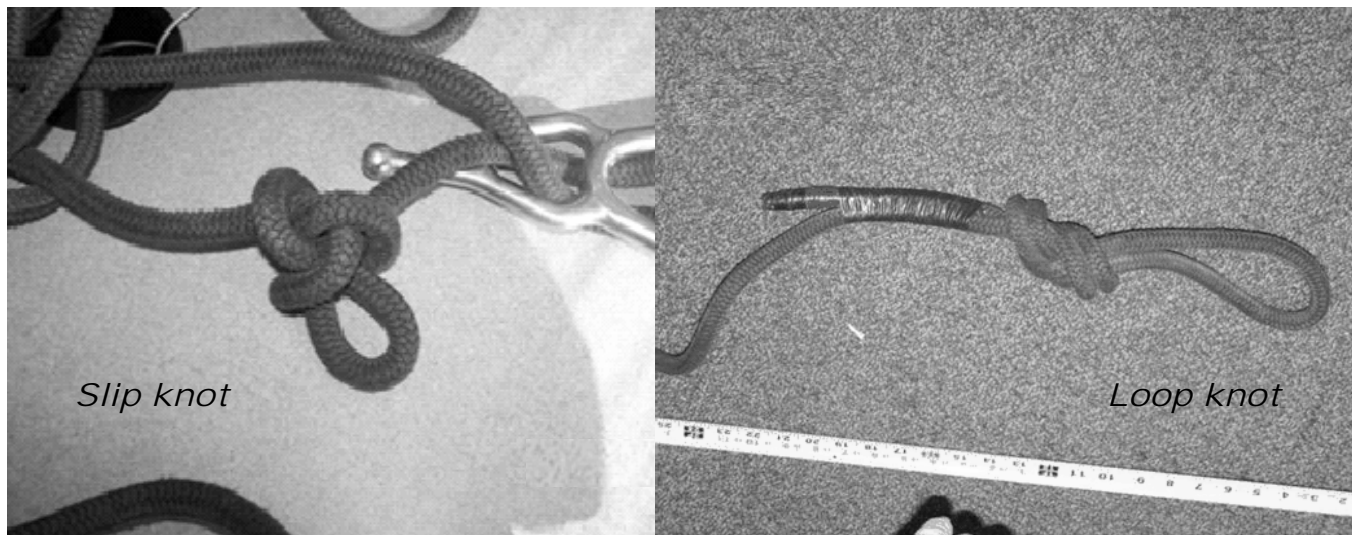
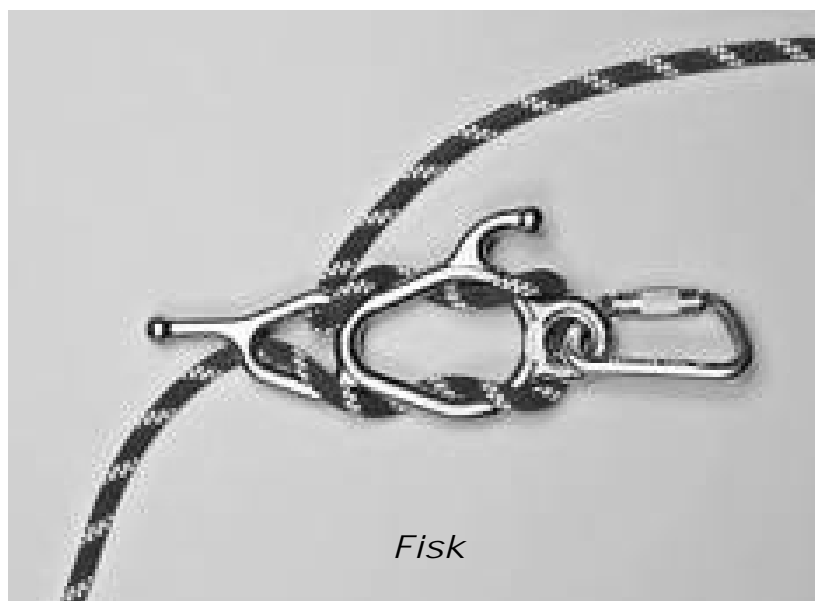
FIGURE 2. Lifeline: Controlled descent device or Fisk, along with slip knot and loop knot at each end of the lifeline.
